Akaroa Court House PRO 3635-005

**Detailed Engineering Evaluation
Quantitative Assessment Report**

71 Rue Lavaud, Akaroa

Jan Stanway Senior Structural Engineer CPEng 222291	Date: March 2014 Reference: 6-QUCCC.78 Status: Final V2

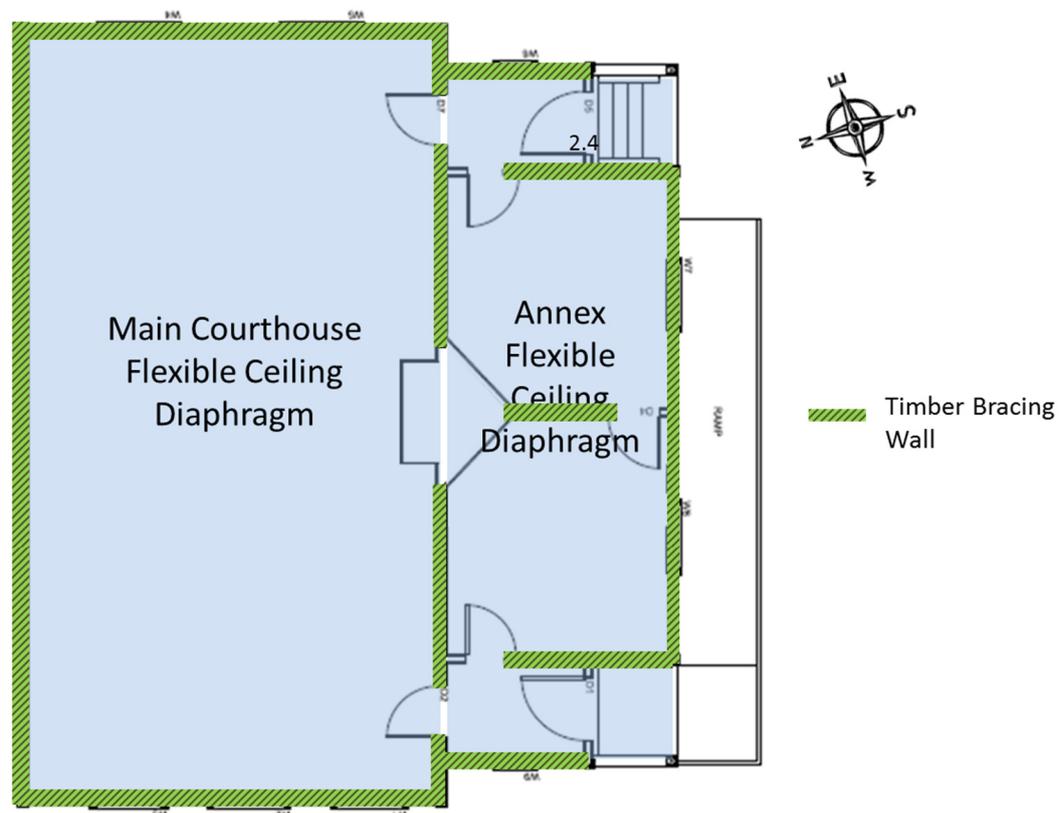
Figure 3: Building Layout and Location of Timber Bracing Wall

The lateral load resisting system in both principal directions are the perimeter and internal timber framed walls acting as bracing walls. The walls are assumed to be constructed with continuous let-in diagonal timber braces, which was a typical timber construction practice at the time. An overview of the key lateral resisting elements is as shown in Figure 3 below.

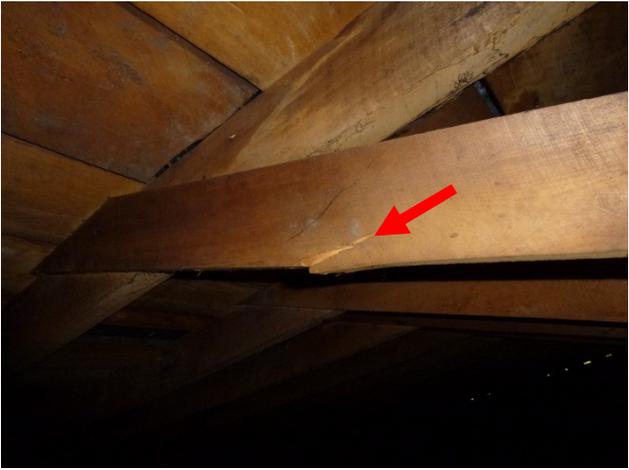
No observed earthquake related damage. A minor crack to a courtroom roof timber collar was noted. See Photo 2 in Appendix 1.

2.	Minor crack to timber collar at courtroom roof framing.

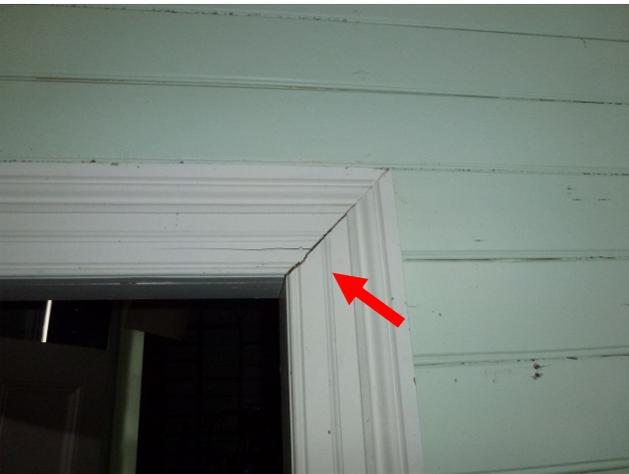
No observed earthquake related damage. A minor crack to the corner of door jamb in the annex was noted. See Photo 3 in Appendix 1.

A photograph showing a close-up of a wooden timber collar in a roof structure. A red arrow points to a small, dark crack running along the length of the timber.
3.	Minor split at corner of door jamb in annex

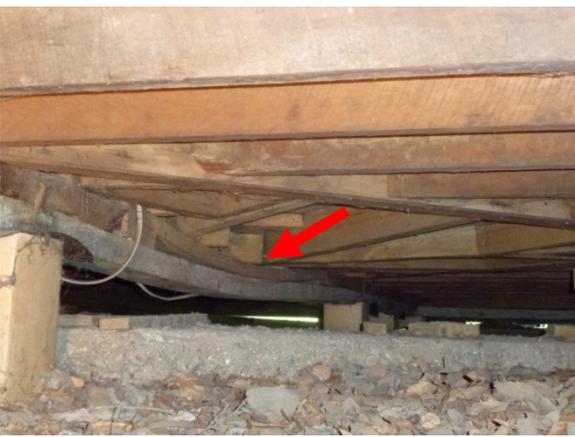
No observed earthquake related damage to the timber flooring. However, there was a timber bearer sagging significantly below where the former central fireplace/chimney was located. See Photo 4 in Appendix 1. The bearer at this location appeared to be spanning longer than average spacing of the piles. This appears to be the likely cause of the sagging. Furthermore, there is an existing air conditioning unit located directly above this location. The vertical acceleration due to the recent earthquake may have worsened the condition.

Due to constrained access at the time of investigation, it could not be determined if there was any cracking to the bearer or surrounding joists. Further investigation is recommended, prior to re-occupying the building to establish the extent of the damage.

A photograph of a white-painted door jamb in an annex. A red arrow points to a small vertical split or crack at the top corner of the jamb.
4.	Sagging bearer below former internal fireplace / chimney

- a. As a matter of priority, replace or upgrade existing substructure with a foundation system of sufficient lateral resistance.
- b. Repair sagging bearer below the former fireplace; and investigate and repair as necessary the adjacent structural members.

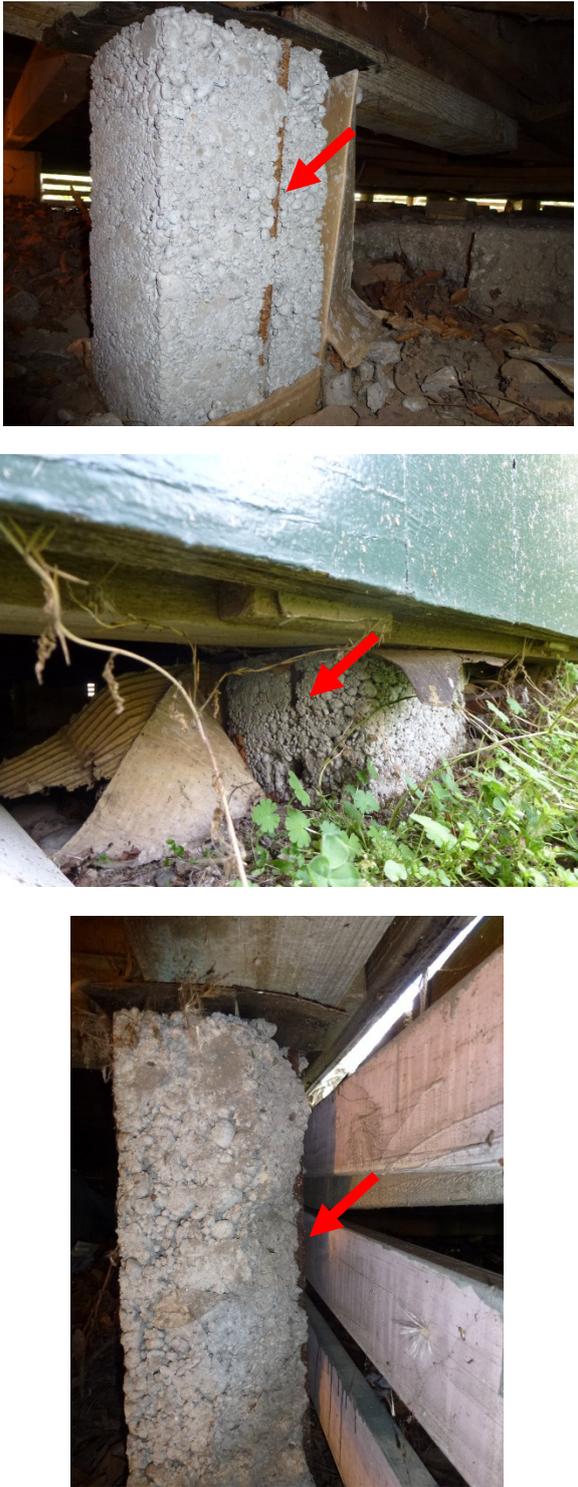
Most of the piles were wrapped in cardboard formwork used in the construction of the in-situ concrete piles. For those concrete piles that could be visually inspected, no major earthquake related damage was observed. However, they showed signs of serious honeycombing due to the

concrete not being well vibrated when formed. Some of the reinforcement has no concrete cover and are subject to continuous corrosion. See Photo 5 in Appendix 1.

<p>5.</p>	<p>Exposed reinforcing bar and honeycombing to concrete piles</p>

Due to the poor condition of the existing piles and the lack of lateral bracing capacity (as described further in Section 8), it is recommended that the entire foundation to be upgraded or replaced to a foundation system that has a capacity sufficient for the design loads as a matter of priority .

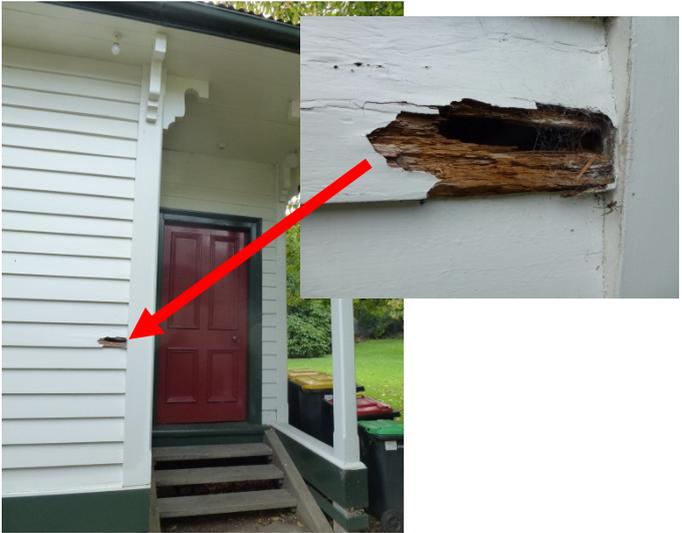
- Degrading weatherboard adjacent to the south east entrance. See Photo 6 in Appendix 1.
- Signs of degrading internal timber match lining below the east elevation window. See Photo 7 in Appendix 1.

<p>6.</p> <p>Rotting weatherboard adjacent to south east corner entrance</p>

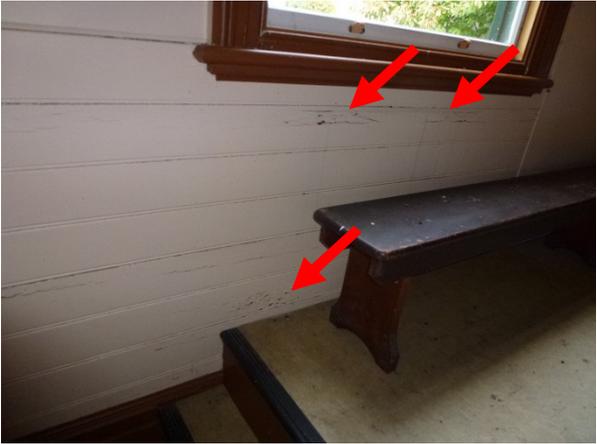
<p>7.</p> <p>Decaying timber matchlining below the east elevation window</p>

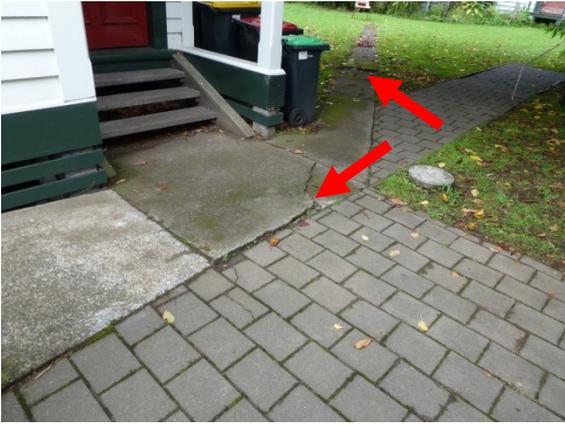
The existing foundations of the Akaroa Court House building appear to have performed satisfactorily in the recent seismic events. No liquefaction has been observed on site. The heave that appears to have occurred to the concrete footpath on the south east corner of the building is most likely to have occurred during construction. Due to the likely presence of silty gravels at shallow depths, the risk of lateral spreading and liquefaction induced settlement is considered low. No further geotechnical testing is recommended at this location.

<p>8.</p> <p>Up to 20mm of apparent ground heave on the concrete footpath</p>

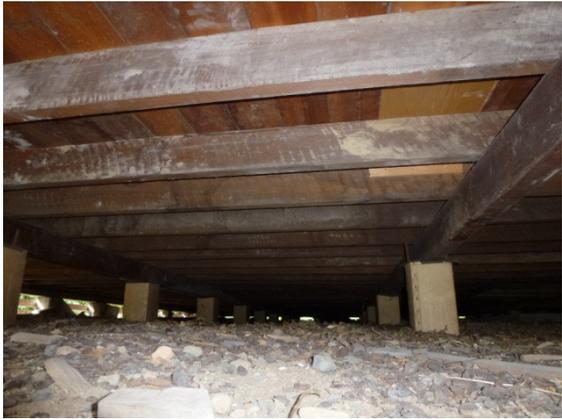
- There does not appear to have been any liquefaction in the vicinity of the building.
- The Akaroa Court House building appears to be founded on square concrete piles at regular grid (See Photo 9 of Appendix 1). Structex report dated 19th May 2011 identified deterioration of the pile condition under exterior walls. Opus Structural Engineer has undertaken invasive investigation to assess pile condition and pile footing type and depth. The results of the investigation are presented in Section 6.4 of this report.

<p>9.</p>	<p>Concrete piles below timber flooring</p>
