Akaroa Place de la Poste Toilets

PRK 3644 BLDG 002 EQ2

**Detailed Engineering Evaluation
Quantitative Report**

Date: November 2012
Reference: 6-QUCC1.40
Status: Final

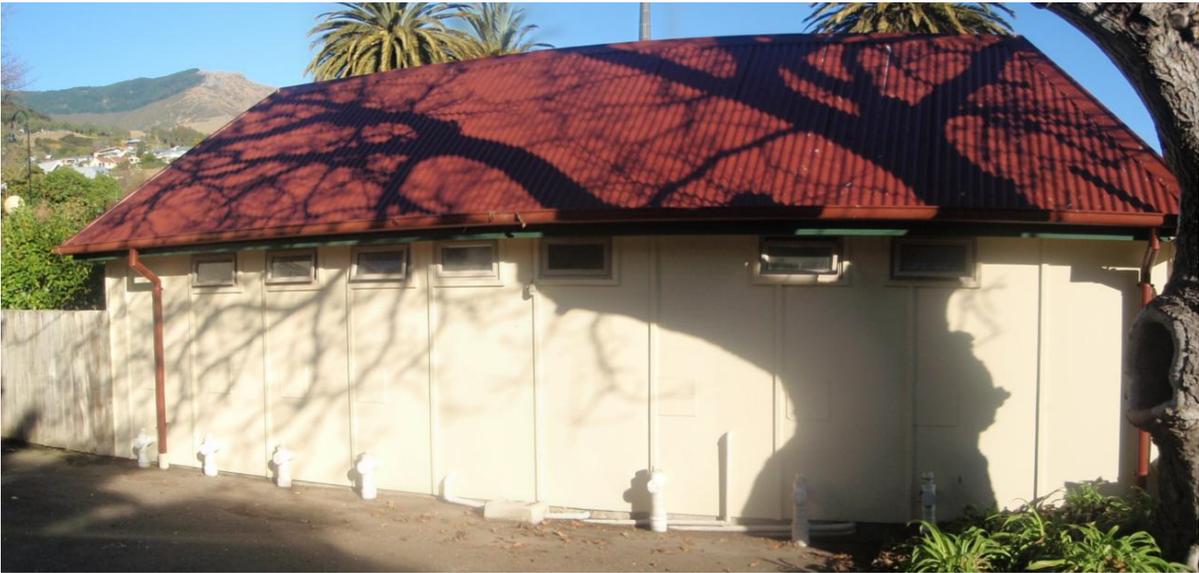
Photo 1: The north wall of the building.

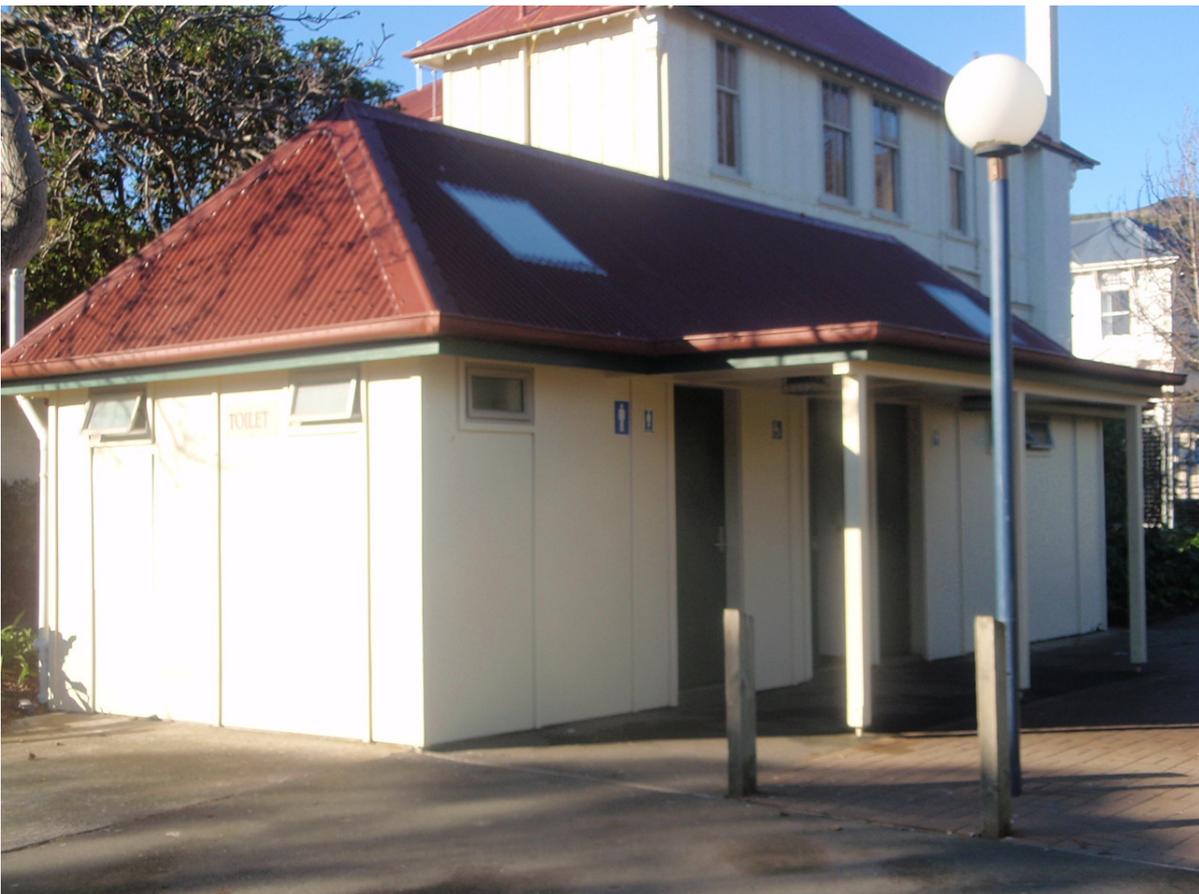
Photo 2: The south and west walls of the building.

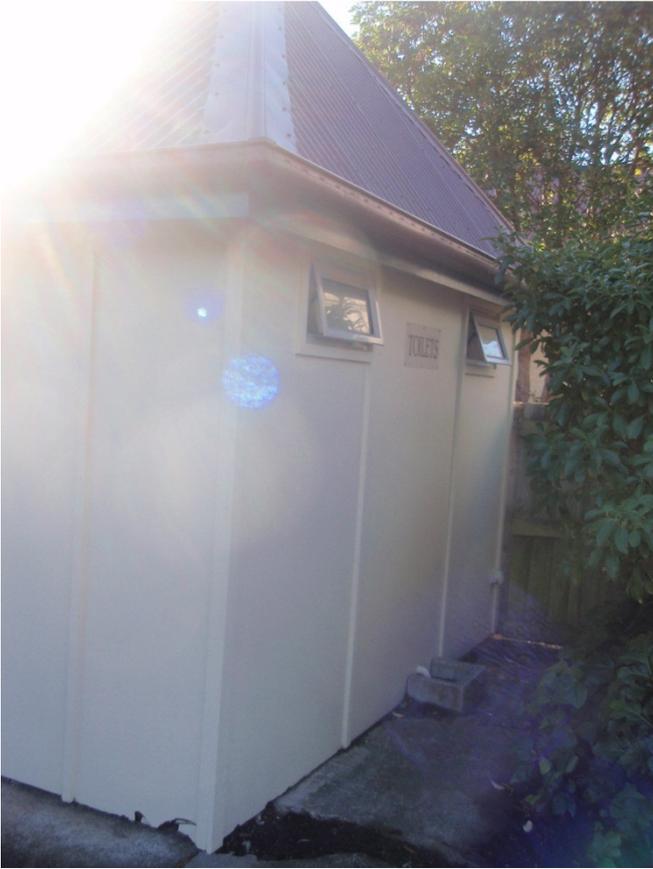
Photo 3: View of the east wall.

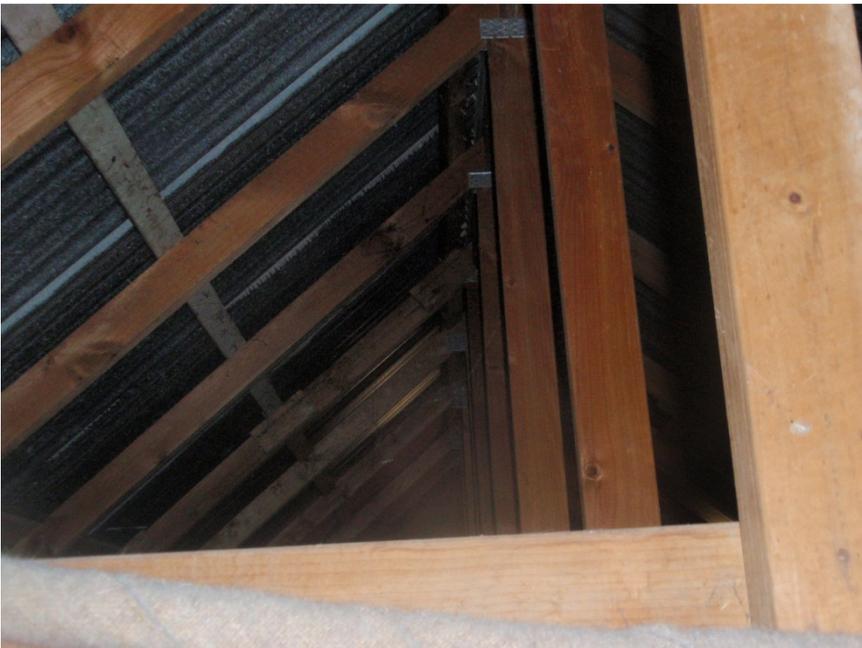
Photo 4: View of the roof trusses.
