**Akaroa Recreation
Ground Toilets
PRK 3739 BLDG 001 EQ2**

**Detailed Engineering Evaluation
Quantitative Assessment Report**

Date: November 2012
Reference: 6-QUCC1.41
Status: Final

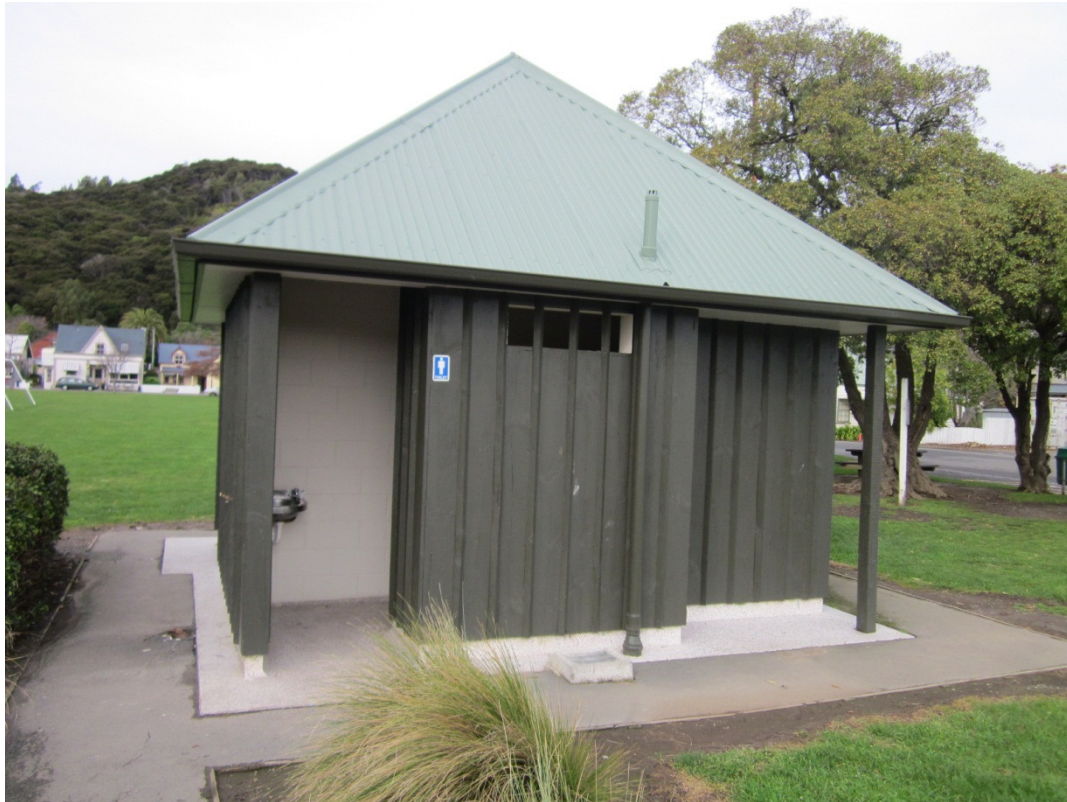
Photo 1: General photo of the structure

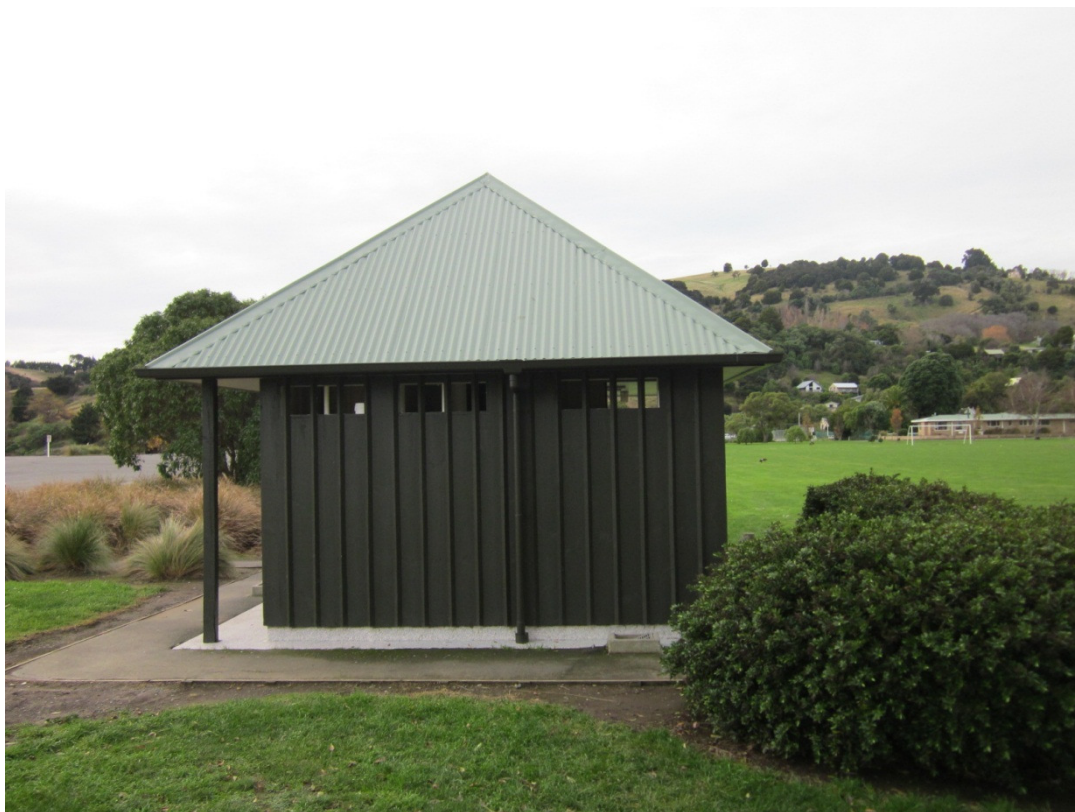
Photo 2: General photo of the structure

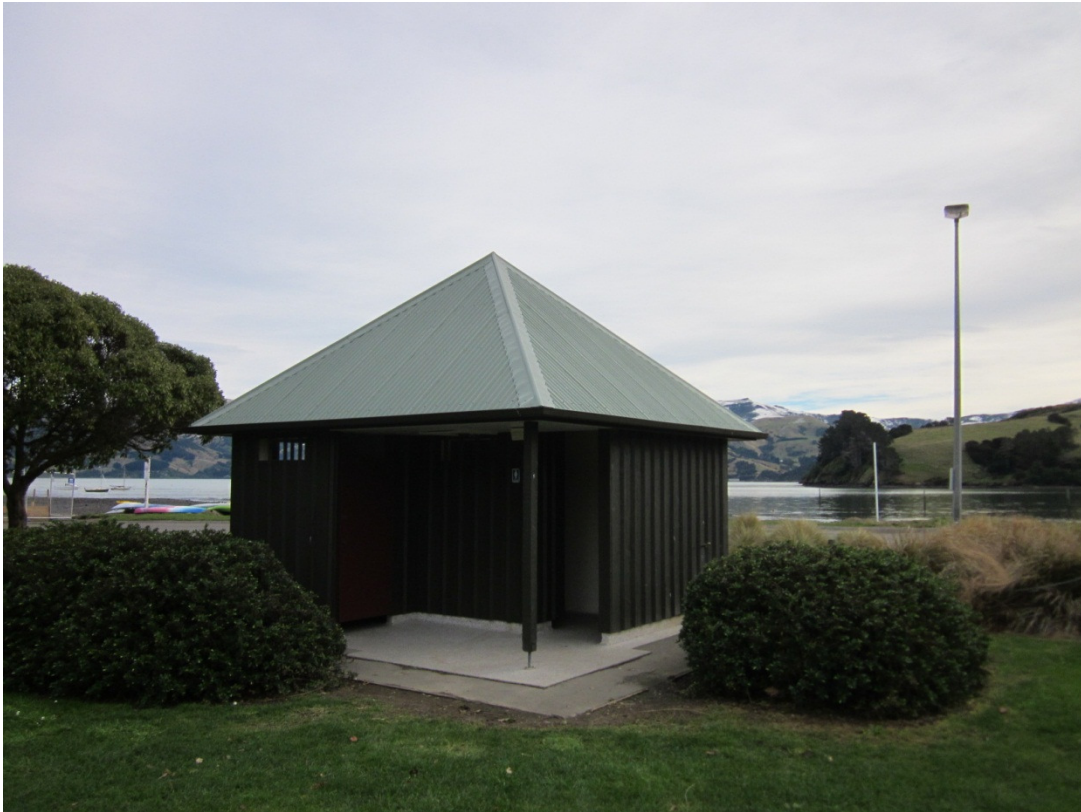
Photo 3: General photo of the structure
