**Allandale Domain Toilets**  
**PRK 3565 BLDG 006**  
Detailed Engineering Evaluation  
Qualitative Report  
Version FINAL V.1

133 Governors Bay Teddington Road, Governors Bay

Christchurch City Council

**Date**  
17<sup>th</sup> May 2013

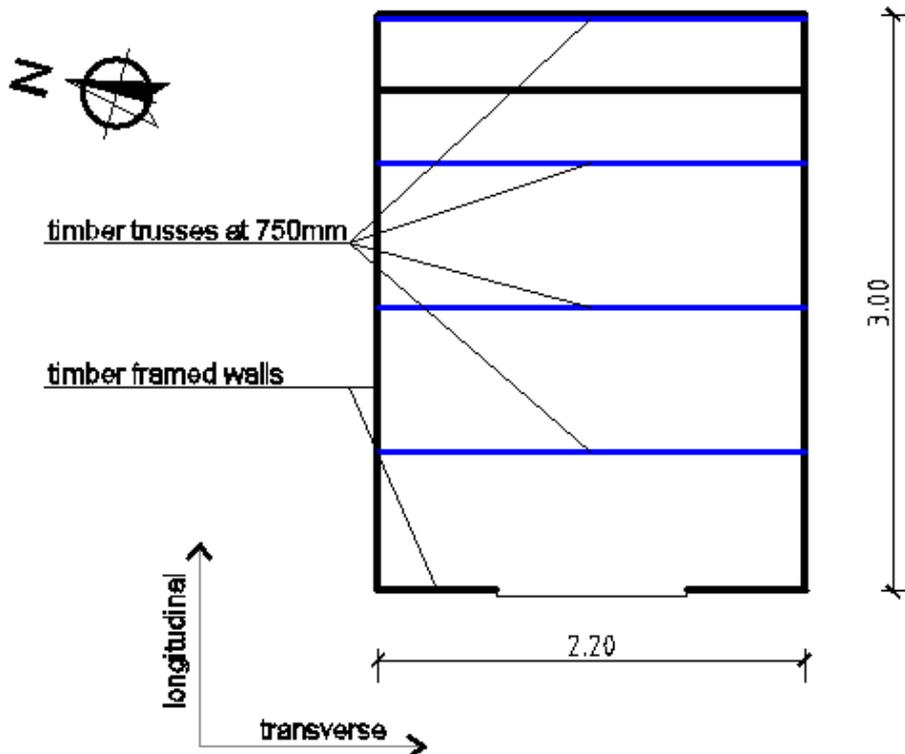
**Figure 2 Plan Sketch Showing Key Structural Elements**

The roof consists of corrugated iron cladding, 75x50mm purlins spaced at 800mm and timber trusses spaced at approximately 750mm centres.

There is a partition wall splitting the toilet into two sections, a large cubicle and a smaller services duct. Both the perimeter and partition walls are timber framed.

Internally, the walls inside the cubicle are clad with villa board lining while the walls inside the services duct are bare. Externally, the perimeter walls are clad with timber weatherboards and stone veneer on their top and bottom half's respectively.

The structure sits on a raft foundation.

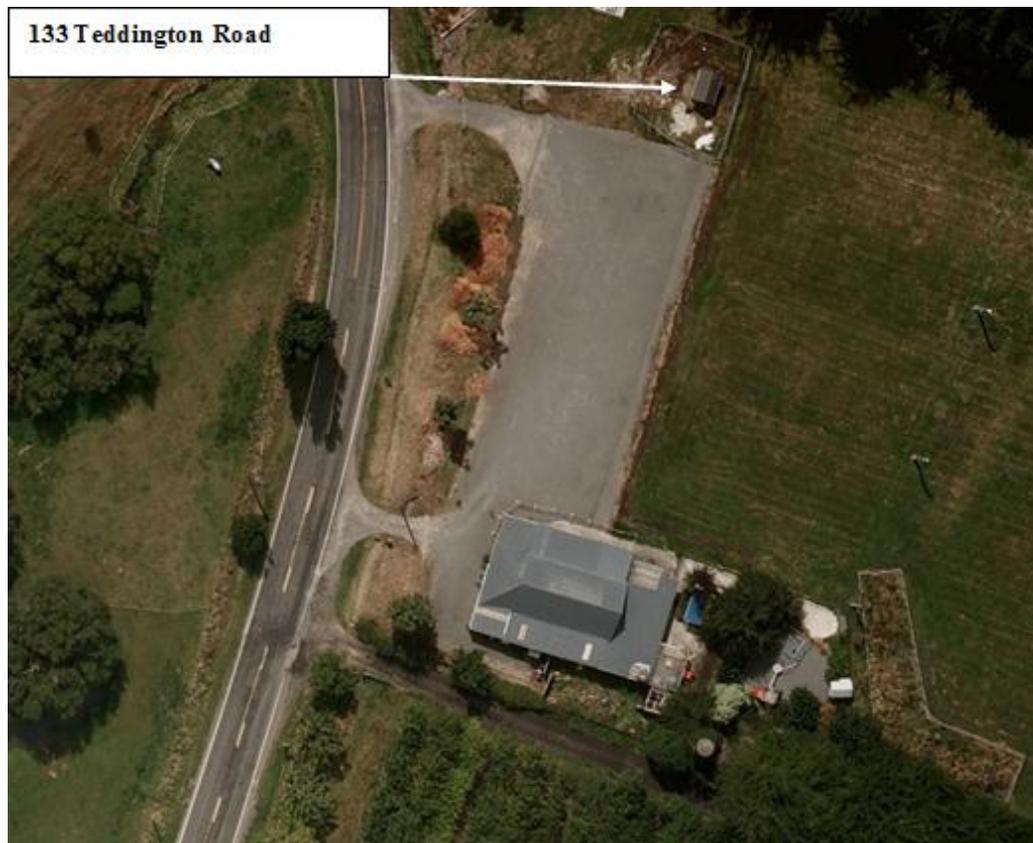
**Figure 3 Post February 2011 Earthquake Aerial Photography**<sup>3</sup>

Aerial photography taken following the 22 February 2011 earthquake shows no signs of liquefaction outside the building footprint, as shown in **Figure 3**.

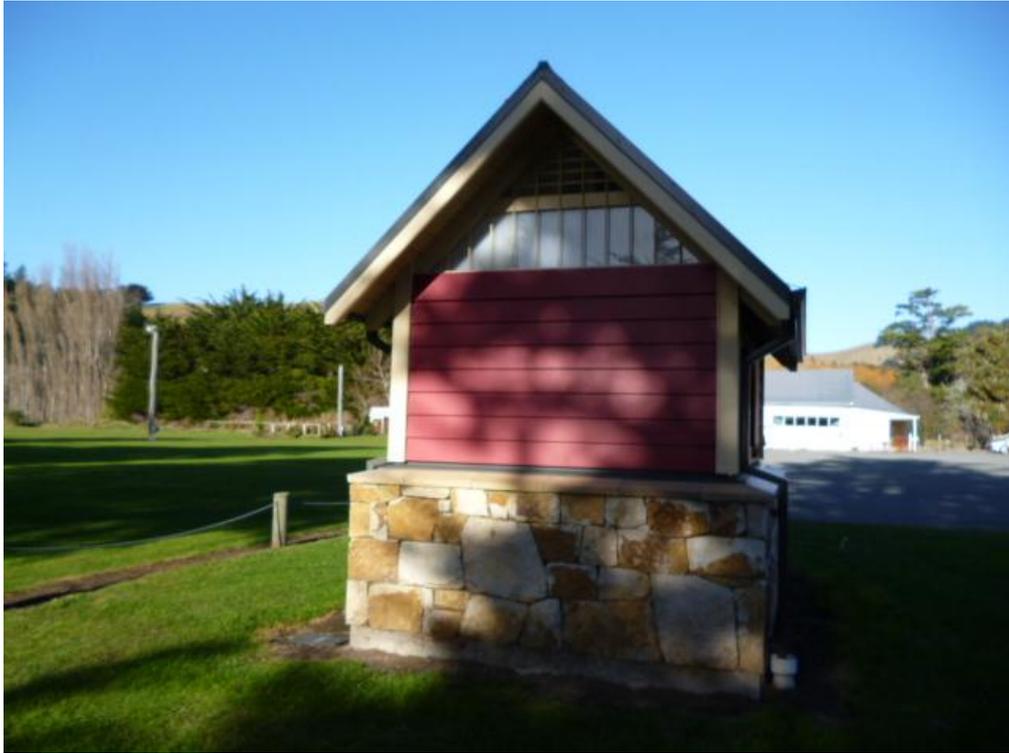
**Photograph 1 Northern elevation.**

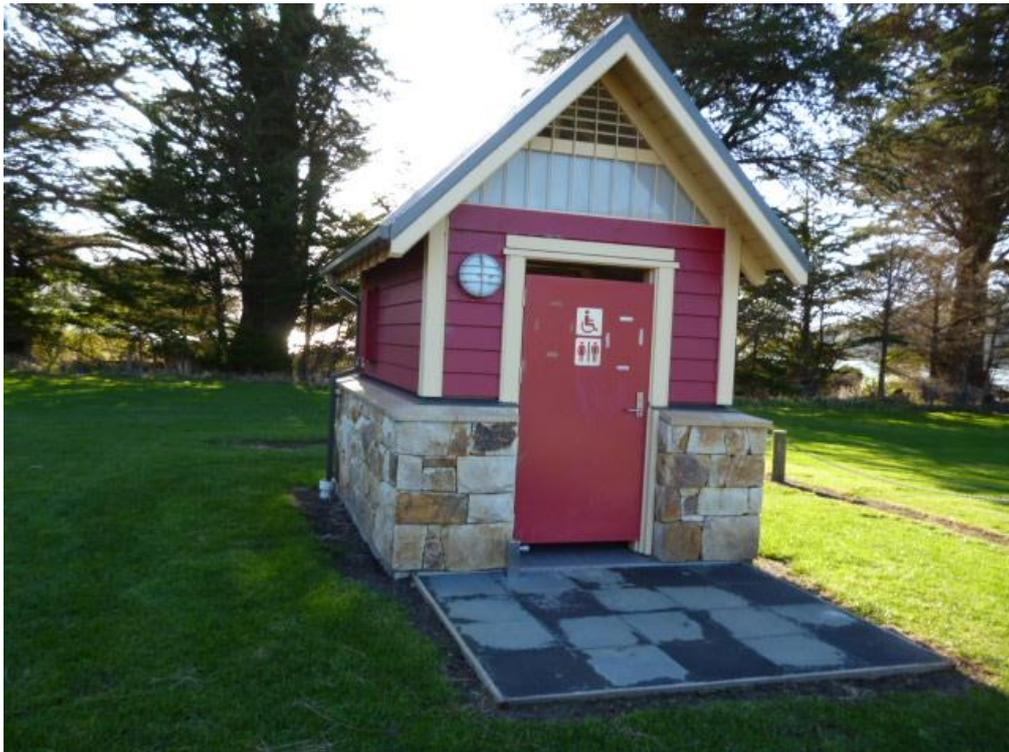
**Photograph 2 Southern elevation.**

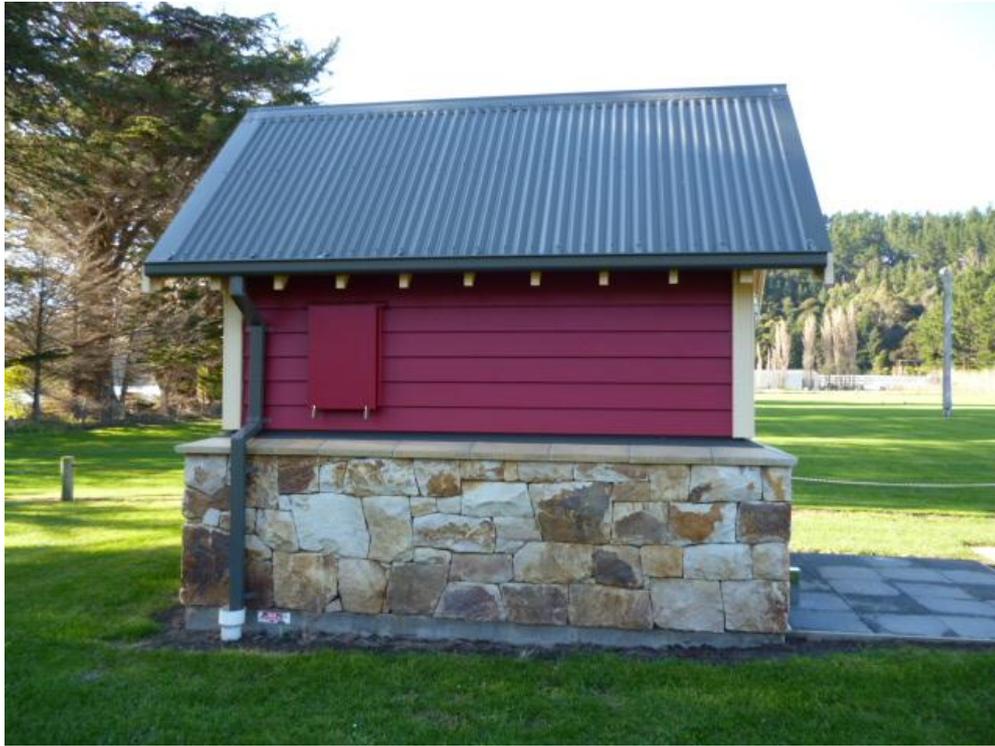
**Photograph 3 Western elevation.**

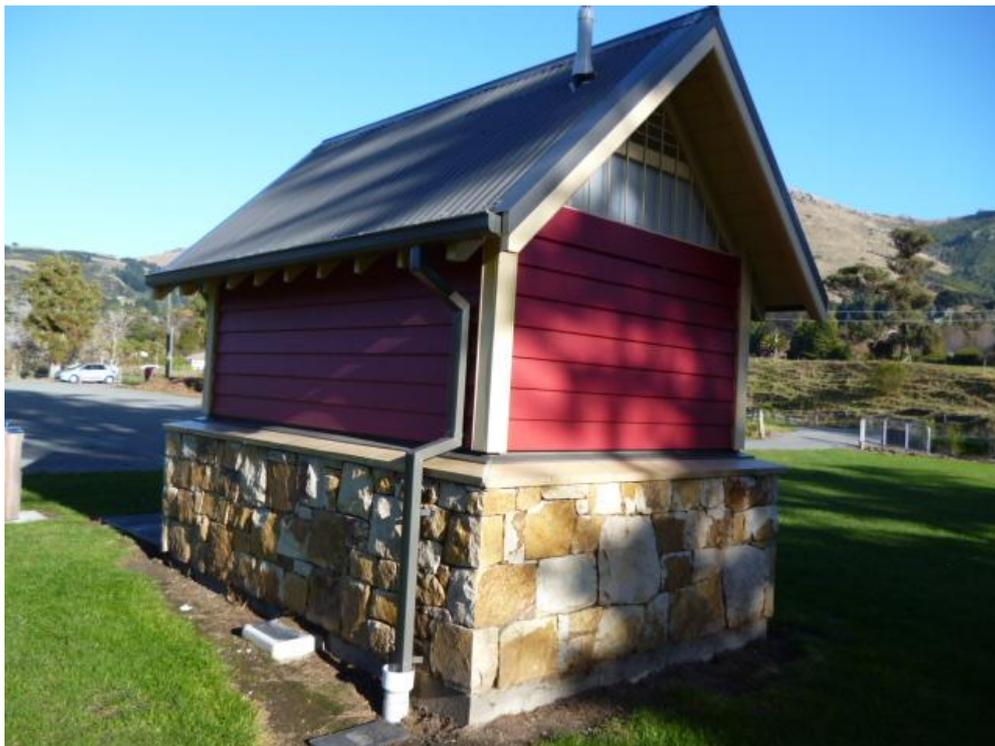
**Photograph 4 Eastern and northern elevations.**

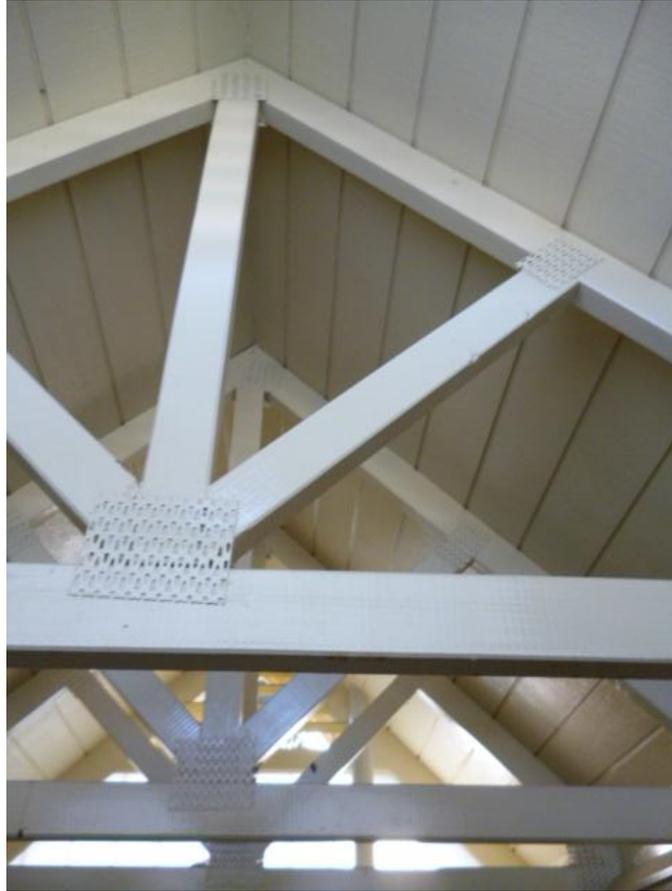
Rigid connections between the roof trusses, wall plates and timber purlins form a rigid braced frame.

**Photograph 5 Roof Trusses.**

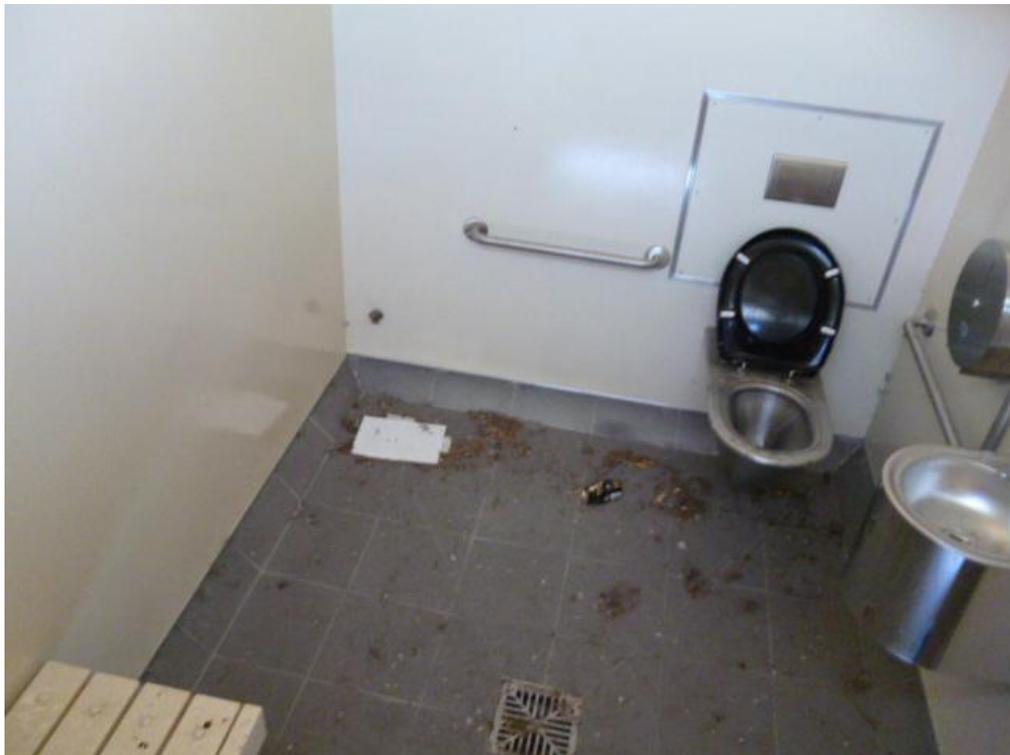
**Photograph 6 Interior flooring.**
