**Alma Place
Housing Complex
PRO 0715**

**Detailed Engineering Evaluation
Quantitative Assessment Report**

1 - 25 Alma Place, Shirley, Christchurch

Date: November 2013
Reference: 6-QC305.00
Status: Final

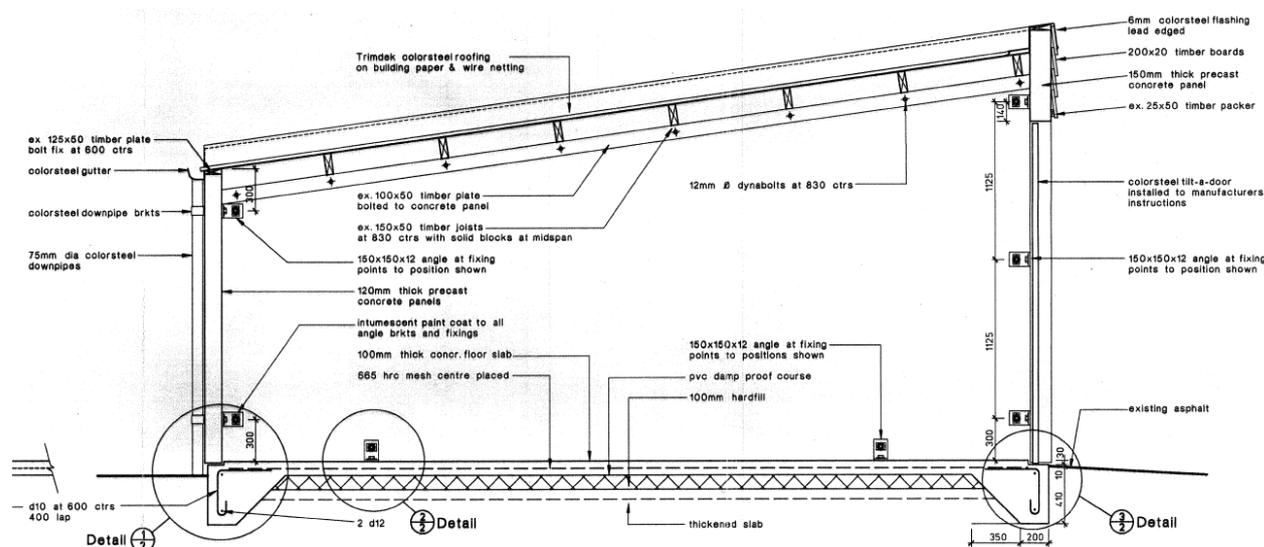
Figure 5: Cross section of panels and fixing for garages.

The storage garages have a capacity of 39% NBS as limited by the in-plane capacity of columns in the front wall in the longitudinal direction. The residential units have capacities of 58% NBS and are limited by the in-plane shear capacity lined timber-framed shear walls in the longitudinal direction.

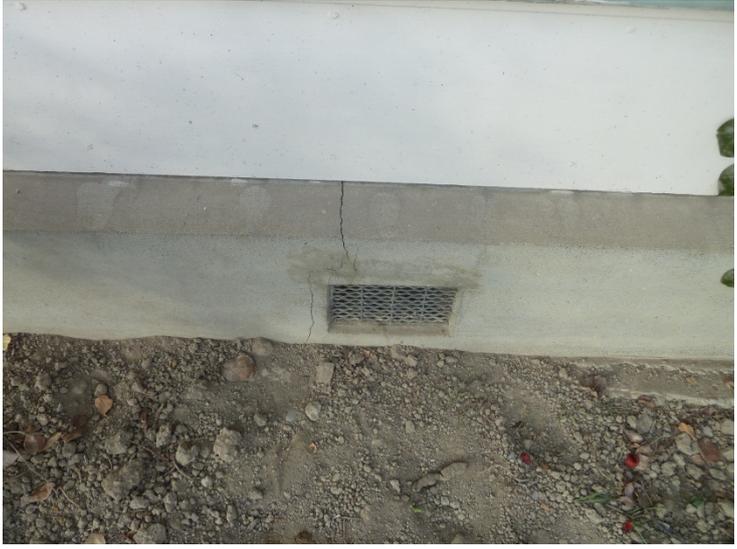
Cracks around the vents to the foundations were observed on most of the residential units.

10	Typical cracking around the vents in the perimeter foundations of the units

- A strengthening works scheme be developed to increase the seismic capacity of all buildings to at least 67% NBS. This will need to consider compliance with accessibility and fire requirements.
- Cosmetic repairs be undertaken.
- Veneer at height (gable ends) have their veneer ties checked.

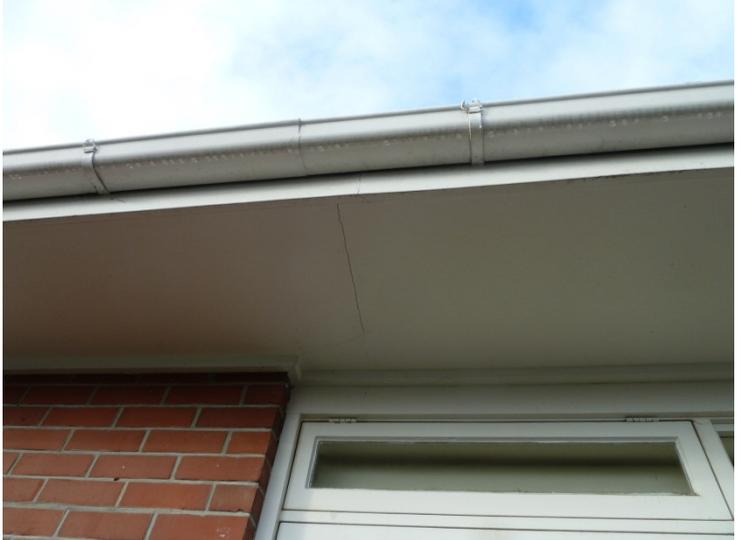
A minor amount of cracking was observed in the cladding under the eaves.

11	Typical cracking in the soffit of the units

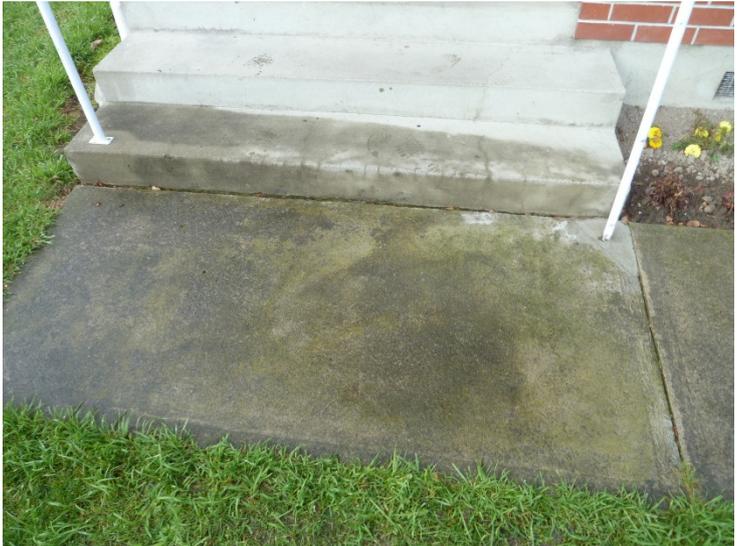
12	Separation between steps and walkway

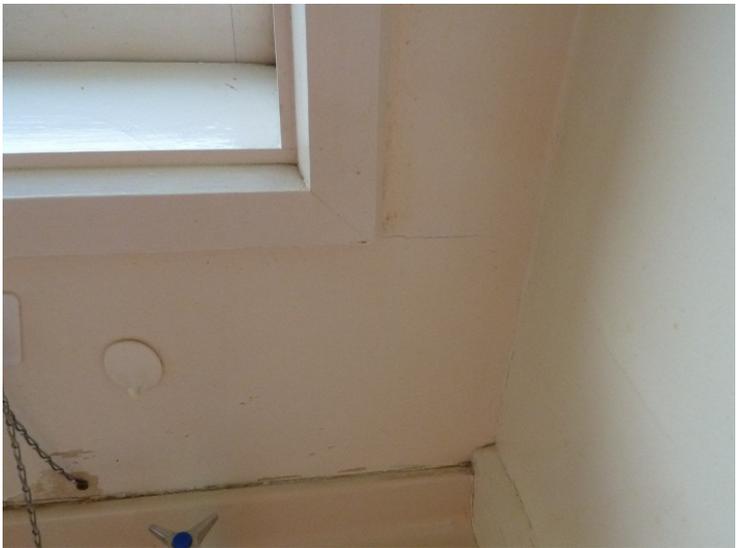
Some minor cracking of plasterboard-lined walls was observed in majority of the units that were inspected.

13	Typical cracking in the GIB lined walls around the windows

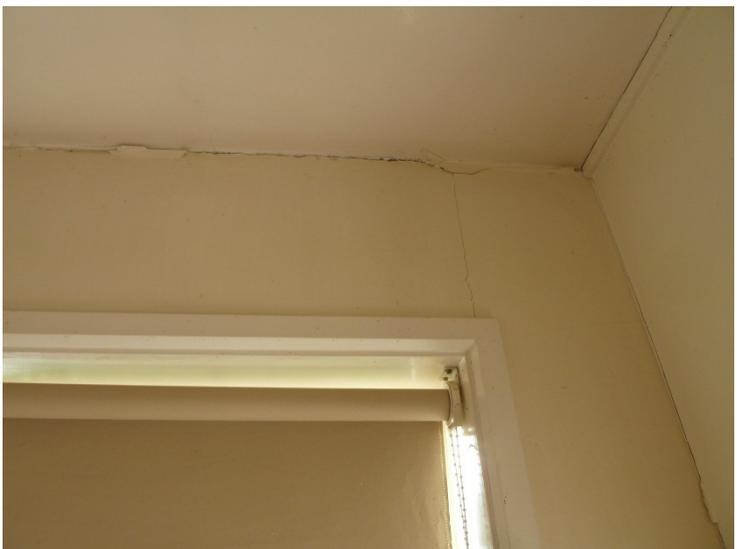
14	Typical cracking between the wall and ceiling lining

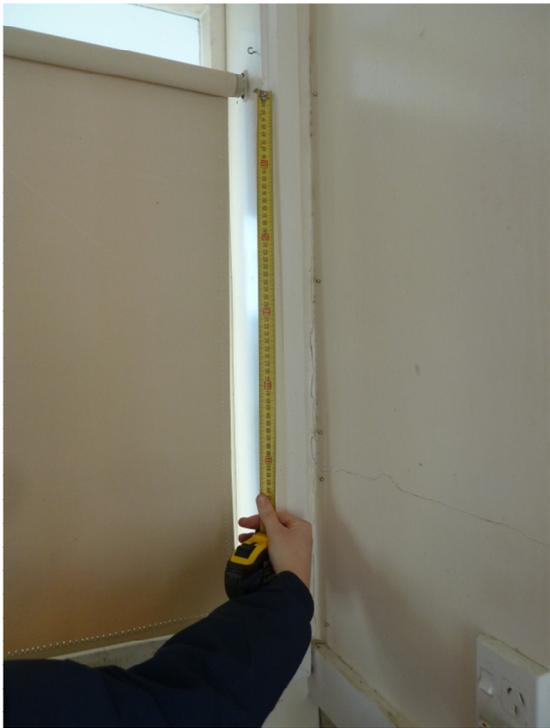
15	Typical cracking where the GIB wall linings have been joined. Image showing spacing of GIB screws
