Angus Courts Housing Complex PRO 1144

**Detailed Engineering Evaluation
Quantitative Assessment Report**

Angus Courts Housing Complex Quantitative Assessment Report

Date: February 2014
Reference: 6-QC307.00
Status: Final

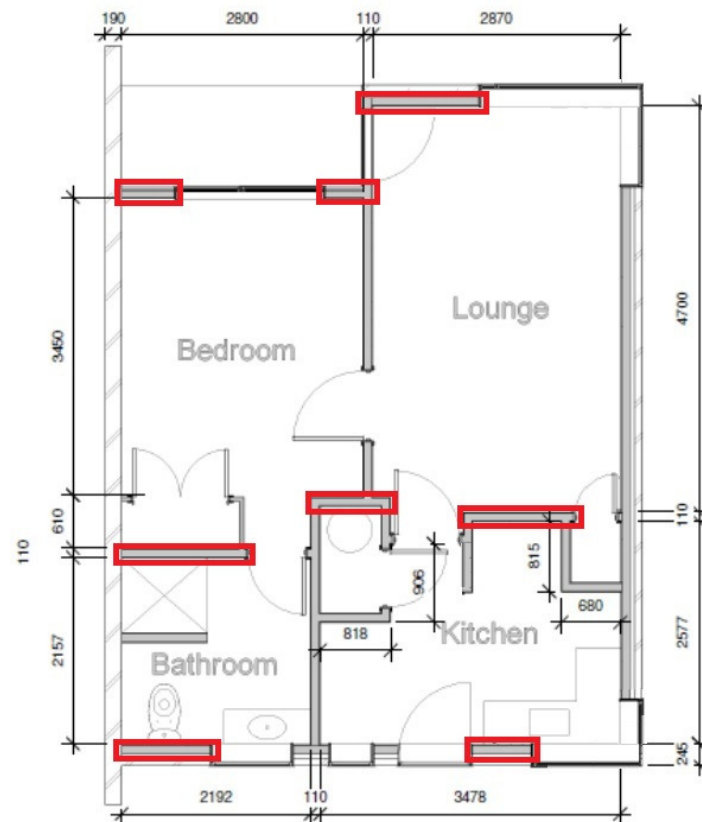
The blocks have capacities of 54% NBS as limited by the in-plane shear capacity of the timber-framed walls in the longitudinal direction.

Figure 6: Walls used for bracing in the longitudinal direction.

- Strengthening schemes be developed to increase seismic capacity of all blocks to 67%NBS.
- Cosmetic repairs be undertaken as required.

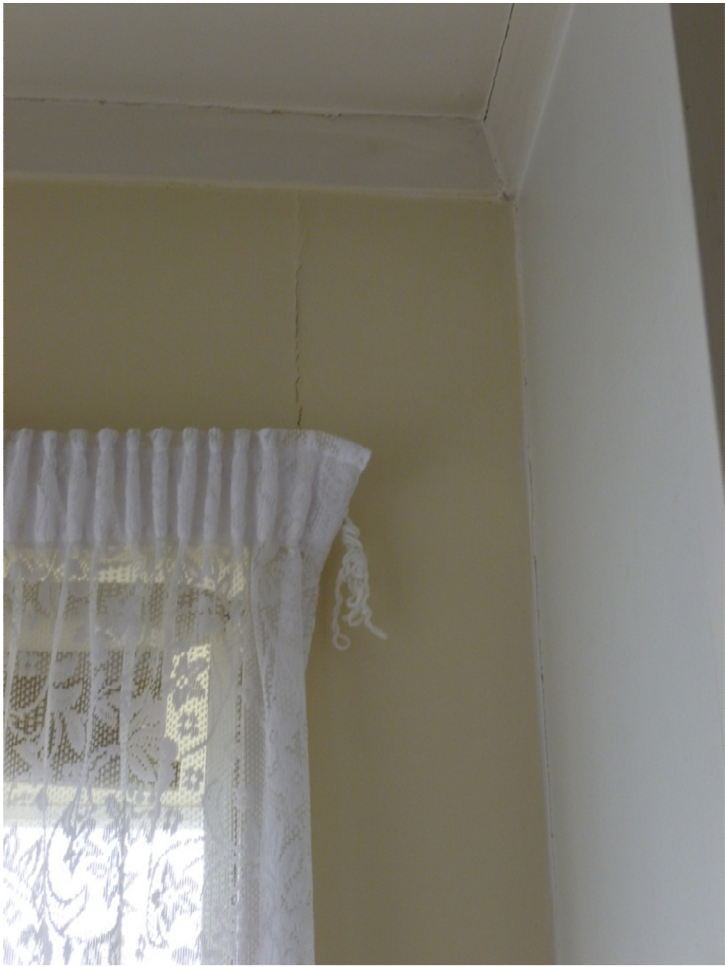
Minor cracking in the plasterboard was observed typically above doors and at the ceiling to wall intersection. Minor cracking was also observed in the ceiling diaphragms. This damage is considered minor and does not affect the lateral resistance of the structure.

A photograph showing a vertical crack in the white plaster above a window. The window is covered with a white lace curtain. The crack runs from the top of the window frame up towards the ceiling.
10.	Typical cracking at ceiling

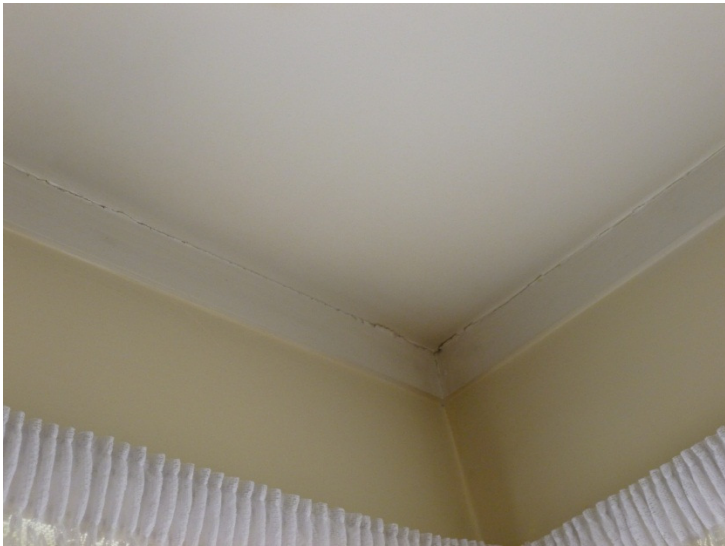
A photograph showing a corner of a room where the ceiling meets the walls. There is visible cracking in the white plaster along the top of the walls and at the corner of the ceiling.

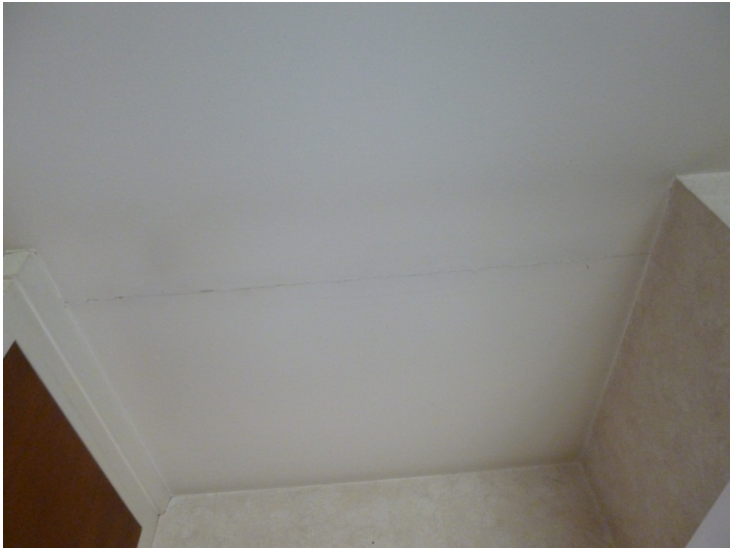
11.	Typical cracking of the ceiling diaphragm

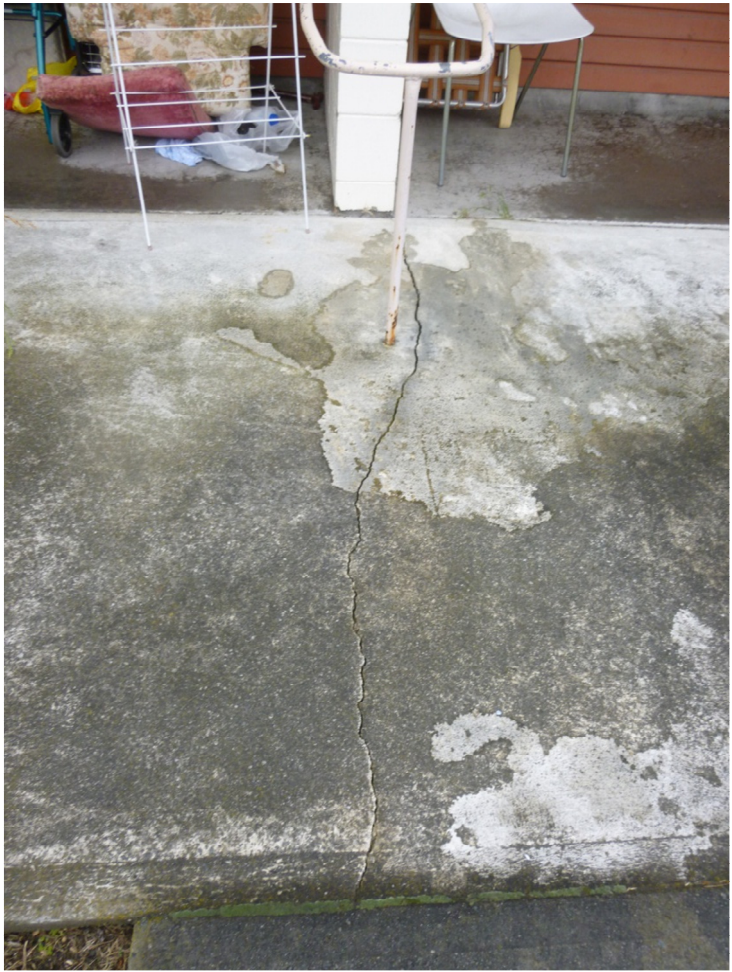
Cracking was observed in the concrete patios and ramps to the units. Stepped cracking was observed in the concrete block veneer, typically under windows. Cracking through the concrete block veneer was observed in the rear of the units.

12.	Typical cracking of the units entrance ramps

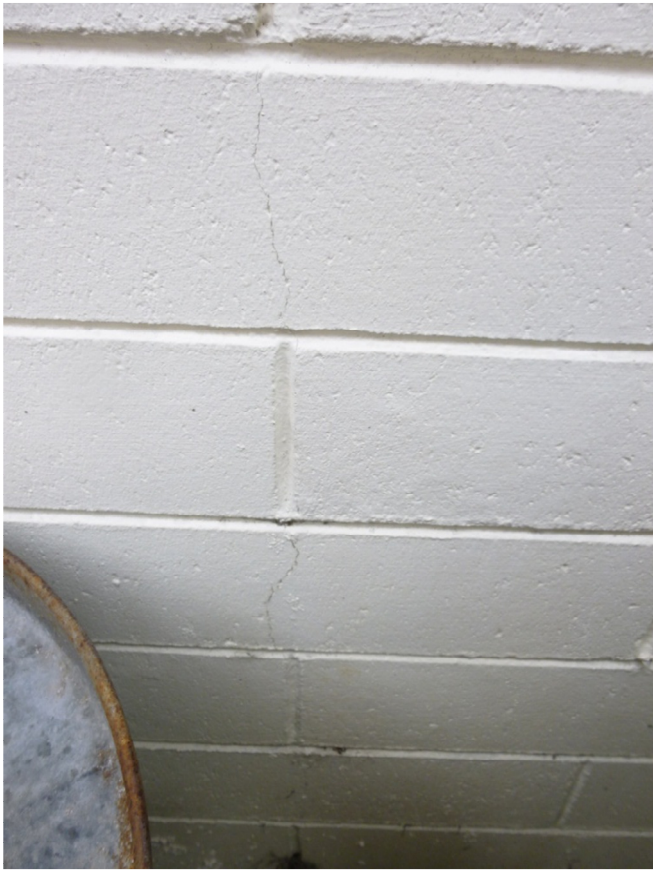
15.	Typical cracking through the block veneers

A close-up photograph of white block veneers. A vertical crack runs through the center of the image, passing through several courses of blocks. The crack is slightly irregular and appears to be a surface crack. The blocks are rectangular and laid in a standard pattern.
16.	Cracking of the foundation (Block F)

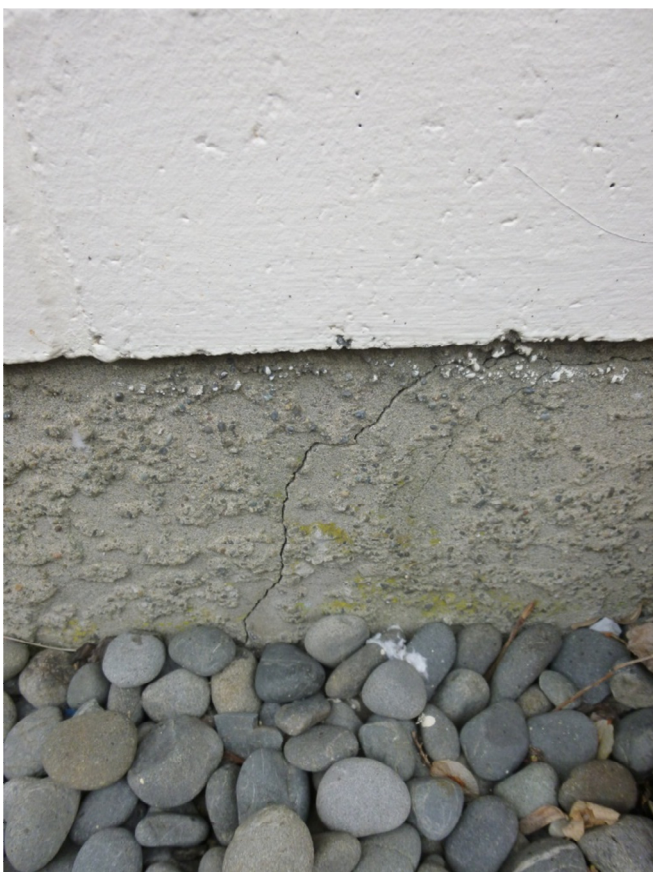
Minor cracking of the foundation veneer render was observed in Block F (photo 16) and is not believed to affect the slab.

A photograph showing the base of a white block veneer wall where it meets a concrete foundation. A prominent vertical crack runs down the center of the concrete foundation. The foundation is situated above a bed of smooth, grey river stones. The concrete appears weathered and slightly discolored.
