**Shelter/Shed – Ashgrove Terrace /
Ashgrove Park
PRK_1084_BLDG_001 EQ2**
Detailed Engineering Evaluation
Qualitative Report
Version Final

35 Ashgrove Terrace, Somerfield

Christchurch City Council

Date
18th September 2012

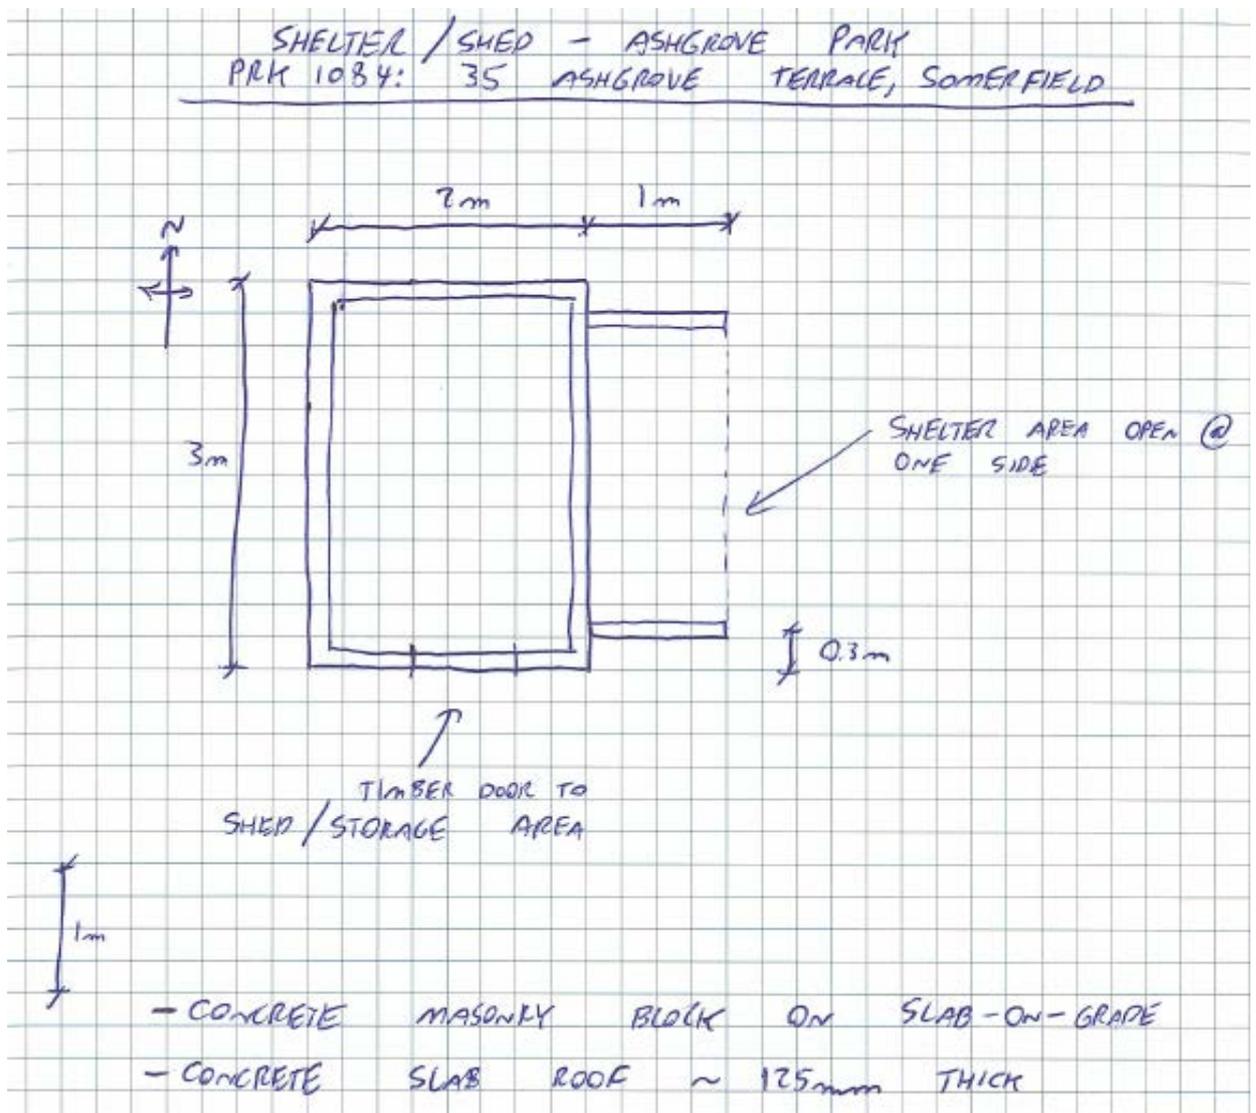
Figure 2 Plan Sketch Showing Key Structural Elements

The building is a single row of filled or partially filled concrete masonry block walls. The single storey construction has a concrete slab on grade floor. The heavyweight concrete slab roof is self-supported and has no other structural elements. The concrete slab rests on the concrete masonry block walls

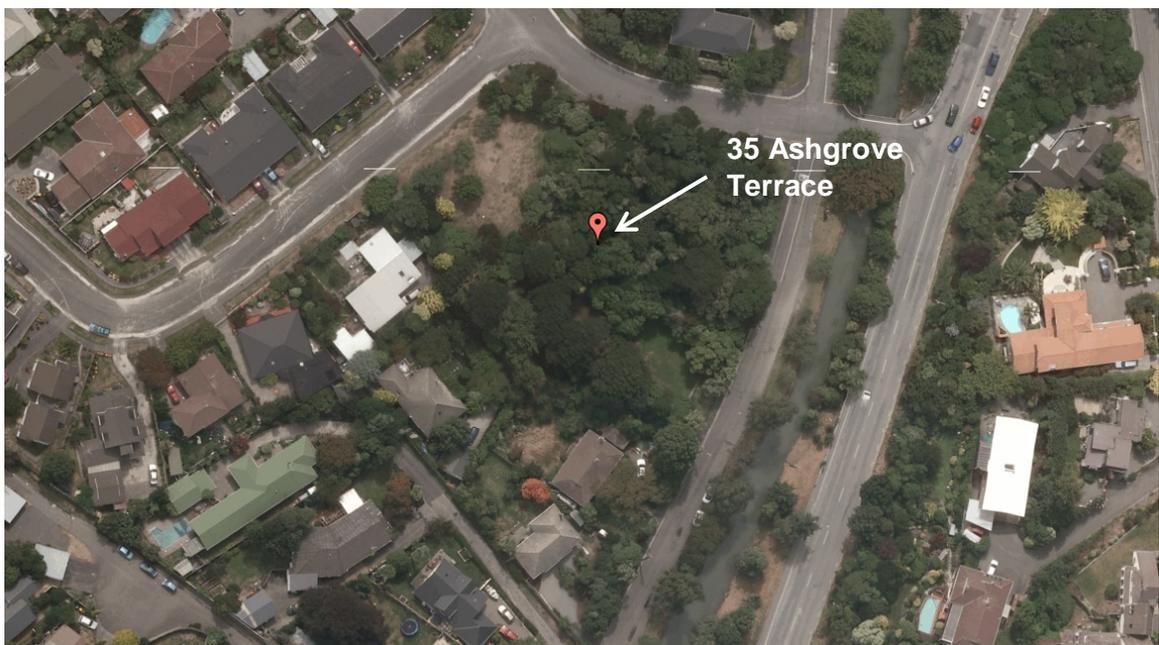
Figure 2 Post February 2011 Earthquake Aerial Photography²

Aerial photograph taken following the 22 February 2011 earthquake shows signs of low to moderate liquefaction close to the site, as shown in Error! Reference source not found..

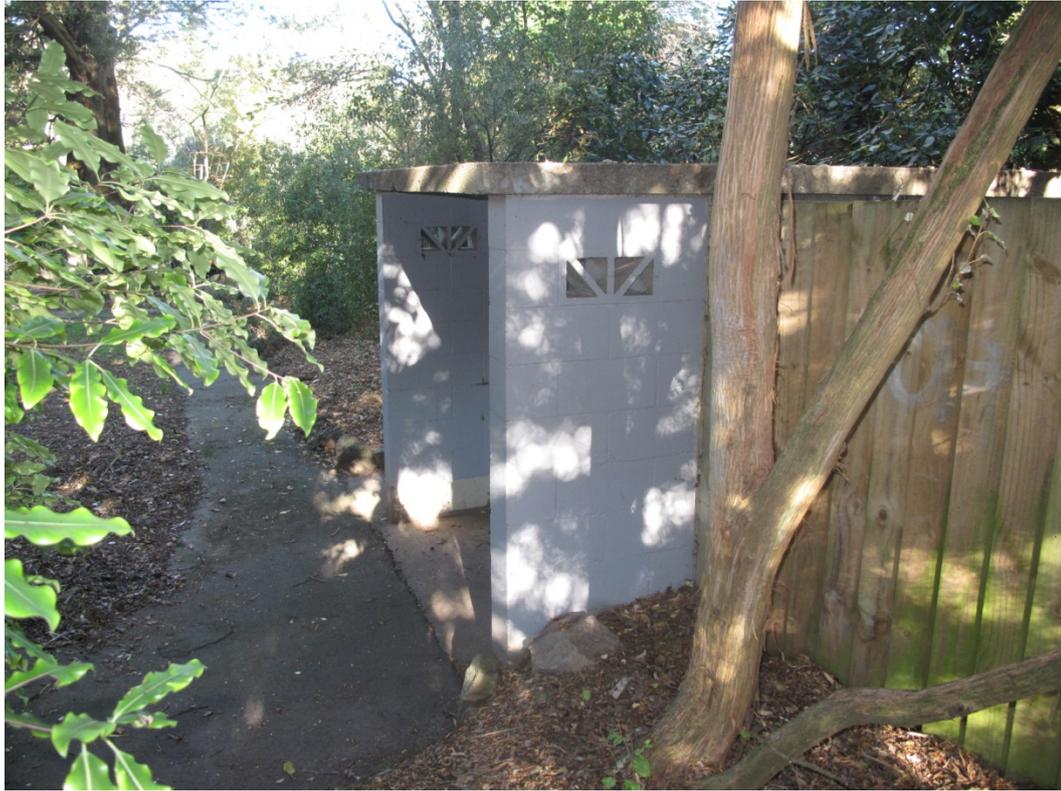
Photograph 1 North elevation.

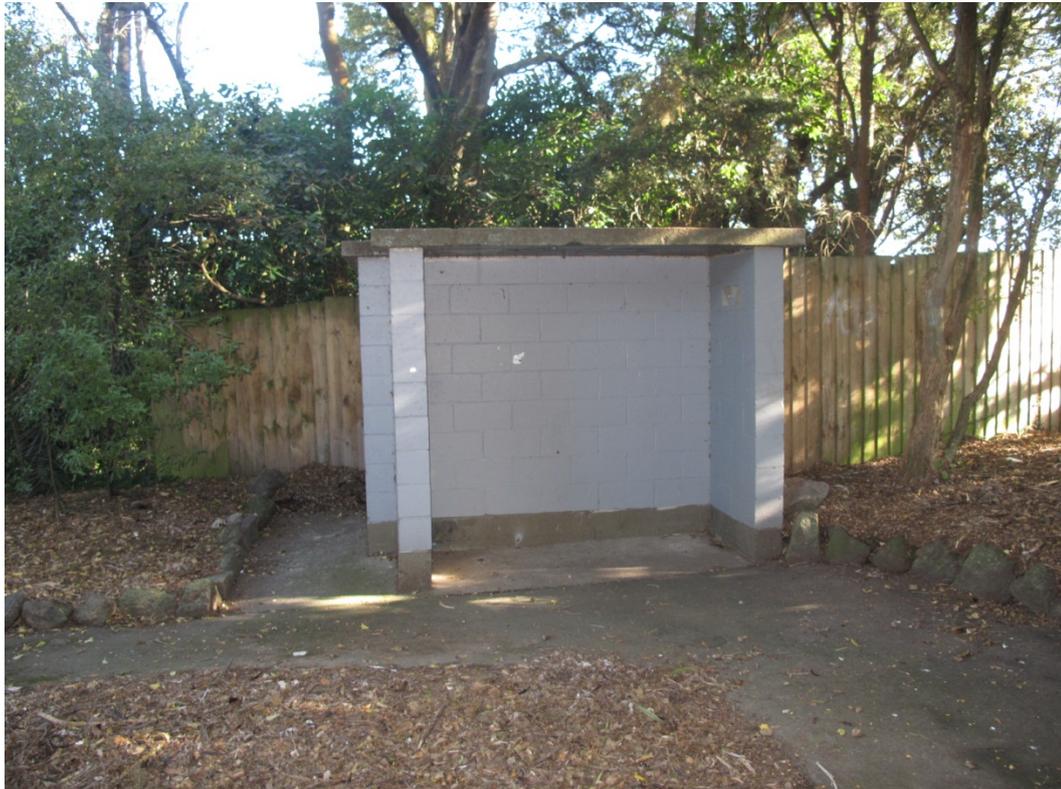
Photograph 2 View of the shelter from the east.

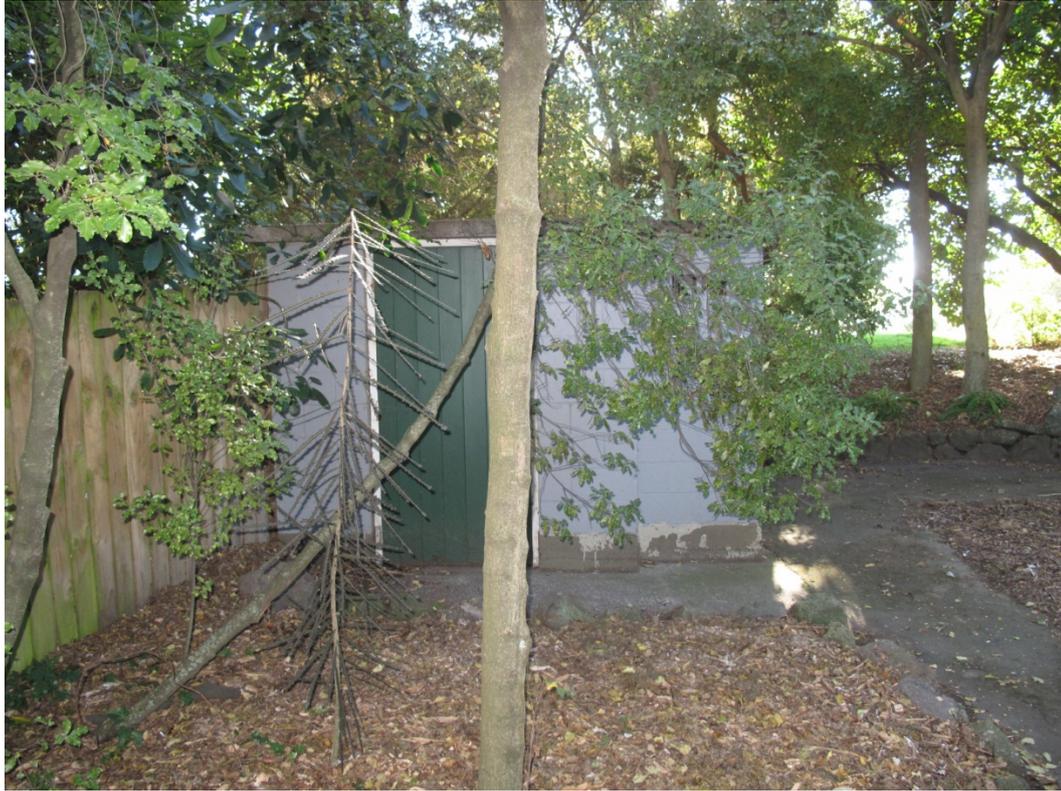
Photograph 3 View of the shelter/shed from the south.

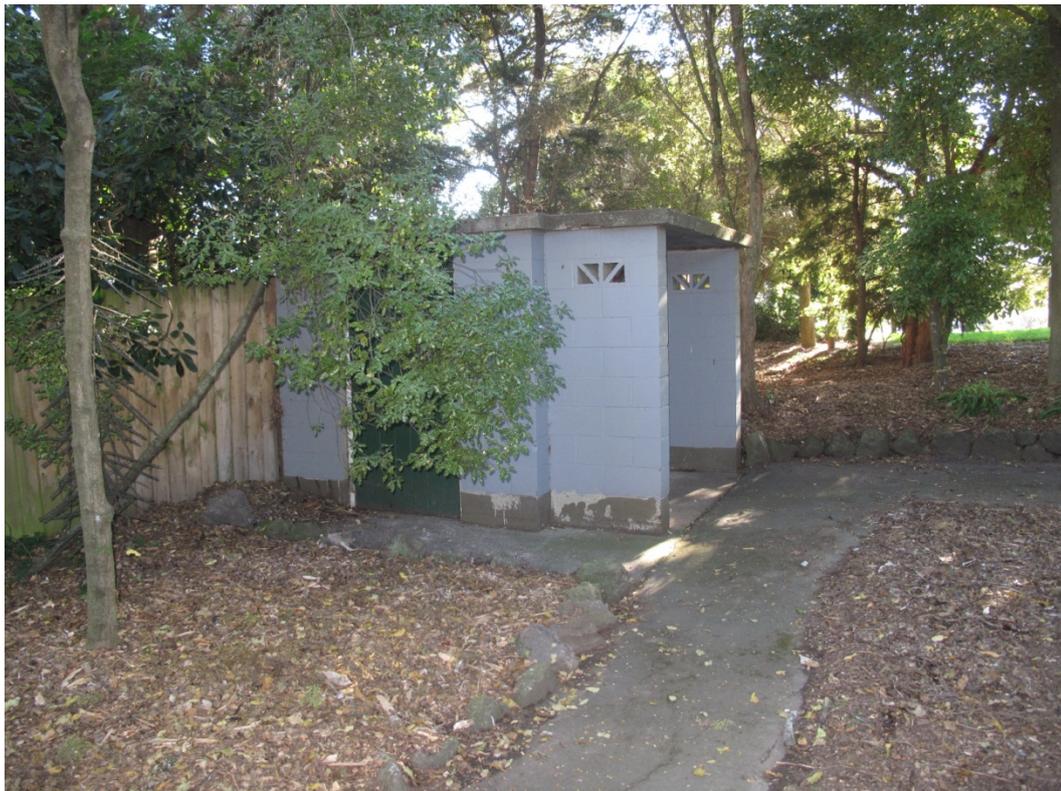
No residual displacements of the structure were noticed during the inspection of the building. However the path on the southern side of the structure shows signs of cracking and possible differential movement. The path is located near the top of the slope above the Heathcote River. See Photographs 4 and 5 in Appendix A.

Liquefaction was observed on site and in the surrounding neighbourhood. As noted in Section 8.5 of this report it is possible that liquefaction will occur on site. The effect liquefaction will have on the structure may be a threat. In addition the location on a slope indicates potential ground spreading. Therefore in terms of the IEP the site characteristics have been deemed to be significant.

Photograph 4 The building is located near the top of the slope above the Heathcote River.

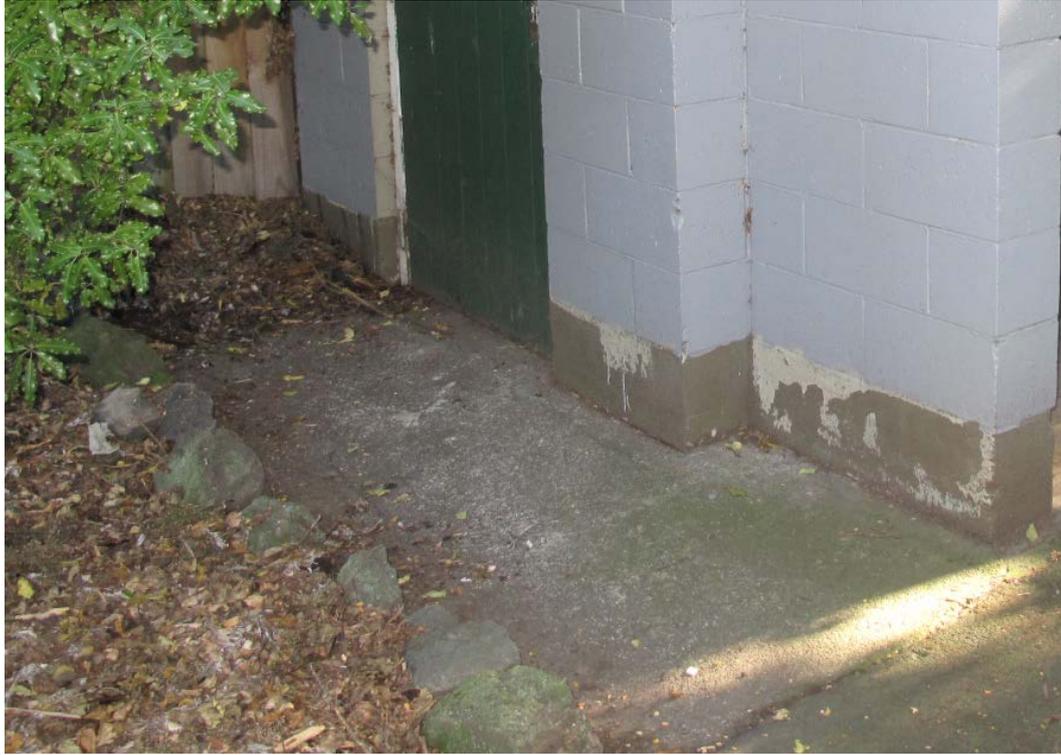
Photograph 5 Cracking in the concrete path on the south side may indicate differential movement.

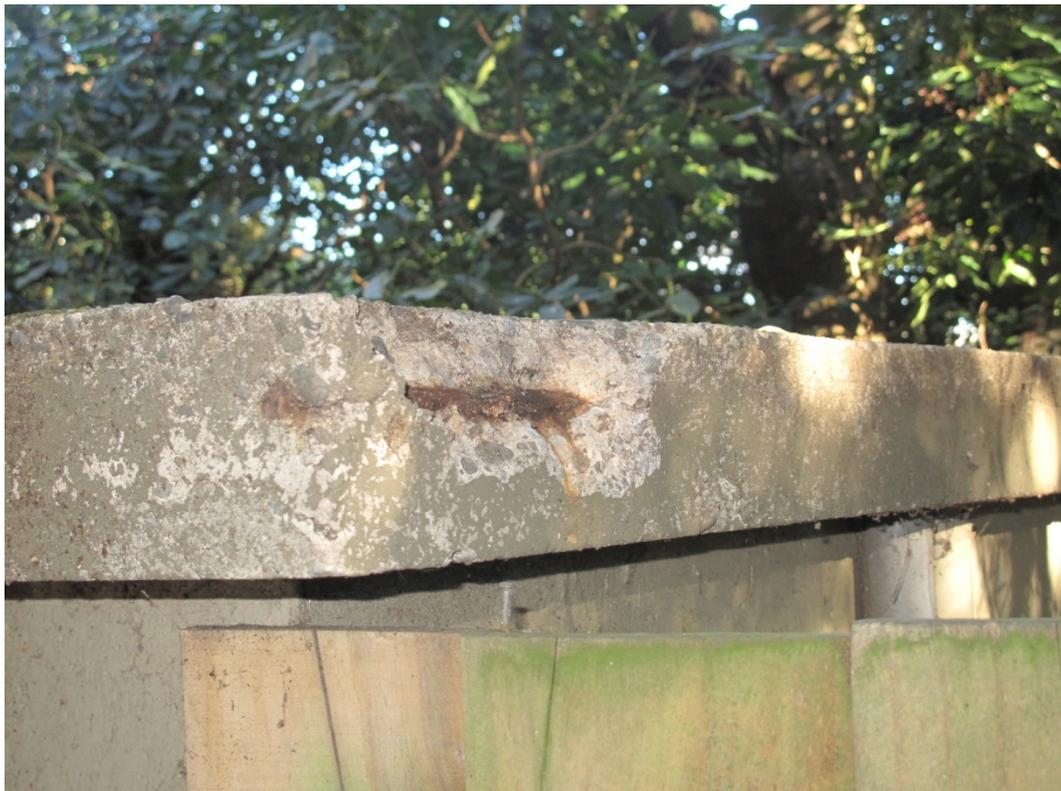
Spalling was evident around the edges of the concrete slab roof structure. The corrosion appears to be historic but some of the spalls appear to have been displaced by earthquakes with fresh concrete exposed. See Photographs 6 and 7.

Photograph 6 Corrosion on the edge of the concrete roof slab appears to be historic.

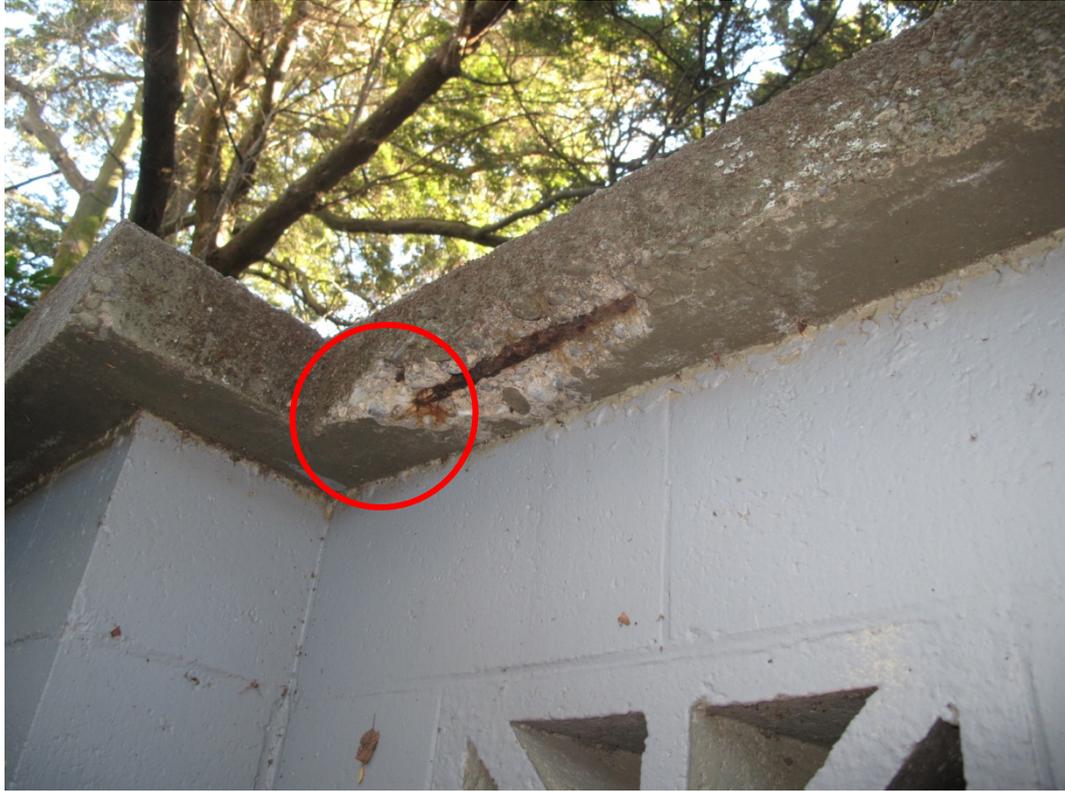
Photograph 7 The concrete exposed around the spall appears fresh.

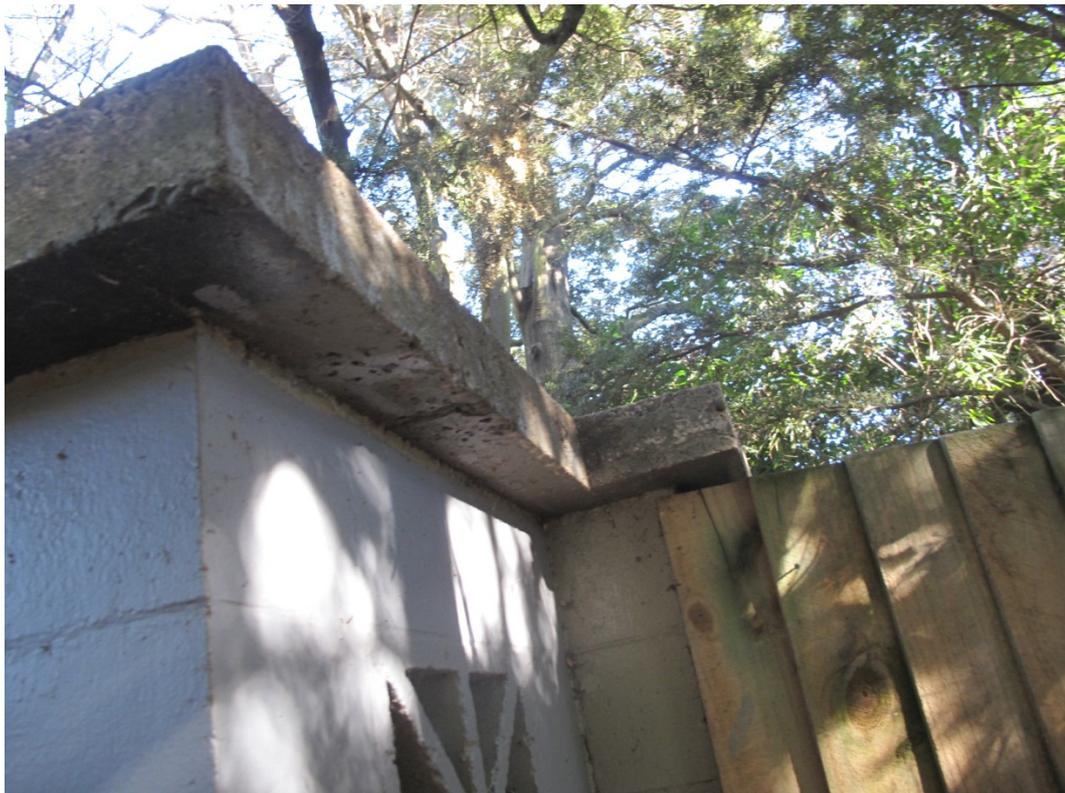
The concrete slab roof is mostly visible. No access was available to area inside the shed, but the part over the shelter was visible. The roof slab structure is straightforward and due to the spalling some of the reinforcement is visible. The bracing can be assumed to be sufficient for small size of the structure and therefore the roof is not a critical structural weakness. See photographs 8 and 9.

Photograph 8 The heavyweight roof increased the height of the seismic mass.

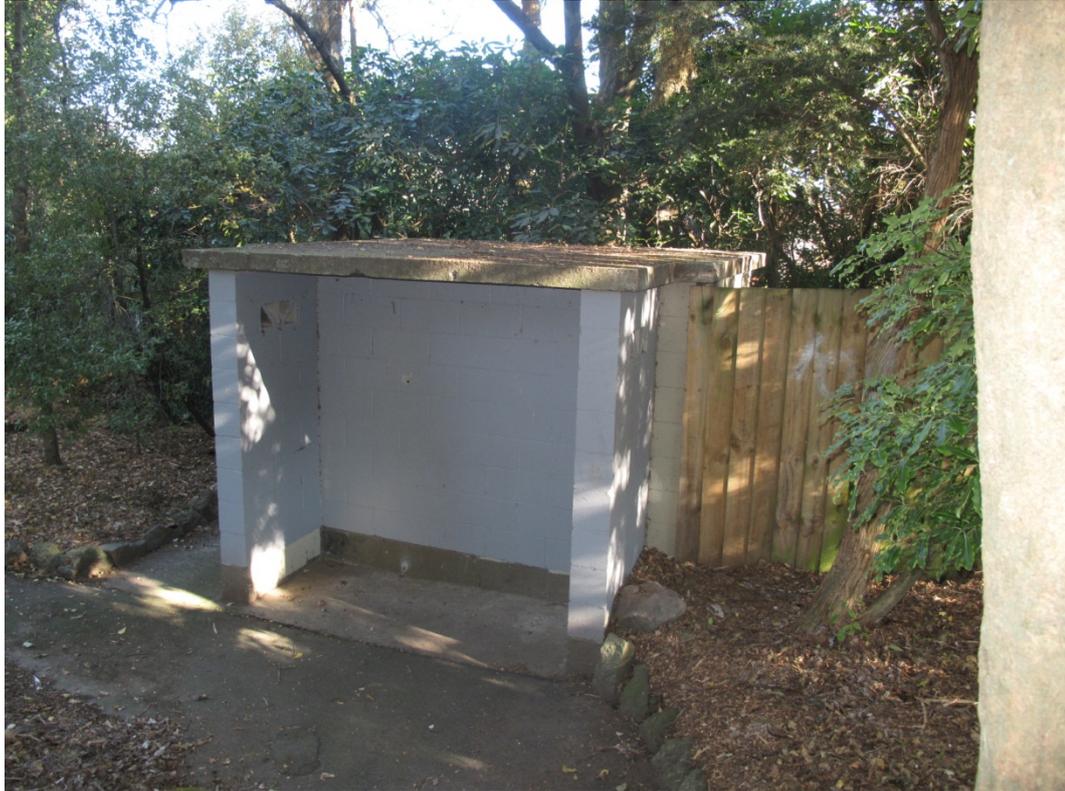
Photograph 9 The simple structure appears to be adequately braced.

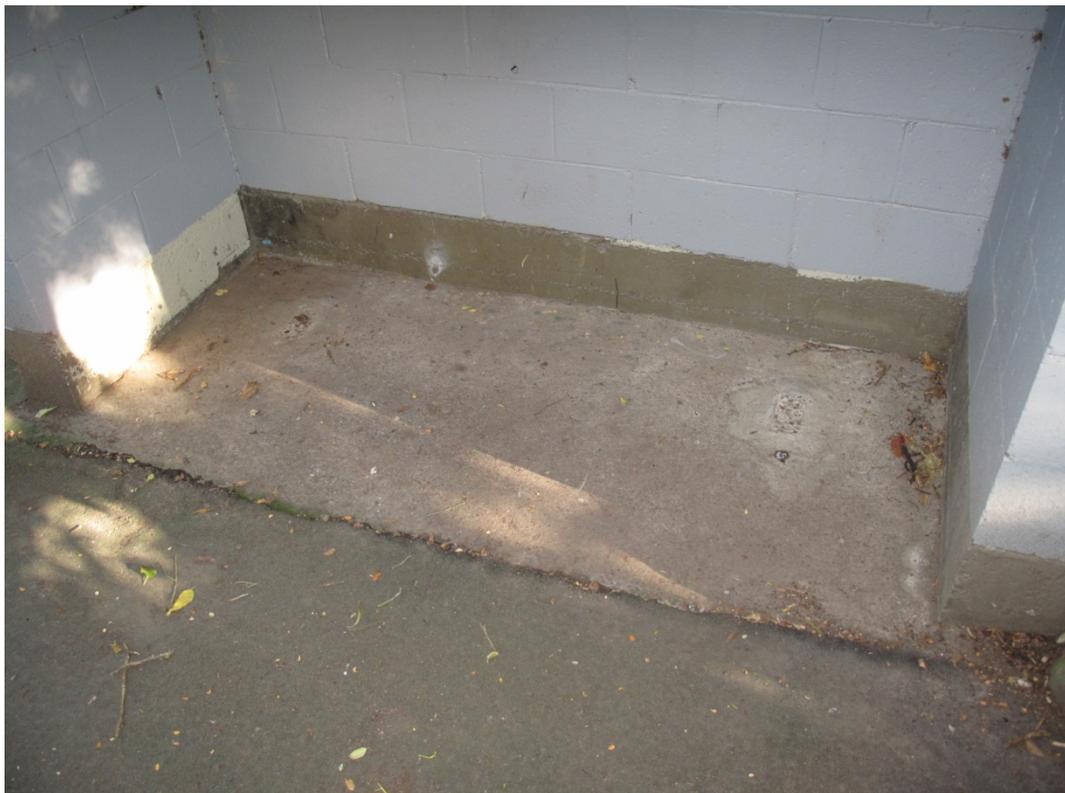
No cracks were visible in the slab on grade foundation.

Photograph 10 No visible damage or cracking of the concrete slab on grade floor.
