**Avice Hill Reserve Library
PRK 0284 BLDG 004 EQ2**

Detailed Engineering Evaluation

Quantitative Assessment Report

Avice Hill Reserve Library

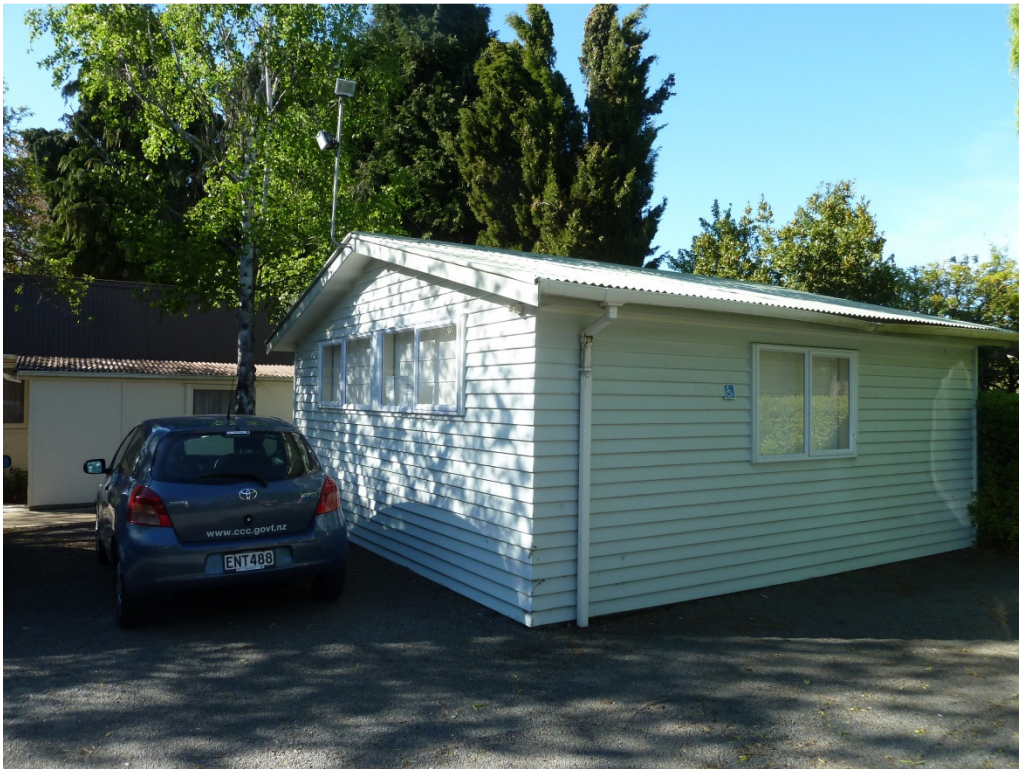
Photo 1: External View from Front

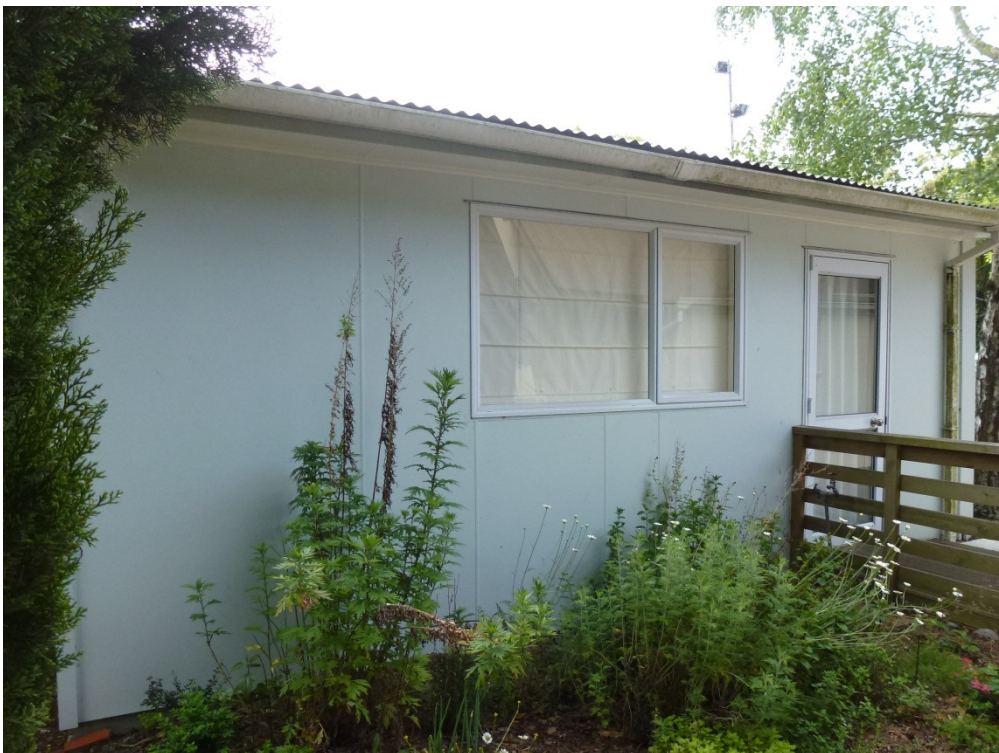
Photo 2: External View from Rear

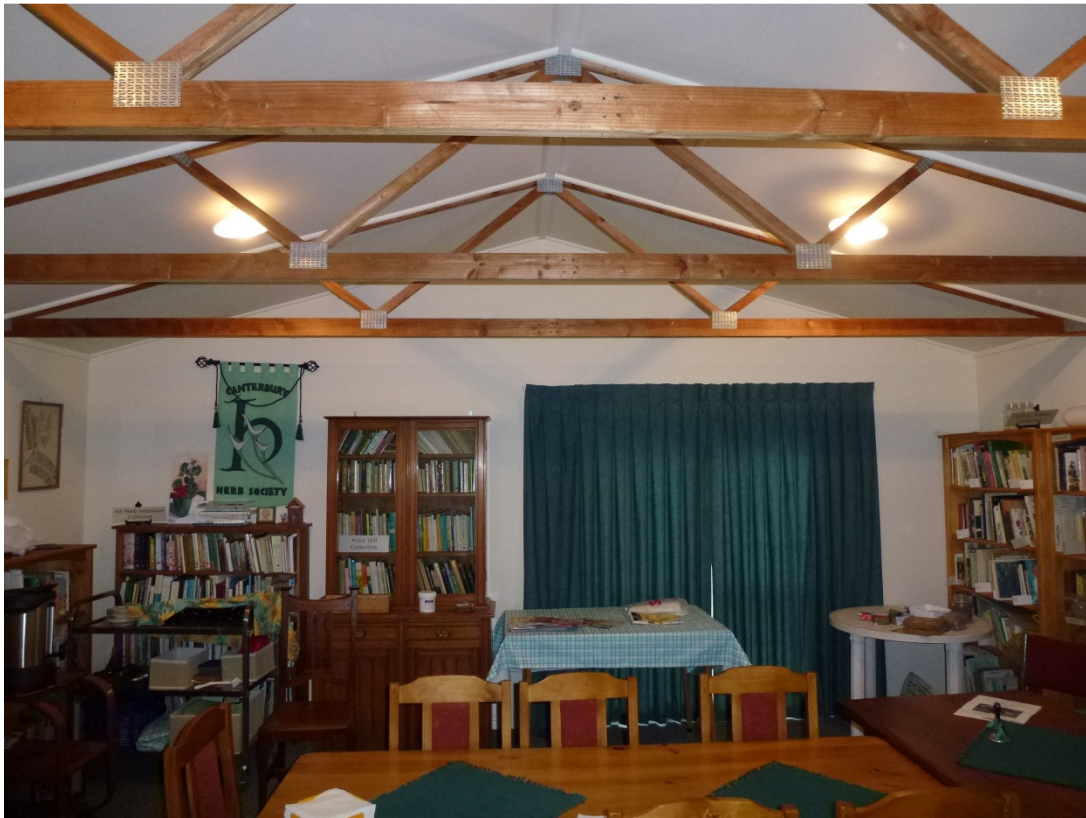
Photo 3: Internal View
