**Avice Hill Reserve
Pottery Room
PRK 0284 BLDG 002 EQ2**

**Detailed Engineering Evaluation
Quantitative Assessment Report**

Date: 7 February 2013
Reference: 6-QUCC1.64
Status: Final

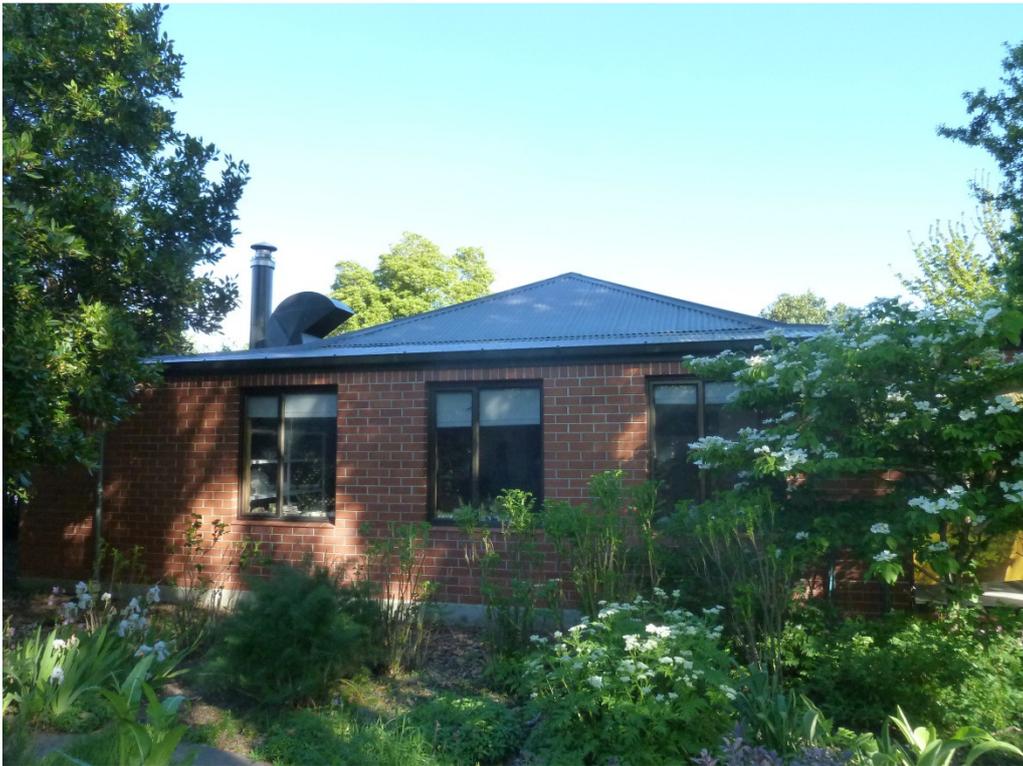
Photo 1: External view from west

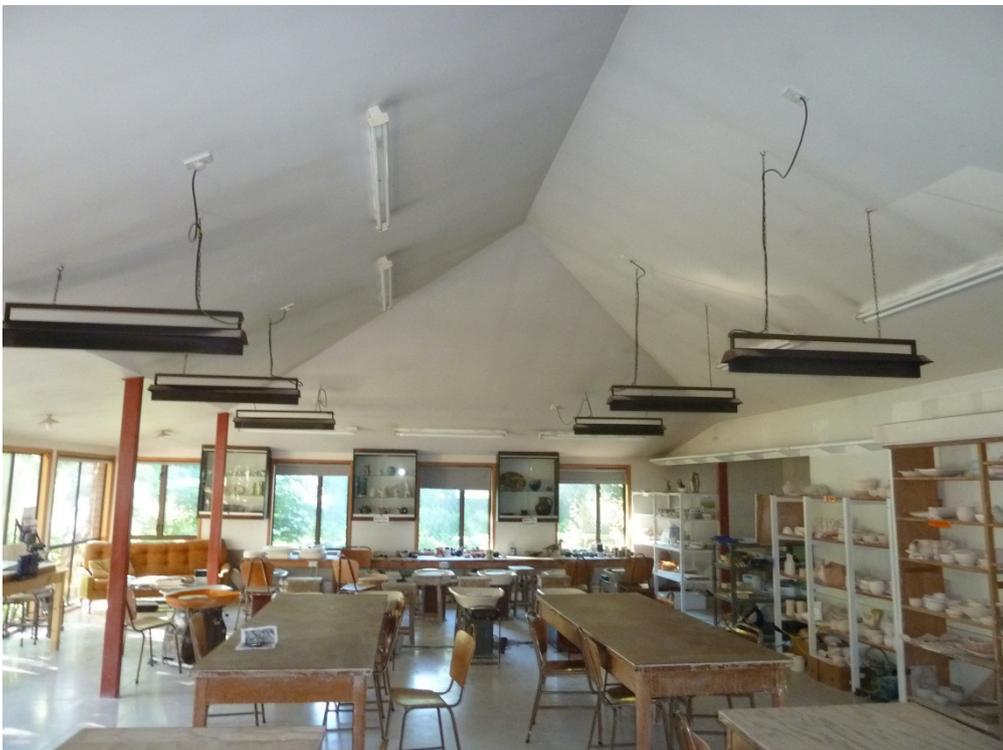
Photo 2: Internal View

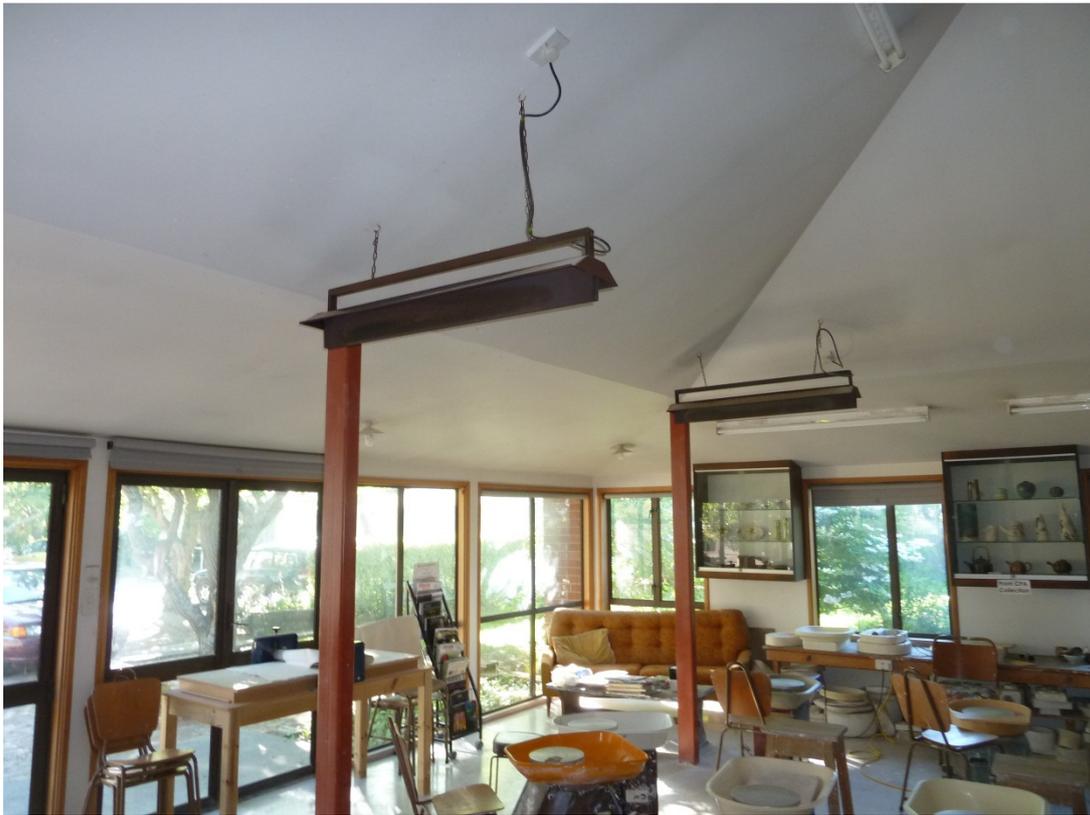
Photo 3: View towards front
