**Avice Hill Reserve  
Original Room  
PRK 0284 BLDG 003 EQ2**

**Detailed Engineering Evaluation**

**Quantitative Assessment Report**

Date: 7 February 2013  
Reference: 6-QUCC1.46  
Status: Final

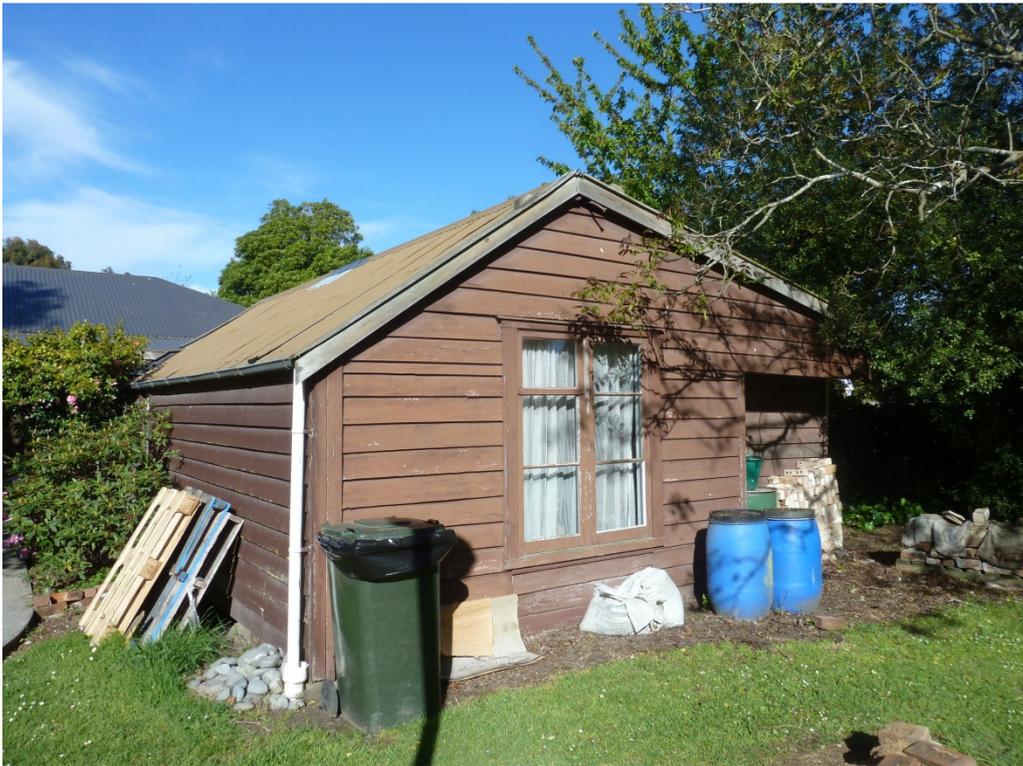
**Photo 1: External View from Front**

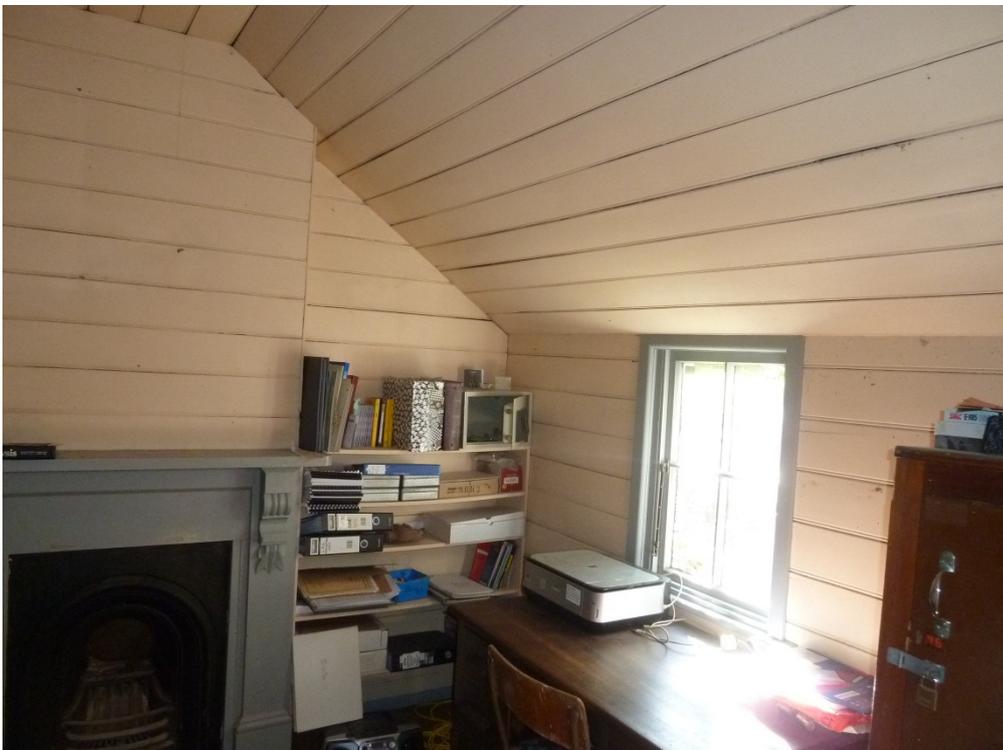
**Photo 2: Internal View**

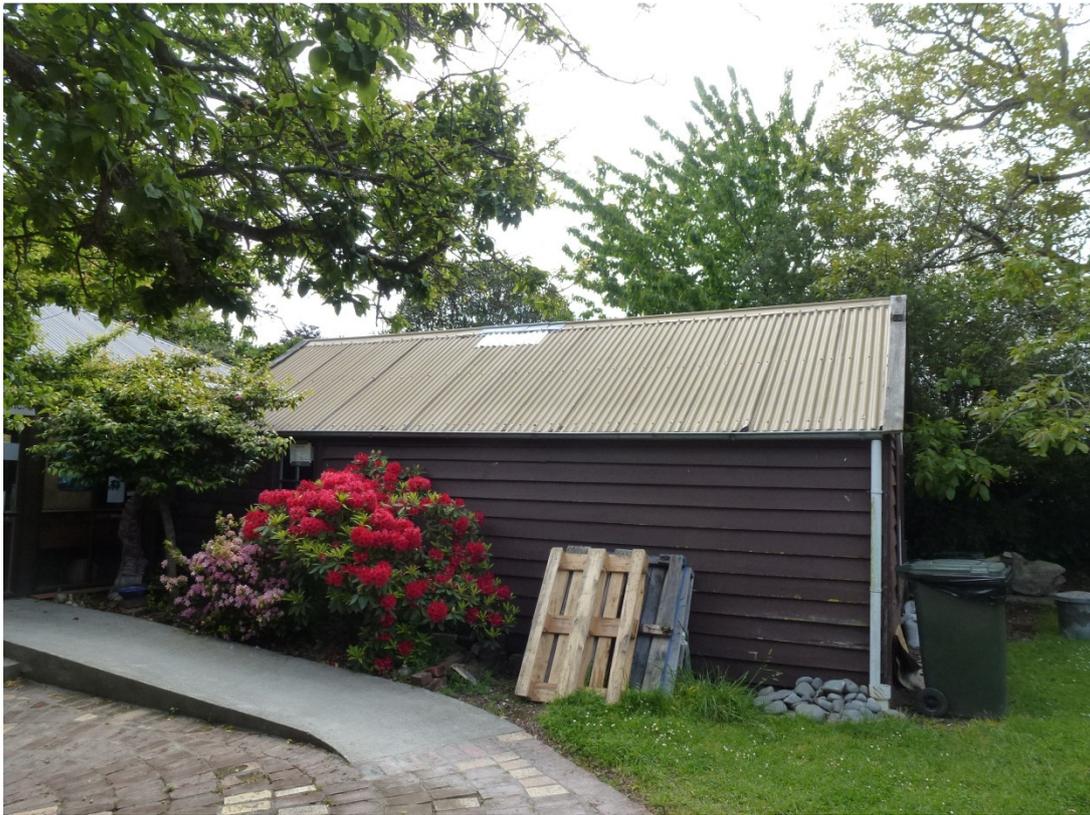
**Photo 3: East elevation**

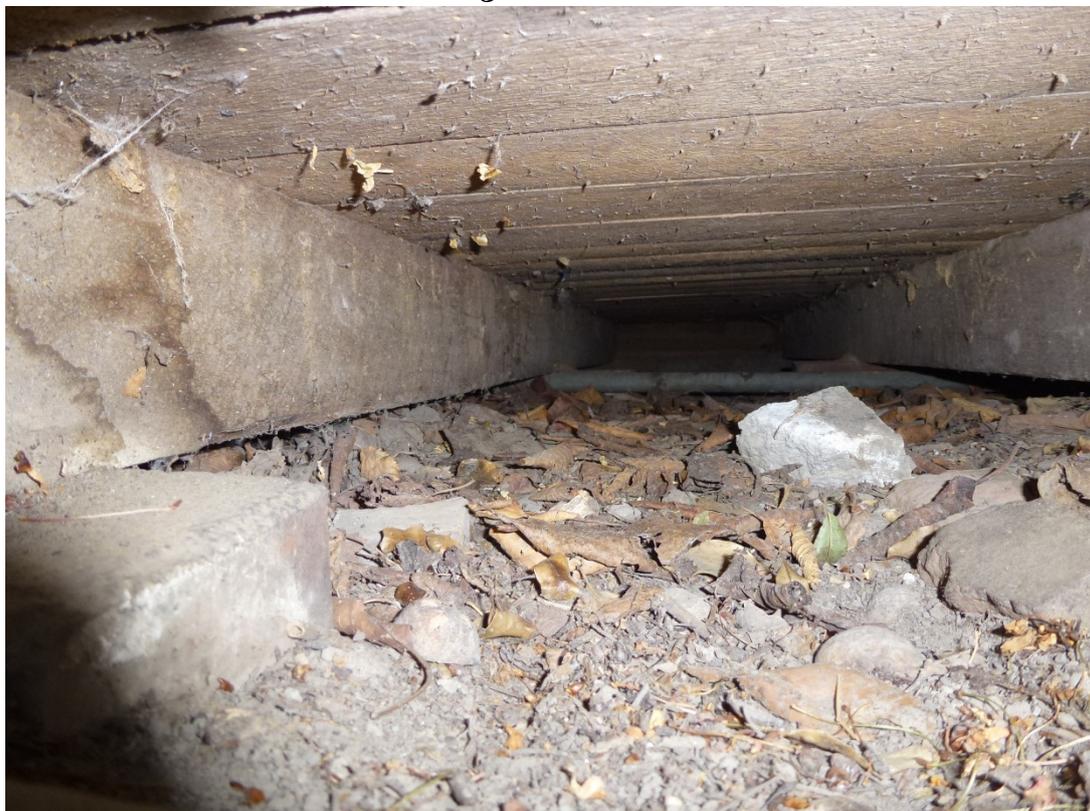
The ground floor is timber framed with bearers resting on brick and concrete pads. The gap between the underside of the bearers and natural ground is variable but is approximately 100mm. There were no indications of positive fixings of the bearers to the foundation pads.

1. The foundation capacity is difficult to determine due to the lack of information available, however given the lack of positive connections between the foundations and the bearers, it is likely to be below 100%NBS.

**Photo 4: Subfloor detail**
