**Avondale Park Toilet
PRK 1283 BLDG 001**

Detailed Engineering Evaluation
Quantitative Report
Version FINAL

Mervyn Drive, Avondale
Christchurch

Date
24th September 2013

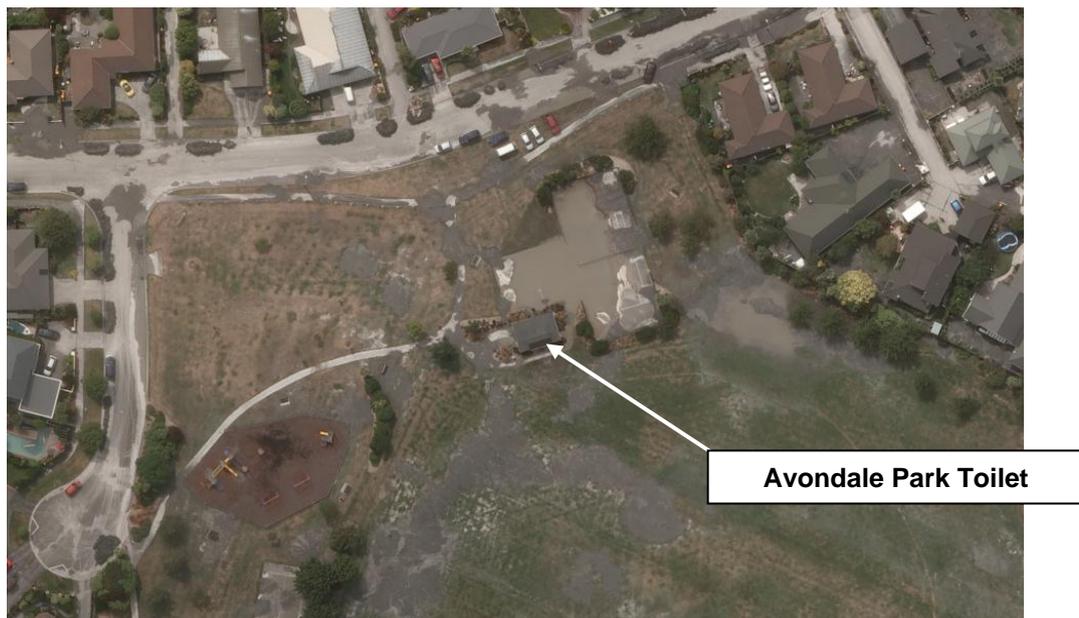
Figure 4 Post February 2011 Earthquake Aerial Photography

Aerial photography⁸ taken following the 22 February 2011 earthquake shows signs of severe liquefaction in Avondale Park in the form of sand boils, and on nearby streets, as shown in Figure 4. Ponding in the courts adjacent to the site also occurred following the 22 February 2011 earthquake. Aerial photography taken following the 4 September 2010 earthquake shows no signs of liquefaction, and aerial photography taken following the 13 June 2011 and 23 December 2011 earthquakes shows no new evidence of liquefaction.

The Canterbury Geotechnical database shows that cracks between 10 and 50 mm occurred within 150 m of the site⁹.

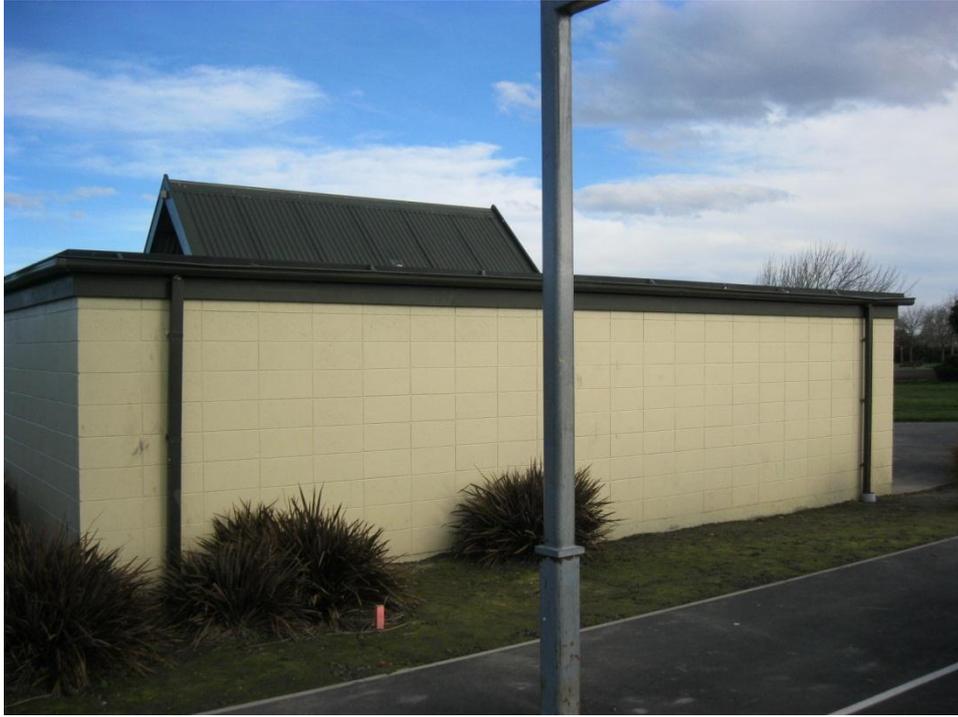
Photograph 1: North Elevation

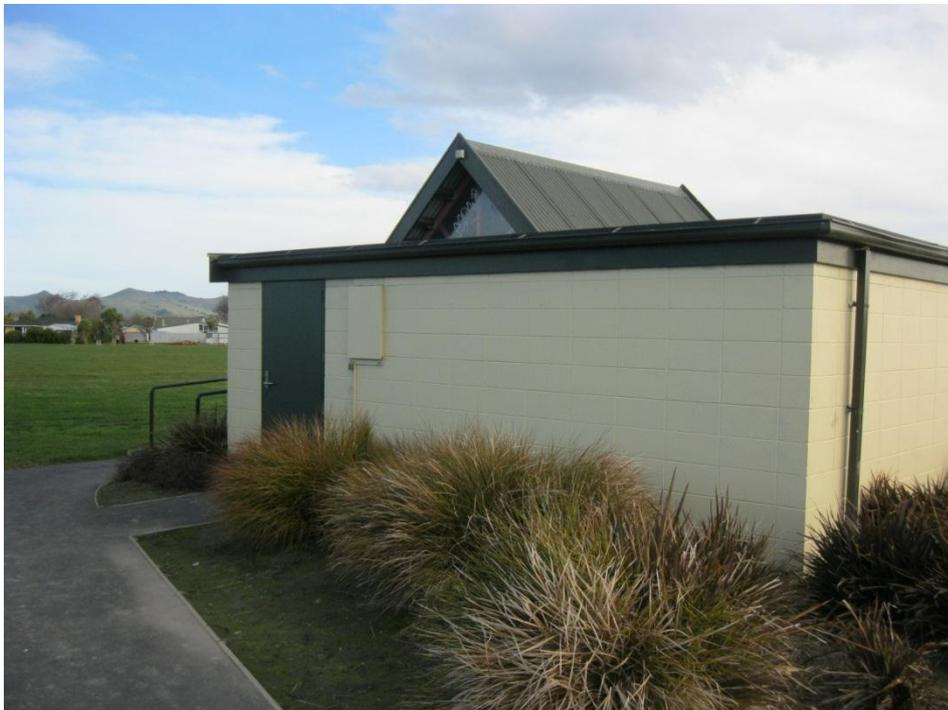
Photograph 2: East elevation

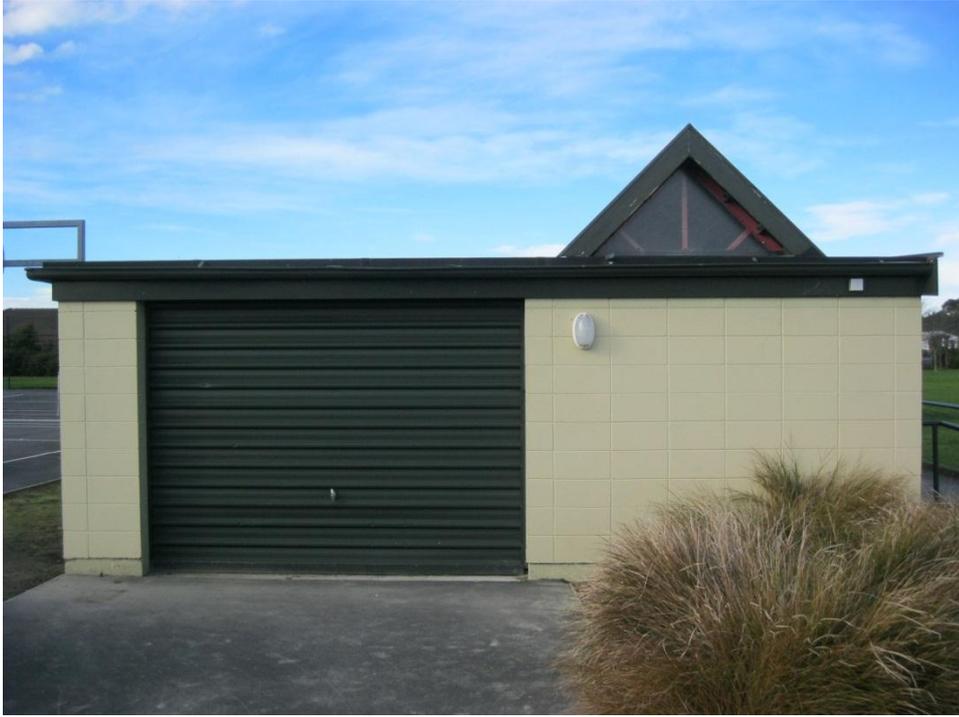
Photograph 3: West Elevation

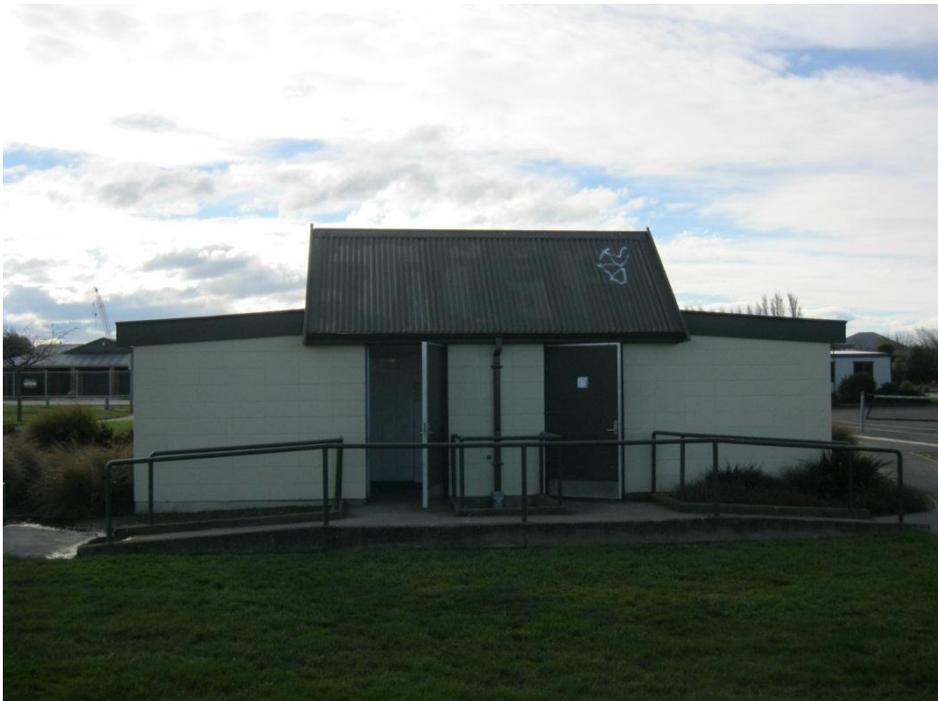
Photograph 4: South Elevation

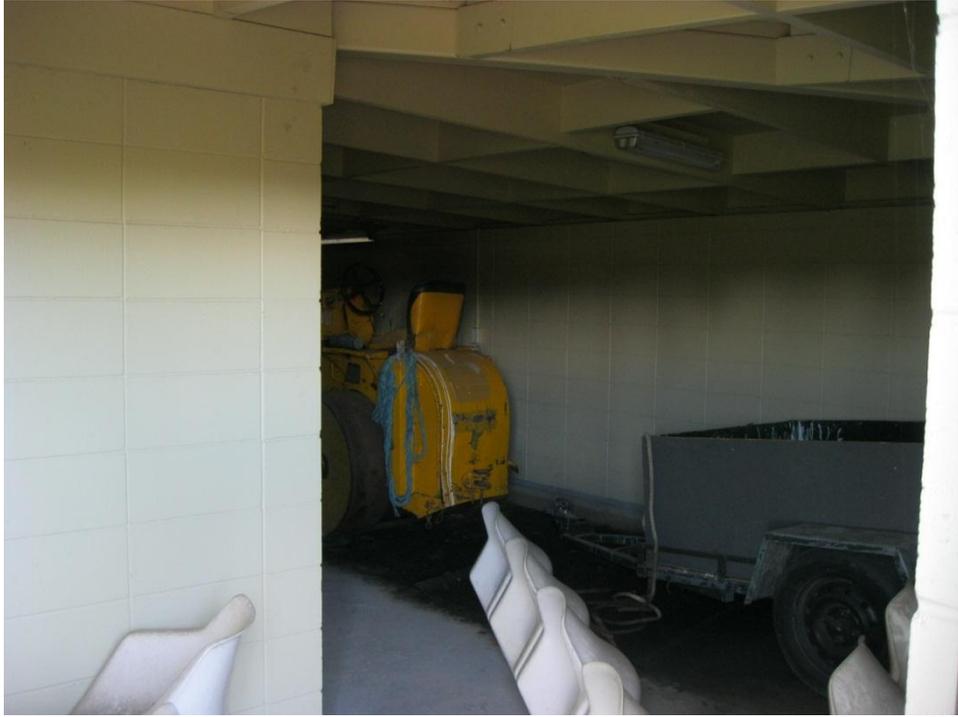
Photograph 5: Interior of the Storage Room

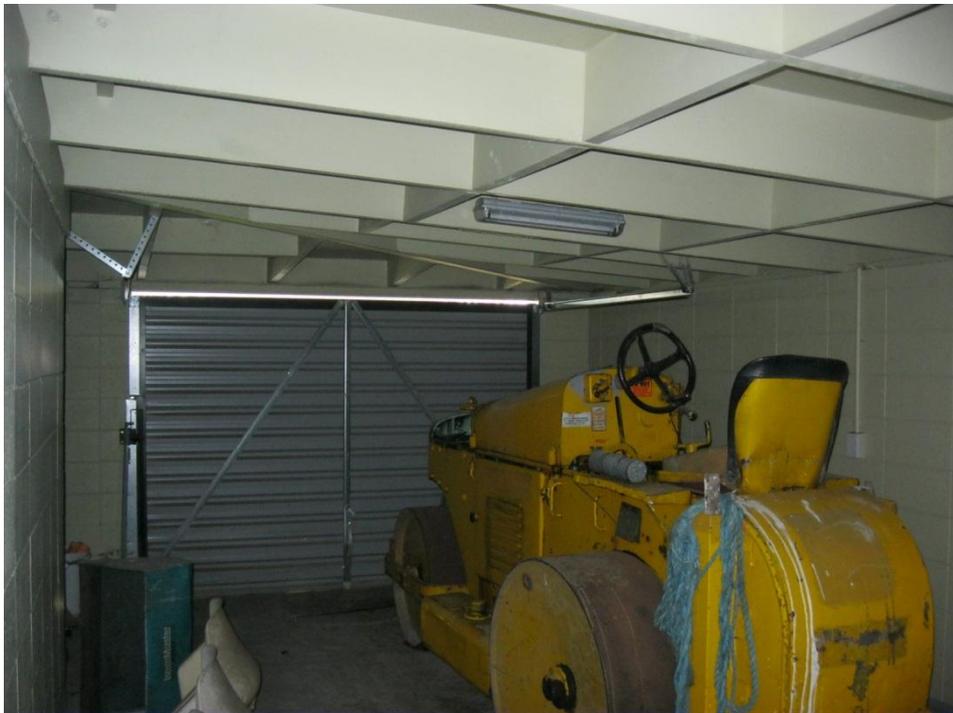
Photograph 6: Interior of the Storage Room

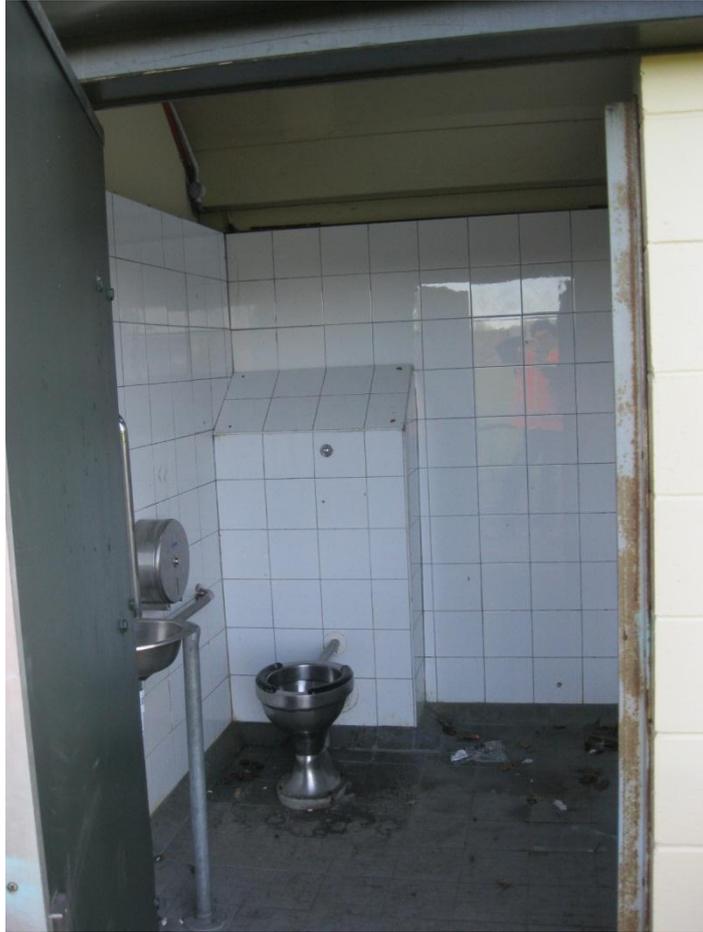
Photograph 7: Interior of Toilet
