Men's Toilet Avonhead Cemetery  
PRK 0217 BLDG 003  
Detailed Engineering Evaluation  
Qualitative Report  
Version Final

140 Hawthornden Road

Christchurch City Council

**Date**  
20<sup>th</sup> May 2013

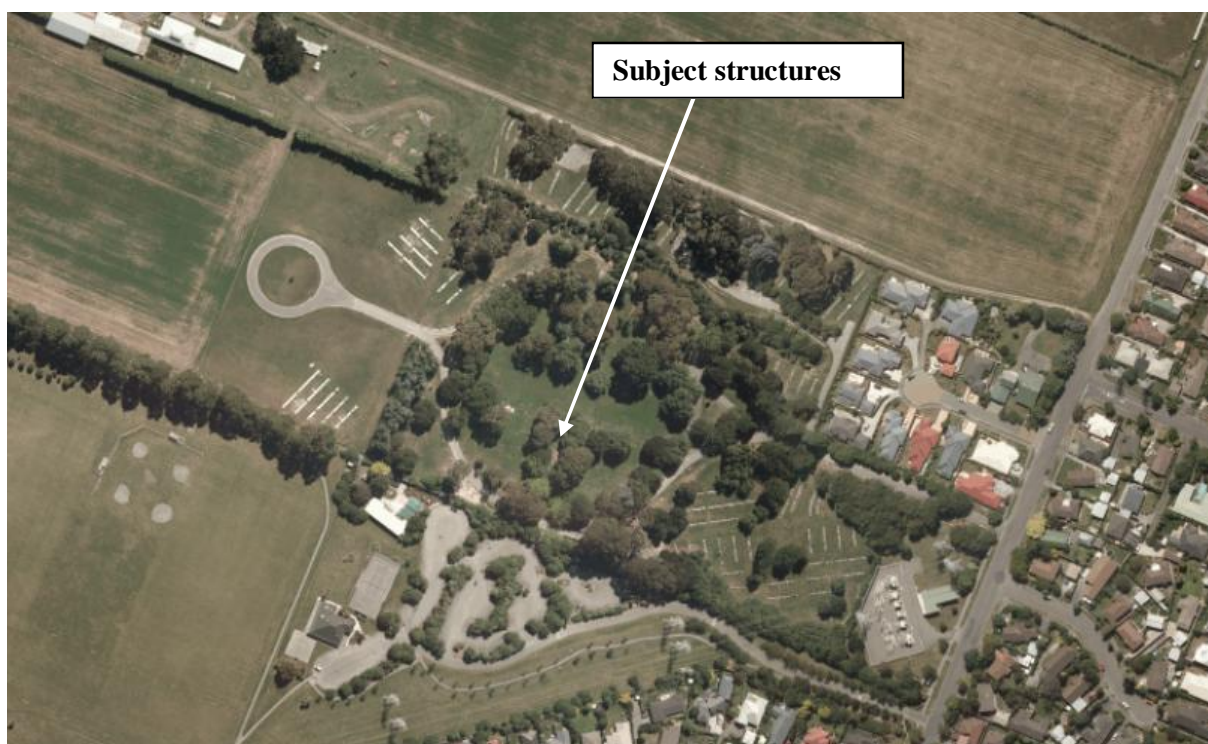
**Figure 5 Post February 2011 Earthquake Aerial Photography<sup>3</sup>**

Aerial photography taken following the 22 February 2011 earthquake shows no signs of liquefaction outside the building footprint or adjacent to the site, as shown in Figure 5.

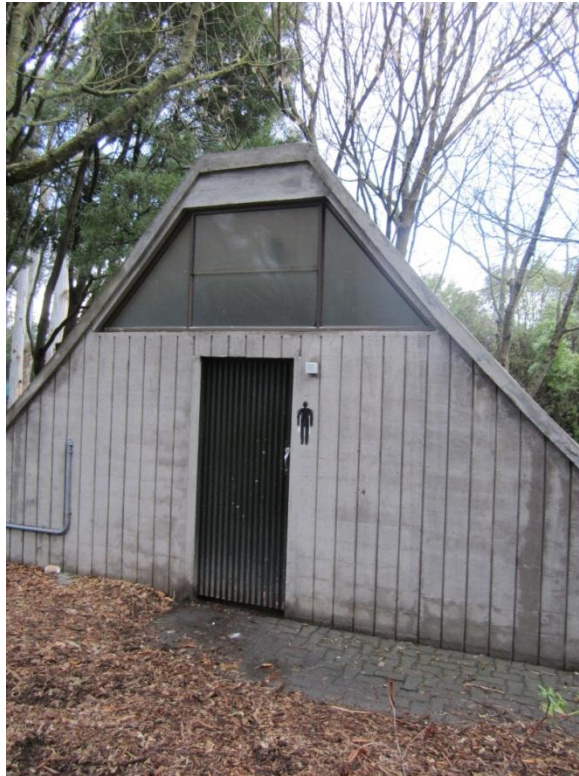
**Photograph 1 North elevation.**

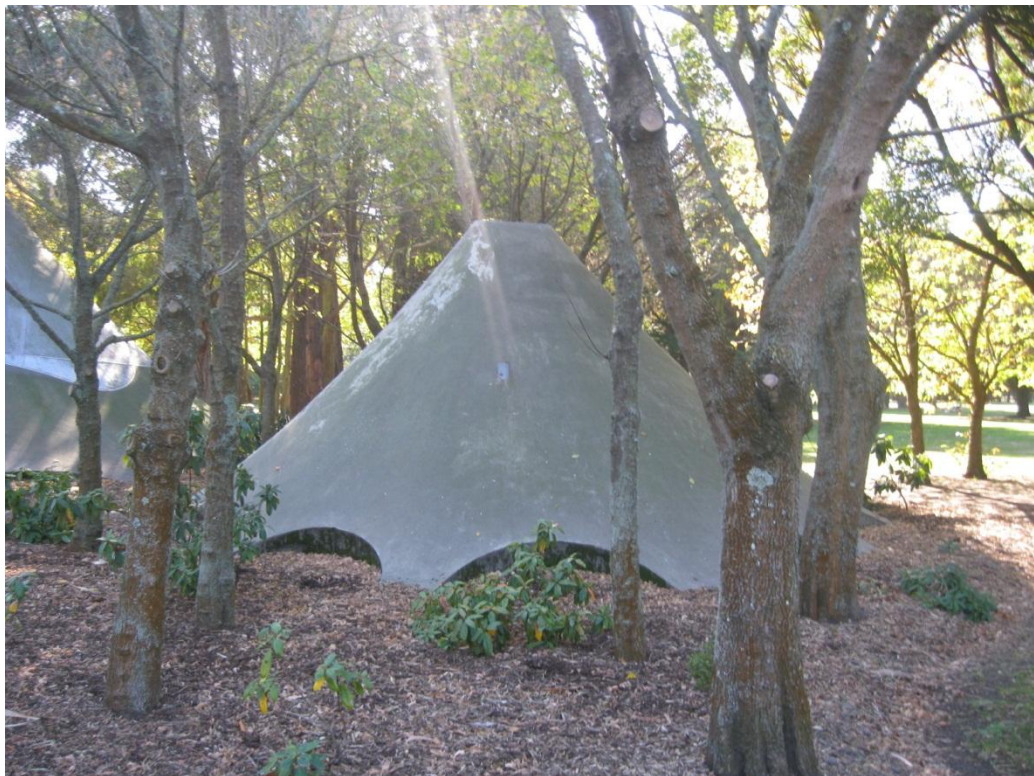
**Photograph 2 View of the toilet from the south.**

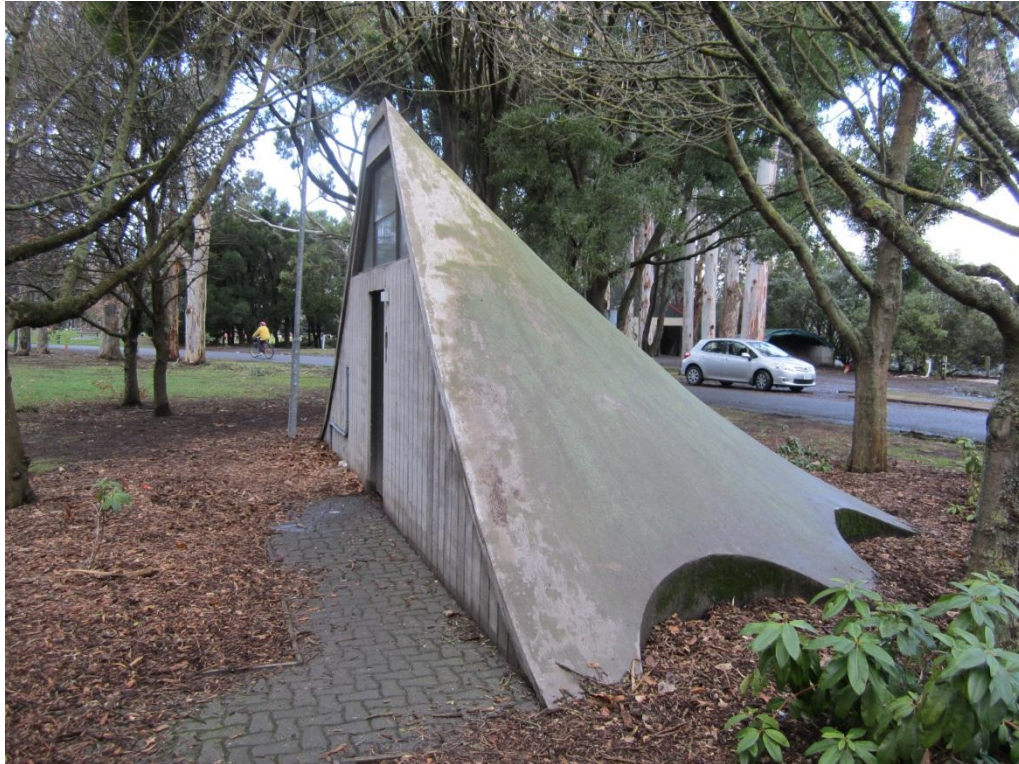
**Photograph 3 View of the toilet from the west.**

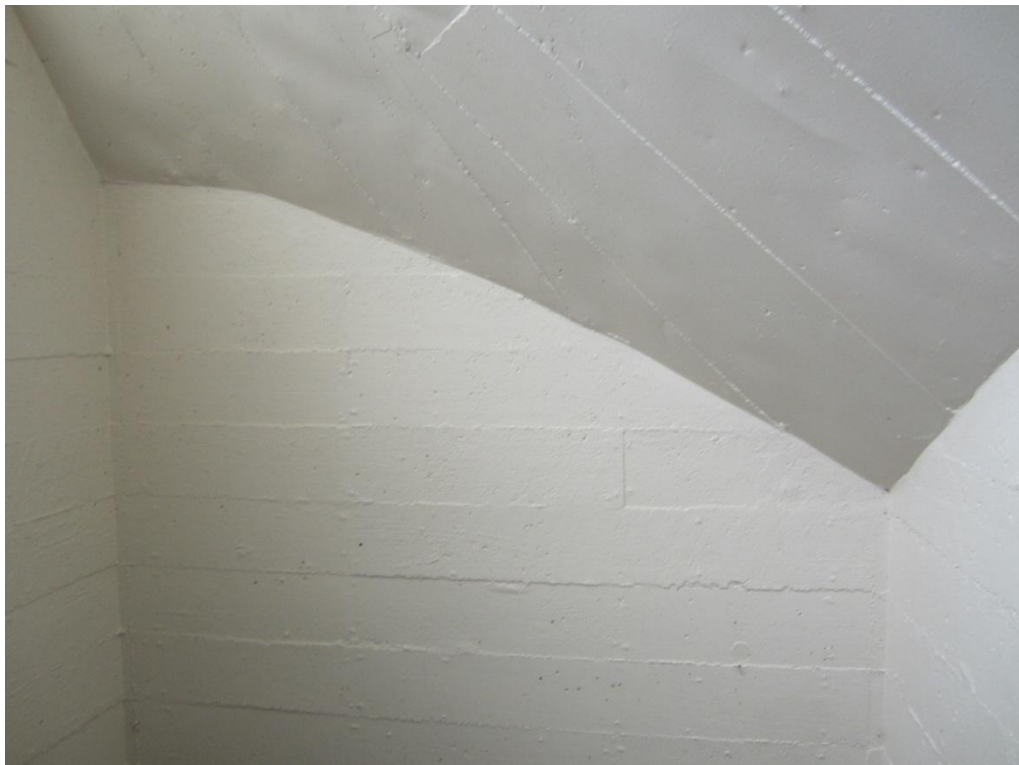
**Photograph 4 Reinforced concrete walls and roof slab soffit.**

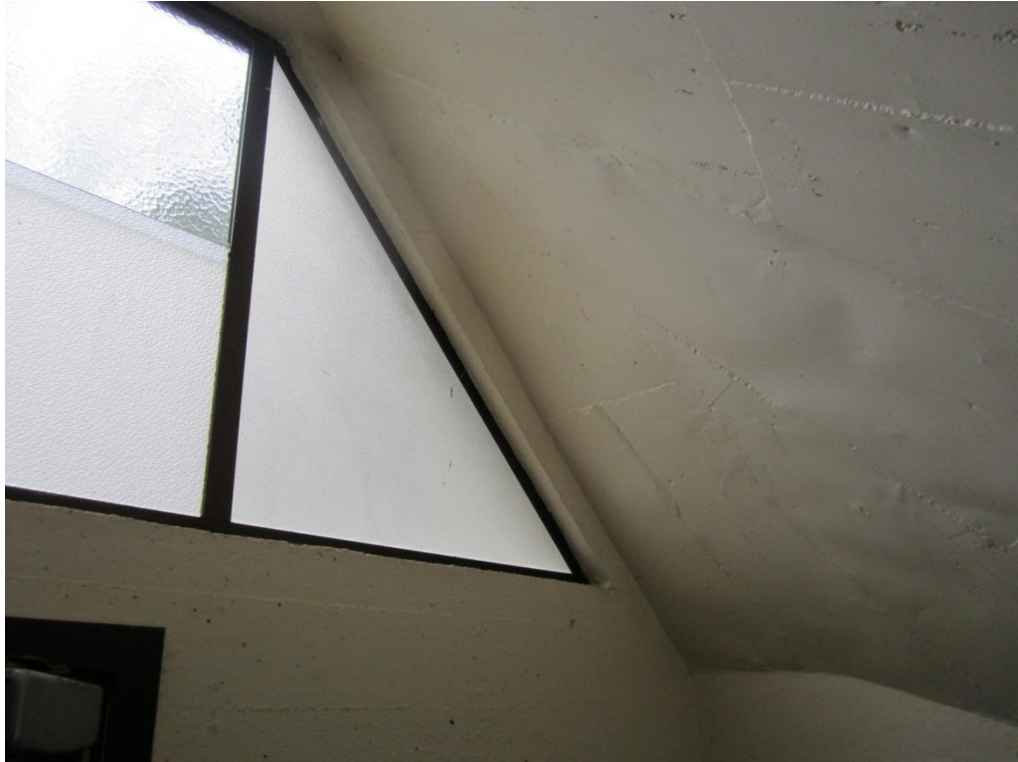
**Photograph 5 View of window and roof slab soffit.**
