Avonheath Courts BE 1401 EQ2

**Detailed Engineering Evaluation
Quantitative Assessment Report**

**86 Beachville Road, Redcliffs,
Christchurch 8081**

Date: December 2012
Reference: 6-QUCC1.93
Status: Final

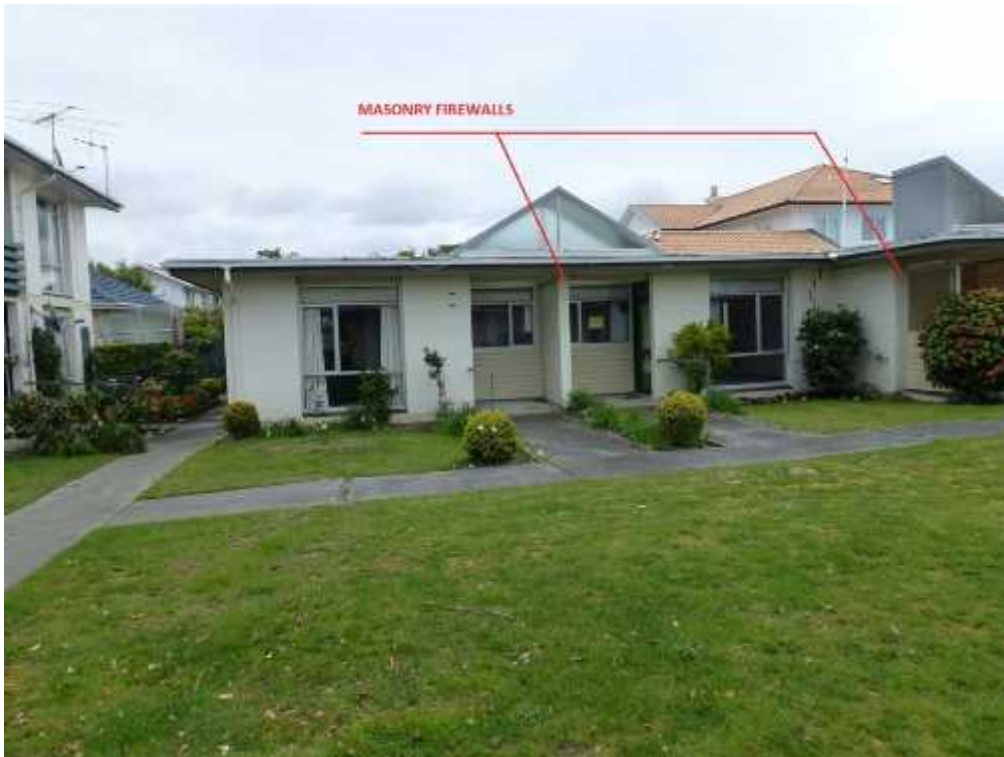
Photo 1 – Block A East Elevation

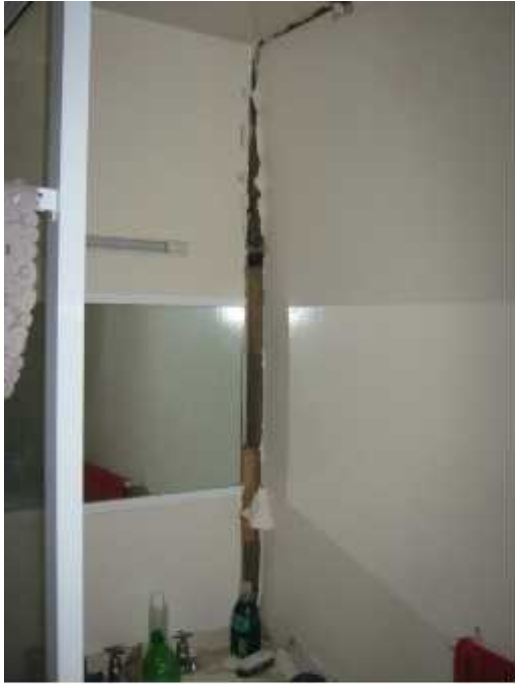
4.	Separation between Units 8 and 9 due to lateral spreading

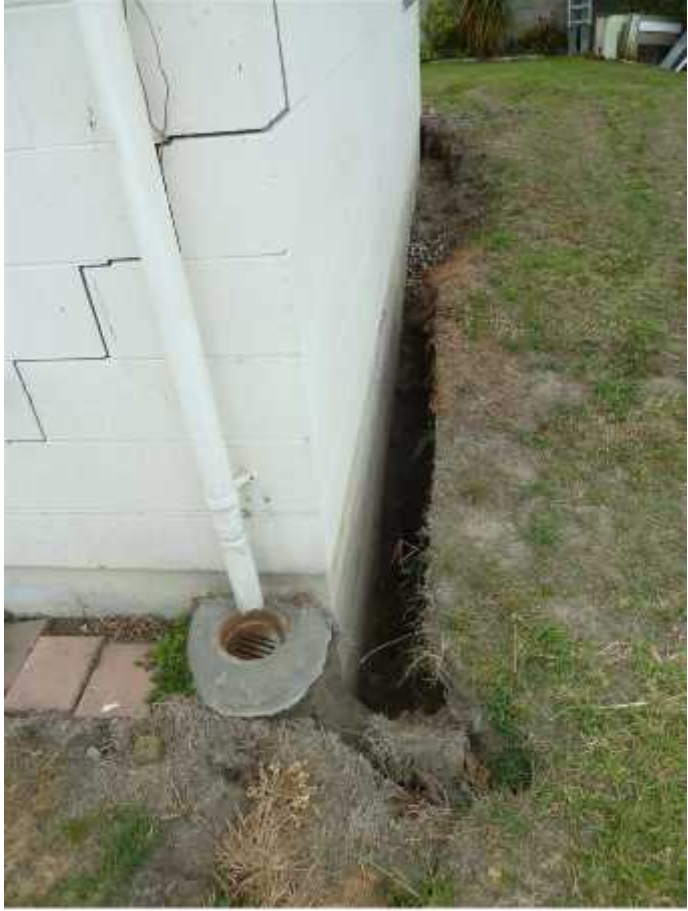
Blocks A and B have suffered significant damage primarily due to lateral spread and differential settlement of the land. This has caused up to 20mm of separation between Units 1 to 5. In Units 6 to 10, the damage has been concentrated in Unit 8, with a separation of up to approximately 70mm.

7.	Block A – Significant ground damage /differential settlement of foundations induced by soil lateral spreading

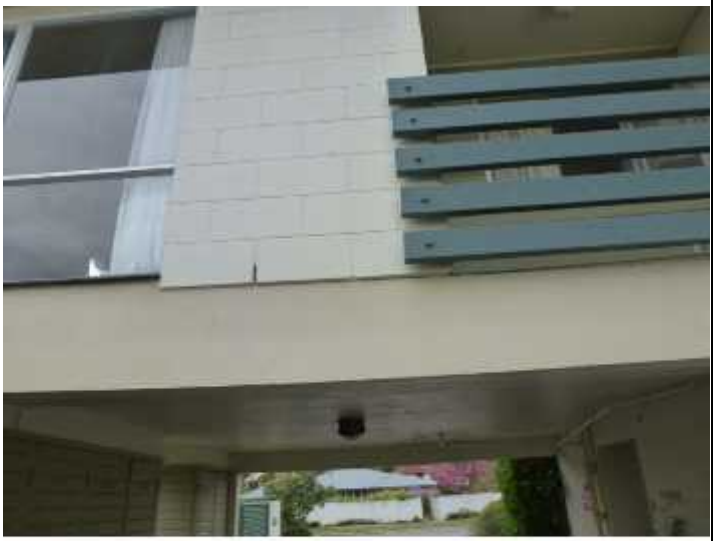
12.	Cracking between block veneer and concrete bond beam

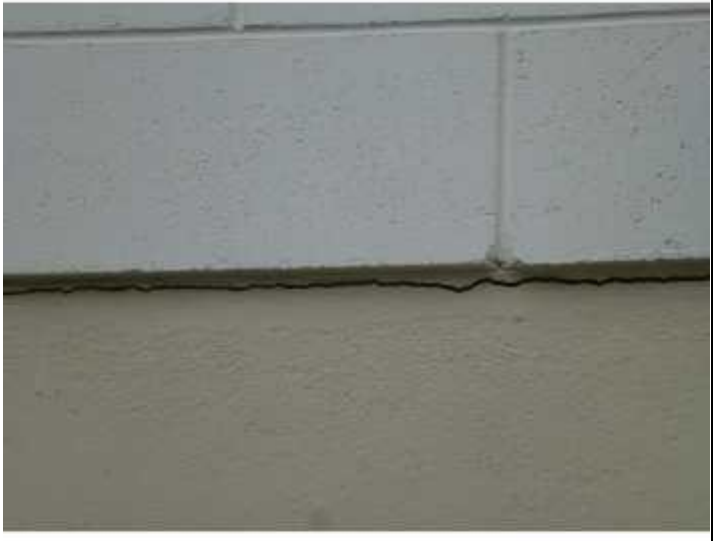
13.	As above

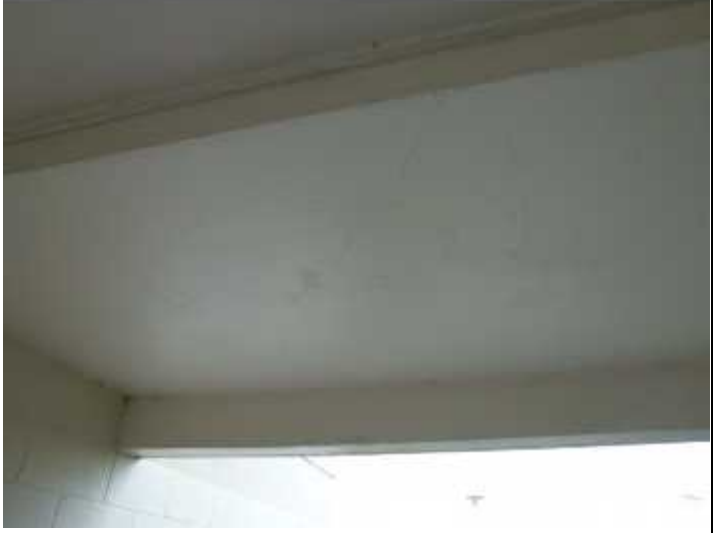
14.	Hairline cracking to suspended slab

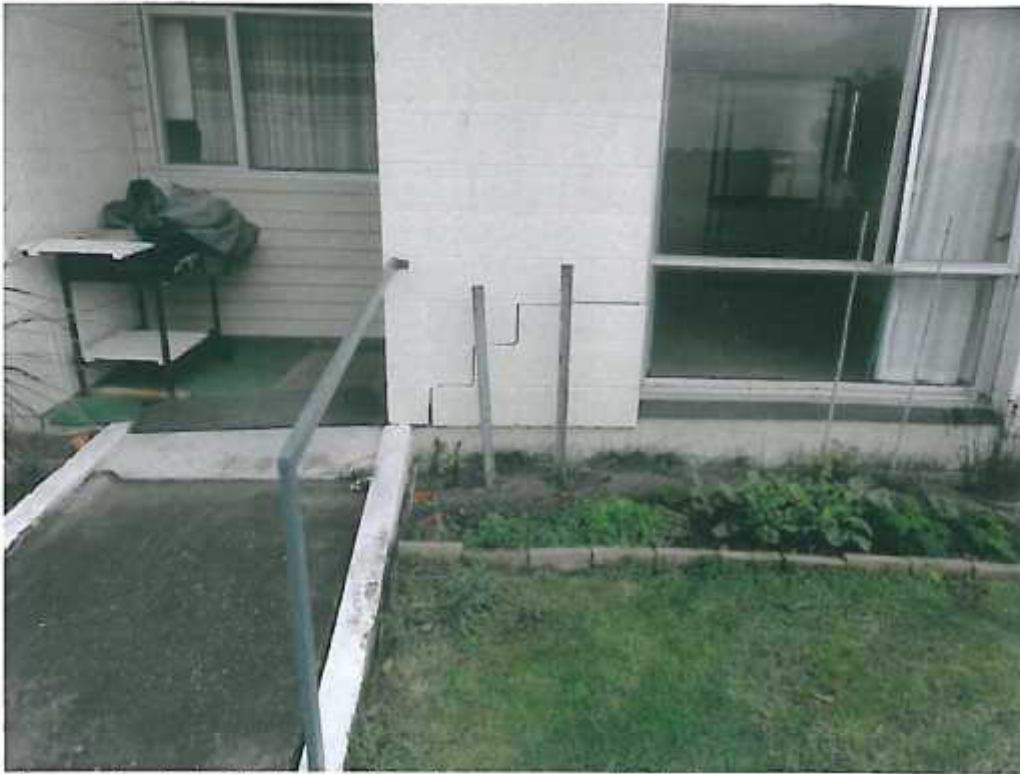
Photo 1: Cracks in block-work of north east corner of Unit 6

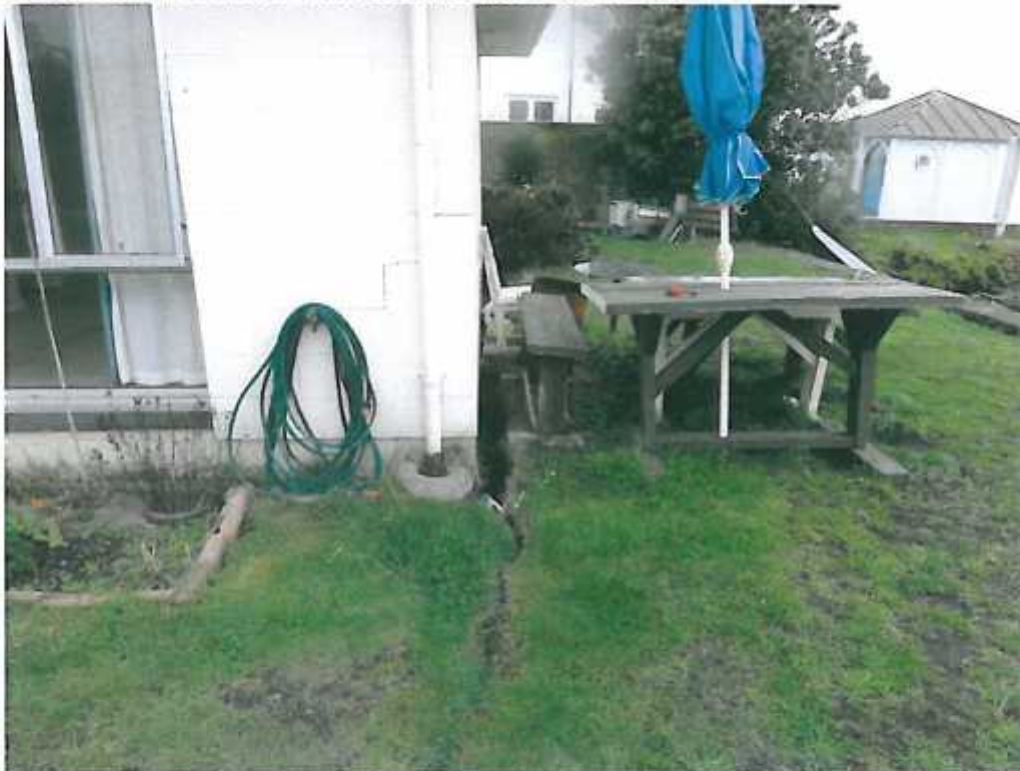
Photo 2: Cracks in block-work of north east corner of Unit 6

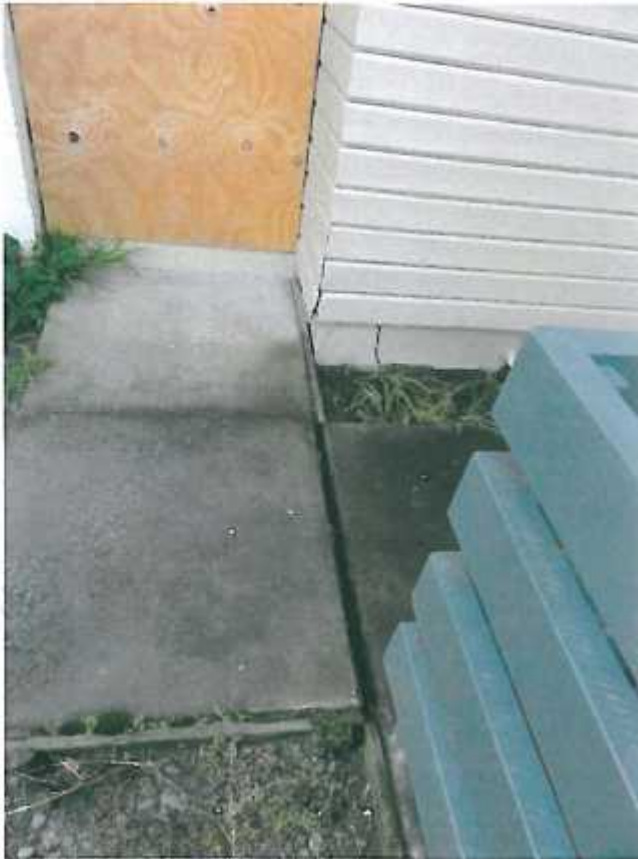
Photo 3: Crack in foundation in western side of Unit 8.

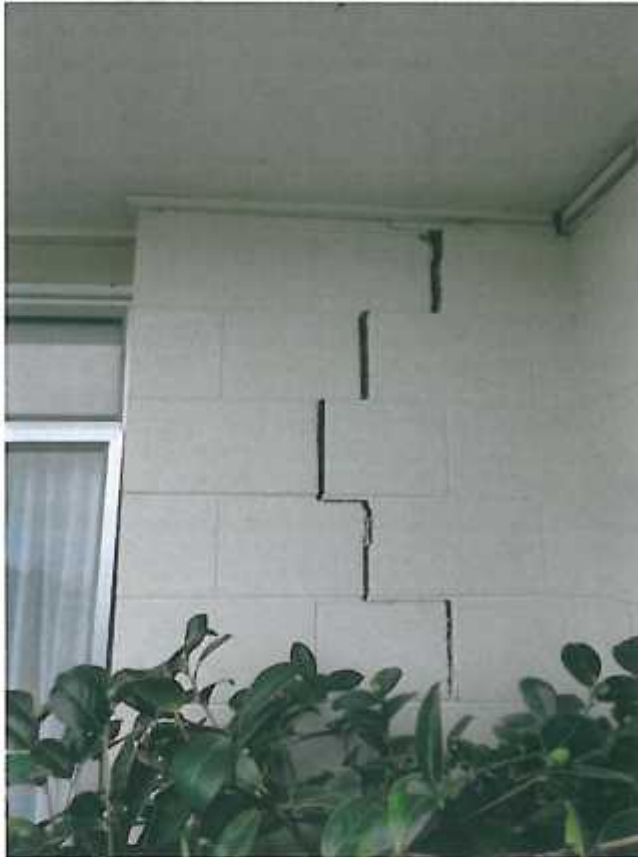
Photo 4: Crack in block-work on north east corner of Unit 9

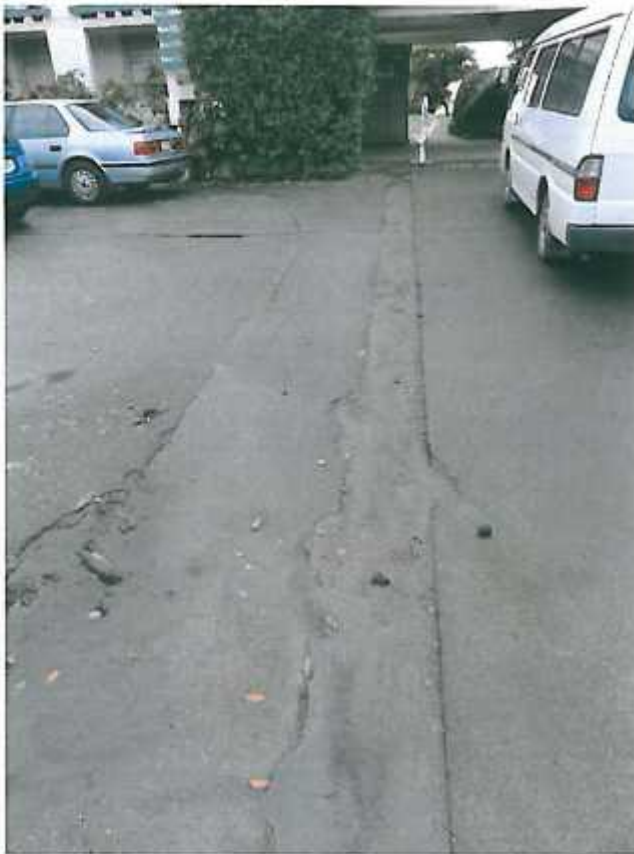
Photo 5: Sand boils in car park area, close to service trench

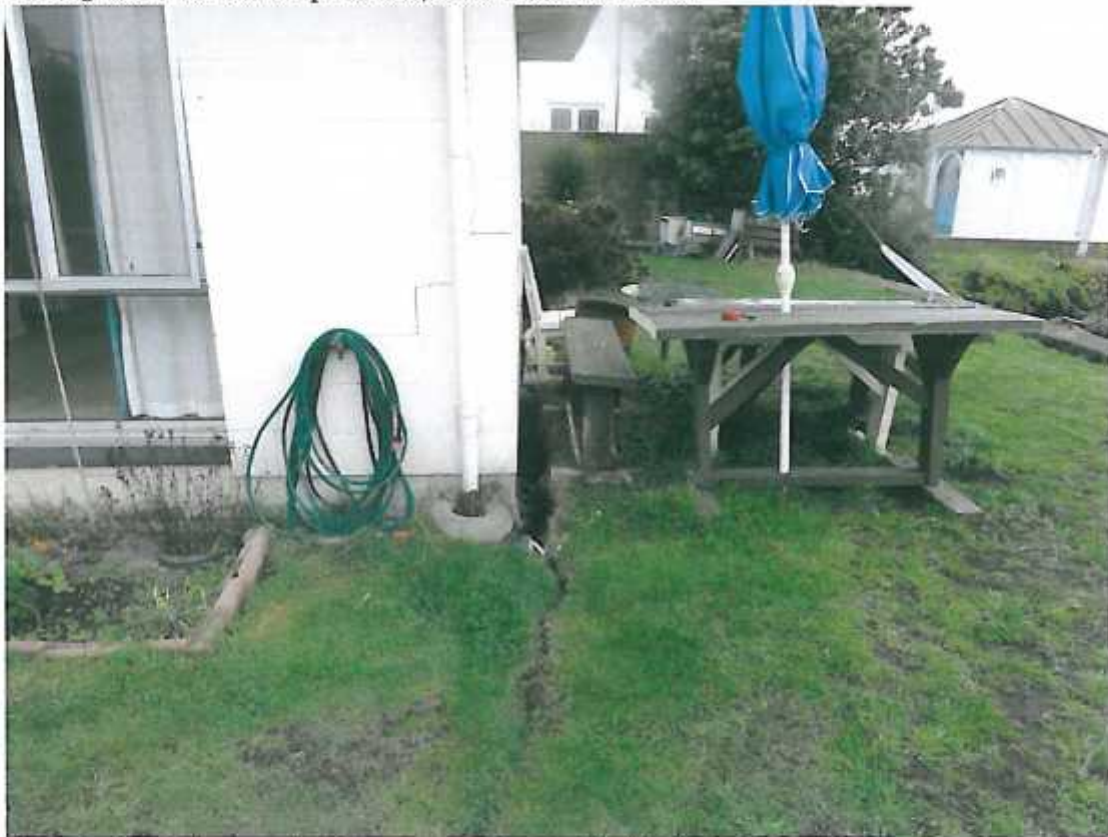
Photo 6: Crack in ground adjacent to northern wall of Unit 6

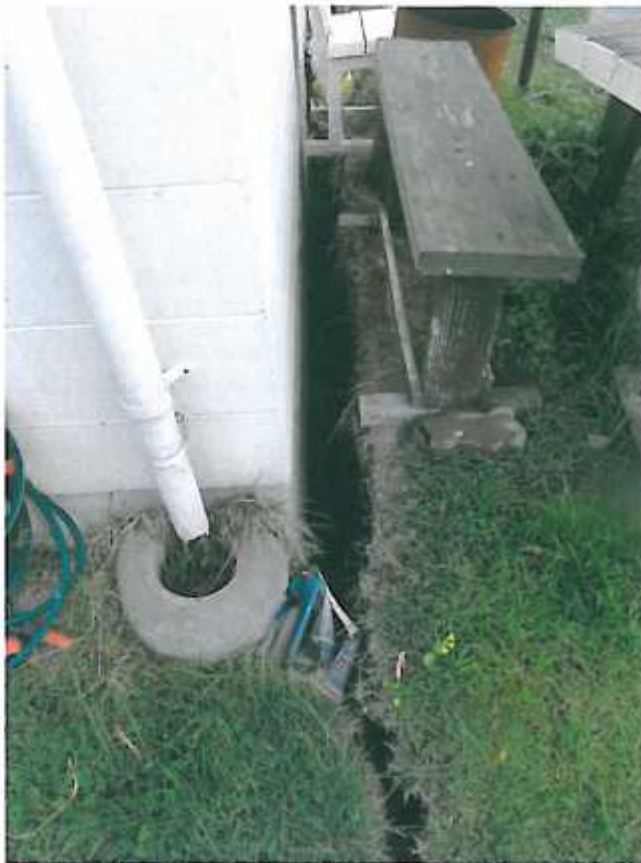
Photo 7: Crack in ground adjacent to northern wall of Unit 6

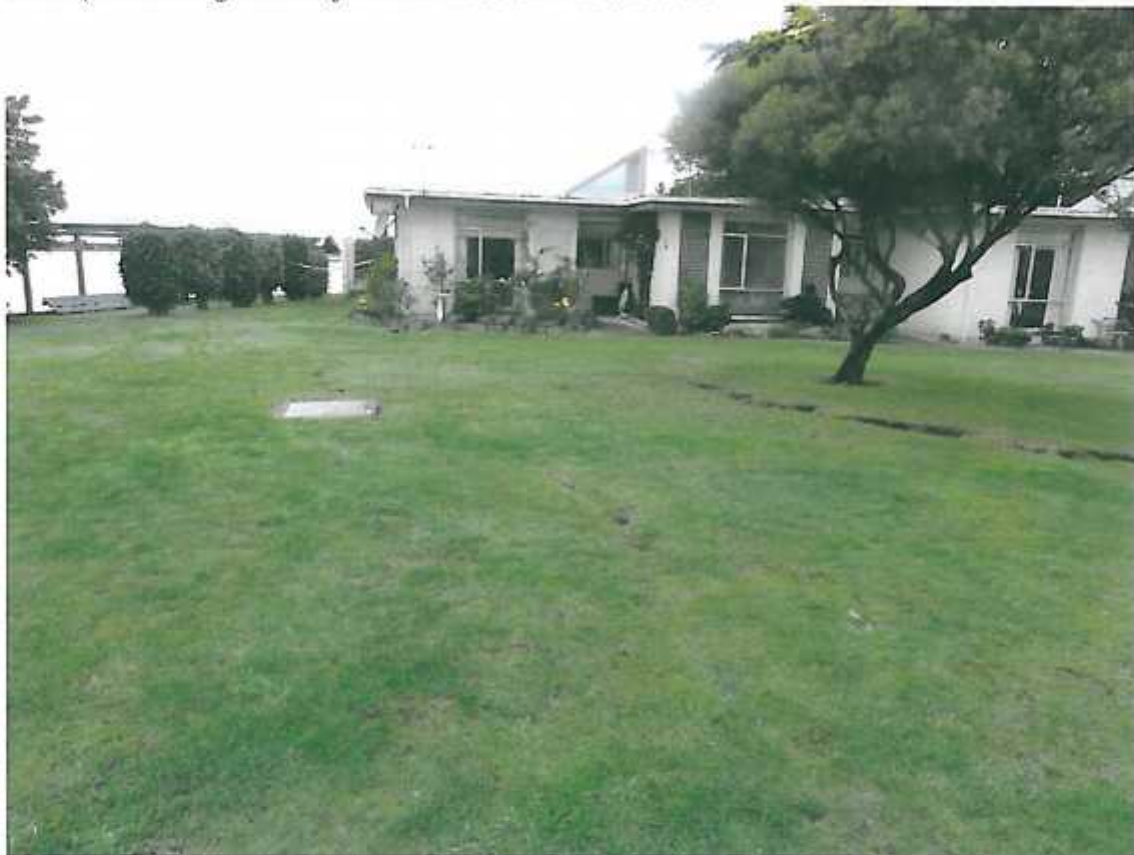
Photo 8: Cracks in lawn area in northern part of site.

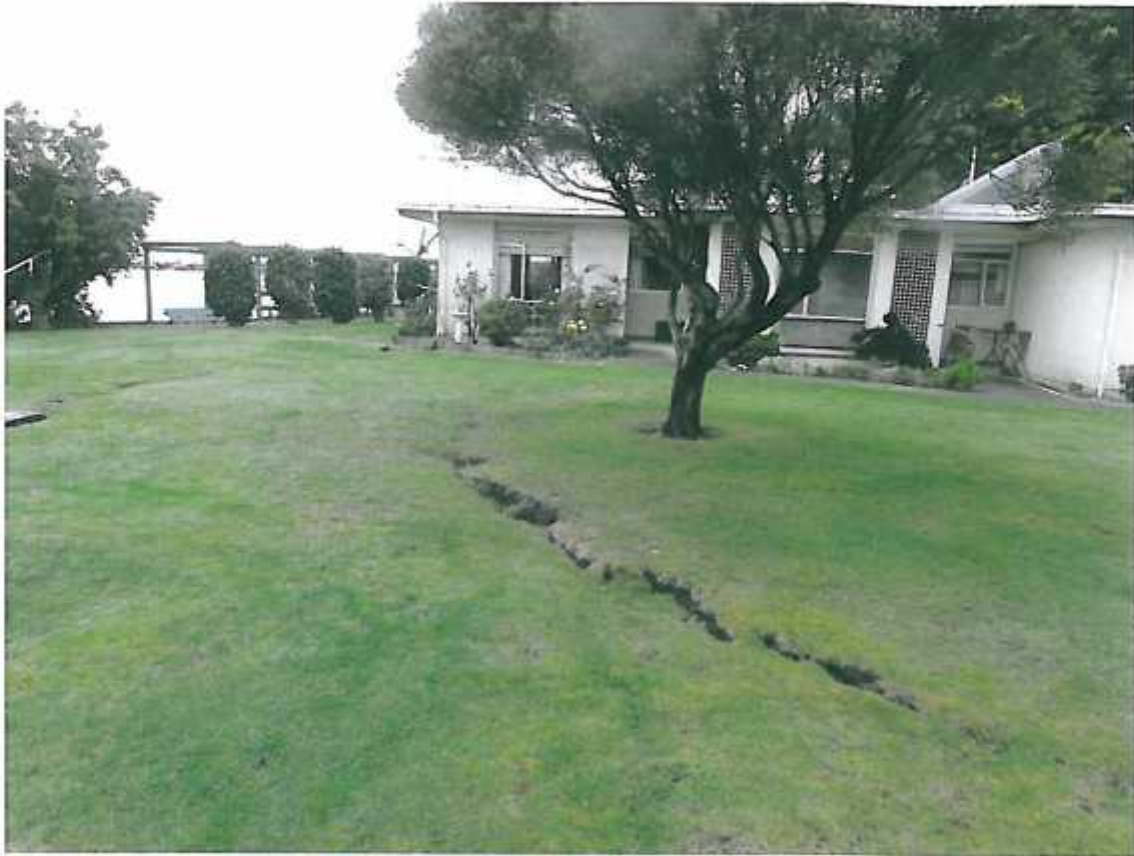
Photo 9: Cracks in lawn area in northern part of site.

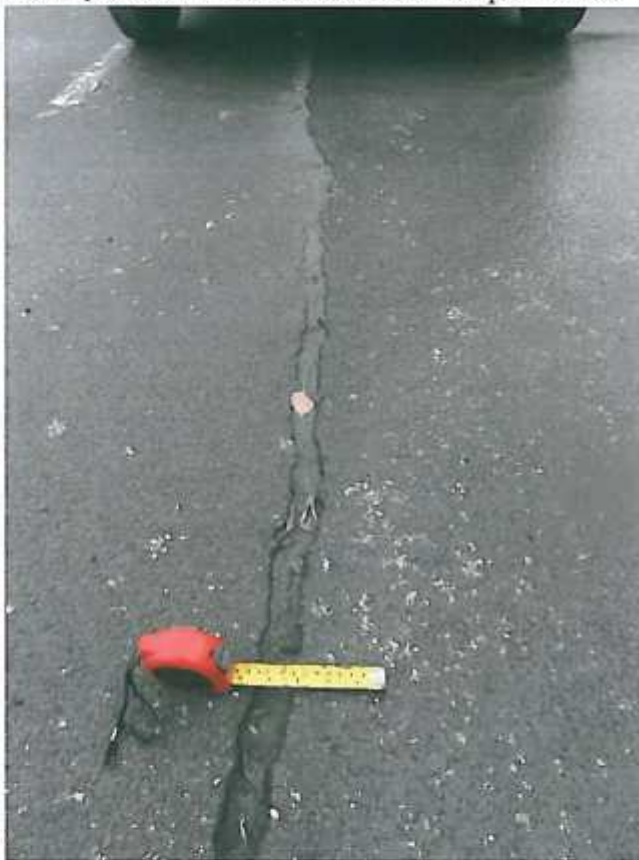
Photo 10: Crack in car park, with sand boil infill

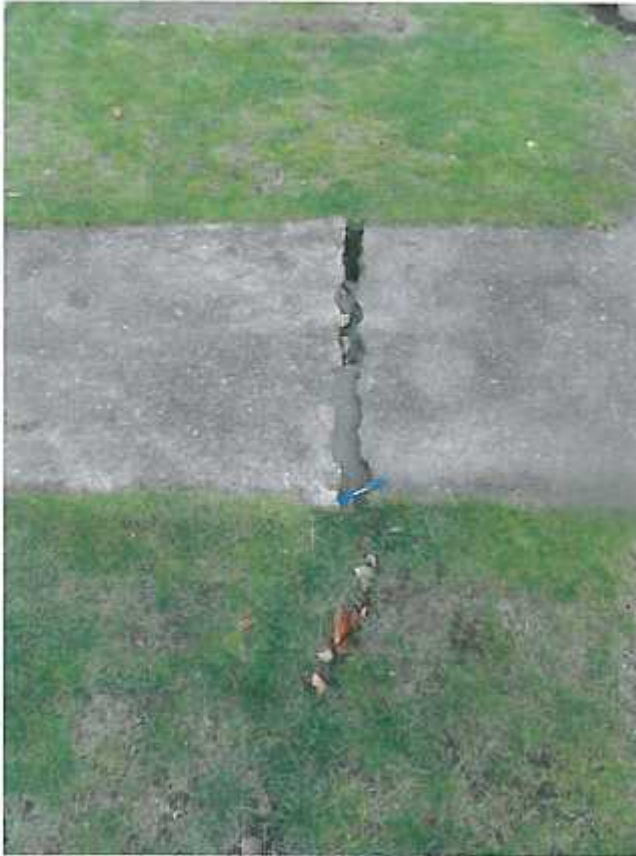
Photo 11: Crack in path with sand boil infill, by Unit 9 and 10

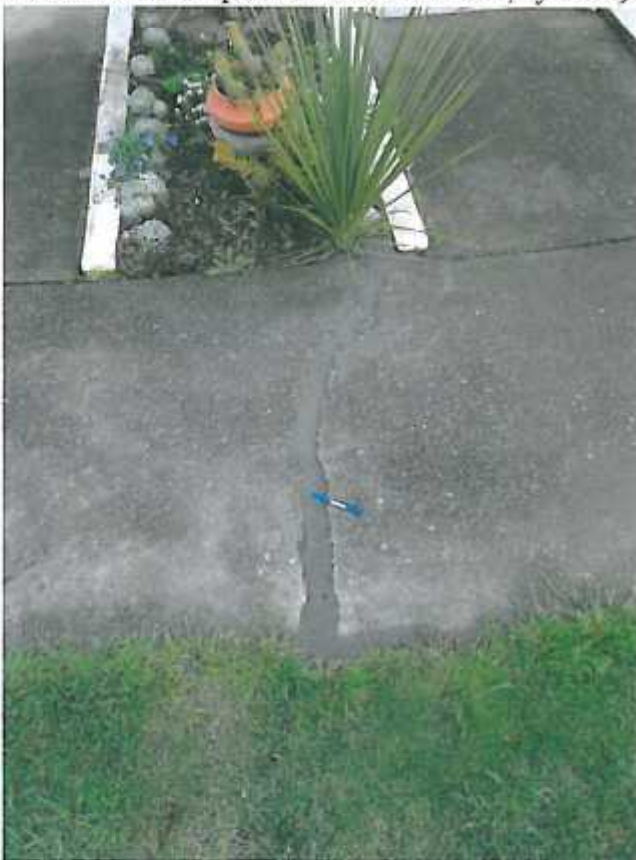
Photo 12: Crack in path with sand boil infill, by Unit 7 and 8

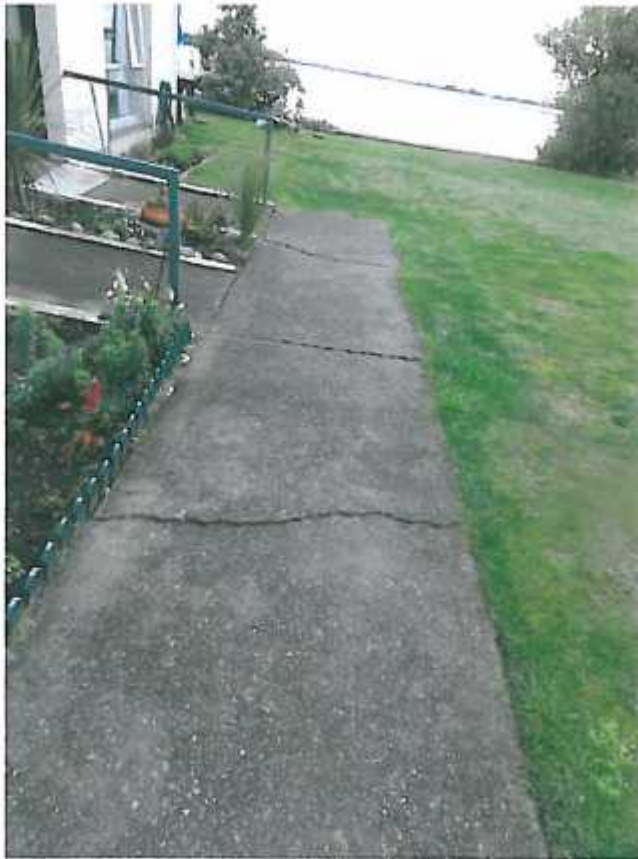
Photo 13: Cracks in path on eastern side of units 7 and 8

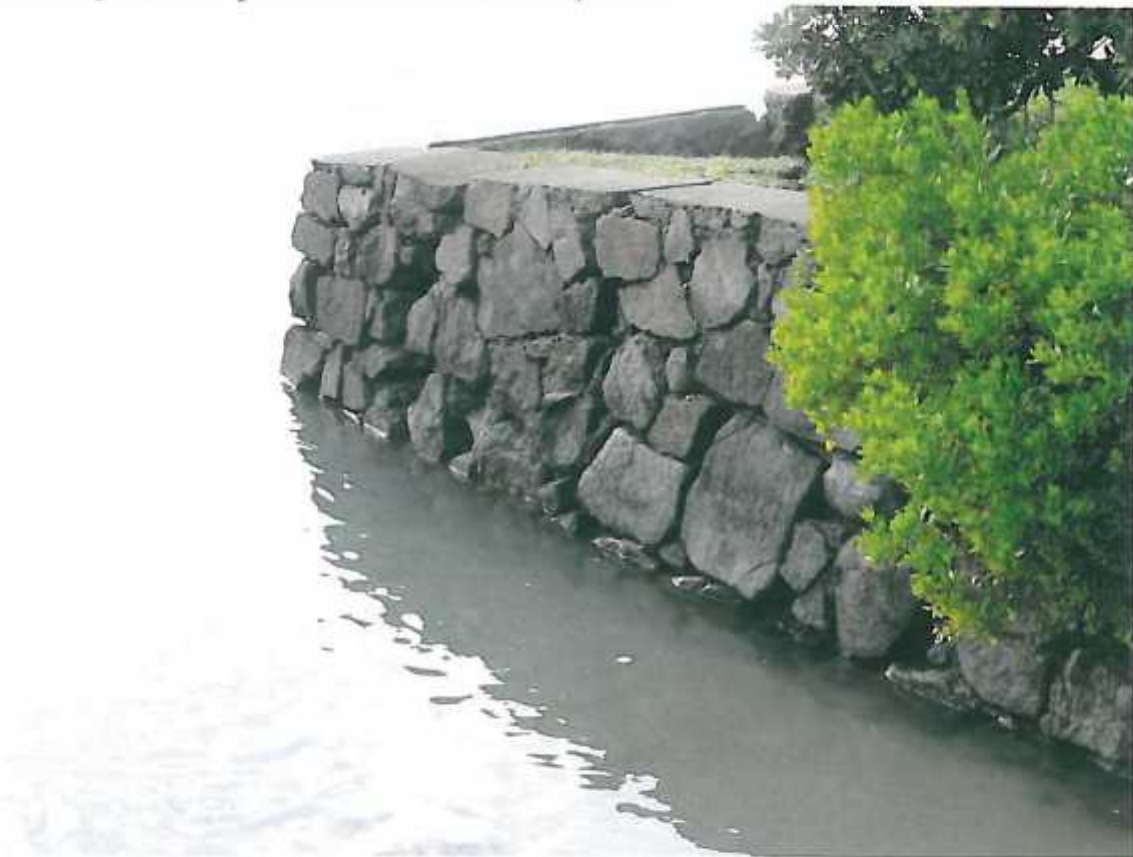
Photo 14: Crack damage to retaining wall in north part of the site.
