**Awa-iti Domain  
Community Building  
PRK 3746 BLDG 009 EQ2**

**Detailed Engineering Evaluation**

**Quantitative Assessment Report**

Date: April 2013  
Reference: 6-QUCC1.25  
Status: Final

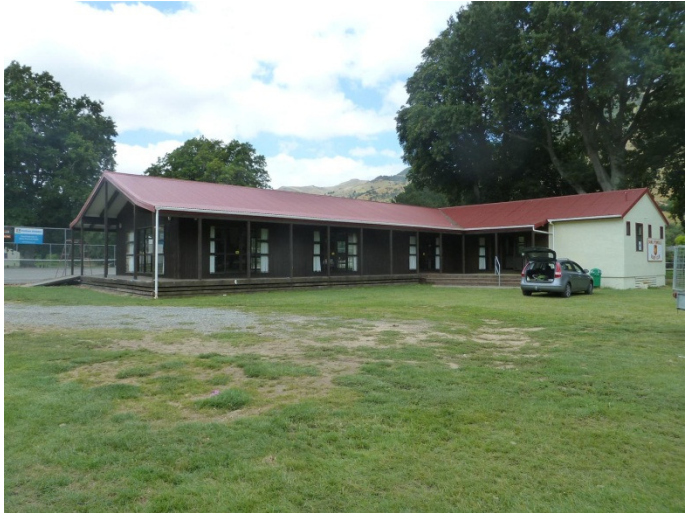
Awa-iti Domain Community Building		
No.	Item description	Photo
1.	External View – West Side

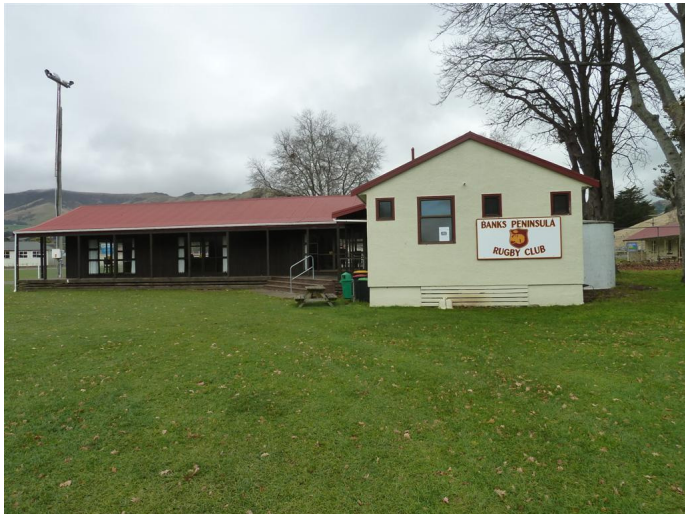
2.	South west end wall

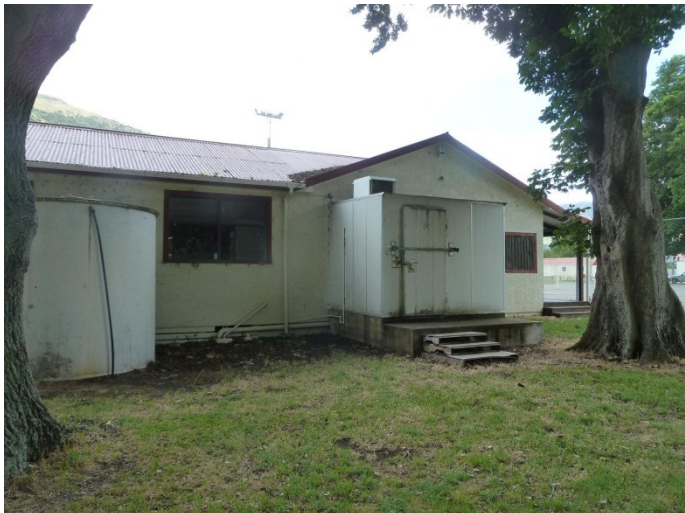
3.	South east end wall

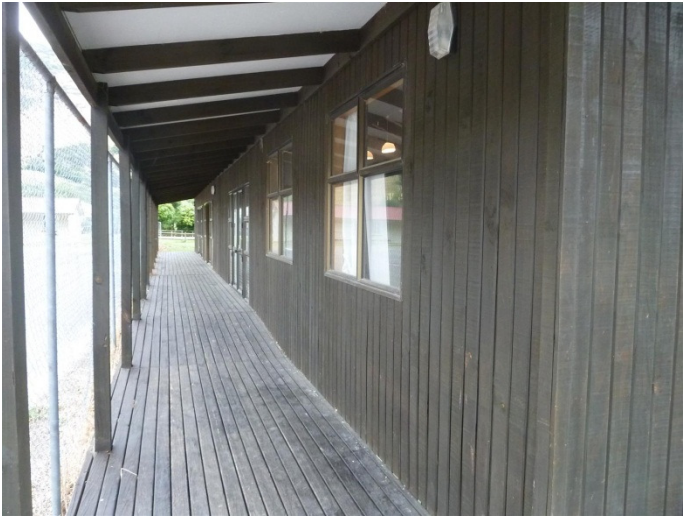
4.	North east side wall

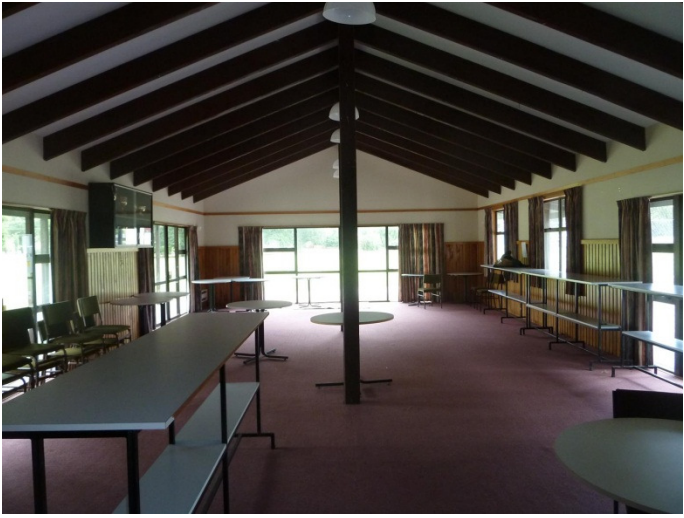
The seismic capacity of the building is limited by the lack of wall bracing, especially across the building in the north-west end wall. Bracing walls are far apart in the main structure, with up to 12.8m spacing, as well as having limited length which causes them to be overloaded. The building has a calculated seismic capacity of 69% NBS, and is therefore not classified as an earthquake prone building in accordance with NZSEE guidelines.

The external end wall and first internal wall towards the north-west end of the building limit the capacity of the building to 69% NBS. If strengthening to 100%NBS is desirable, then these areas would need to be addressed.

5.	Internal view of north west end wall

Due to the building receiving a rating of greater than 67% NBS, strengthening is not required. However, it is recommended that strengthening be considered to the north-western end of the building.

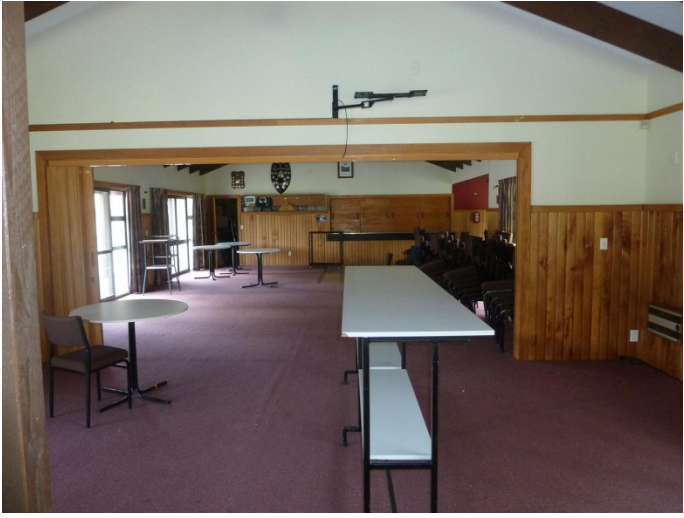
6.	Internal view of first internal bracing wall from north west end wall

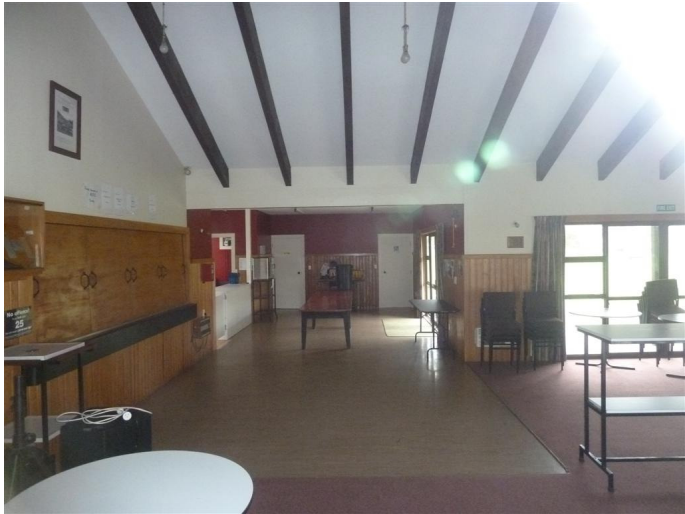
7.	Main structure to kitchen passage

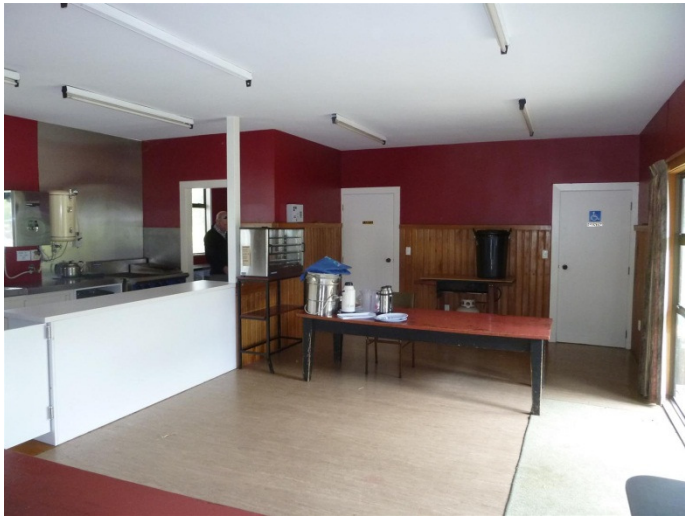
8.	Kitchen

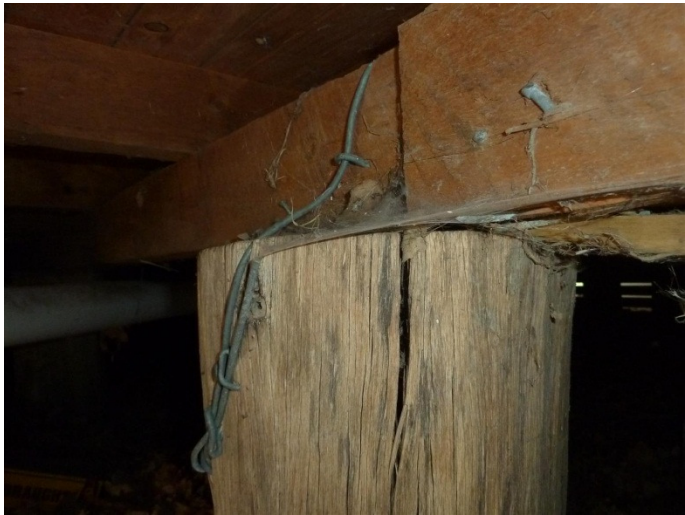
The floor bearers are tied down to the timber piles by way of no. 8 galvanised fencing wire looped over the bearer and stapled to the face of the pile. Due to the inconsistent installation of this type of connection it is near impossible to assess quantitatively. However, it is estimated that this tie down is sufficient to resist both overturning and lateral shear to a capacity of greater than 100% NBS.

9.	Bearer to timber pile connection

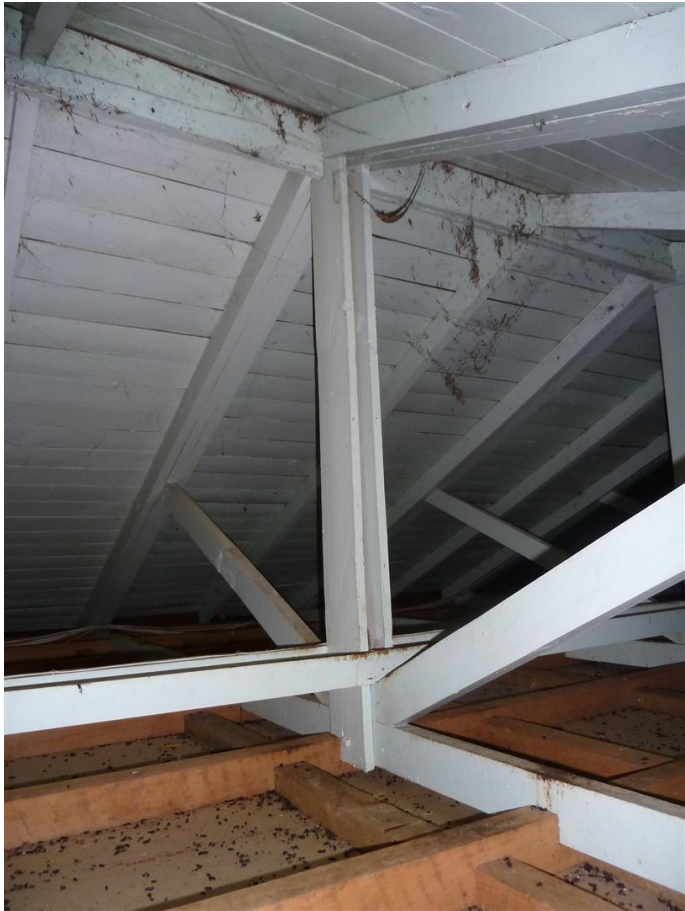
10.	Timber roof trusses
