**Bartlett Street
Housing Complex
PRO 0524**

**Detailed Engineering Evaluation
Quantitative Assessment Report**

7 Bartlett Street, Riccarton,

Date: February 2014
Reference: 6-QC313.00
Status: Final

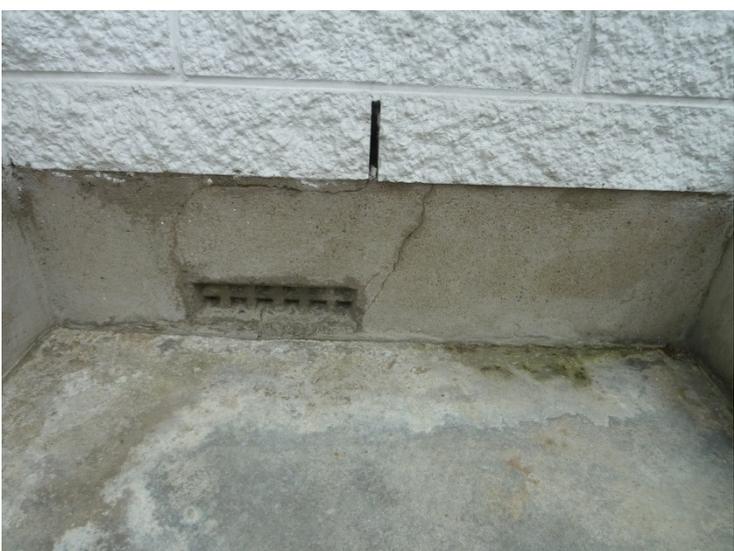
Foundation damage was limited to minimal cracking in the concrete foundation perimeter footing on some of the blocks (photo 8).

8.	Typical cracking of concrete perimeter footing

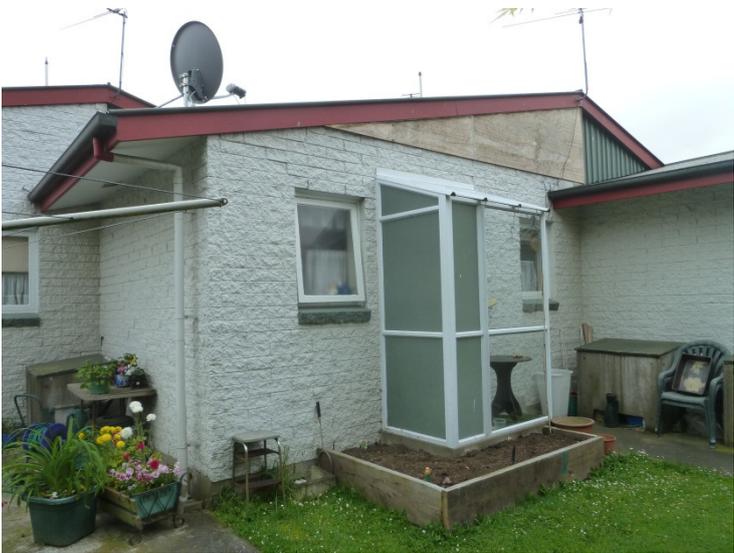
Damage to the brick veneer at gable end height appears to have been sustained on Unit 2 and 6 (photo 9). The damaged gable veneer has been removed and the opening has been closed temporarily using ply sheet.

<p>9.</p> <p>Removal of brick veneer at gable ends. Ply sheet used as weatherproofing</p>

- Veneer at height (gable ends) have the veneer ties checked.
- Structural schemes be developed to increase the seismic capacity of the buildings to at least 67%NBS.
- Lightweight cladding be installed at gable ends where brick veneer has been removed.
- Cosmetic repairs be undertaken as required.

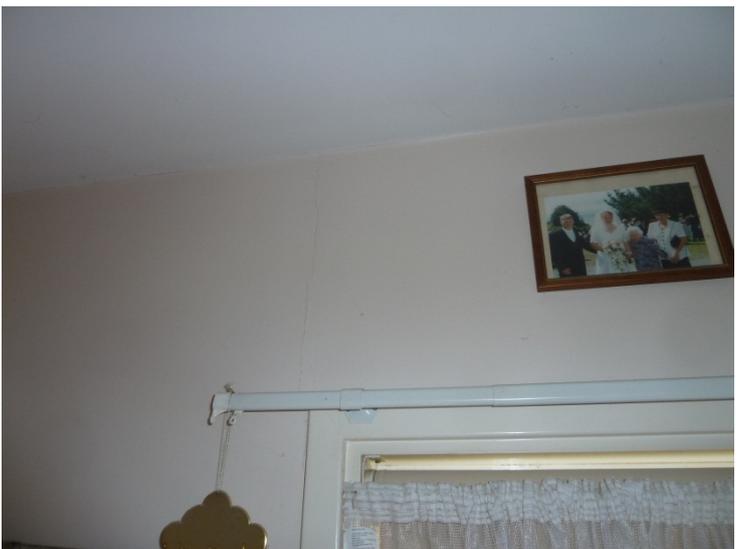
Minimal cracking of plasterboard ceiling diaphragms and wall linings was observed in the units (photo 12). This form of damage is common throughout the units, and is deemed low and not affect the lateral-resistance structure.

12.	Typical cracking of wall lining
