**Beckenham Park - Toilet Block**  
**PRK 1077 BLDG 001 EQ2**  
Detailed Engineering Evaluation  
Quantitative Report  
Version FINAL

18 Norwood Street, Beckenham

Christchurch City Council

**Date**  
20 December 2012

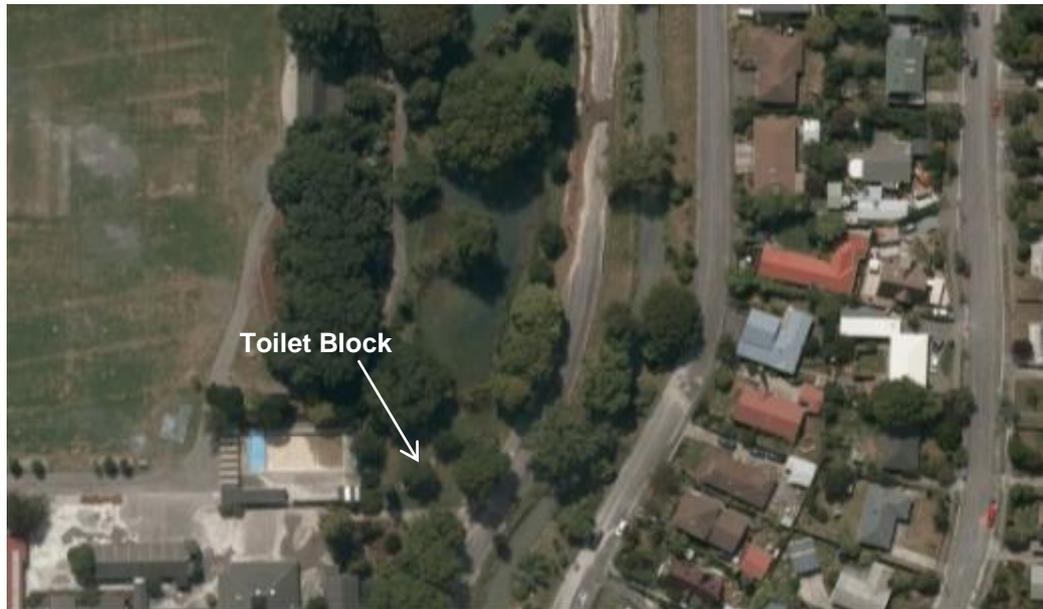
**Figure 3 Post February 2011 Earthquake Aerial Photography<sup>5</sup>**

The site is located within 100m of the Heathcote River and is therefore within the potential zone of lateral spread. However, no obvious evidence of global lateral movement was observed or recorded<sup>4</sup>. A localised slump on the riverbank was recorded<sup>4</sup> on the lateral spread cracking map.

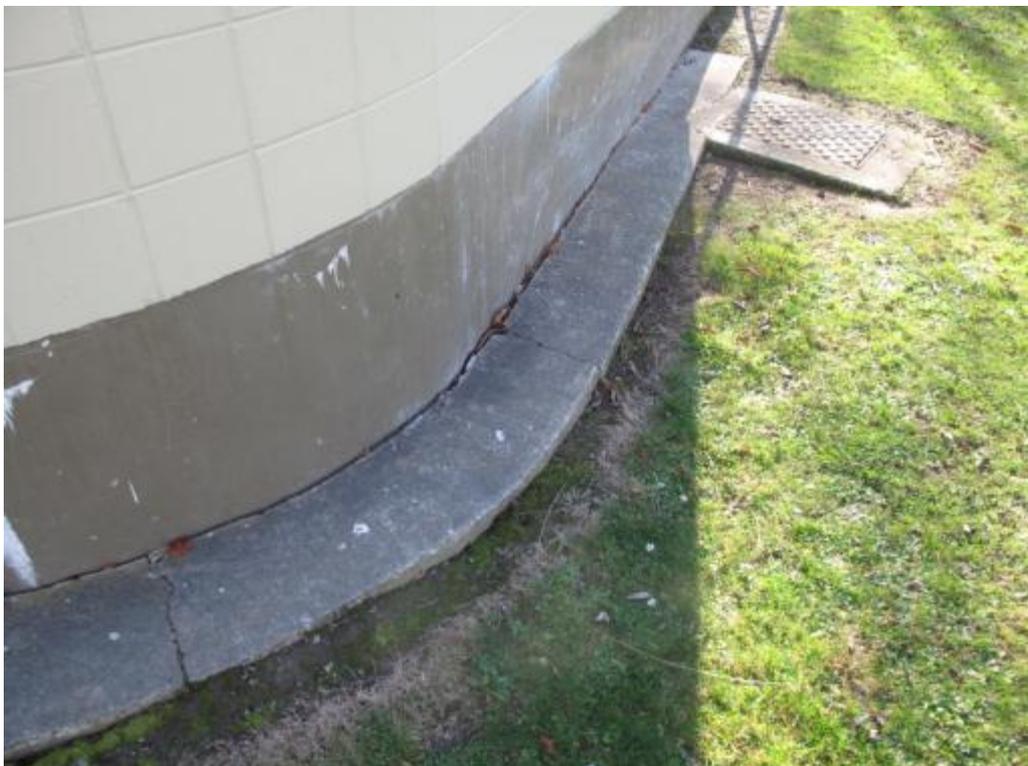
The only visible damage to the structure was minor settlement at the southeast corner of the toilet block and minor cracking in the adjacent strip footing. The minor damage and ponding is visible in Photographs 4, 5 and 6 in Appendix A.

Slight cracking and movement around the concrete skirting was visible in the southeast corner of the building where the underground services access the structure.

**Photograph 4 Minor damage to the base where the strip footings have settled.**

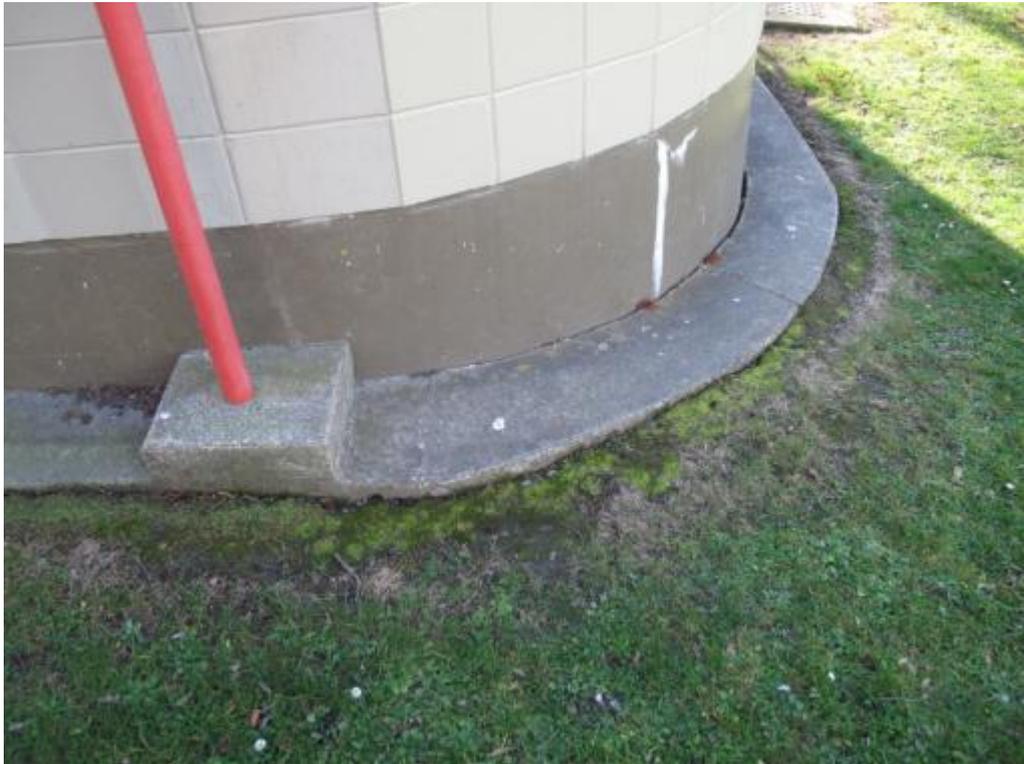
**Photograph 5** Minor damage to the base where the strip footings have settled.

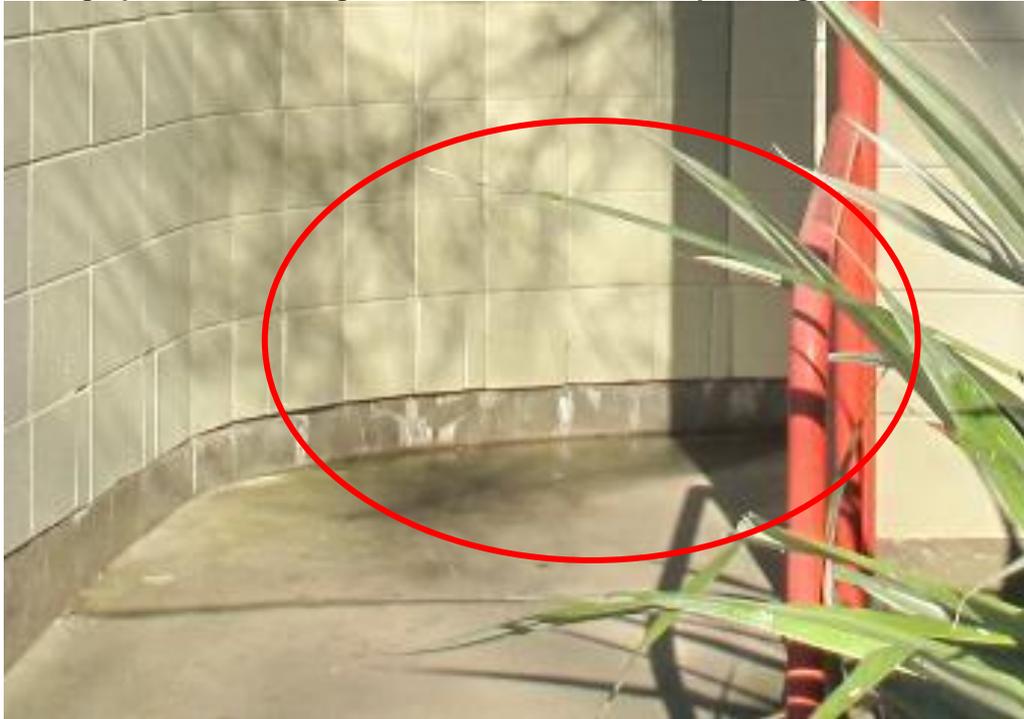
**Photograph 6** Ponding on concrete entrance area possibly due to minor settlement.

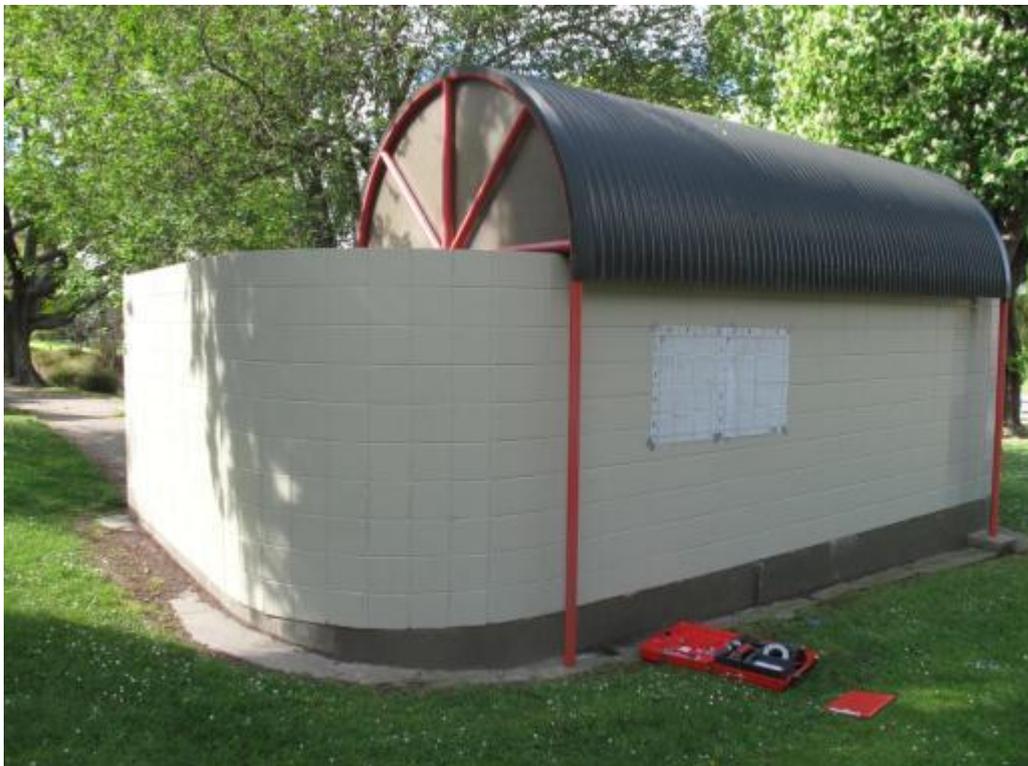
**Photograph 10** Area of rear wall where reinforcement checks have been done.
