Beverley Park Toilets  
Qualitative Engineering Evaluation

**Reference:** 229188

Functional Location ID: PRK 0790 BLDG 001 EQ2

Address: 171-173 Stanmore Road

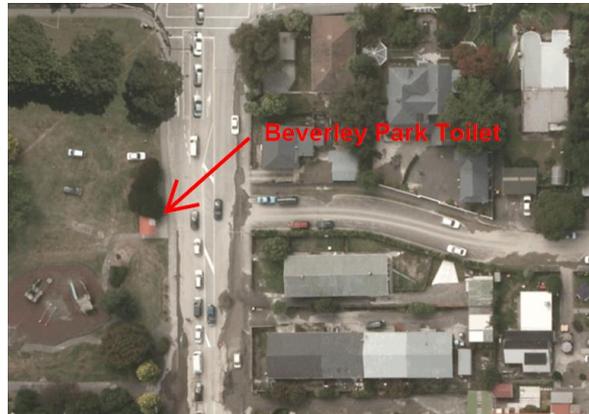
Aerial photograph of Beverley Park showing the location of the toilet and evidence of nearby liquefaction.

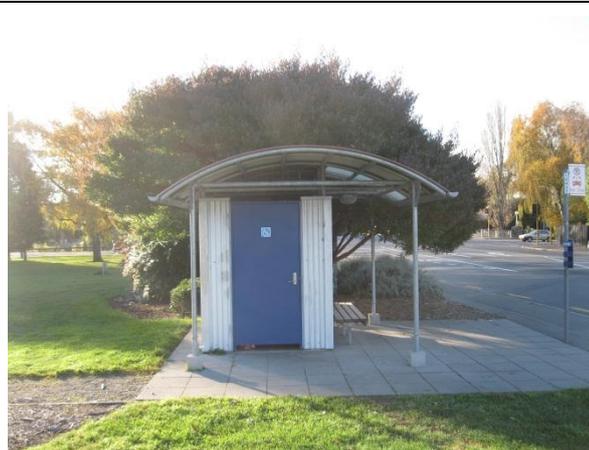
Southern elevation of the Beverley Park Toilets.

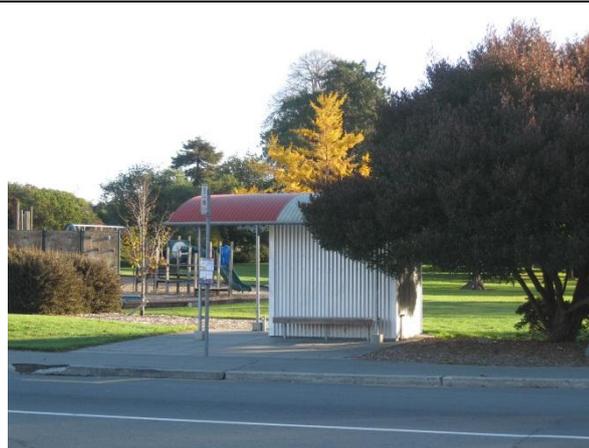
Eastern elevation of the Beverley Park Toilets.

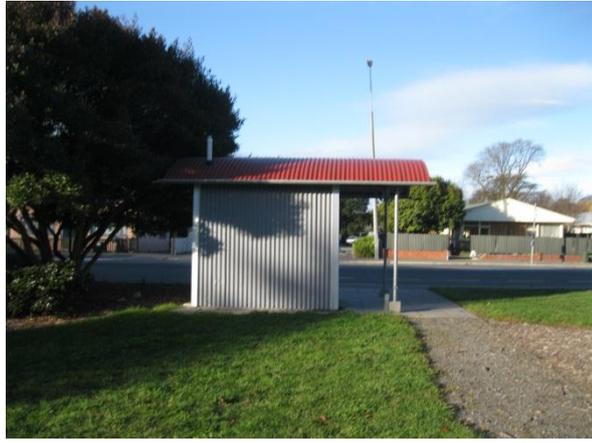
Western elevation of the Beverley Park Toilets.

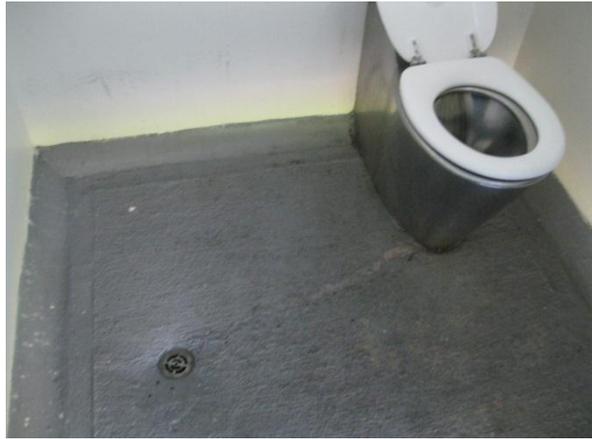
Internal view of the Beverley Park Toilets.

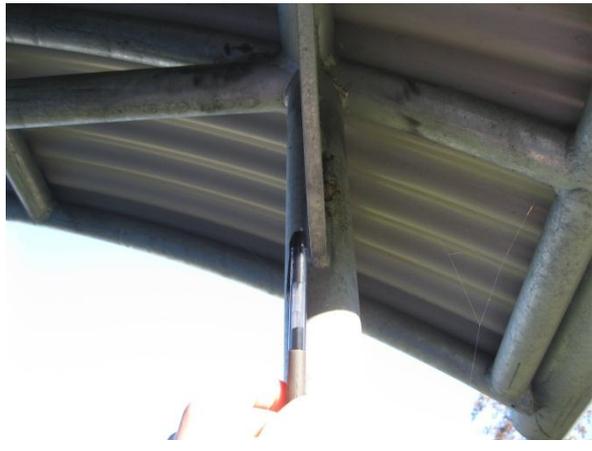
Typical roof connection detail.

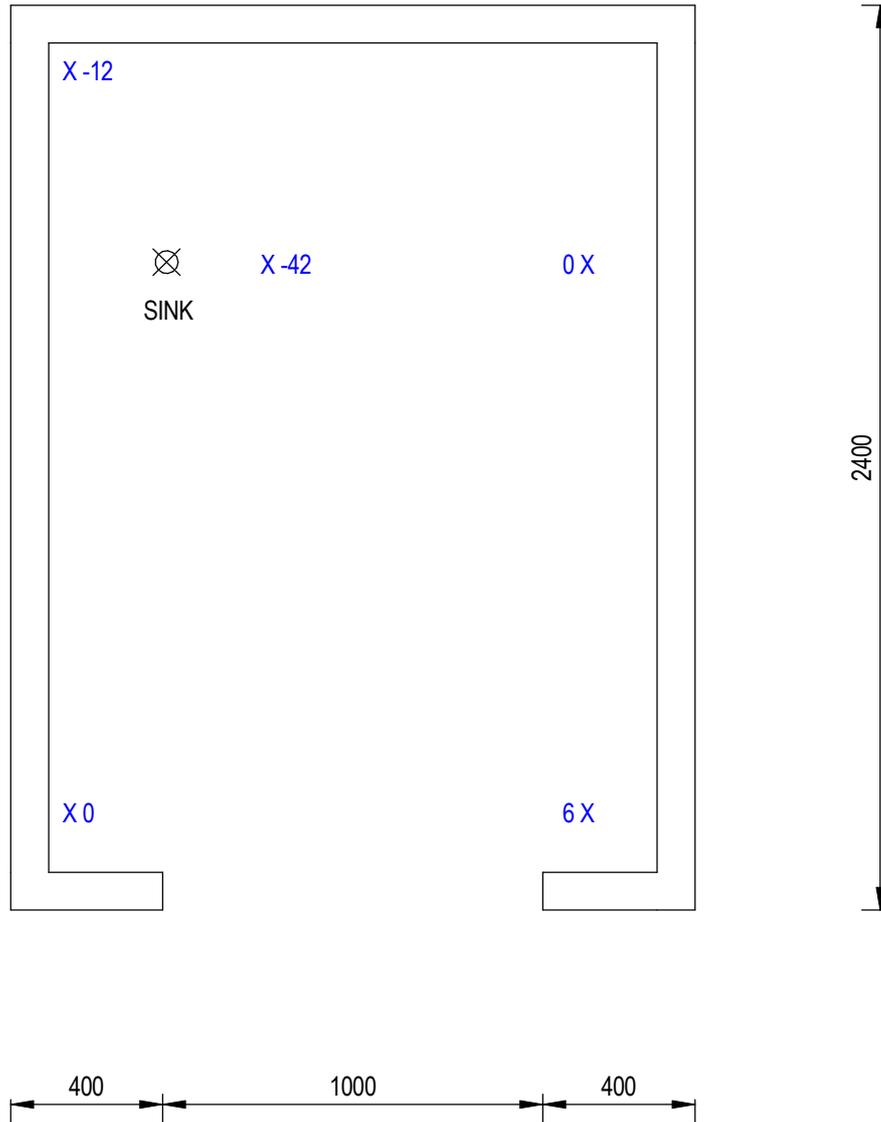
PROJECT
BEVERLEY PARK TOILETS
TITLE
LEVEL SURVEY

We undertook a floor levels survey to establish the amount of settlement that has occurred. The results of the survey are presented on the attached drawings in Appendix A. All of the levels were taken on top of the existing floor coverings which will have introduced some variation.

The floor levels for the Beverley Park Toilets were found to be acceptable given that the slopes in the floor are for drainage purposes.
