**Birdsey Reserve Lockup Shed**  
**PRK 1742 BLDG 003 EQ2**  
Detailed Engineering Evaluation  
Quantitative Report  
Version FINAL

40 Bridle Path Road, Heathcote Valley,  
Christchurch

Christchurch City Council

**Date**  
05 April 2013

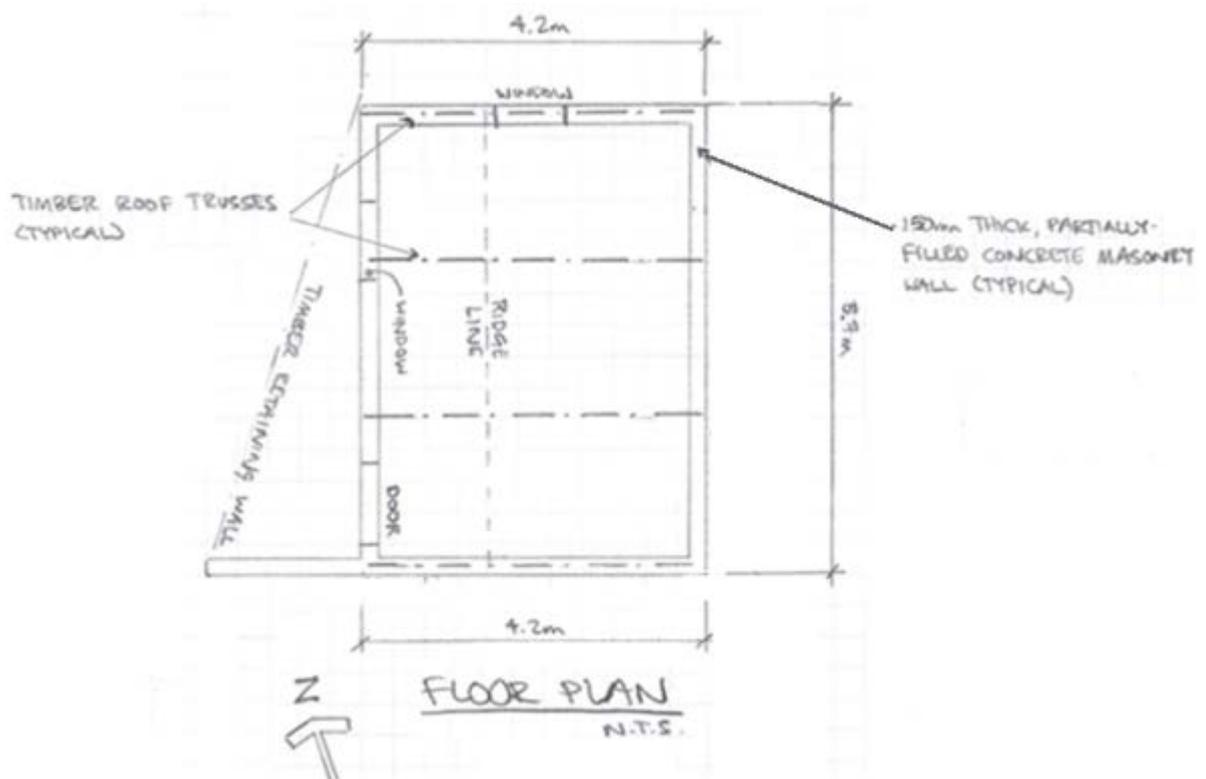
Figure 2 Plan of the building showing key structural elements

A plan sketch is provided in the following Figure 2 to illustrate the main structural members of the building.

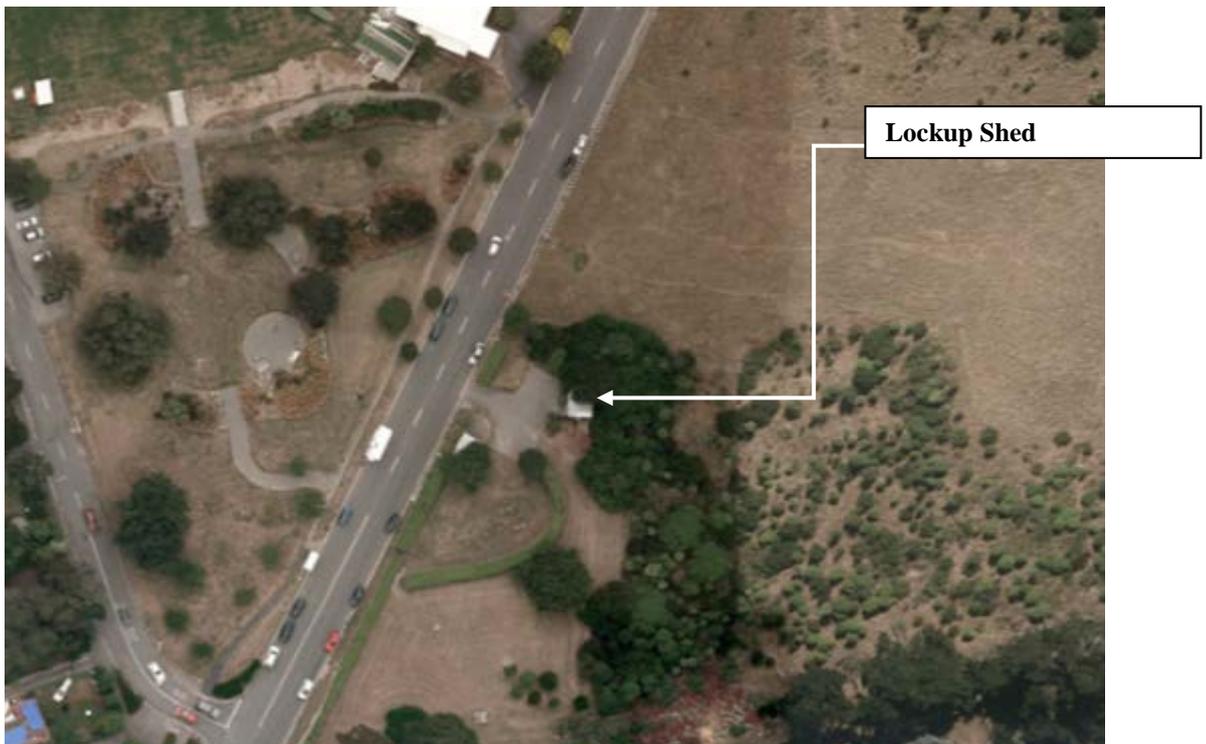
**Figure 3 Post February 2011 Earthquake Aerial Photography** <sup>2</sup>

Aerial photography taken following the 22 February 2011 earthquake shows no signs of liquefaction outside the building footprint or adjacent to the site, as shown in Figure 3.

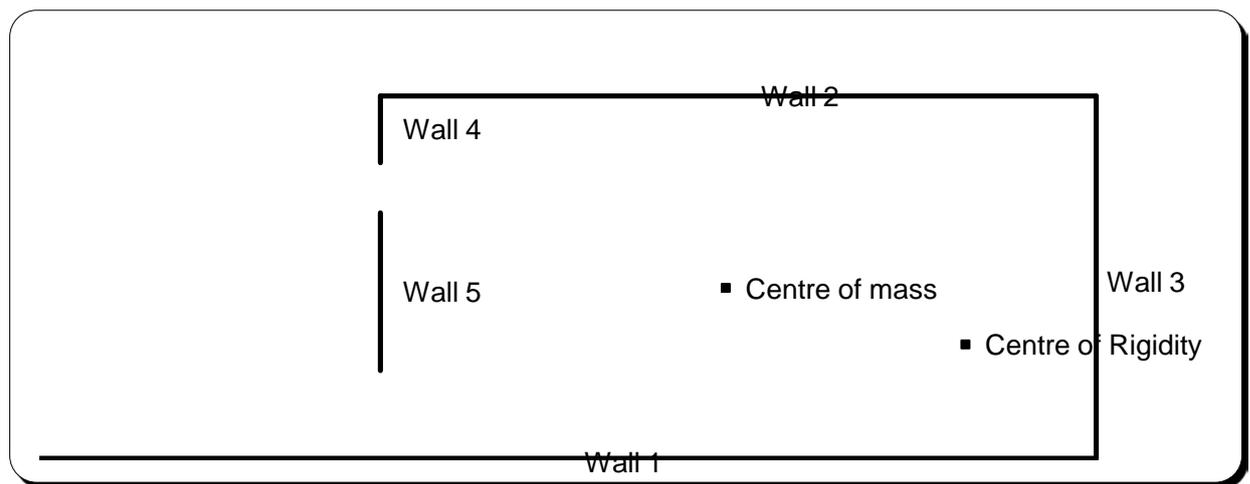
Figure 4 Plan Details and Wall Locations of Lockup Shed

The position of each wall is indicated in the plans below and each wall is named accordingly.

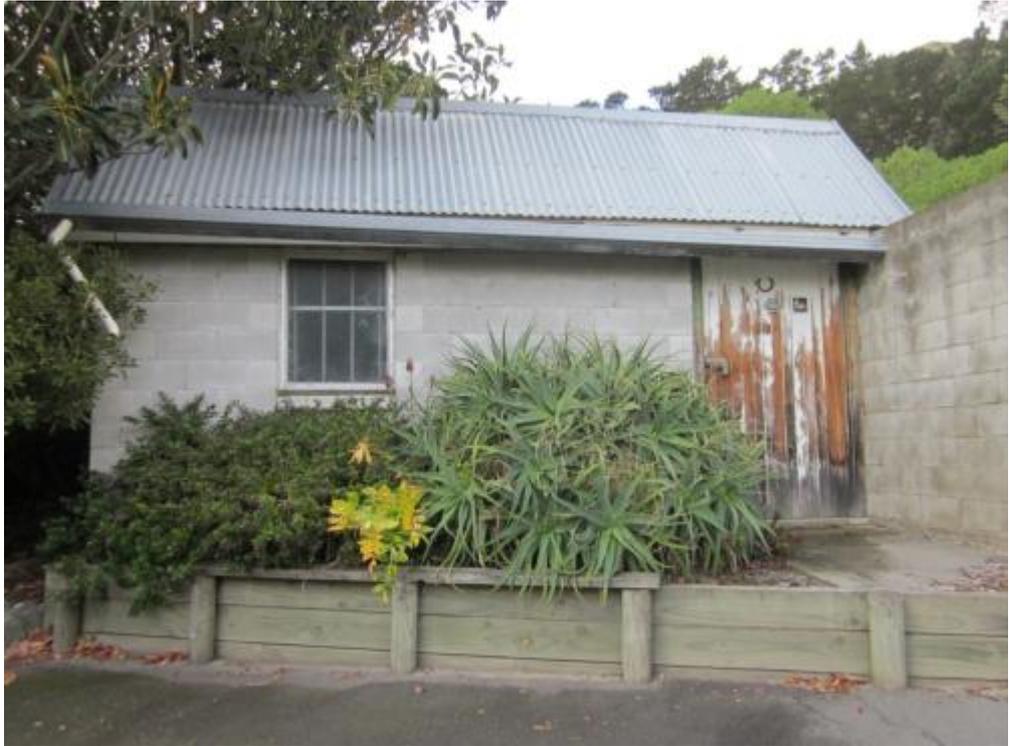
**Photograph 1: Western elevation.**

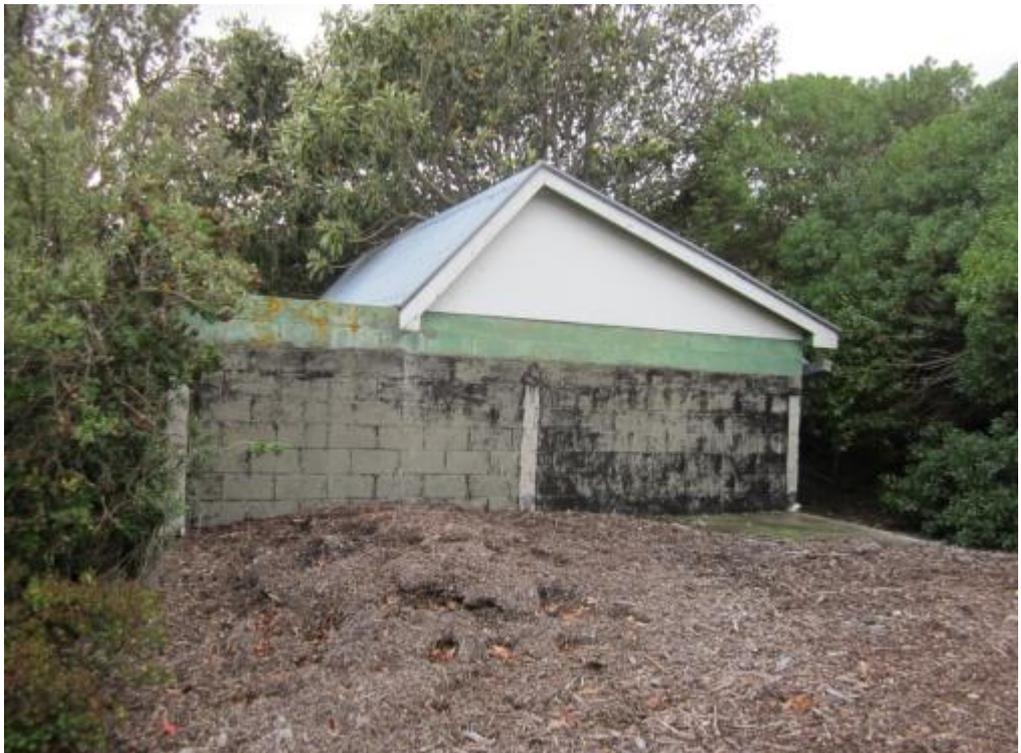
**Photograph 2: Southern Elevation.**

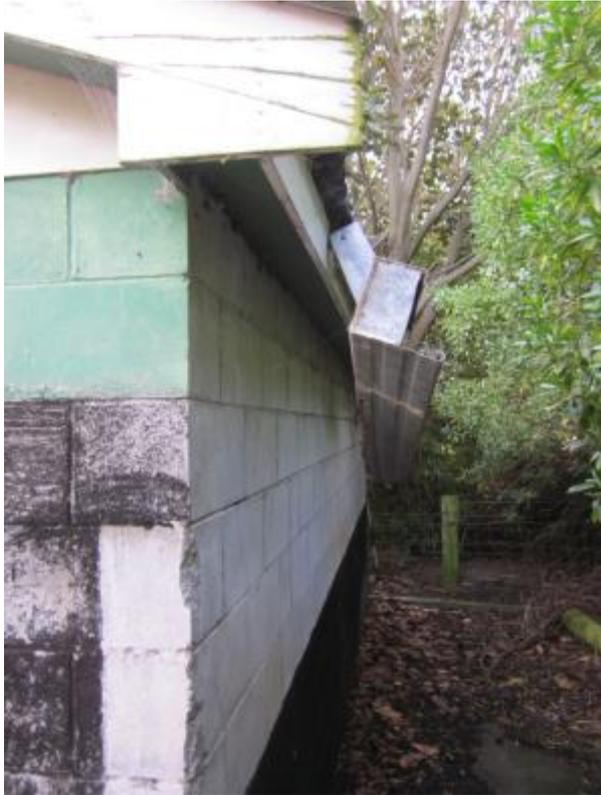
**Photograph 3: Southeast corner elevation.**

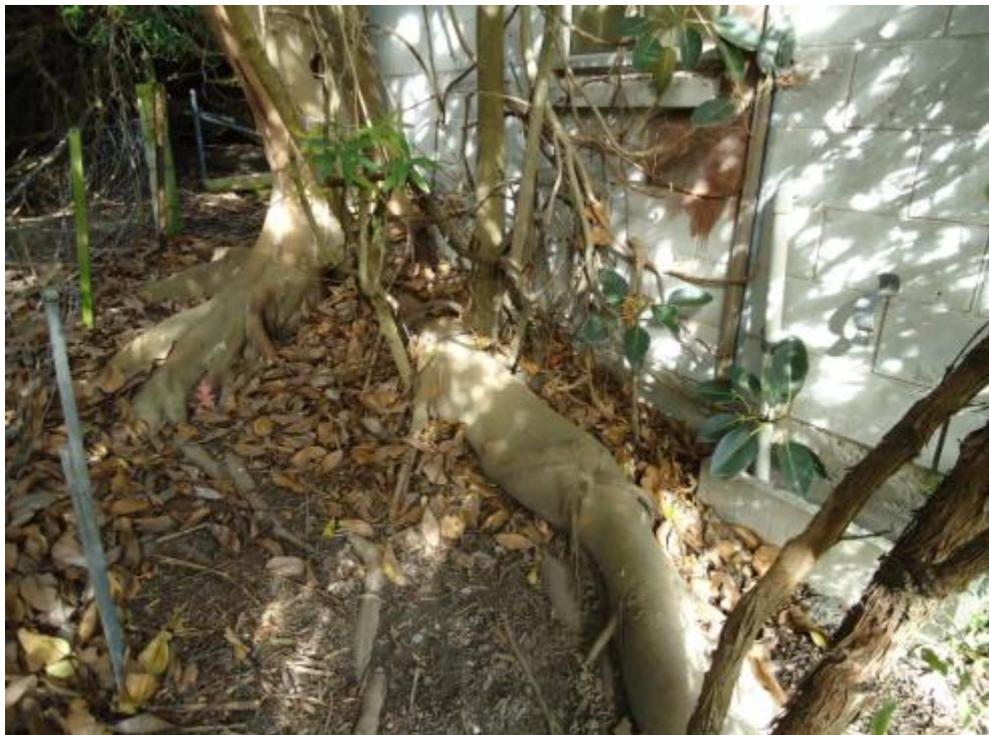
**Photograph 4: Northern wall damaged by tree roots.**

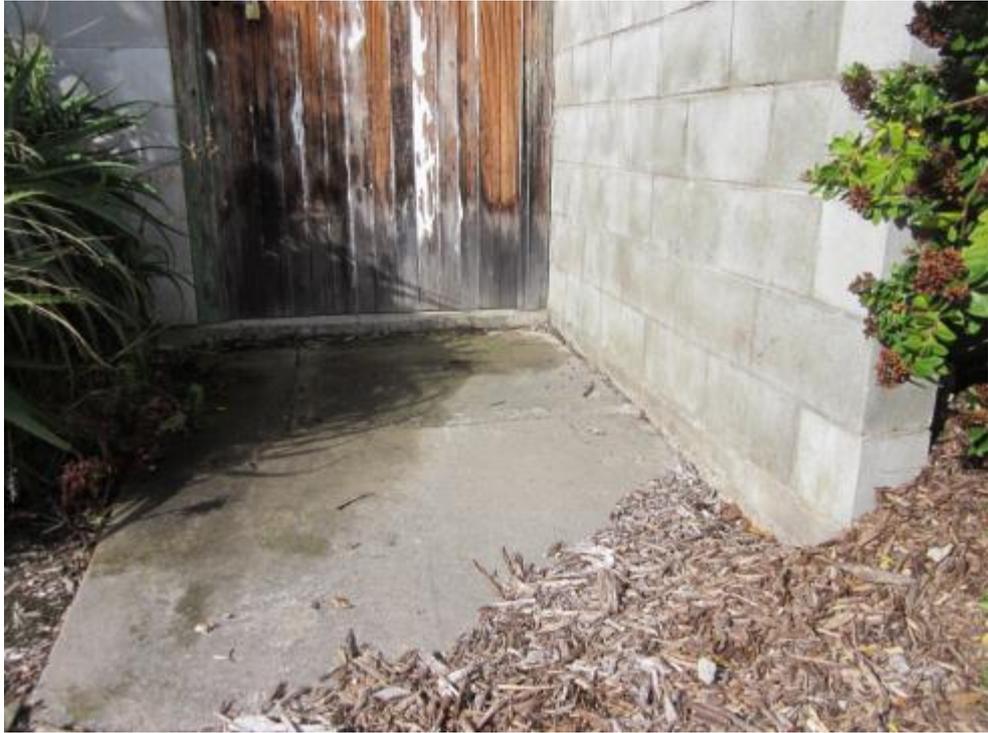
**Photograph 5: Small concrete pad and extended southern external wall at western wall entry door.**

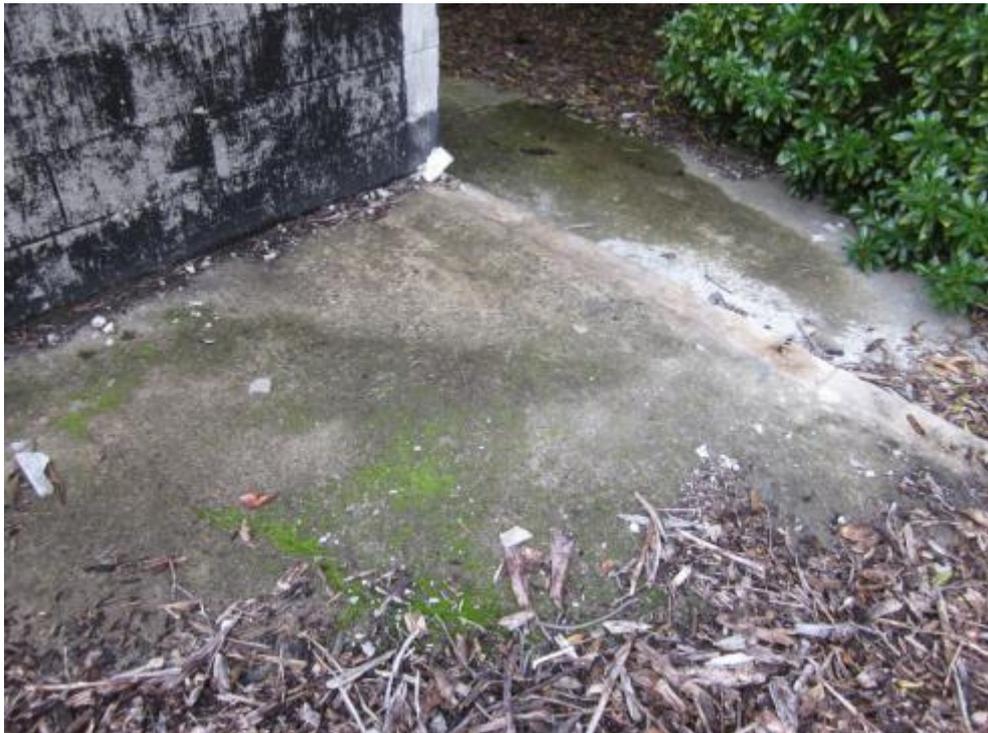
**Photograph 6: Leftover concrete pad and southern external wall.**

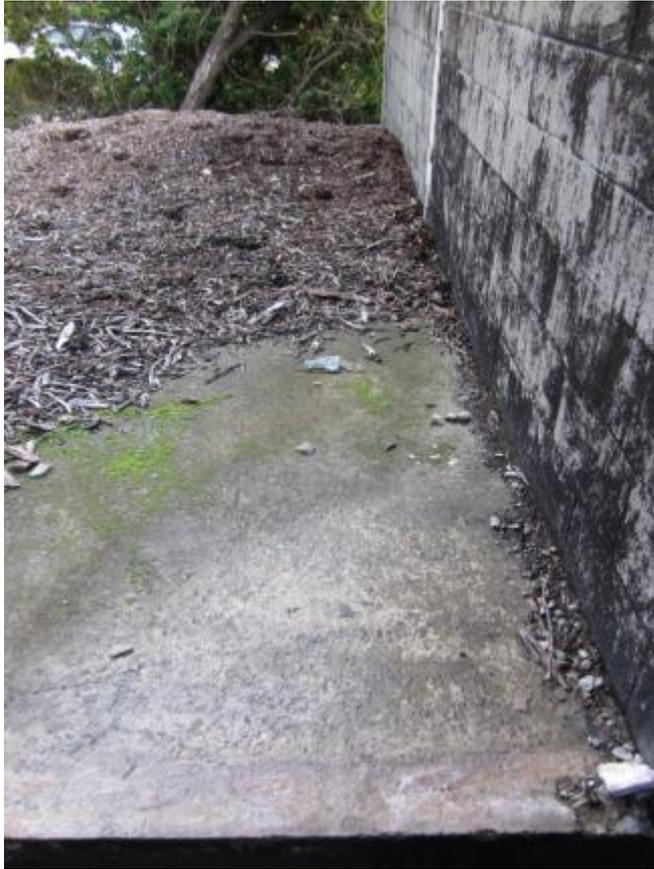
**Photograph 7: Leftover external concrete pad adjacent to southern external wall.**

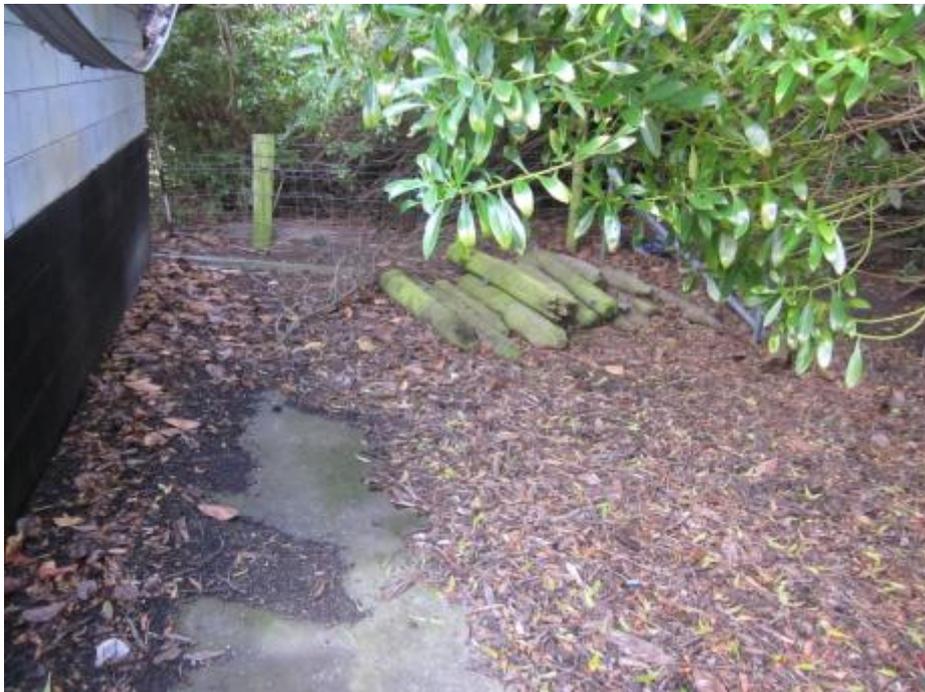
**Photograph 8: Concrete pad at eastern side of structure used for timber storage.**

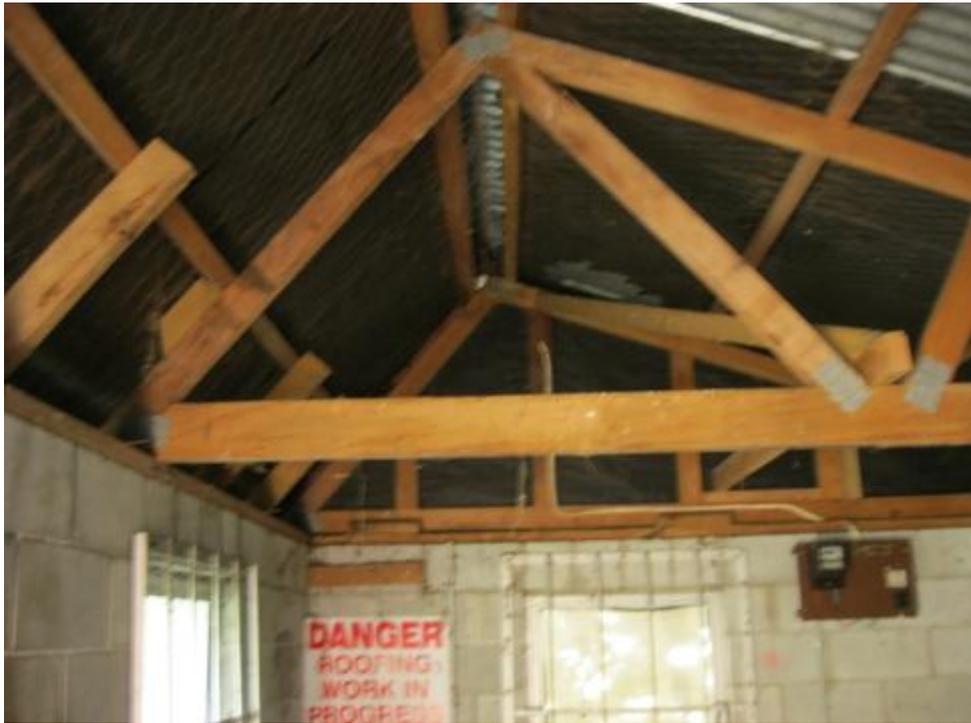
**Photograph 9: Interior view of timber roof trusses and external concrete masonry walls.**

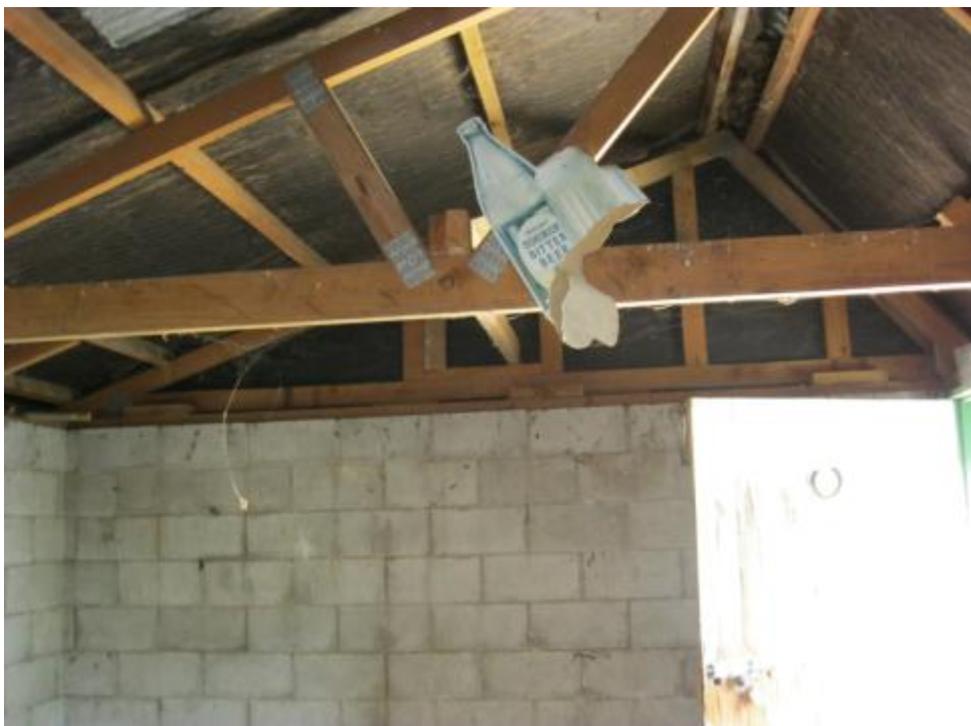
**Photograph 10: Interior view of timber trusses and external concrete masonry walls.**

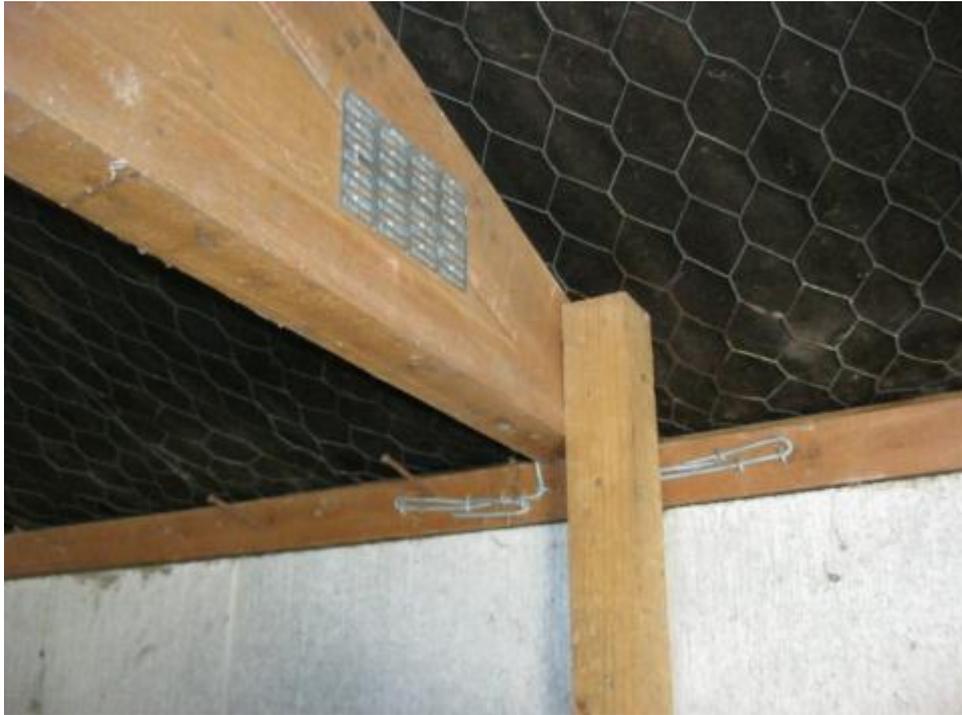
**Photograph 11: Typical timber roof truss attachment to top plate on external concrete masonry walls.**

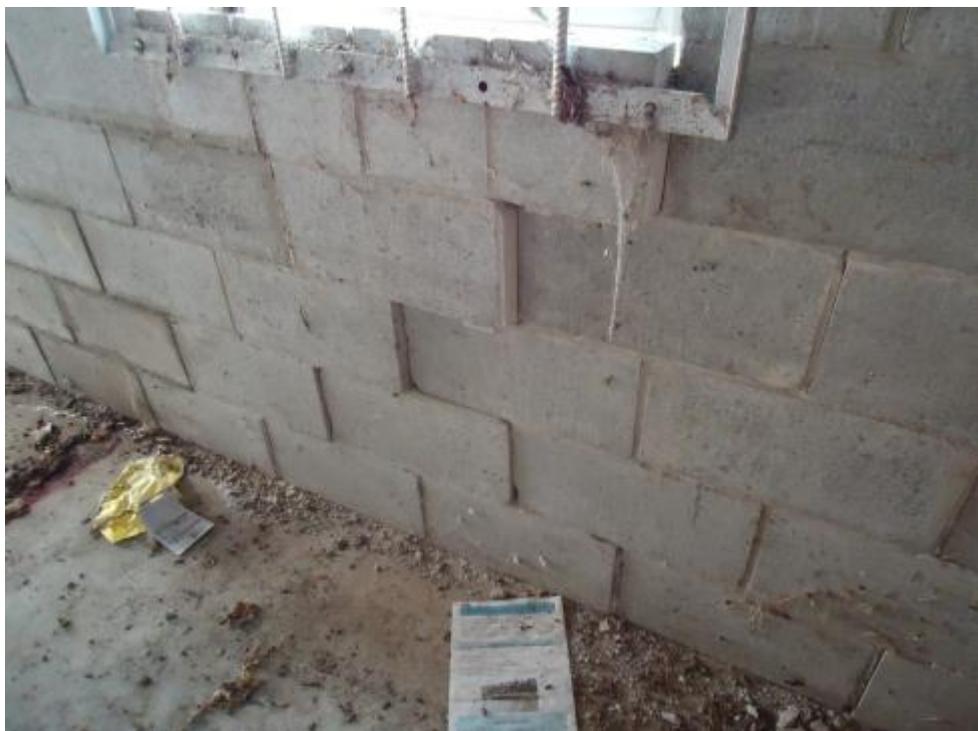
Significant structural damage has occurred to the western and northern walls of the building. Displacement of the walls around the windows has occurred which constitutes a failure of these structural elements (Refer to photographs 12 and 13).

Following a detailed assessment, the Lockup Shed has been assessed as achieving 43 %NBS excluding any structural damage. Significant damage to the walls of the north-west corner is considered to constitute a failure of these structural elements and as such they have achieved 0% NBS. Under the New Zealand Society for Earthquake Engineering (NZSEE) guidelines the lockup shed is considered to be an Earthquake Prone building.

**Photograph 12: Interior view of displacement to western wall by window adjacent to the north western corner of the building.**

As the Lockup Shed has been assessed to have a %NBS less than 33% NBS, it is deemed to be Earthquake Prone. It is recommended that wall strengthening or replacement options be explored and implemented to bring the %NBS of the building up to a minimum of 67% NBS.

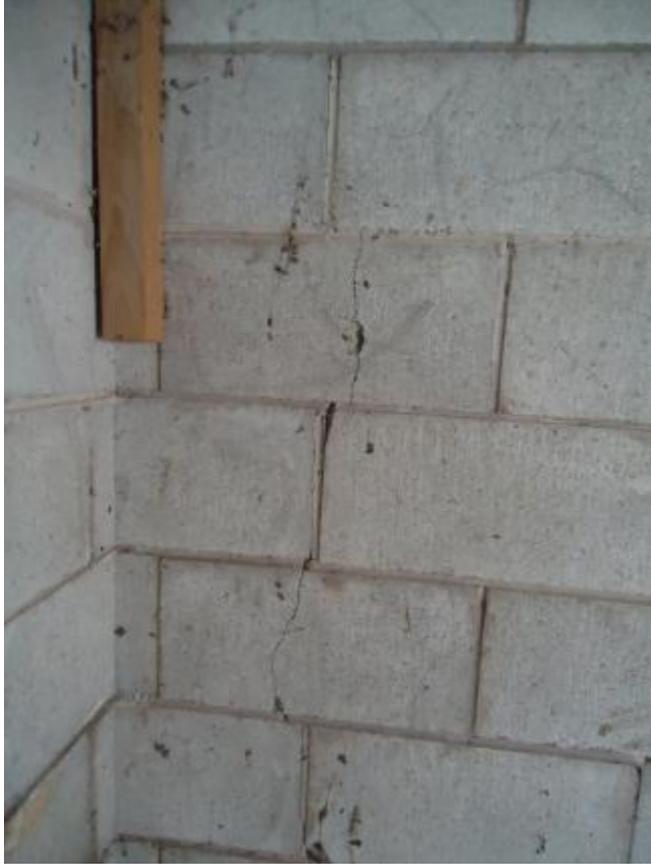
**Photograph 13: Interior view of damage to north eastern wall.**
