**Bishopdale Park Toilets
PRK 0322 BLDG 002 EQ2**

Detailed Engineering Evaluation

Quantitative Assessment Report

Date: November 2012
Reference: 6-QUCCC.67
Status: Final

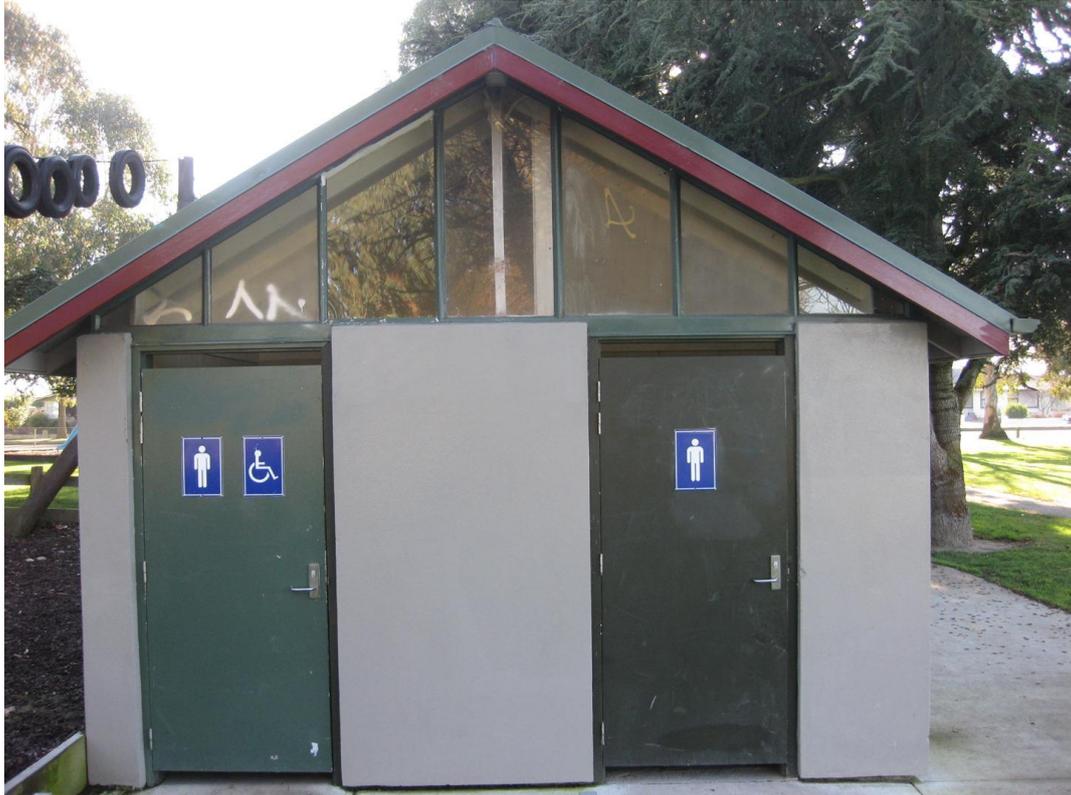
Photo 1: Side photo – male toilet entry

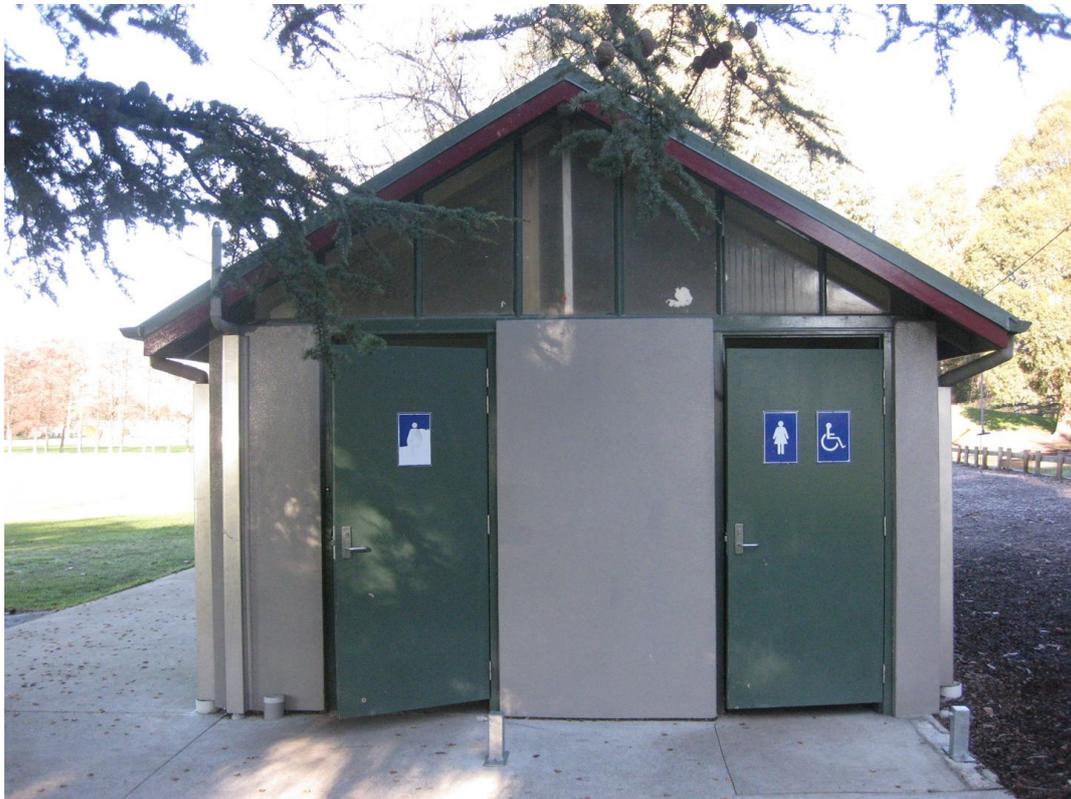
Photo 2: Side photo – female toilet entry

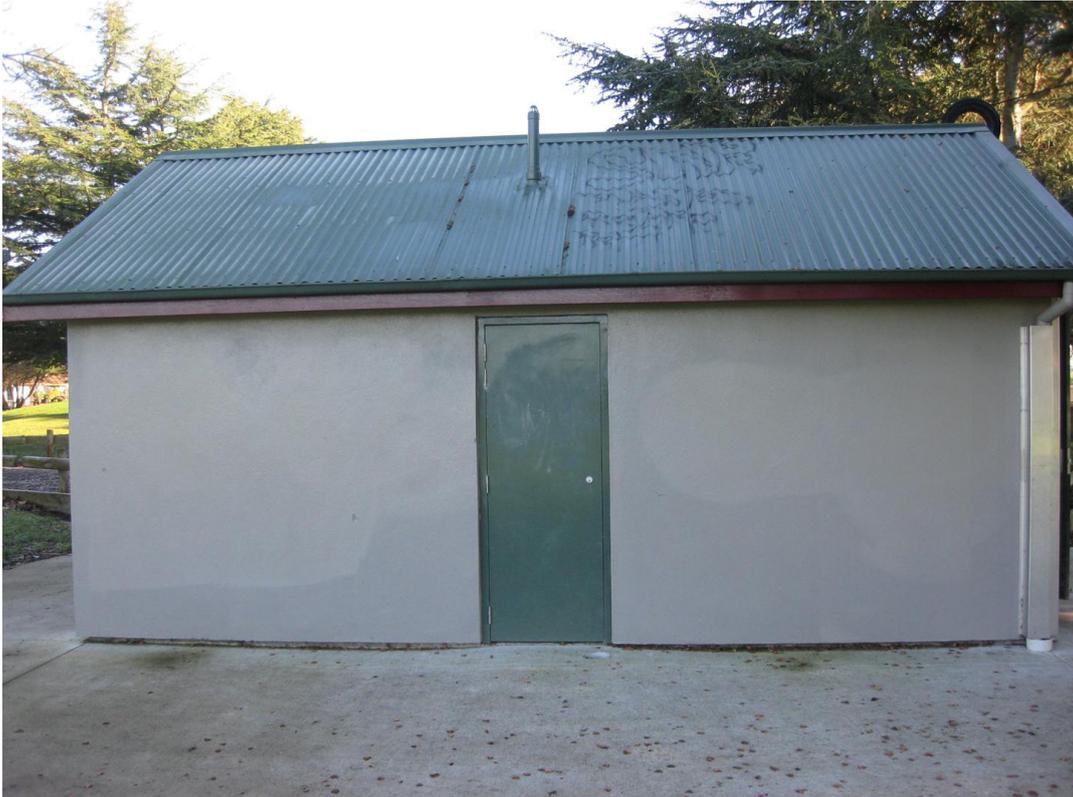
Photo 3: Eastern side photo

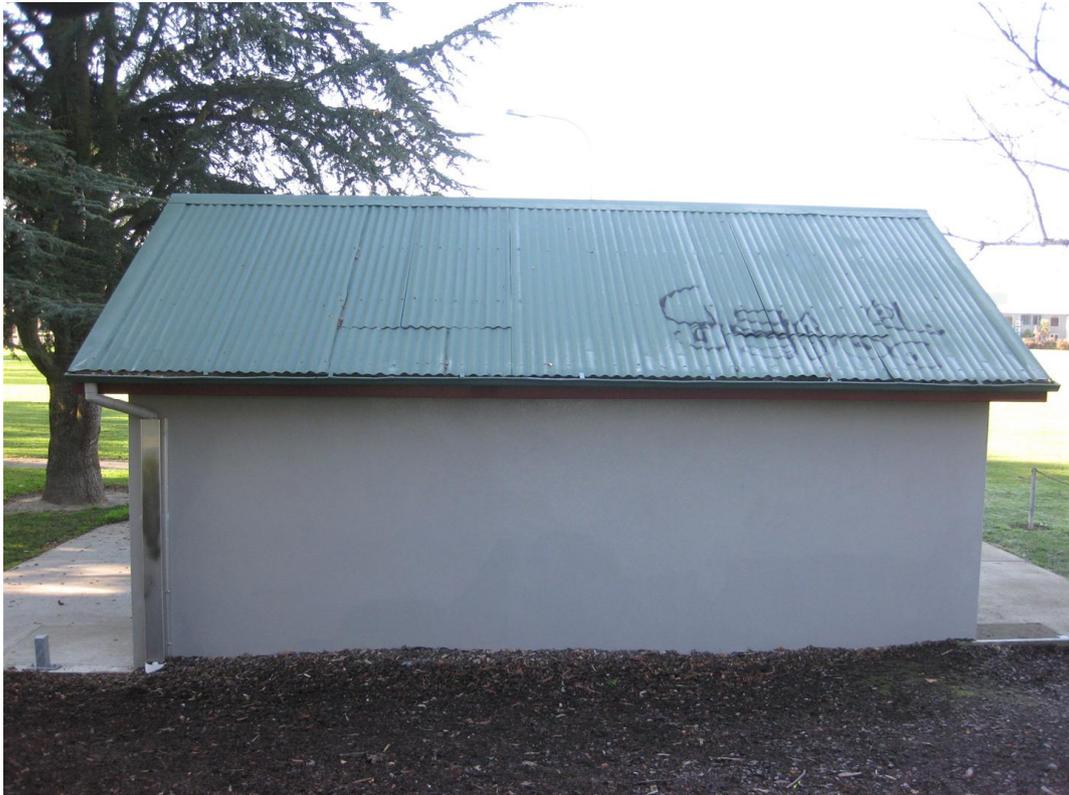
Photo 4: Western side photo

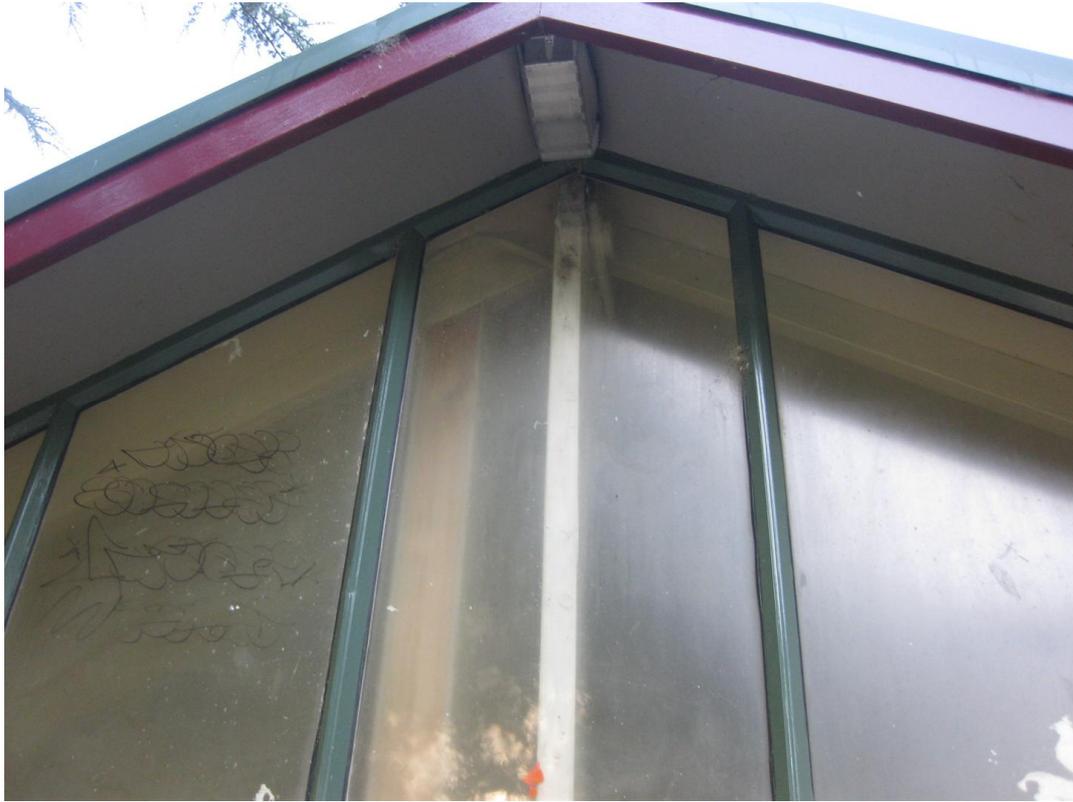
Photo 5: Exterior ridge detail

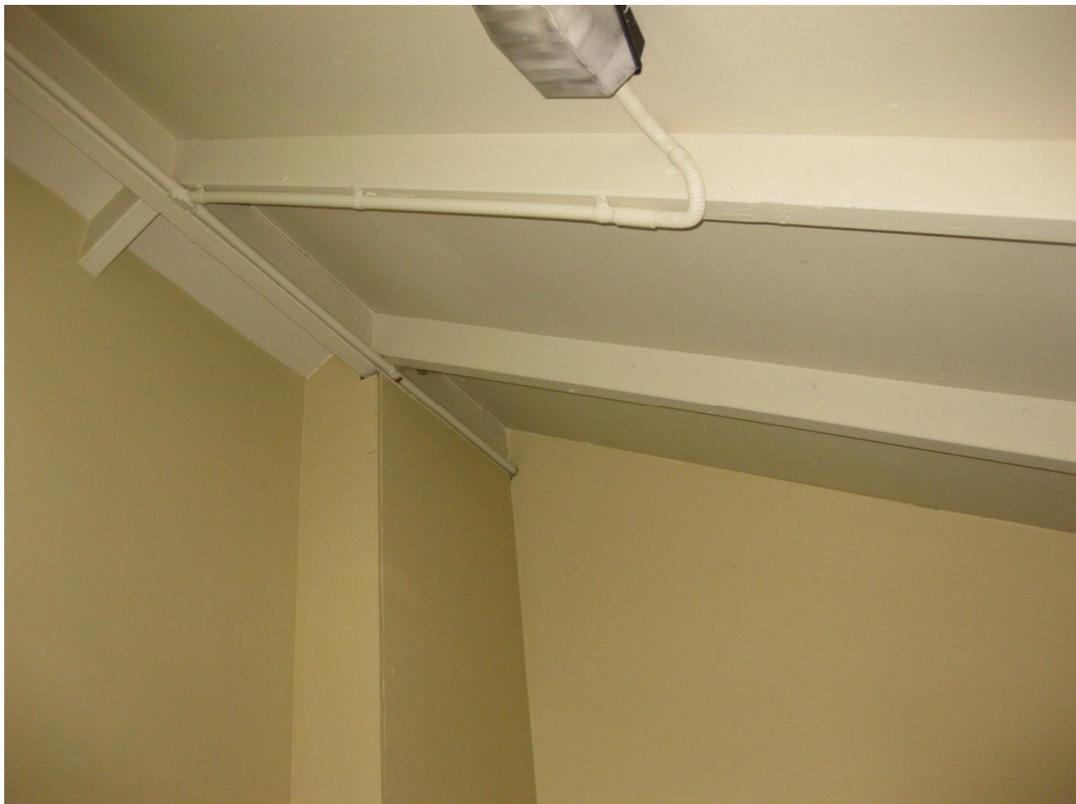
Photo 6: Interior ridge detail

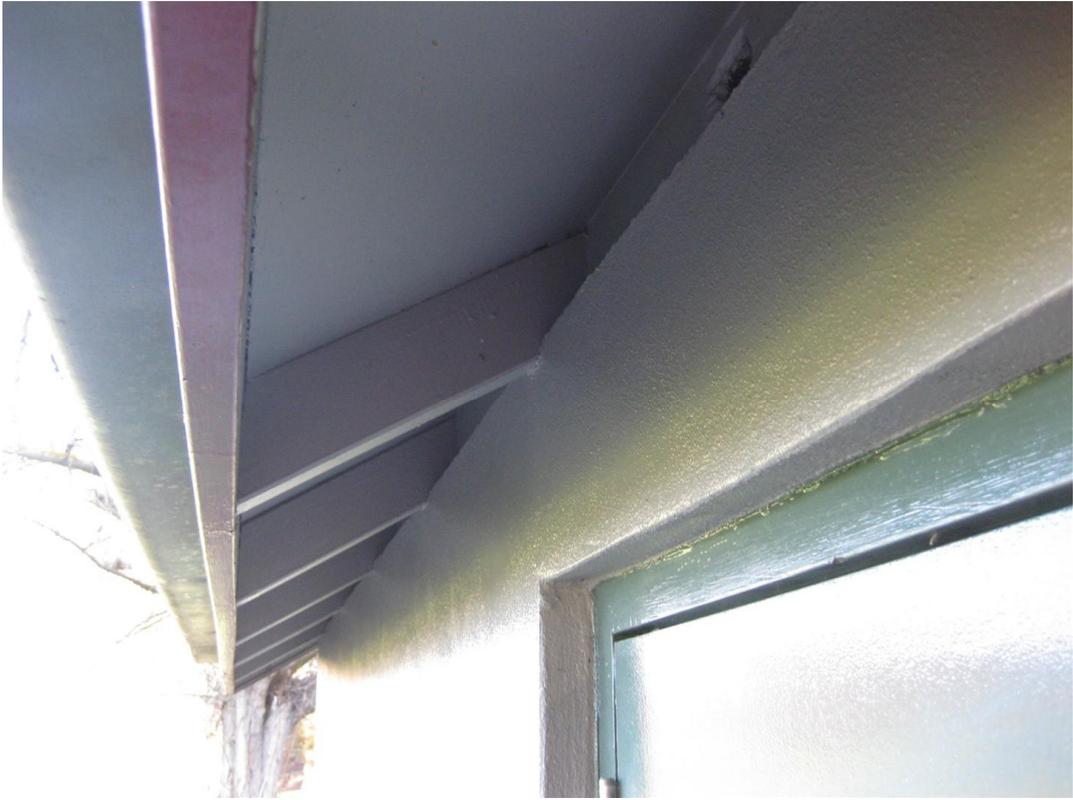
Photo 7: Eave detail

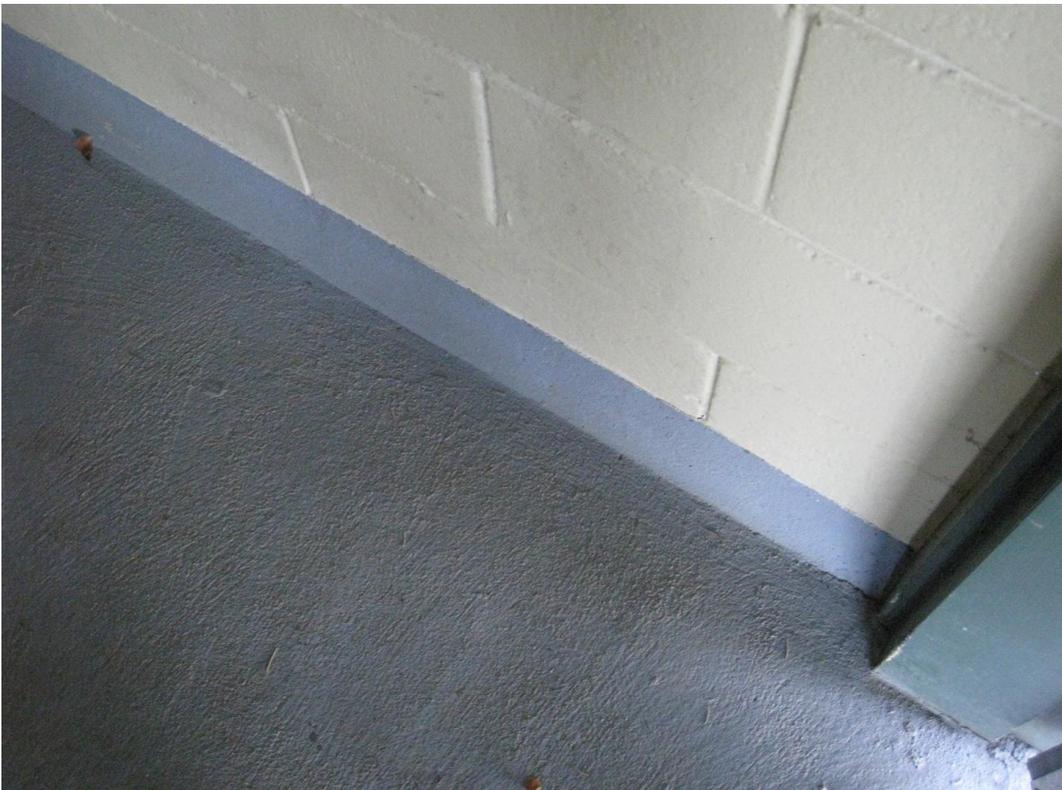
Photo 8: Ground slab at toilet entrance

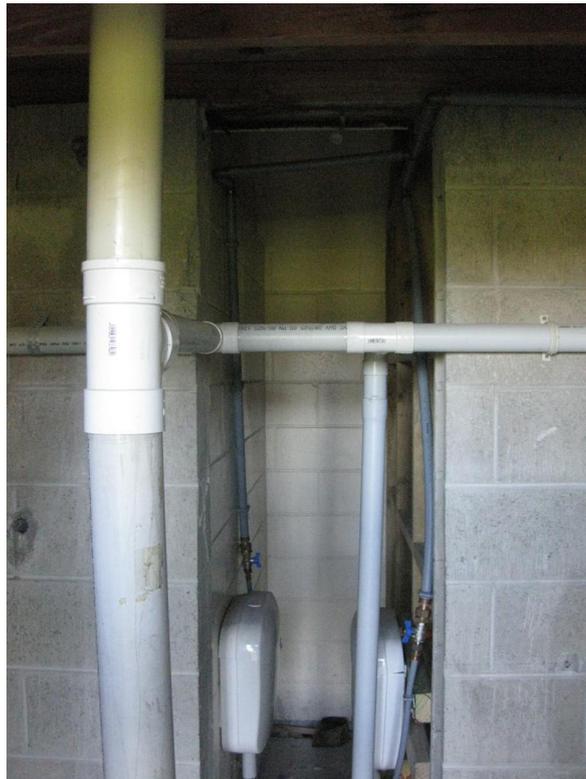
Photo 9: Internal photo in utilities room

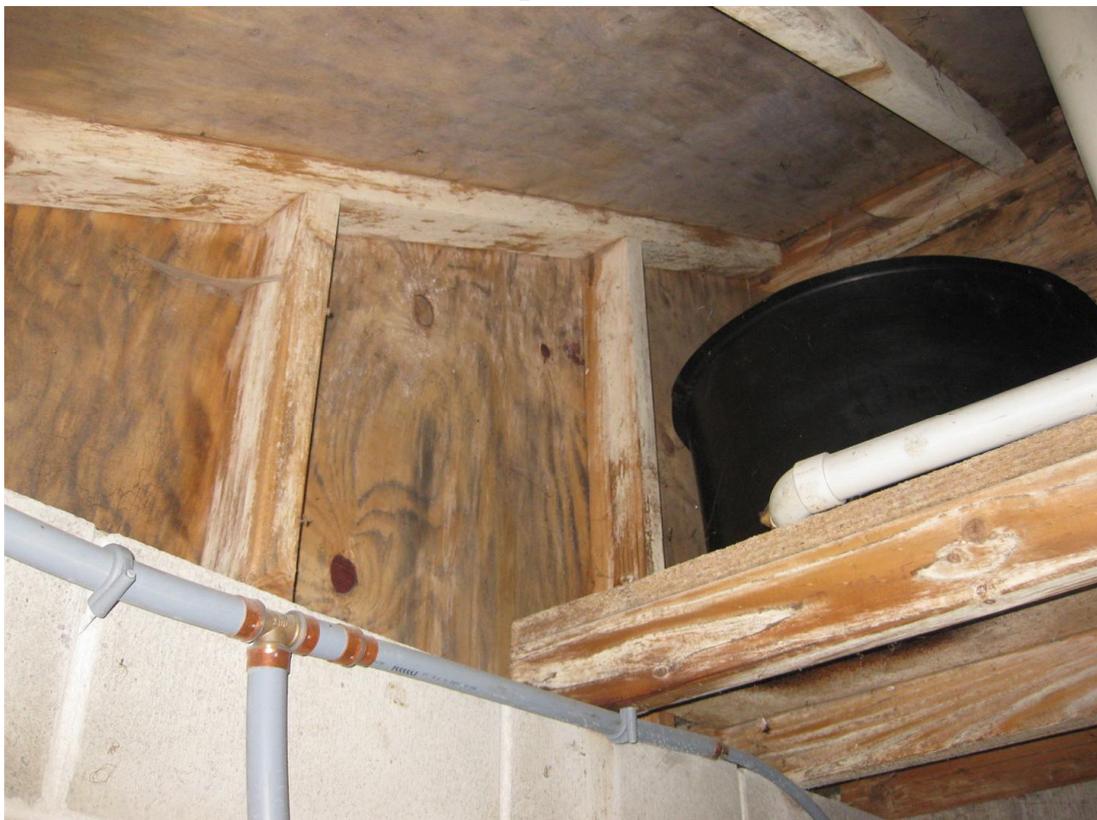
Photo 10: Timber partition wall on top of concrete block wall

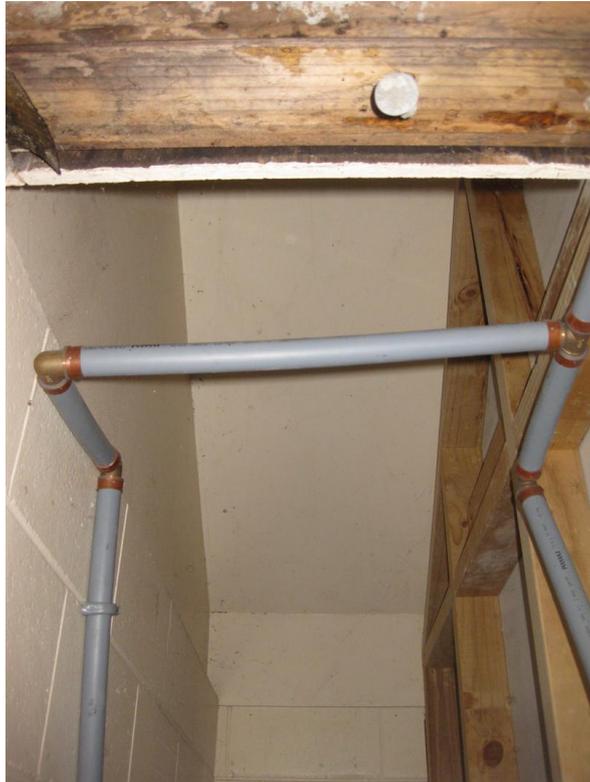
Photo 11: Internal concrete block and timber partition walls

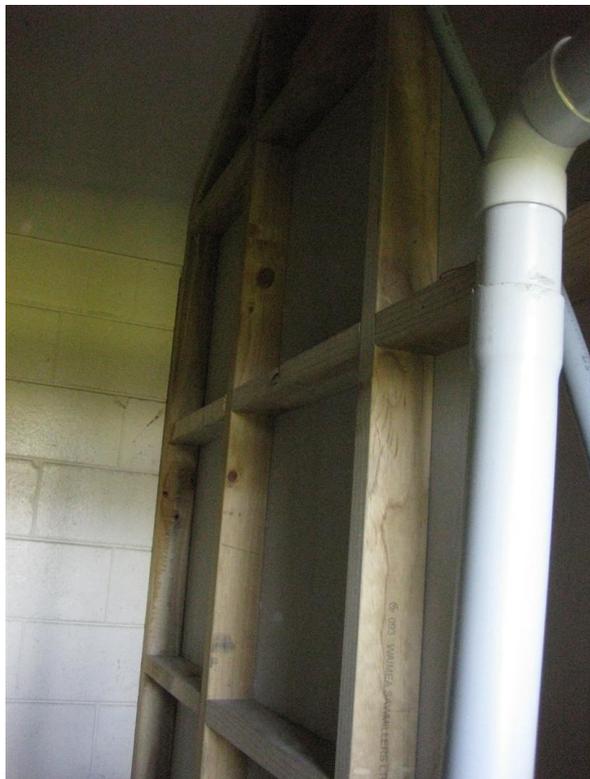
Photo 12: Internal timber partition wall

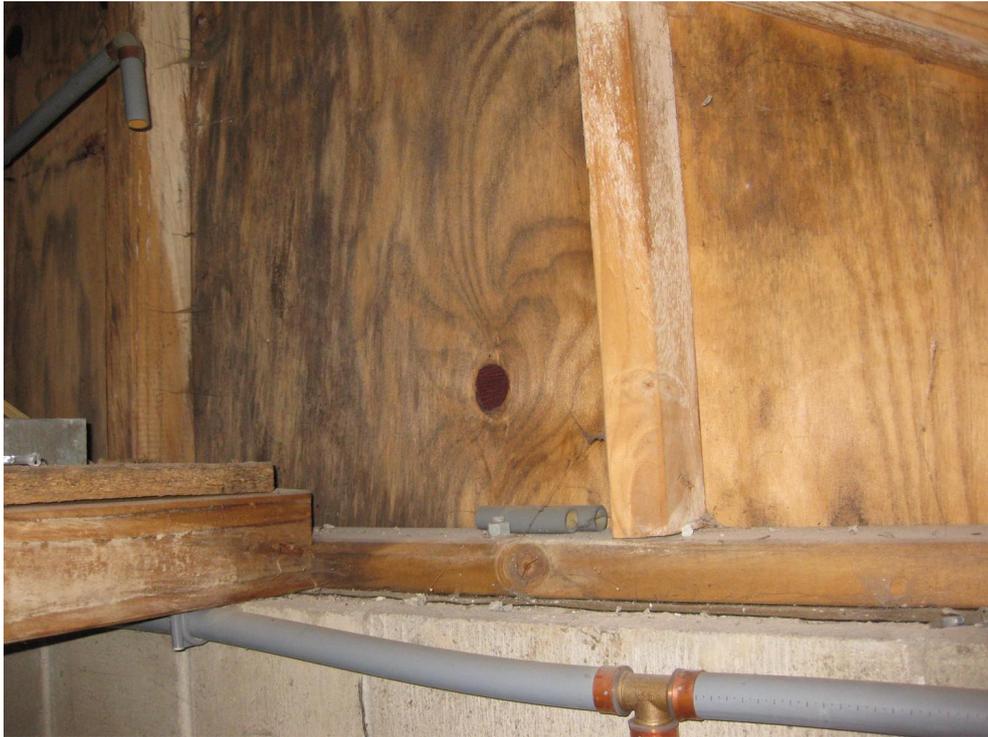
Photo 13: Internal timber to concrete block wall connection

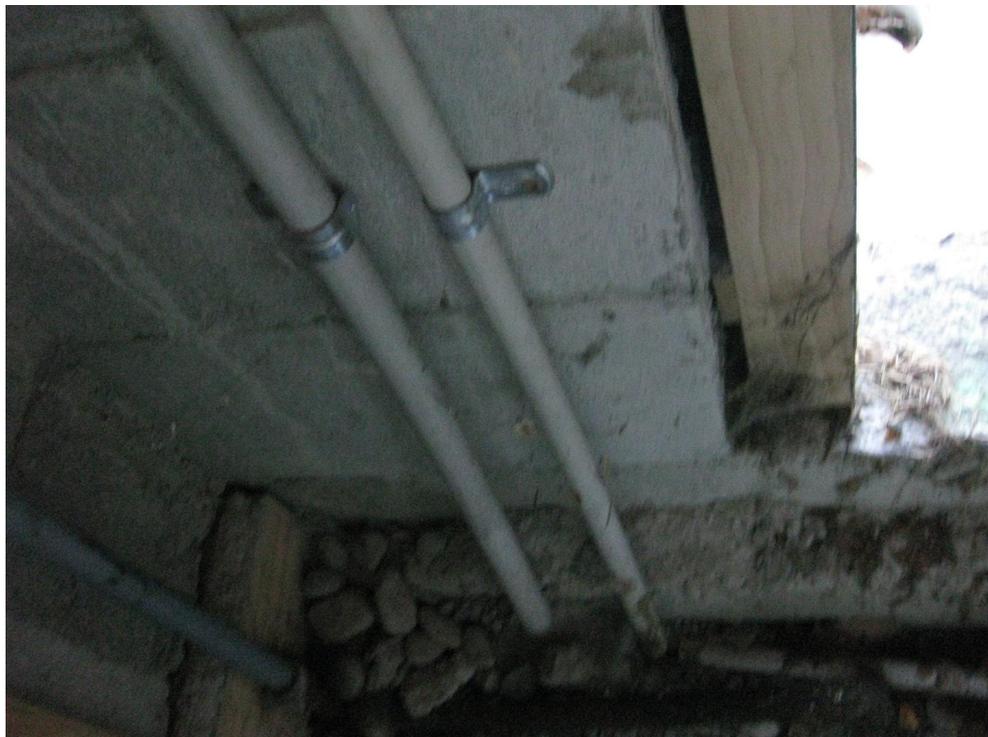
Photo 14: Corner ground photo
