CHRISTCHURCH CITY COUNCIL
PRK_1510_B001
Bishopdale Shop Toilets
Bishopdale Court

QUANTITATIVE ASSESSMENT REPORT

FINAL

- Rev B
- August 2013

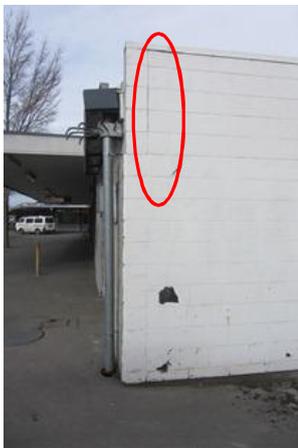
1	Vertical crack to last block on exterior wall. (PHOTO 11 & 12)
---	--

PHOTO 11: Side wall showing crack location

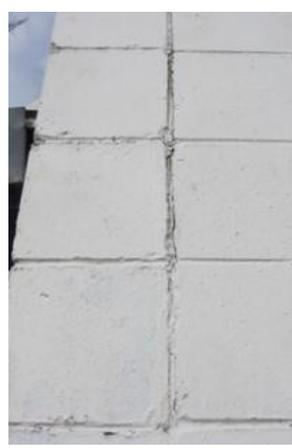
PHOTO 12: Detail of previous photo (probably earthquake damage)
