Garrick and Gilpin House
Botanic Gardens
PRK 1566 BLDG 015 EQ2
Detailed Engineering Evaluation
Quantitative Assessment Report

Quantitative Assessment Report

Date: February 2013
Reference: 6-QUCCC.38
Status: Final V2

Christchurch Botanical Gardens, Christchurch

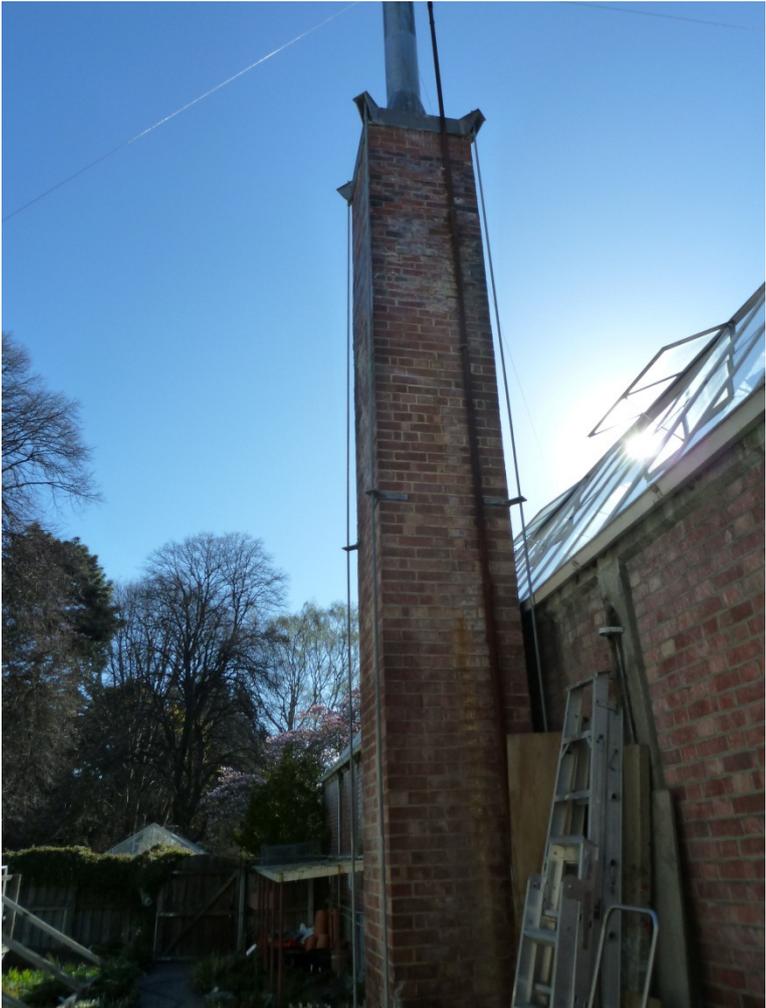
The masonry chimney adjacent the South elevation of Garrick House appears to have been strengthened in the past with the provision of a steel collar at the top of the brickwork. Attached to this collar at each corner are four tensioning rods which are assumed to be anchored into foundations below ground and tensioned to compress the masonry and aid its lateral stability. On top of the masonry is a further steel flue which increases the height

of the chimney. This steel chimney section is stabilised by guy wires down to adjacent structures, see photo 6. Apart from some deterioration of the brickwork from weathering there did not appear to be any cracking due to movement of the chimney.

<p>2. URM chimney with apparent seismic retrofit.</p>

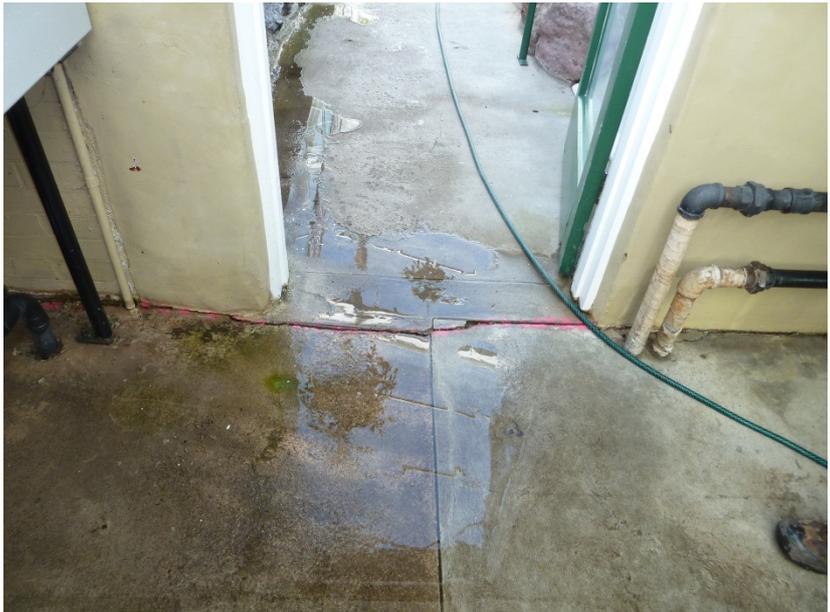
Within the door way between the two Houses there can be seen a crack in the concrete floor slab on the Gilpin House side of the division wall, [see photograph 3]. Externally on the North elevation a crack in the concrete side wall was noted to the West side of the column i.e. on Gilpin House side, see photograph 4]. On the same line on the South elevation a steel plate has been bolted across the junction in the basement concrete wall showing above ground level, [see photograph 5].

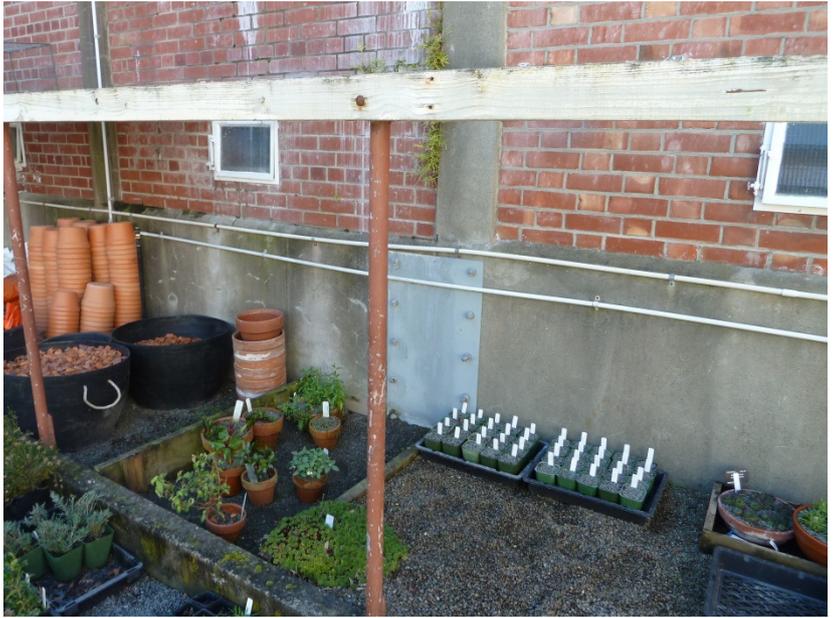
<p>4. Steel plate at junction between Garrick & Gilpin house.</p>
