**Botanic Gardens Irrigation Pump
House
PRK 1566 BLDG 031 EQ2
Detailed Engineering Evaluation
Qualitative Report
Version FINAL**

7 Rolleston Avenue, Christchurch
Central

Christchurch City Council

Date
7/12/12

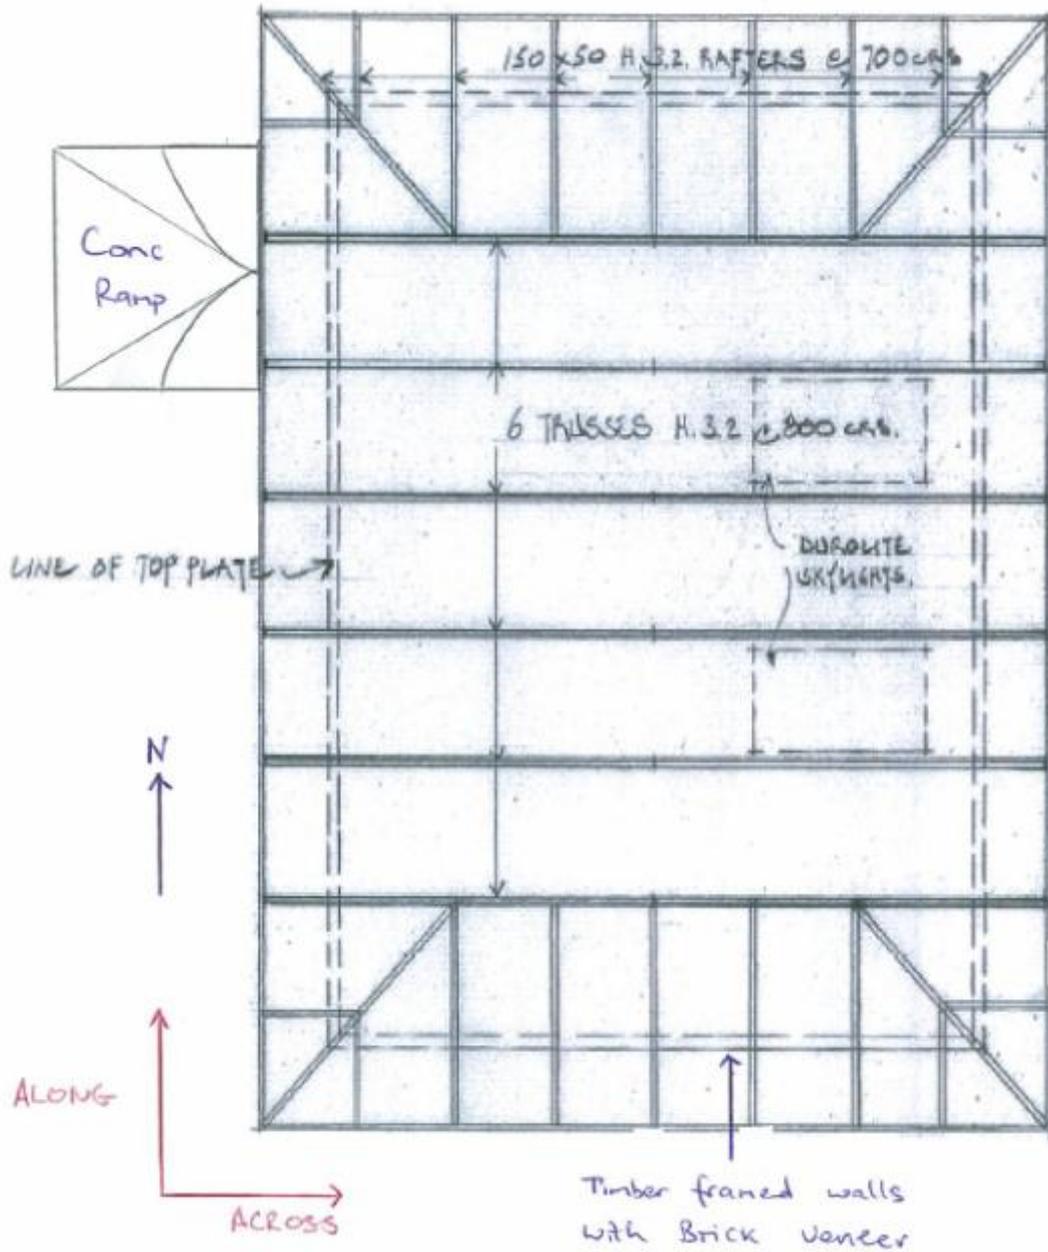
Figure 2 Plan Sketch Showing Key Structural Elements

The single level timber framed structure consists of a Dutch hip roof with lightweight metal cladding on timber purlins spanning between six timber roof trusses. The roof trusses span onto the timber framed walls. Internal wall and ceiling linings consist of plywood. External cladding consists of both brickwork and timber weatherboard. The exterior walls sit on perimeter strip footings. The floor to the structure consists of a 100mm mesh reinforced concrete slab. Contrary to the structural drawings a crane rail has not been installed.

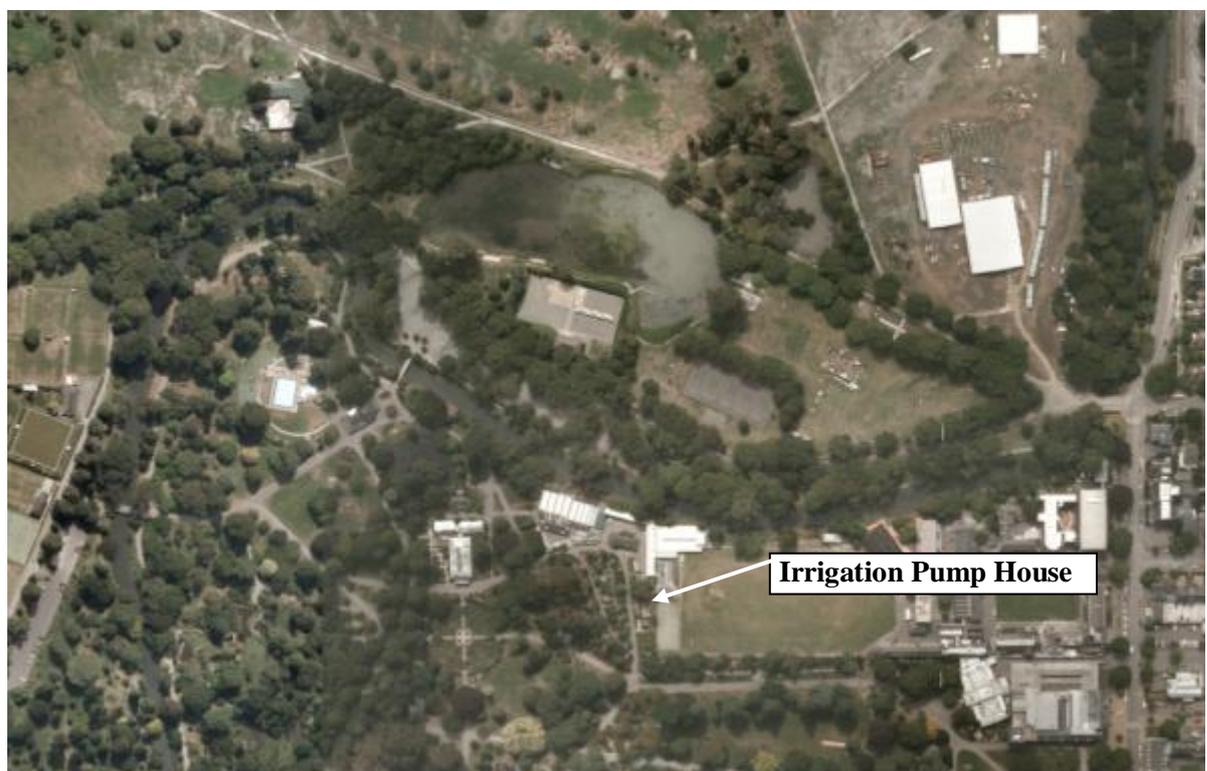
Figure 3 Post February 2011 Earthquake Aerial Photography²

Aerial photography taken following the 22 February 2011 earthquake shows moderate amounts of liquefaction on the northern side of the Avon and in Victoria Lake, in the top-left and top-right corners of Figure 3. However, there is no evidence of liquefaction at the surface within the botanic gardens themselves.

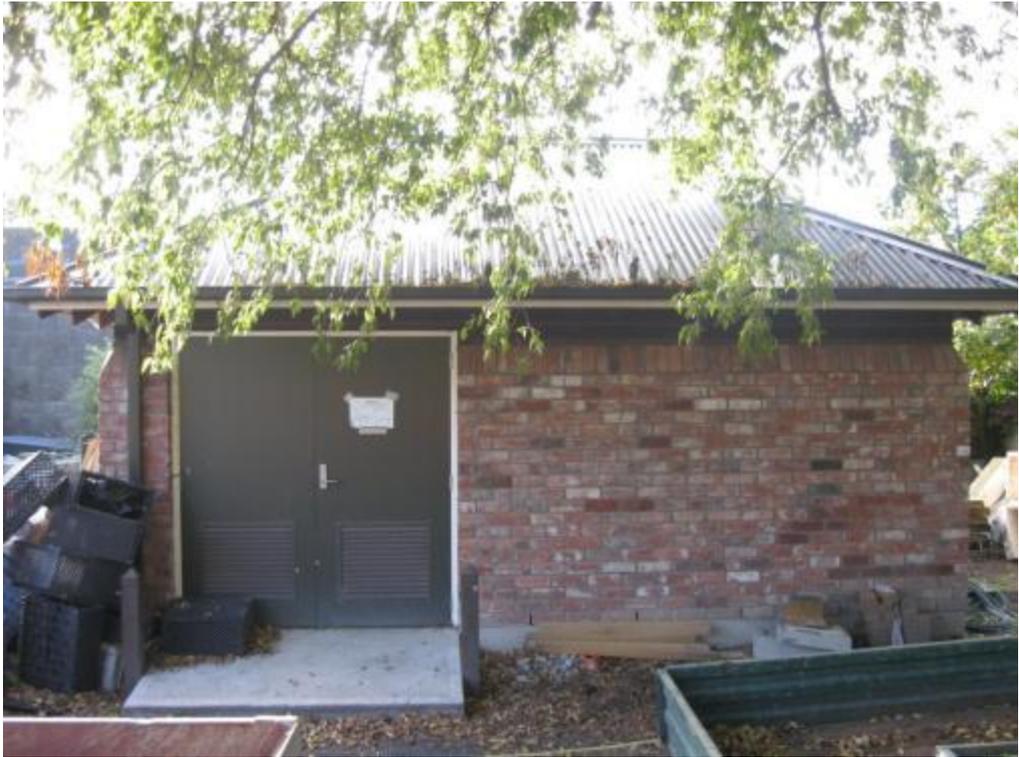
Photograph 1: West facing elevation

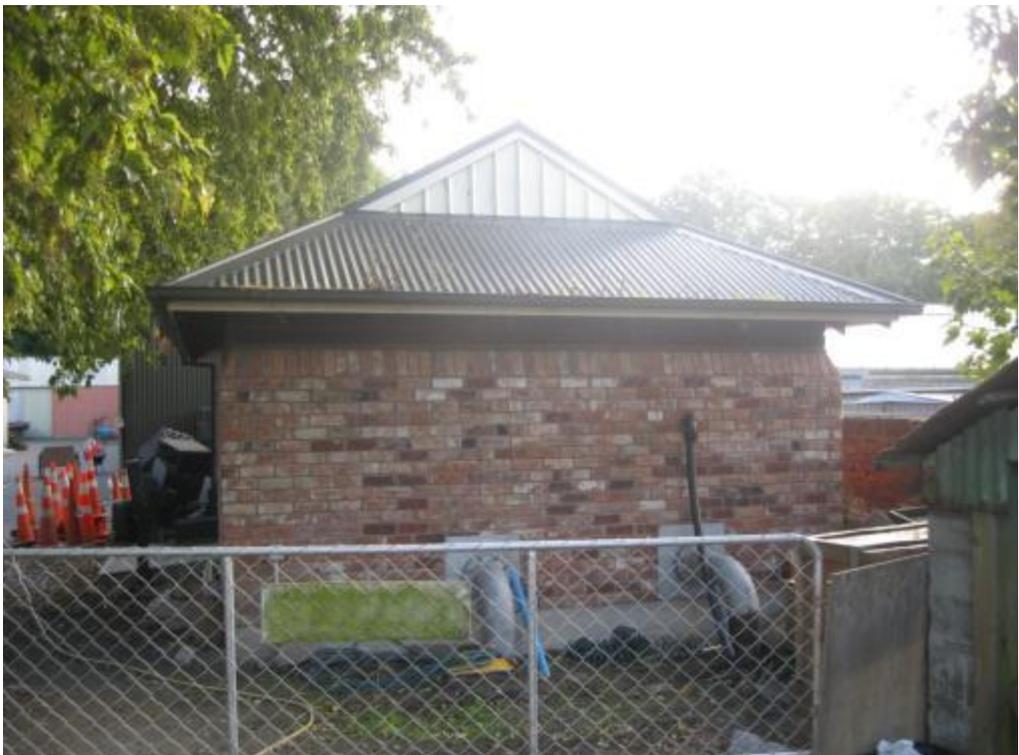
Photograph 2: South facing elevation showing Dutch hip roof

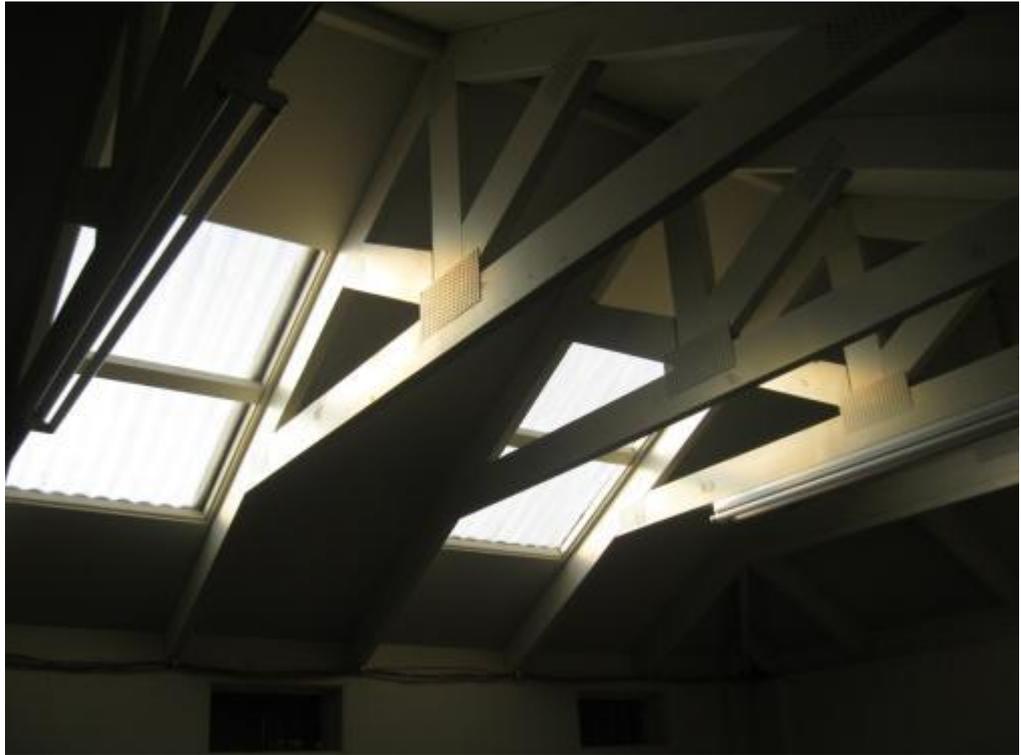
Photograph 3: Skylights to Roof structure

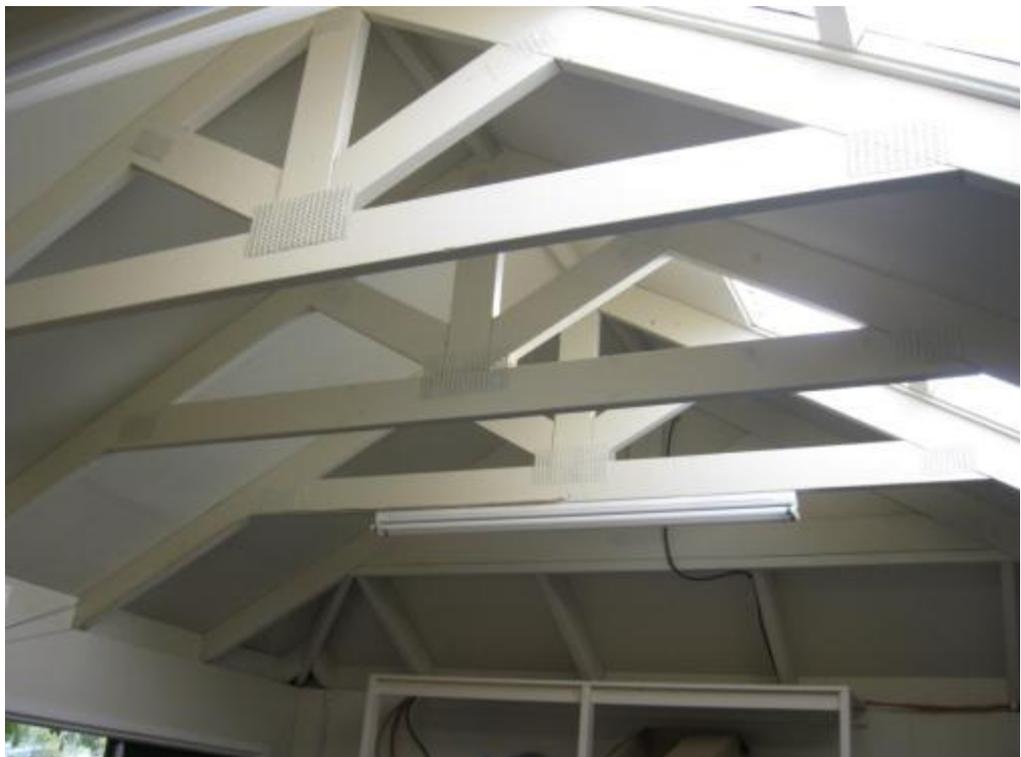
No damage was evident to the roof structure.

Photograph 4: Timber truss roof structure

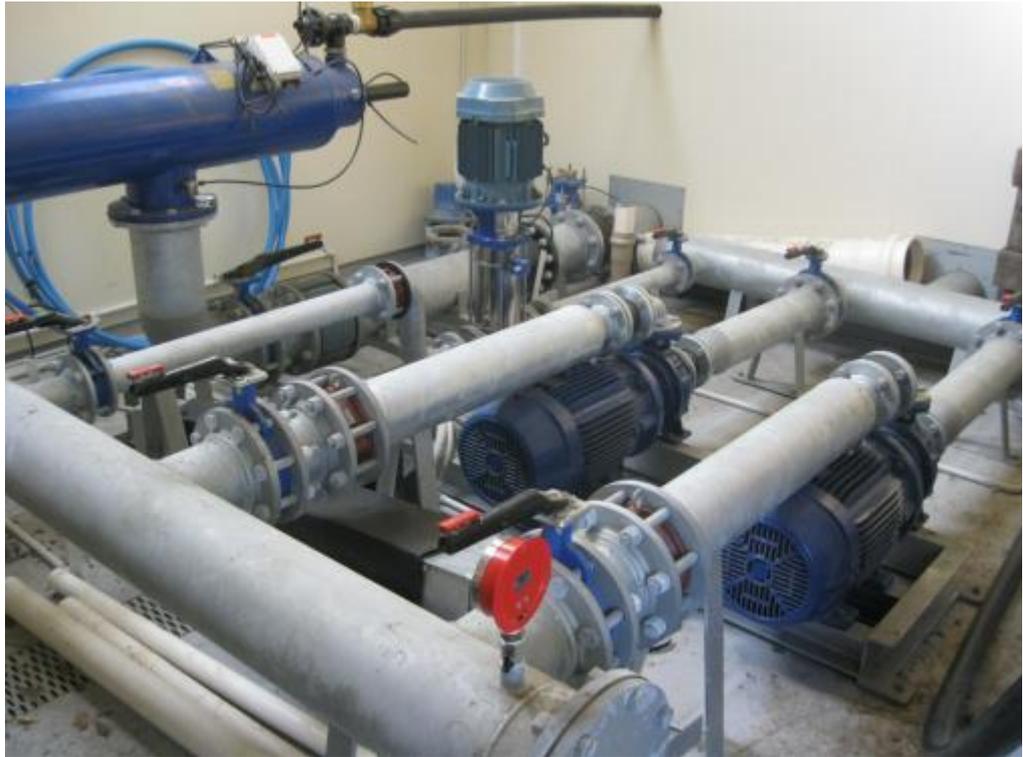
Photograph 5: Pumphouse equipment on reinforced concrete slab

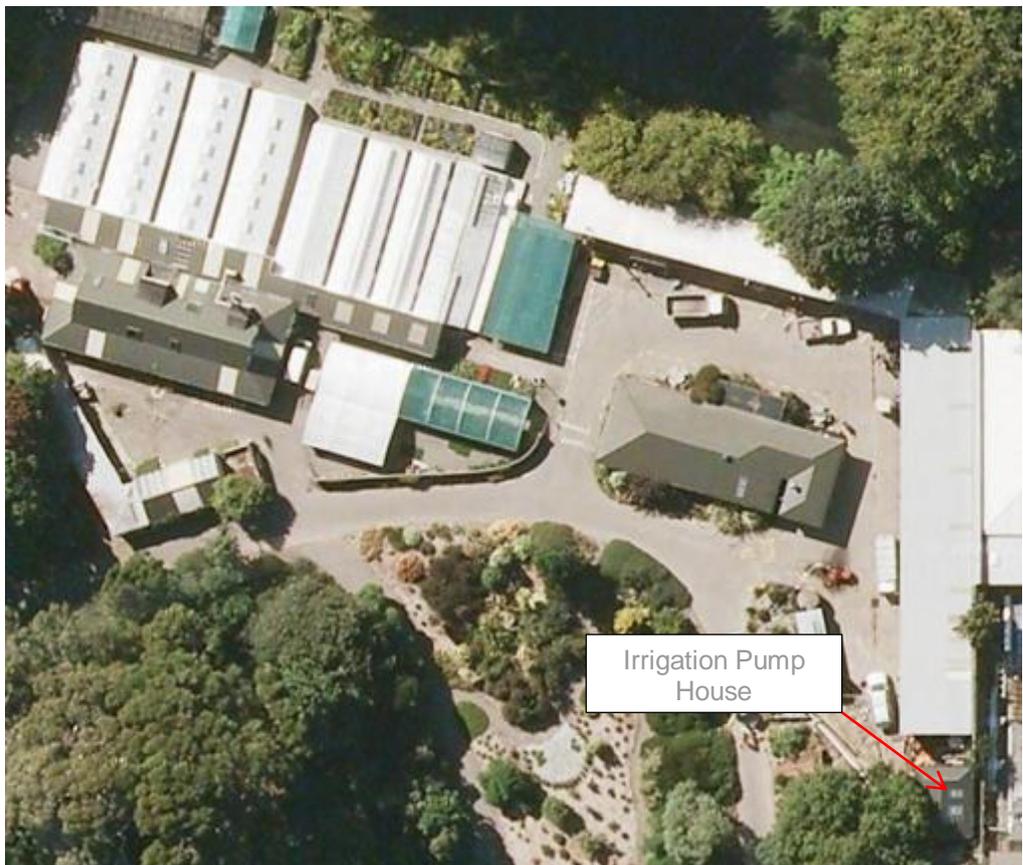
The Irrigation Pump House, constructed in 2007, is located in the Botanic Gardens at 7 Rolleston Avenue, Christchurch central. The site is located opposite the most southerly side of the Office Store with it bordering Christs College to the east. See Photograph 6 in Appendix A for building location on site.

Photograph 6: Building location on site
