Botanic Gardens – Paddling Pool Plant
Shed

Quantitative Engineering Evaluation

Christchurch City Council

Date: 11 October 2013

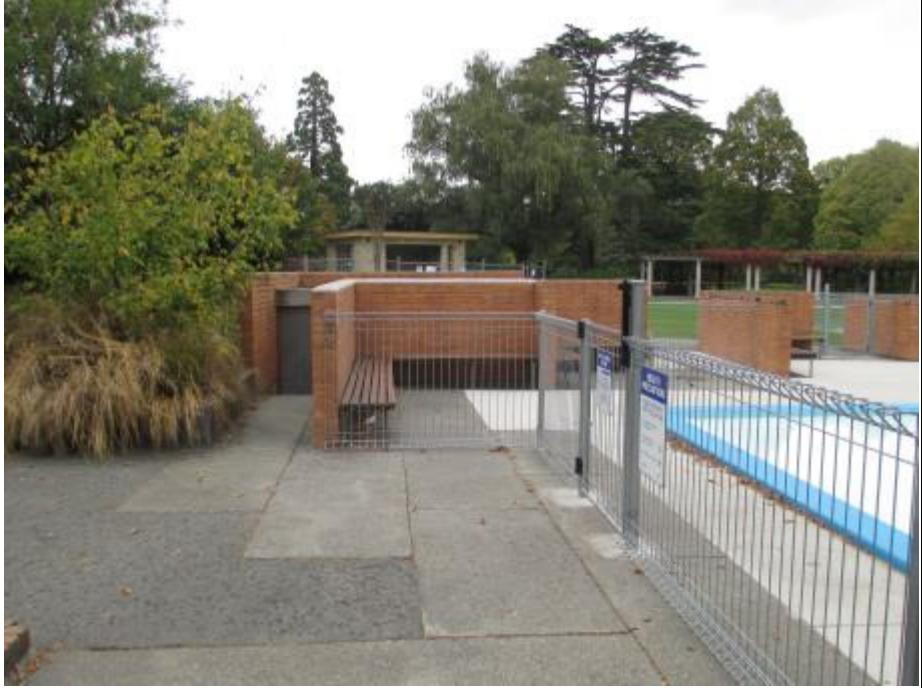
1	General view of building.

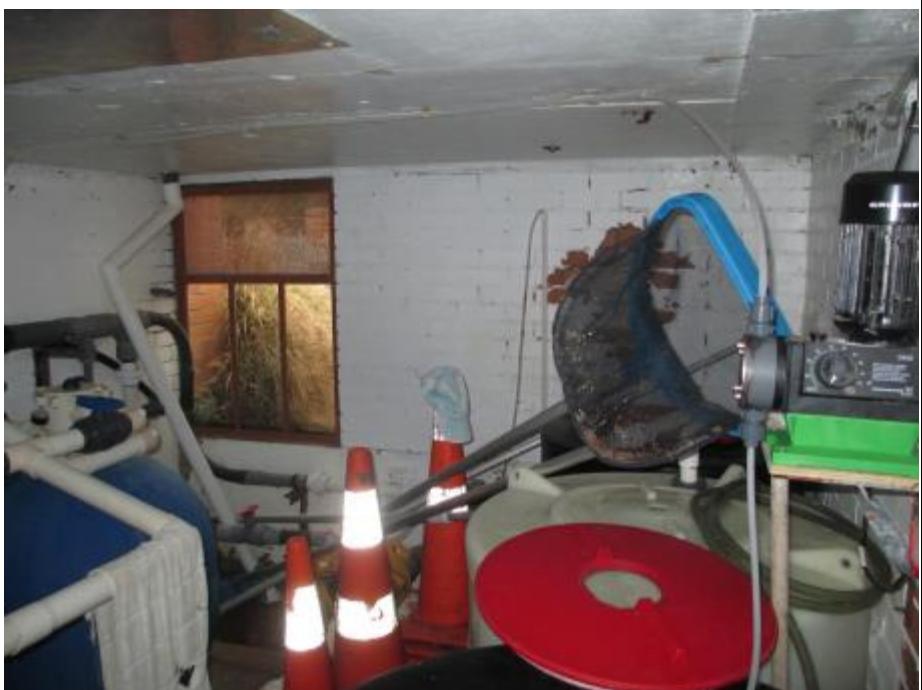
2	General view inside the building.

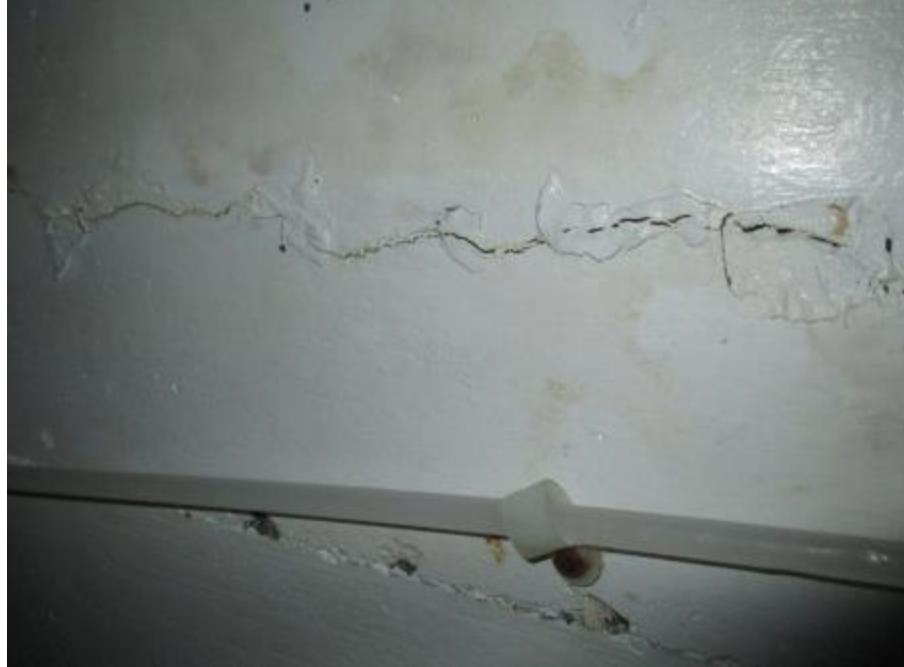
- Concrete roof has multiple cracks through it. The cracks appear to be old and are unlikely to have been caused by the Canterbury seismic events.
- Minor cracks to concrete floor slab. Cracks appear to be old and unlikely to have been caused by the Canterbury seismic events.
- Vertical cracks to the cantilevered walls west of the building. These cracks appear to have been caused or aggravated by the Canterbury seismic events.

The buildings damage appears to have been caused by environmental effects, rather than seismic actions. Except for the vertical cracks to the cantilevered reinforced brick walls located to the west of the building.

3	Cracked roof seen from the interior.

Cracks to the reinforced brick walls and reinforced concrete roof should grouted injected to stop water ingress.

The building has performed well during the Canterbury seismic events with minimum damage. However, the cracks to the concrete roof will need to be injected with a suitable epoxy to stop water ingress into the concrete roof which will degrade over time if not remedied. Vertical cracks to the cantilevered walls west of the building should be also be fully grouted.

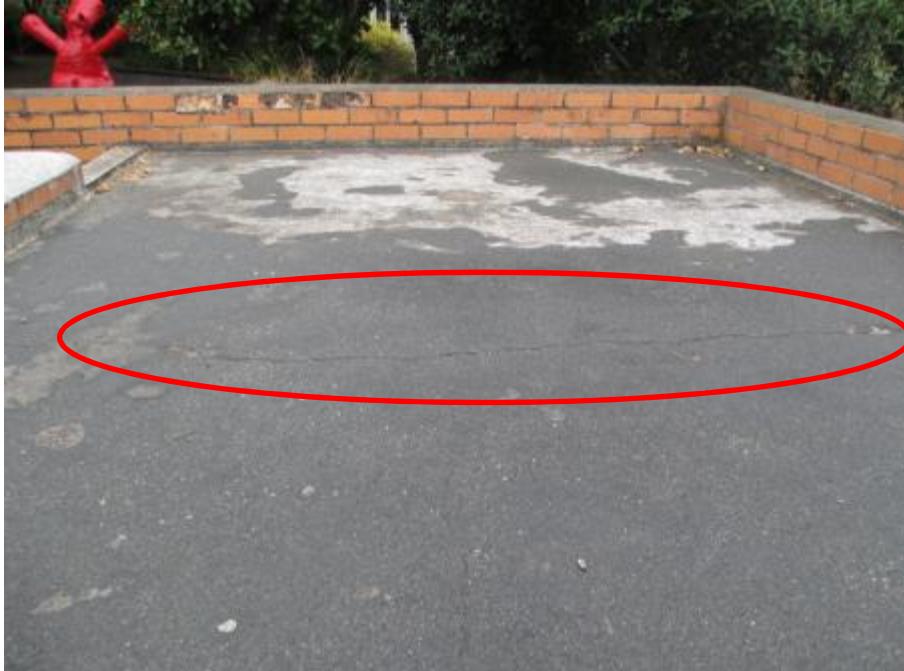
A photograph showing the interior of a building with a white, textured ceiling. A prominent horizontal crack runs across the center of the image, with several smaller cracks branching off from it. A green pipe is visible in the lower right corner.
4	Cracked roof seen from the exterior.

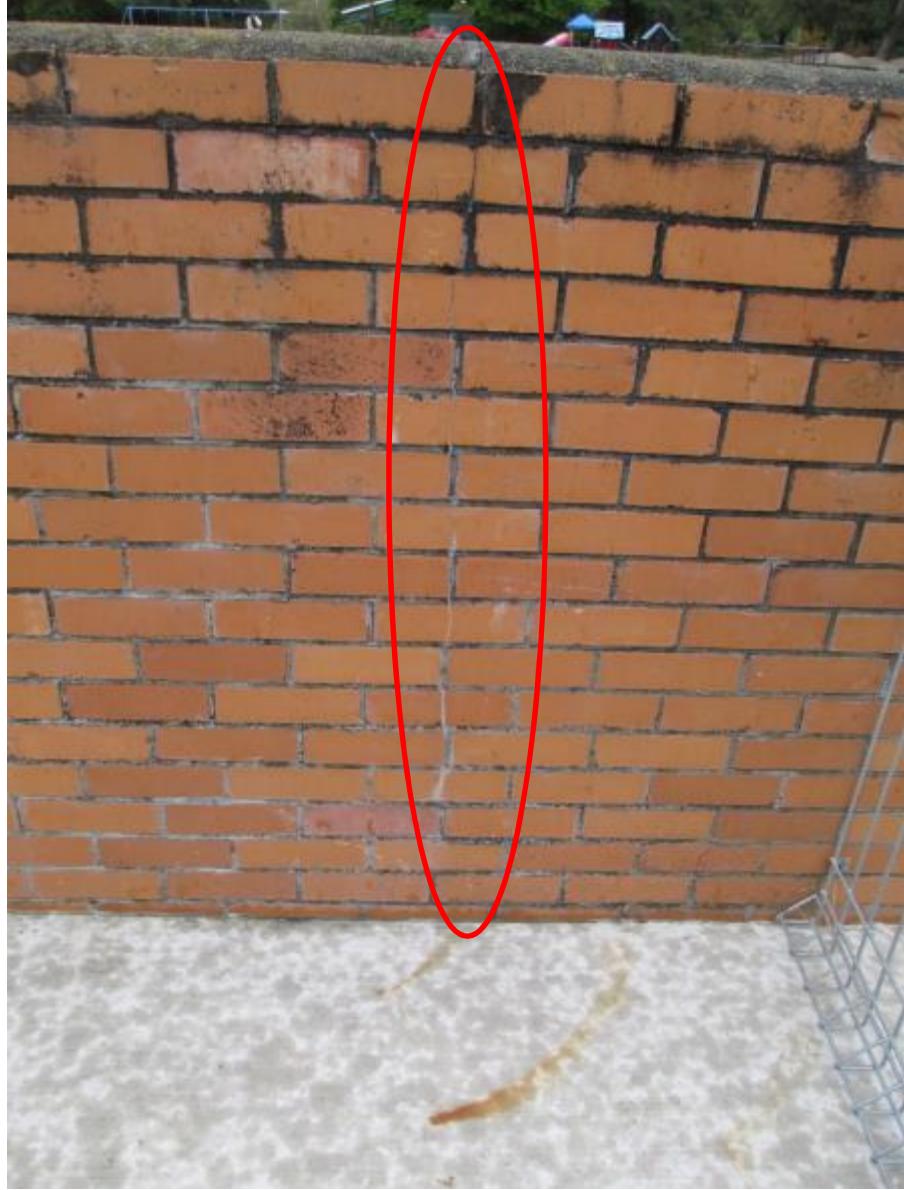
5	Vertical crack in the cantilever wall west of the paddling pool plant shed.

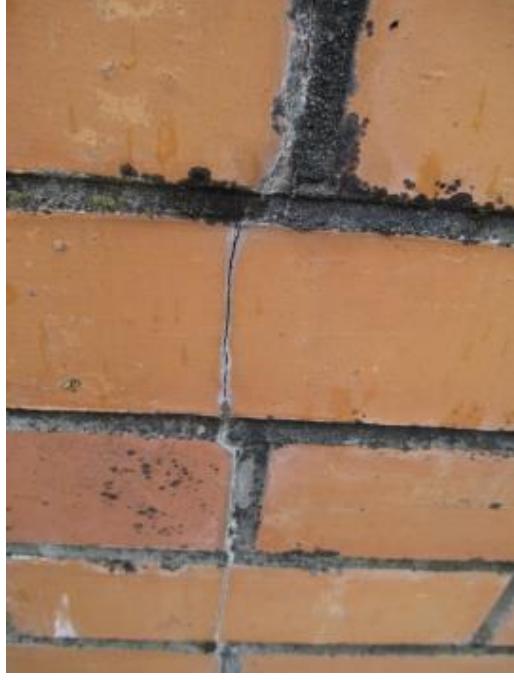
6	Close up view of a typical crack in the cantilevered wall west of the paddling pool plant shed.

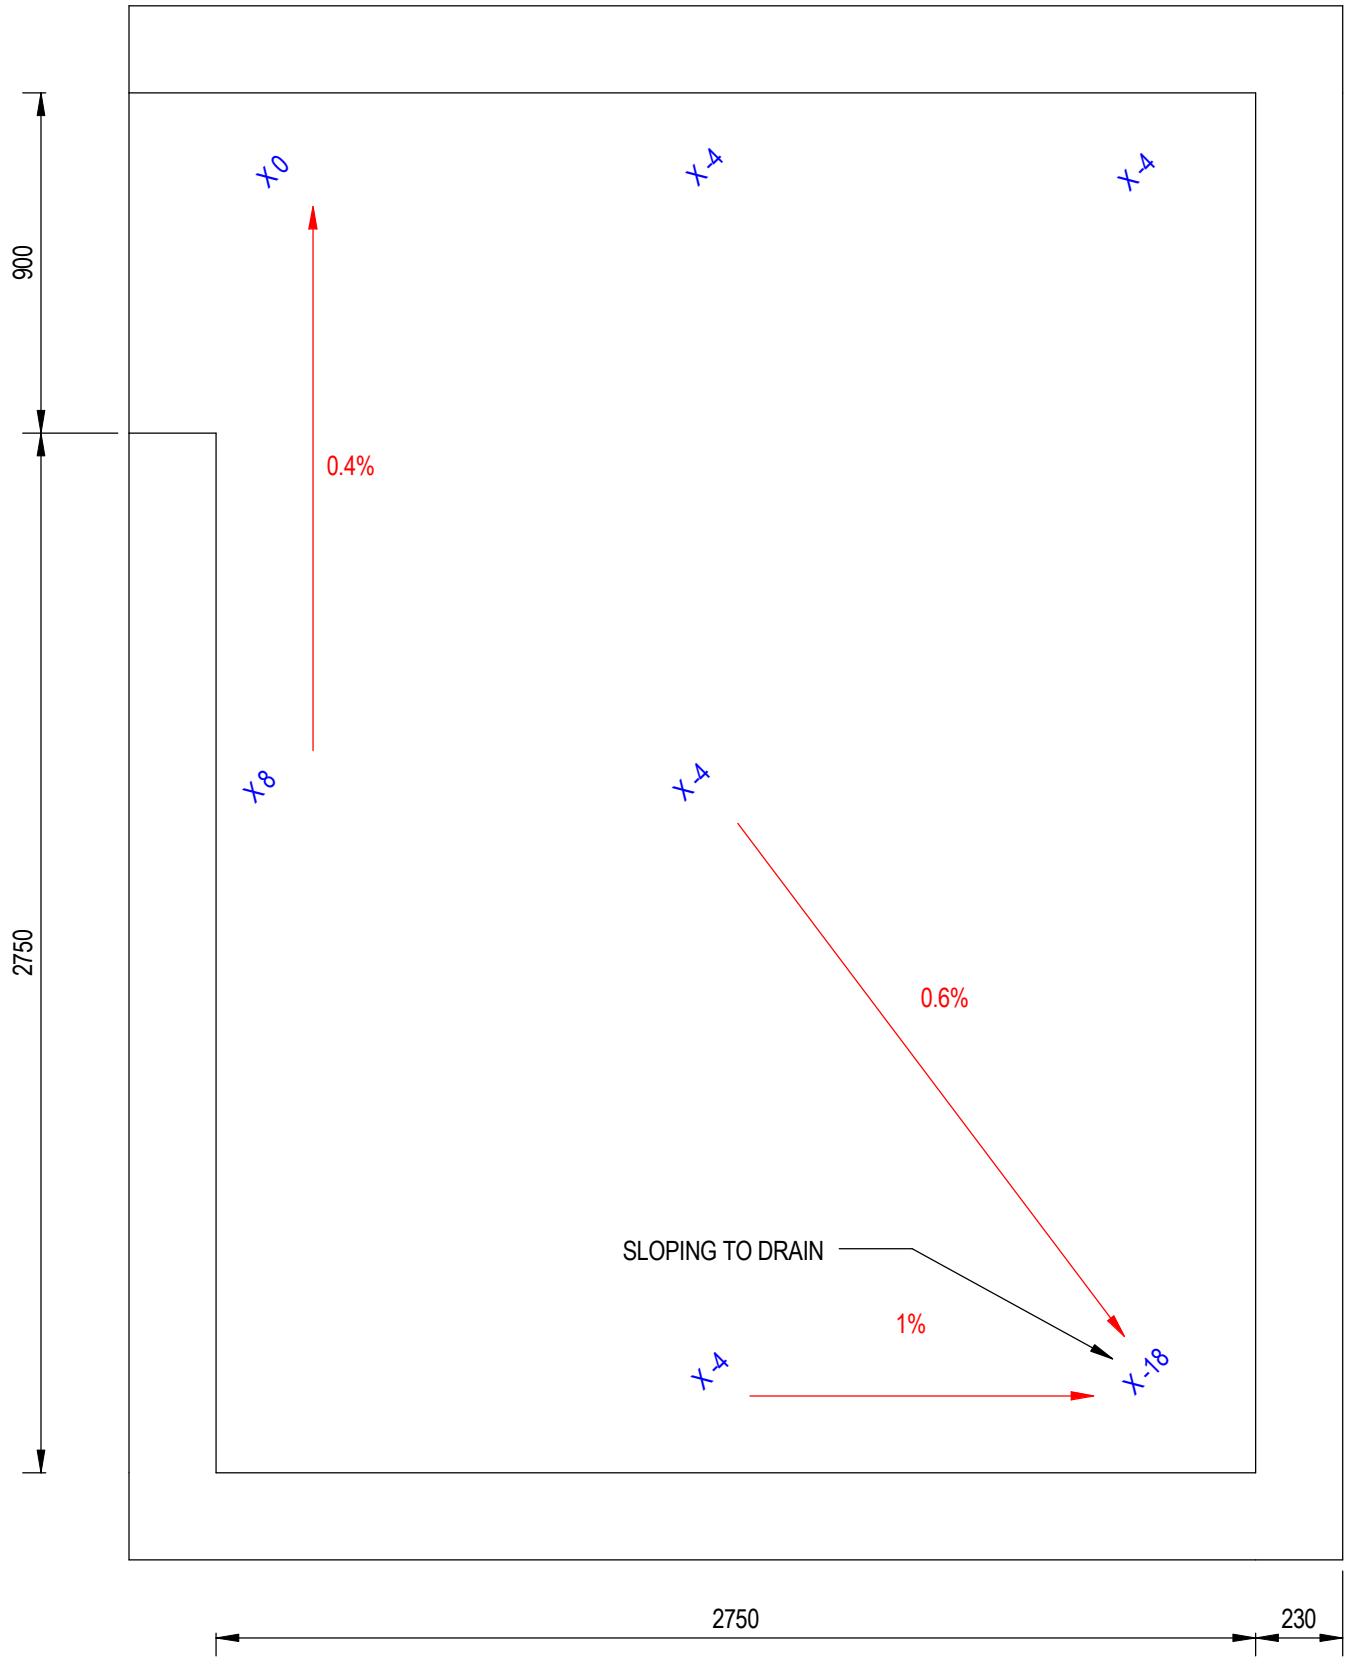
PROJECT		PRELIMINARY NOT FOR CONSTRUCTION	
BOTANIC GARDENS PADDLING POOL PLANT SHED		PROJECT No. 235155	
TITLE FLOOR LEVEL SURVEY		SCALE 1:20	SIZE A4
		DRAWING NO. SK-01	REV

The total difference between the slabs highest point and the slabs lowest point is 26mm which is lower than the above recommendation. The maximum floor slope of 1.0% runs in the direction of a sump at the south-west corner of the building and does not represent foundation damage. All other floor slopes are less than 0.5%, refer Appendix A. Therefore in our view the floor does not require re-levelling.
