**Botanic Gardens Potting Facility**  
**PRK 1566 BLDG 030 EQ2**  
Detailed Engineering Evaluation  
Qualitative Report  
Version Final

Detailed Engineering Evaluation  
Qualitative Report  
Version Final

7 Rolleston Avenue, Christchurch  
Central

Christchurch City Council

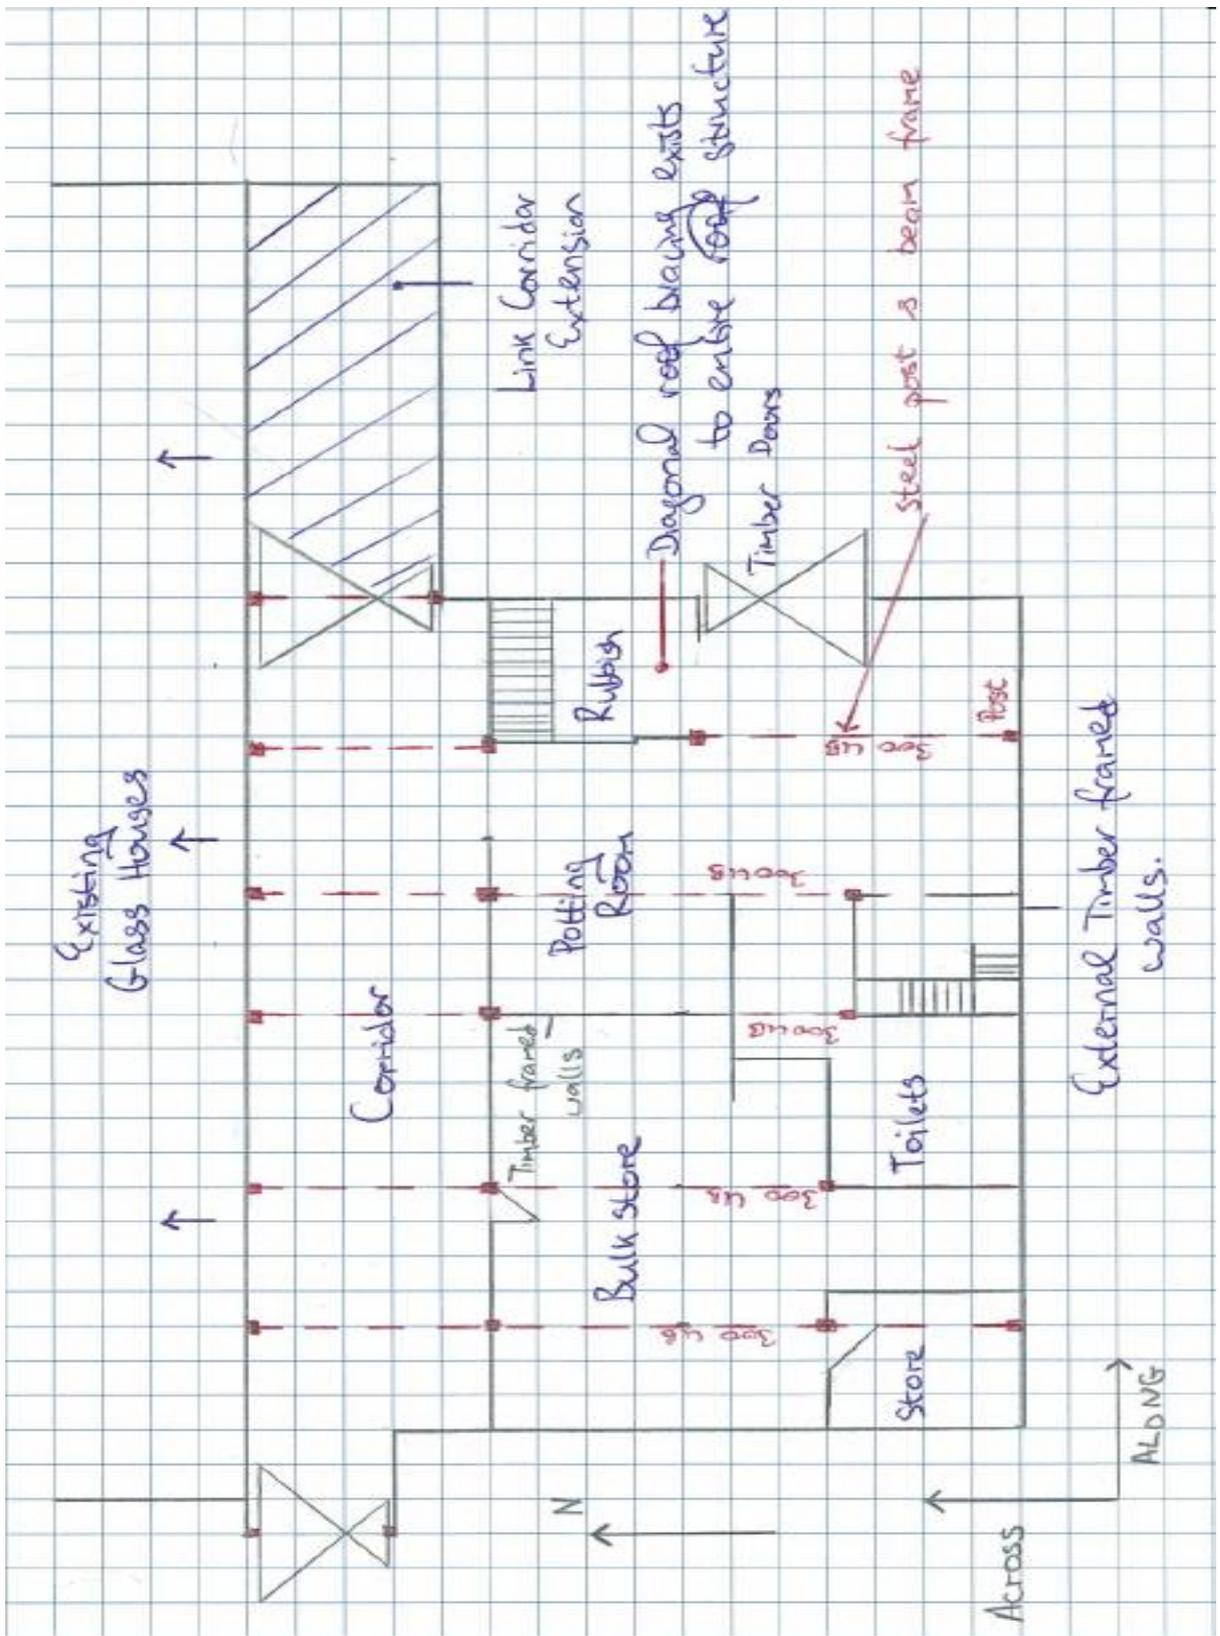
Figure 2 Plan Sketch Showing Key Structural Elements

Internal walls are timber framed with a combination of plasterboard and timber hardboard lining. External wall finishes include a brick veneer and weatherboard to the potting facility with the link corridor comprising of cement board and a glazing system to the north glasshouse boundary. The first storey consists of timber flooring on timber joists supported by the ground floor steel frame system and the ground floor is 125mm concrete slab reinforced with mesh. Reinforced concrete strip footings to the perimeter with slab thickenings below the internal load bearing timber framed walls form the substructure to the building.

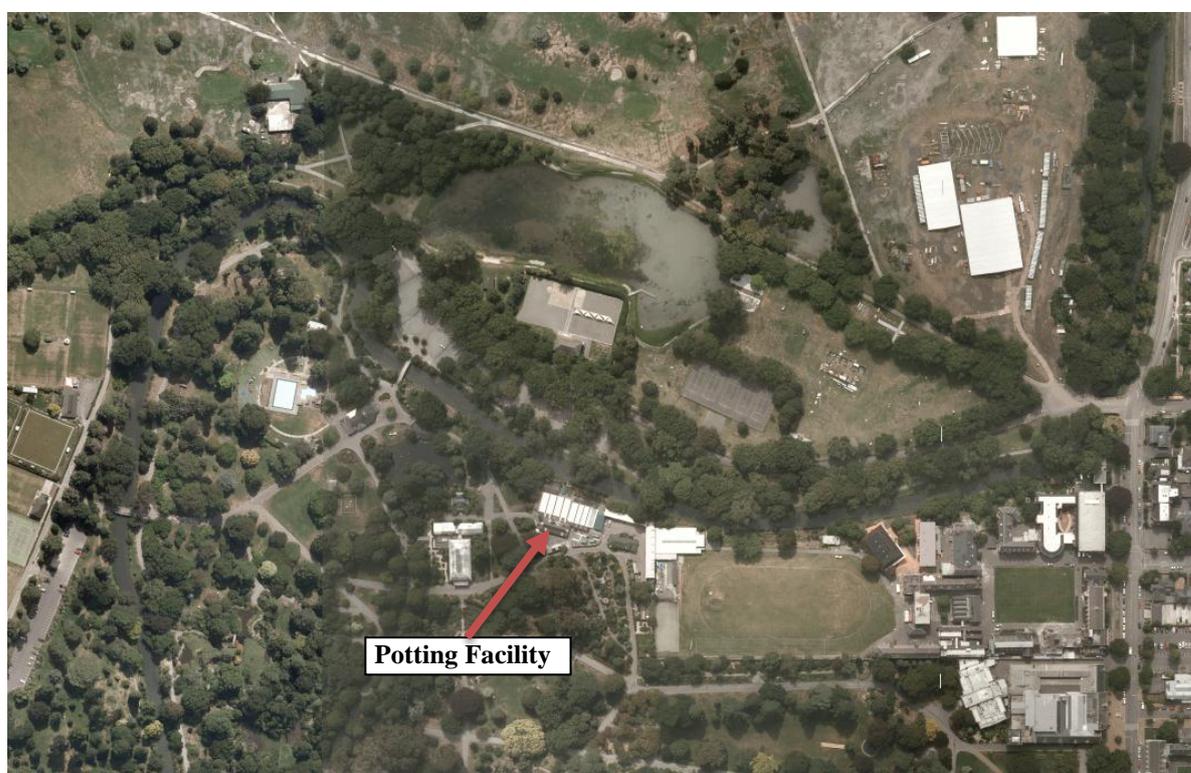
**Figure 3 Post February 2011 Earthquake Aerial Photography<sup>2</sup>**

Aerial photography taken following the 22 February 2011 earthquake shows moderate amounts of liquefaction on the northern side of the Avon and in Victoria Lake, in the top-left and top-right corners of Figure 3. However, there is no evidence of liquefaction at the surface within the botanic gardens themselves.

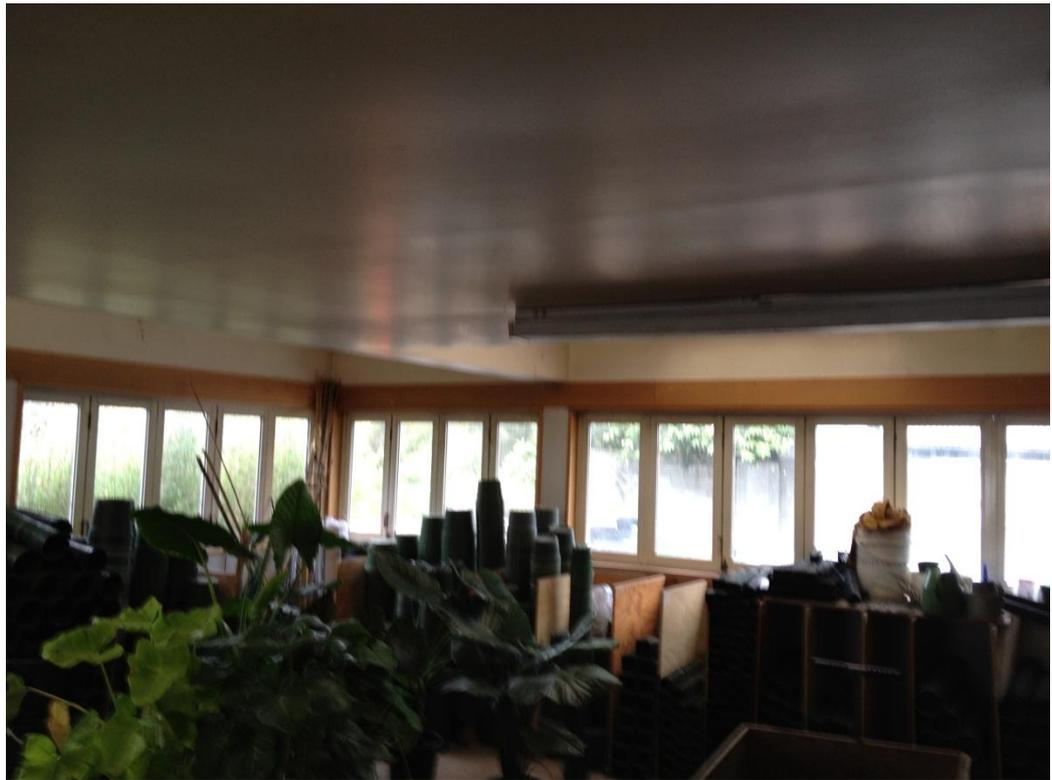
No significant plan irregularity was noted when evaluating the structure. The large number of windows to the south east side of the building could cause potential plan irregularity however due to the plywood bracing present it is deemed to be insignificant. Refer Drawing 2, Appendix B for the location of the plywood bracing.

**Photograph 5: Boxed out post and beam with windows to south east side of building**

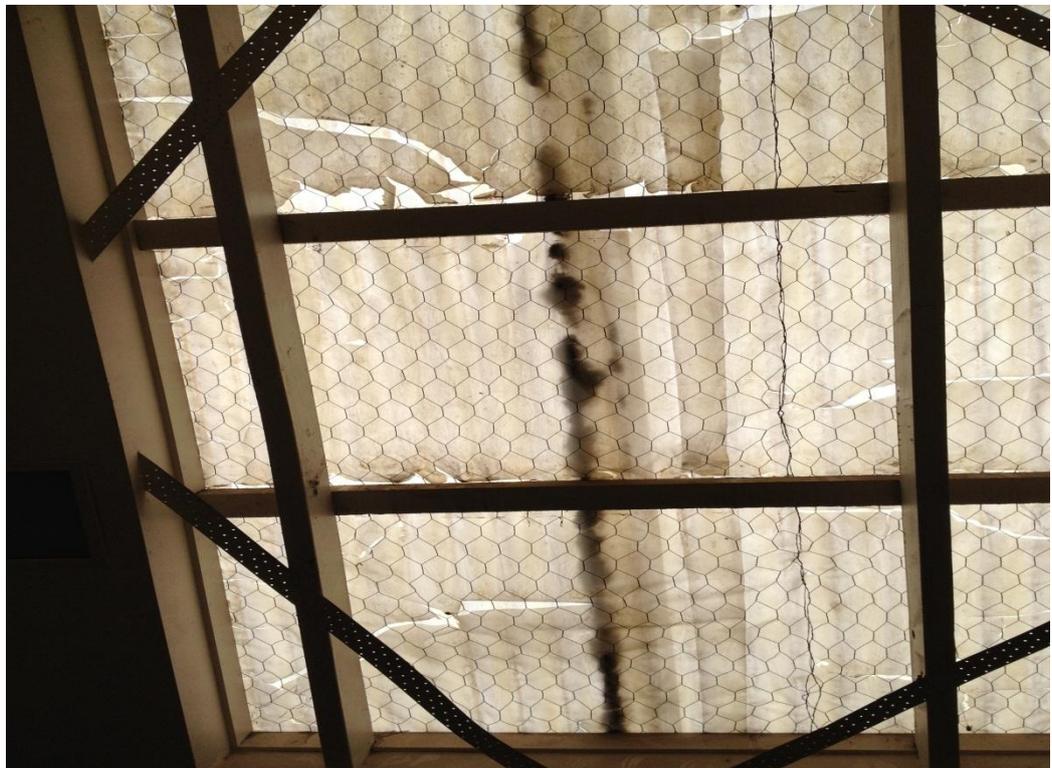
No critical structural weaknesses were observed in the roof structure. Diagonal bracing exists to the roof structure which consists of steel strap bracing with tensioners.

**Photograph 6: Extent of roof diagonal strap bracing through skylights**

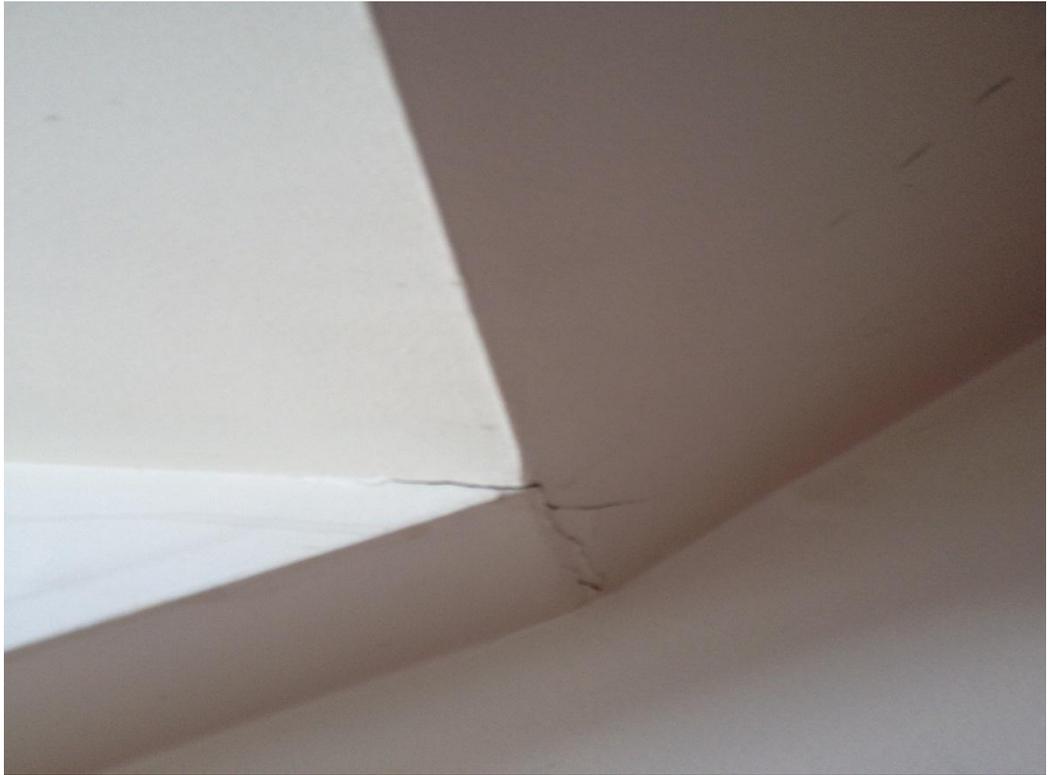
Minor plasterboard cracking was noted to the internal linings. Some of these are new cracks, whilst the remainder are existing cracks that may have opened up slightly during the recent seismic activity. (See photographs 7, Appendix A)

**Photograph 7: Minor cracking to plasterboard**

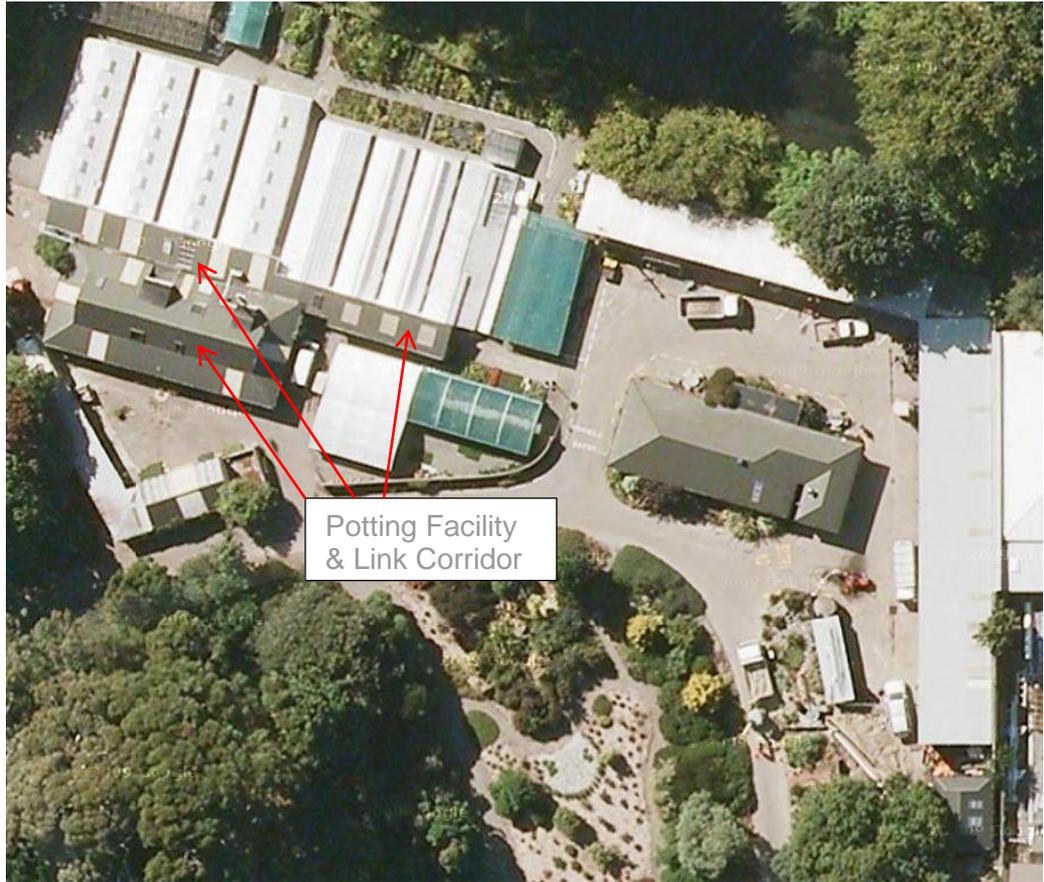
The potting facility is located in the Botanic Gardens yard which is partially surrounded by green field areas and walkways (See Photograph 9, Appendix A). The structure borders the glasshouses to the north and opposite the office library to the east. Minor shear cracking was noted to the external brickwork in the office library building.

**Photograph 9: Building location on site**
