**Botanic Gardens Rangers Office
PRK 1566 BLDG 034**

Detailed Engineering Evaluation
Qualitative Report
Version FINAL

7 Rolleston Avenue, Christchurch
Central

Christchurch City Council

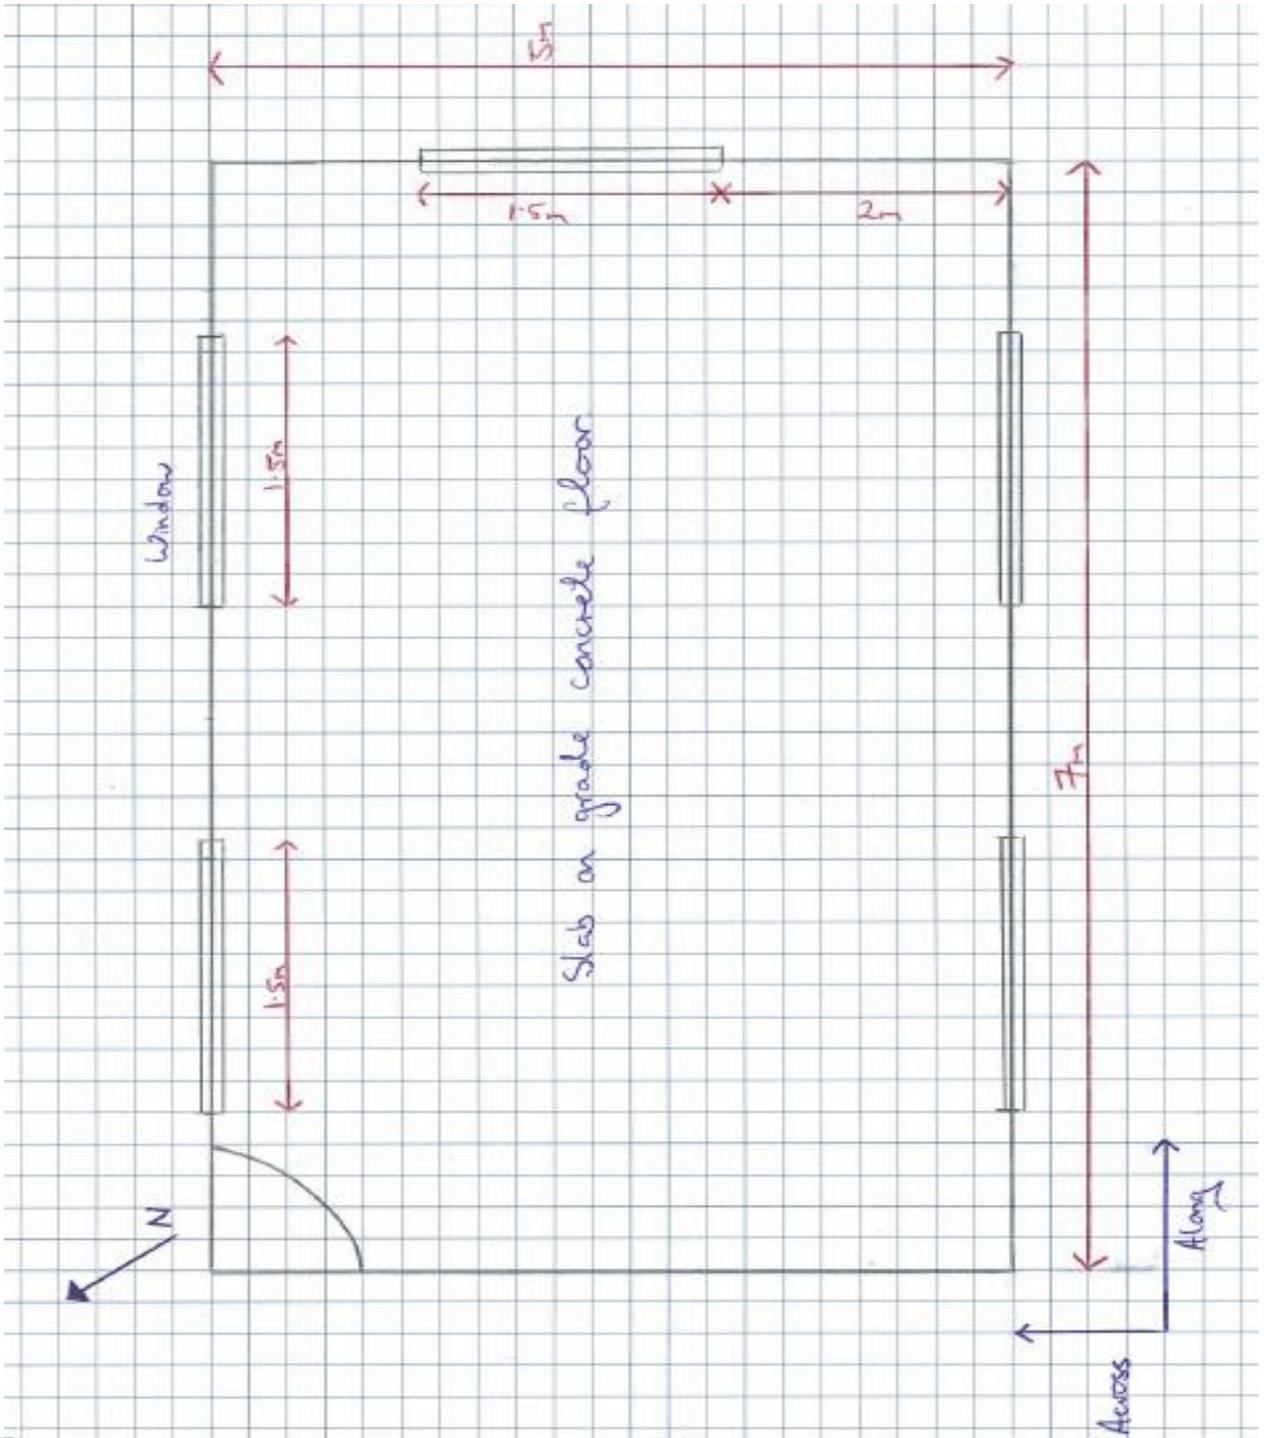
Figure 2 Plan Sketch Showing Key Structural Elements

The gravity loads acting on the structure are resisted by the external timber framed walls. Gravity loads from the roof are transferred through timber purlins spanning between the timber rafters. The loads are then transferred into the timber framed external walls, and into the ground via the concrete perimeter strip footings.

Lateral loads acting on the structure are resisted by the timber framed walls both along and across the building. Diaphragm action will be provided by the plasterboard lined ceiling, transferring lateral forces in the roof structure to the supporting walls and down to the perimeter strip footings.

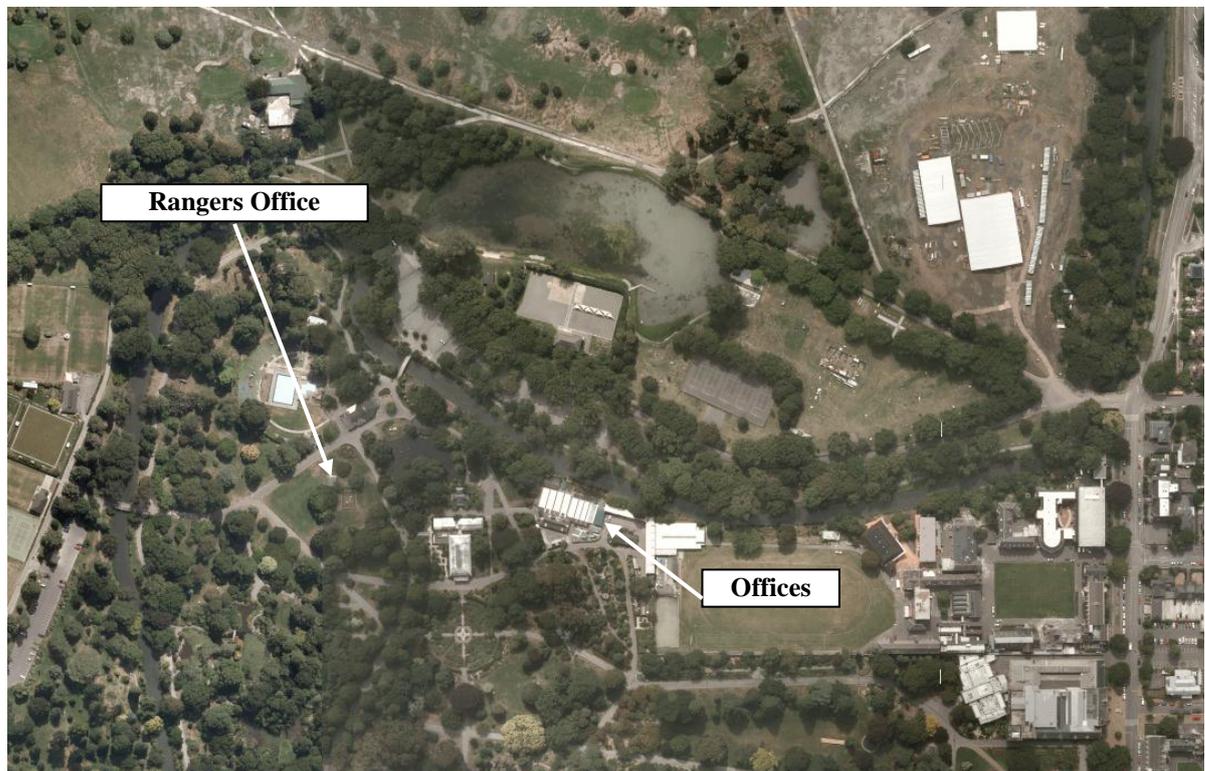
Figure 3 Post February 2011 Earthquake Aerial Photography²

Aerial photography taken following the 22 February 2011 earthquake shows moderate amounts of liquefaction on the northern side of the Avon and in Victoria Lake, in the top-left and top-right corners of Figure 3. However, there is no evidence of liquefaction at the surface within the botanic gardens themselves.

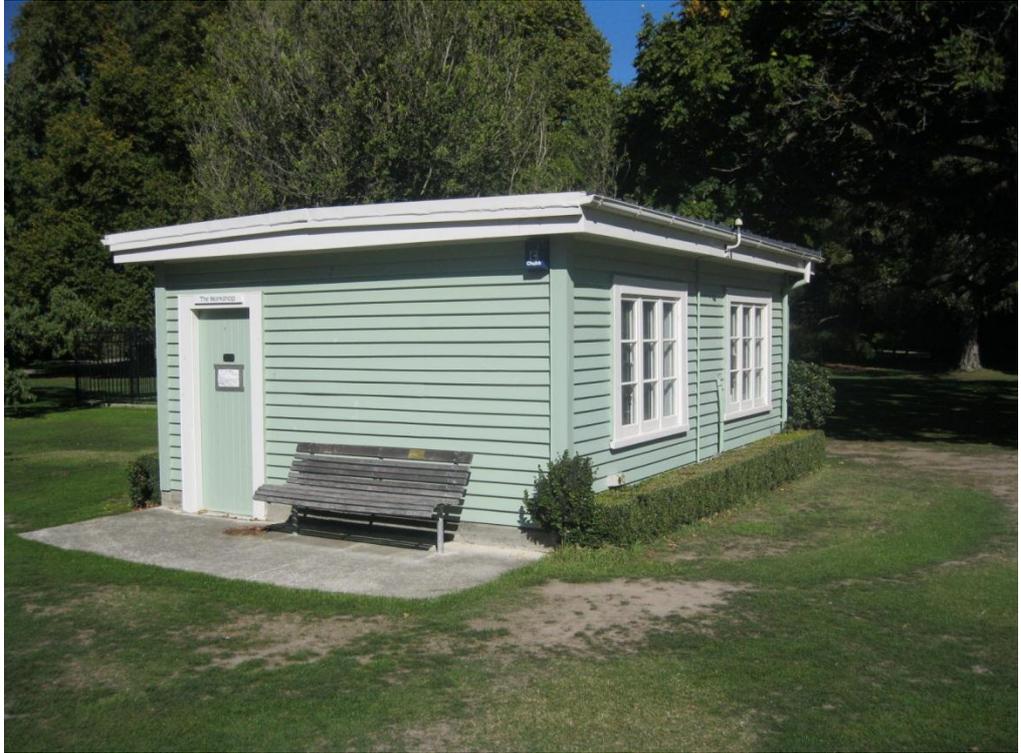
Photograph 1: North and west facing elevation

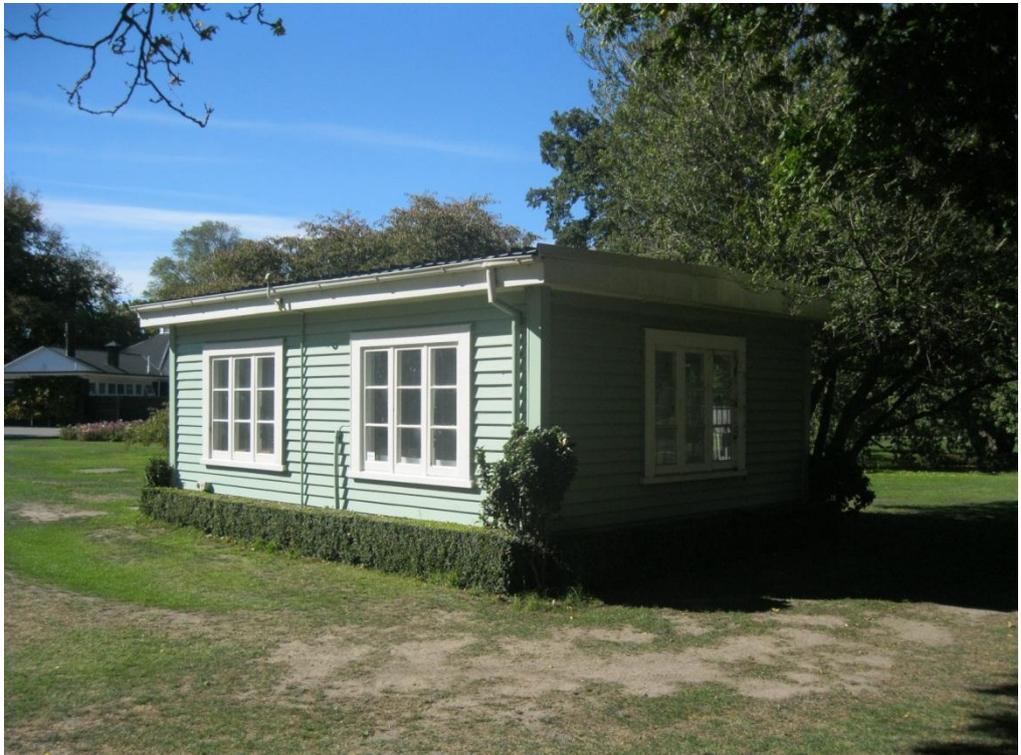
Photograph 2: West and south facing elevation

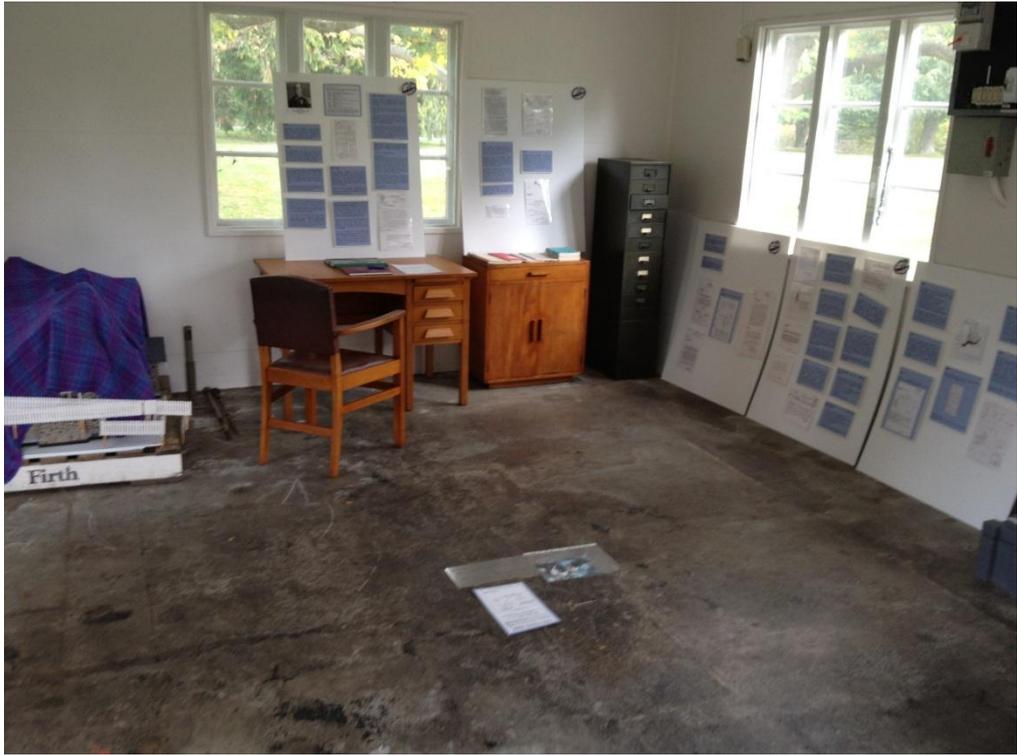
Photograph 3: Internal view

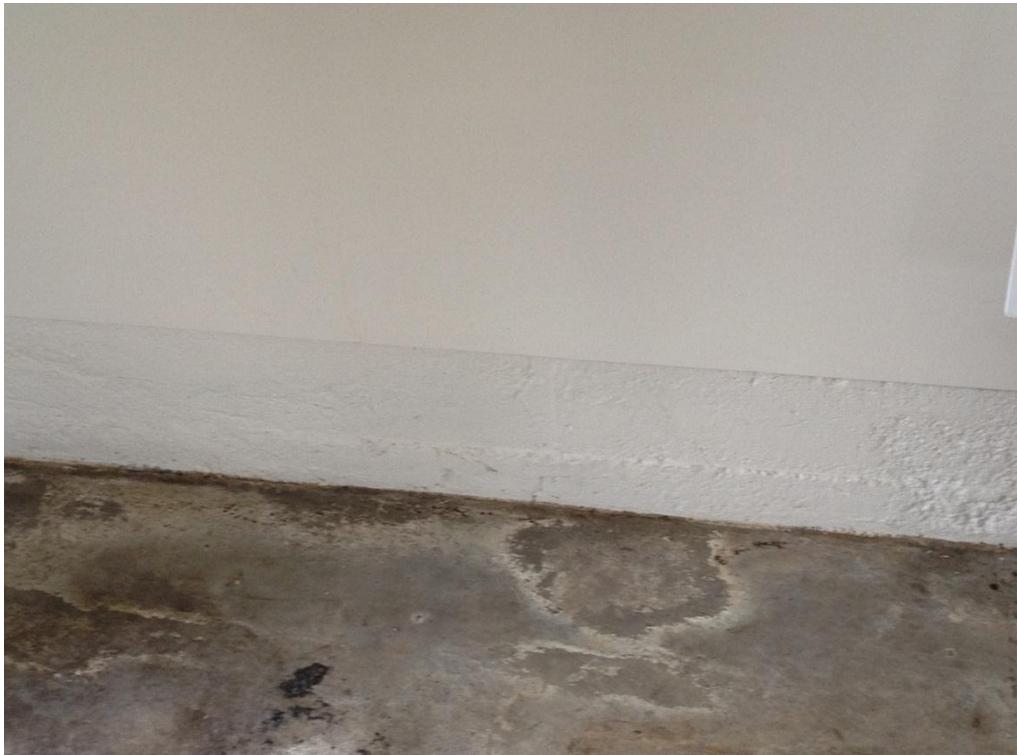
Photograph 4: Perimeter strip footing supporting timber framed wall

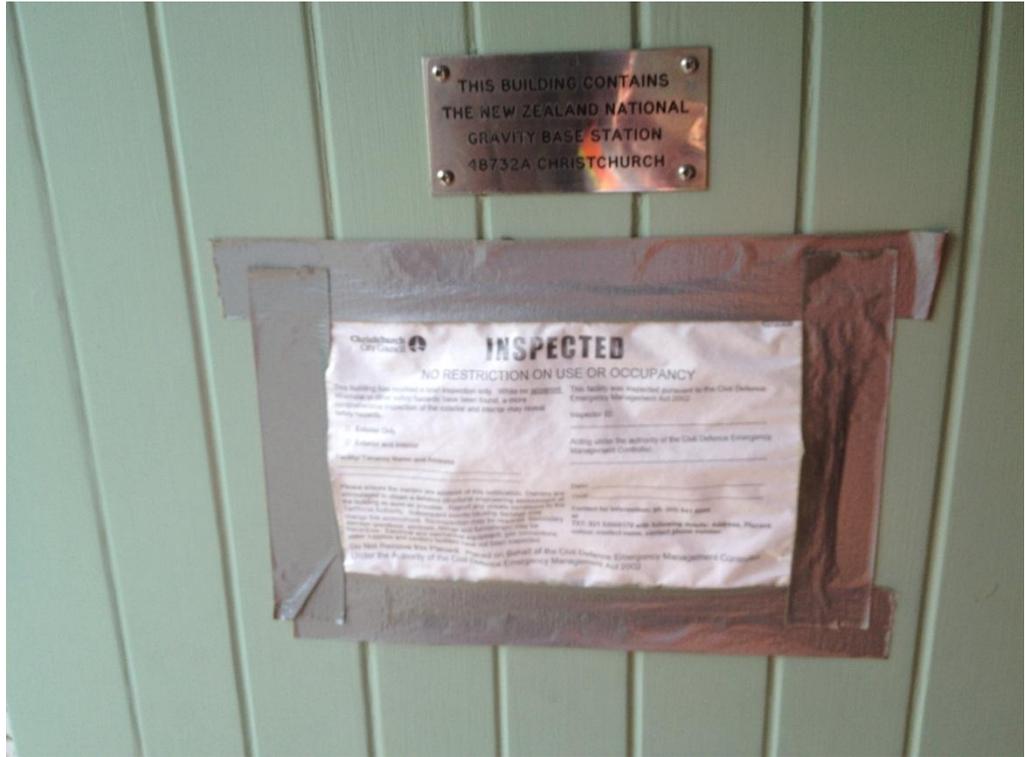
A visual inspection of the building was undertaken on 4 April 2012. Both the interior and exterior of the building were inspected. The building was observed to have a green placard in place. The main structural components of the building were able to be viewed due to the exposed simple construction of the building.

Photograph 5: Current green placard status

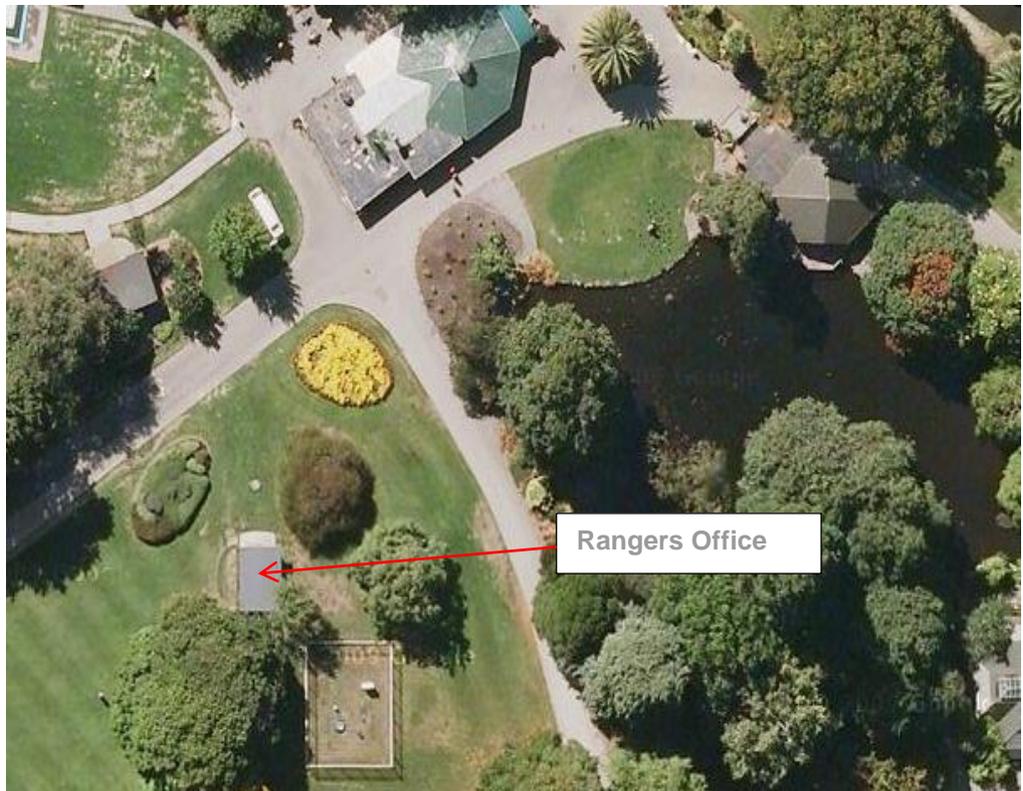
The Rangers Office is located in the Botanic Gardens at 7 Rolleston Avenue, Christchurch Central. The original construction date of the building is unknown but based on site observation it is estimated to be constructed in the 1970's. The site is located in the Botanic Gardens and surrounded by green field areas. See photograph 6 for building location on site.

The Rangers Office located in the Botanic Gardens is surrounded by green field areas with no properties immediately adjacent to the structure. The nearest building is the Tea Kiosk located approximately 40m to the north-east, minor damage was noted to this structure including internal wall lining cracking. See photograph 6 for building location on site.

Photograph 6: Building Location on site

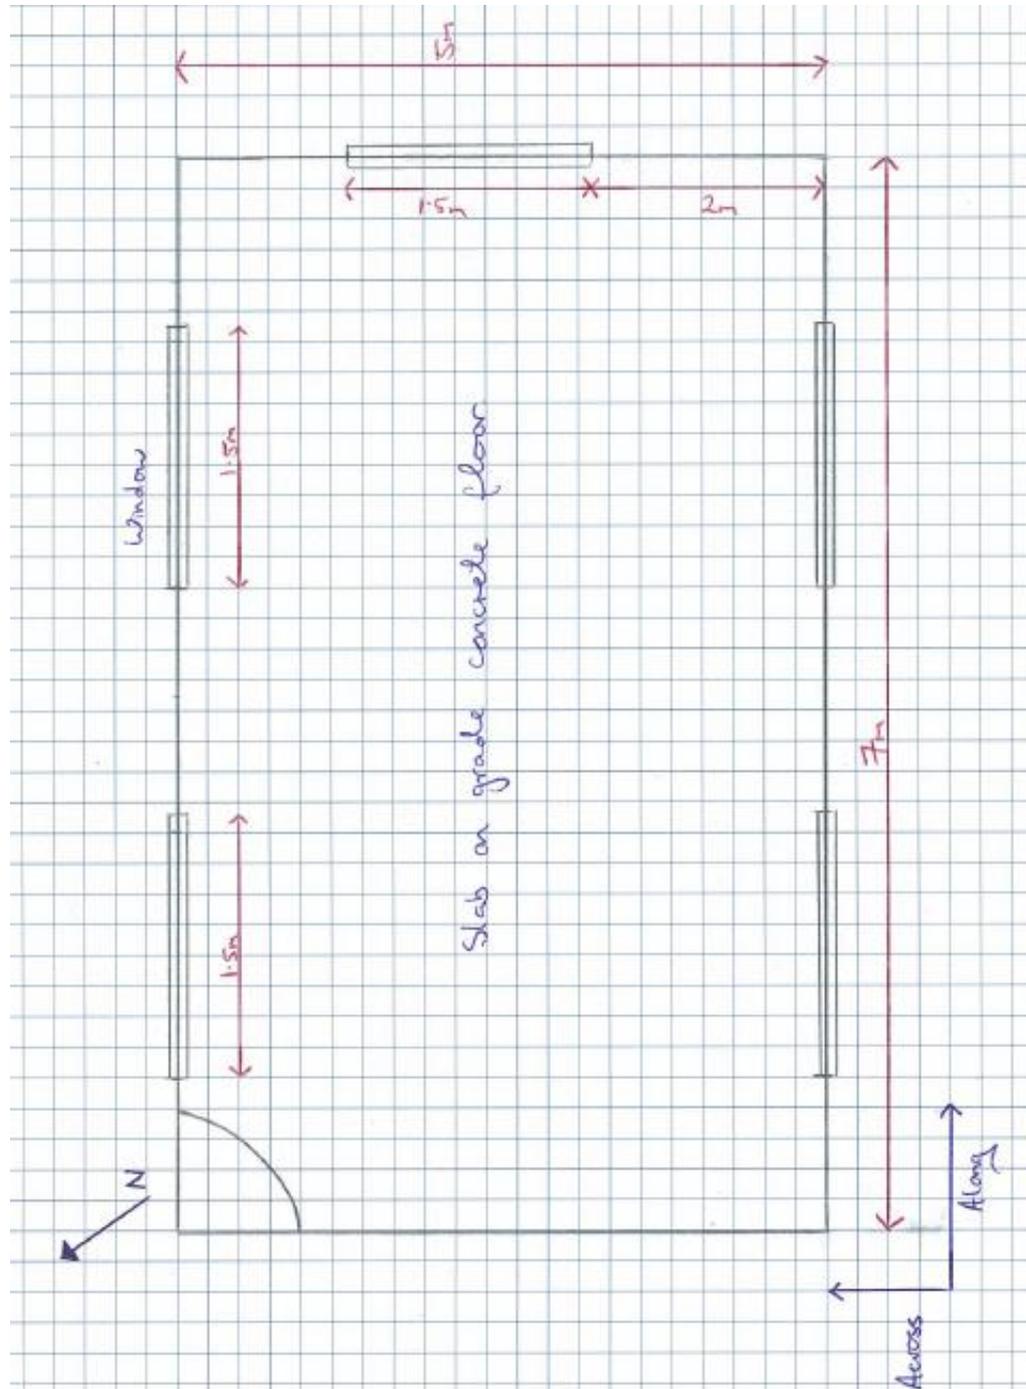
No drawings have been made available for this building. Shown below is a sketch of the building showing key structural elements.
