**Project:**  
 Bottle Lake Forest Chemical Shed  
 Qualitative Engineering Evaluation

**Reference:** 228587  
**Prepared for:** Christchurch City Council  
**Revision:** 2  
**Date:** 22 November 2012

**Functional Location ID:** PRK 0158 BLDG 015 EQ2  
**Address:** 70 Waitikiri Road

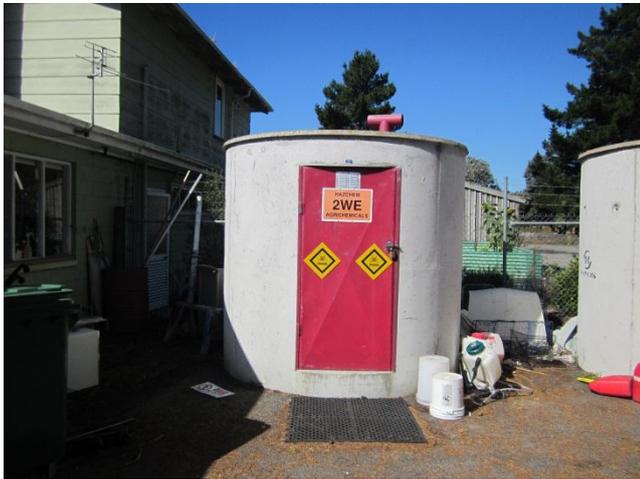
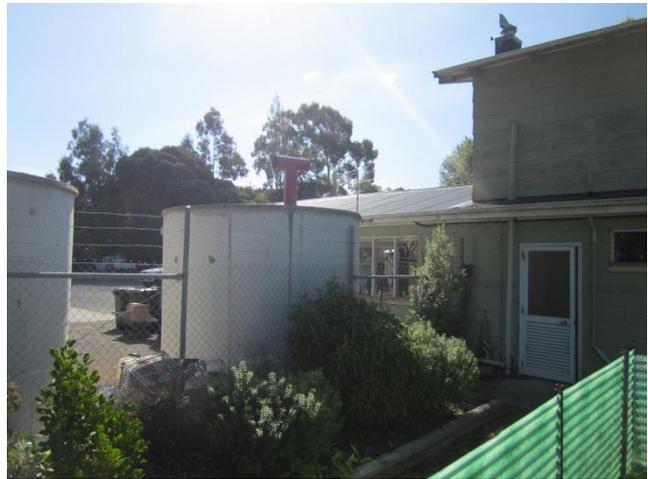
Front Elevation and Rear Elevations of the Chemical Shed

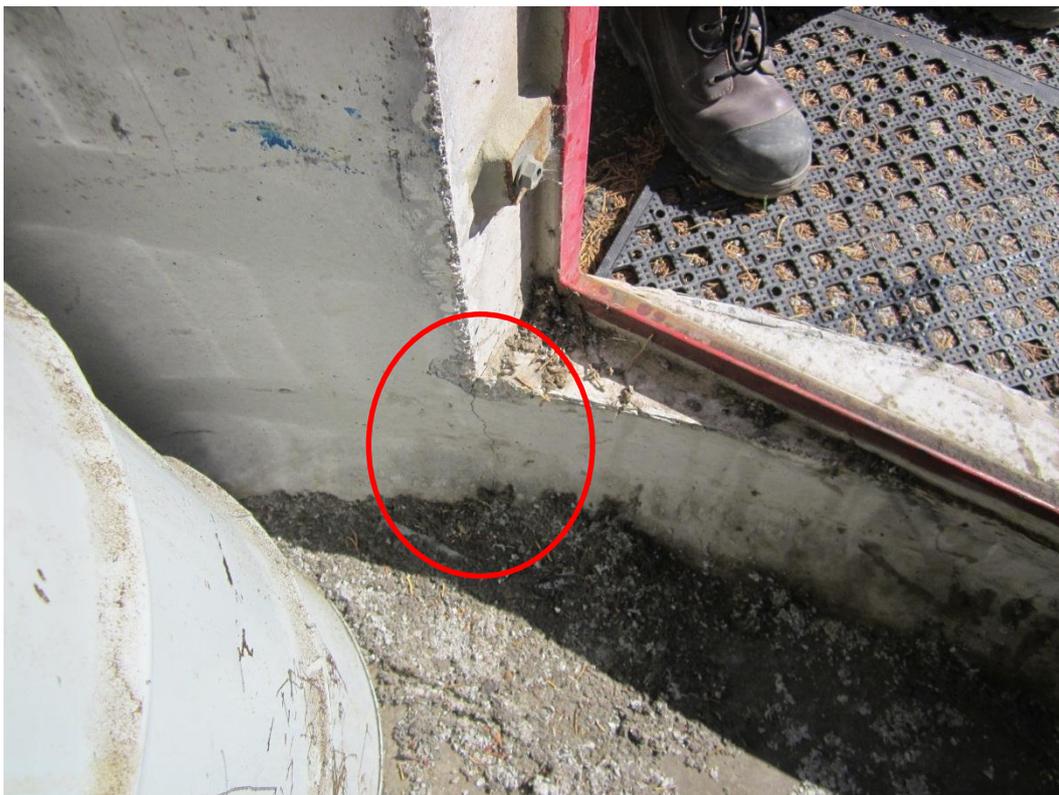
Small diagonal cracks were observed around the door opening. These cracks are a result of stresses concentrations around the door opening. They appear to be fresh and may be a result of seismic actions.

The smooth edges around the door opening suggests that the door opening was not cut post construction and therefore it is assumed that trimming bars are present to control these cracks.

Fresh crack around the door opening
