Bottle Lake Forest - Information
Centre
Qualitative Engineering Evaluation

Reference: 228589
Prepared for:
Christchurch City Council

Functional Location ID: PRK_0158_BLDG_017

Date: 10 October 2013

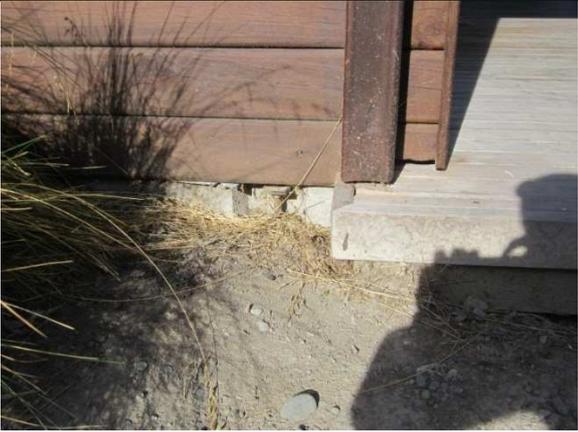
Concrete slab on ground foundation.

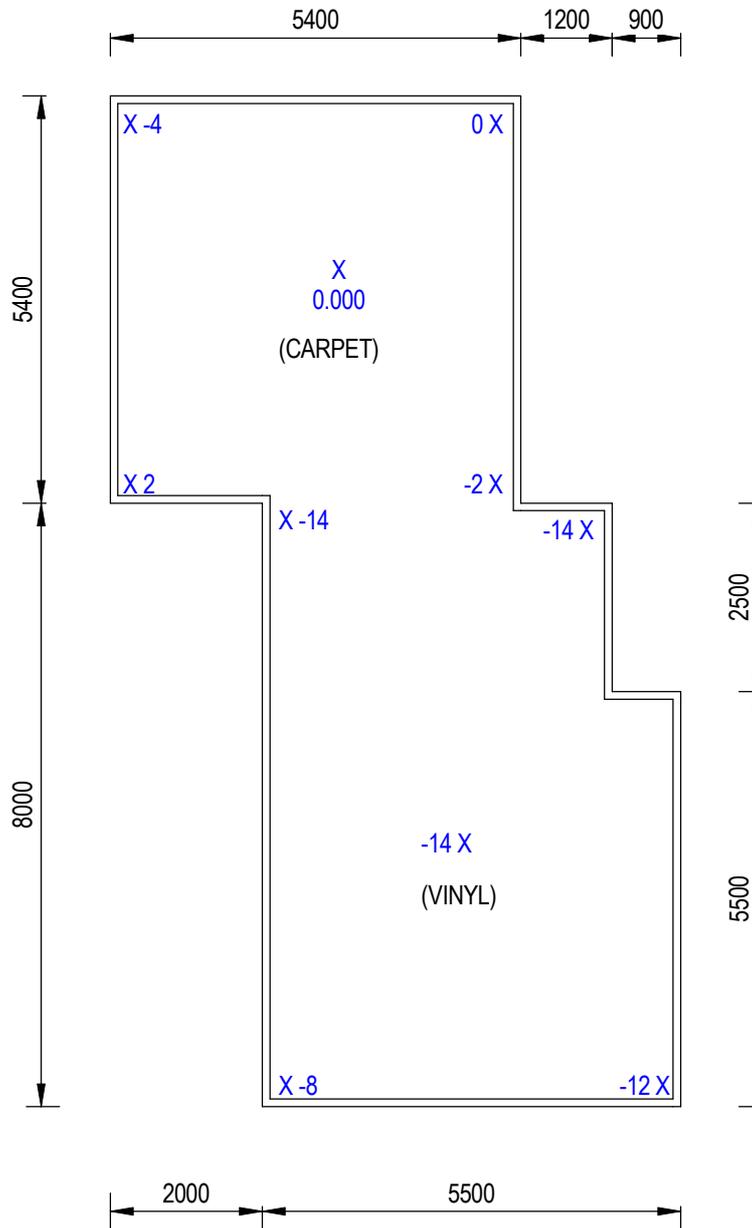
PROJECT
BOTTLE LAKE FOREST CHRISTCHURCH
TITLE
INFORMATION CENTRE FLOOR LEVEL SURVEY

Levels Survey Results	N	Levels survey results are not within acceptable limits. The level damage was present before the earthquakes. It is recommended that the floor is re-levelled.			
Building %NBS From Analysis	74%	Based on an analysis of bracing capacity and demand.			
Qualitative L4 Report Recommendations					
Geotechnical Survey Required	N	Geotechnical survey not required due to lack of observed ground damage on site.			
Proceed to L5 Quantitative DEE	N	A quantitative DEE is not required for this structure.			
Approval					
Author Signature

A levels survey was carried out and the results have been included in Appendix A. The results of the levels survey show that existing floor levels are within acceptable limits.
