Bottle Lake Forest Vehicle Shed
Qualitative Engineering Evaluation

Reference: 228597
Prepared for:
Christchurch City Council

Functional Location ID: PRK 0158 BLDG 002 EQ2

Date: 18 December 2012

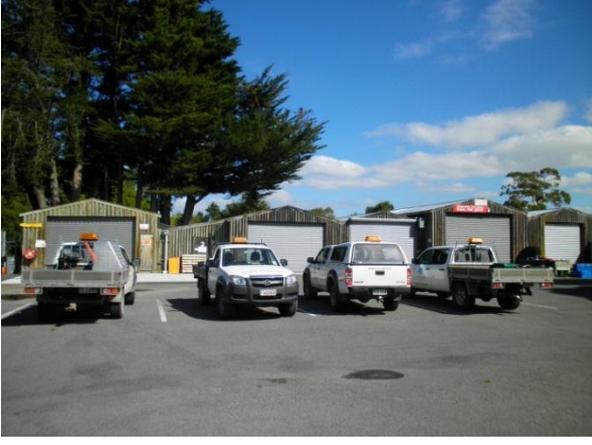
<p>Bottle Lake Park Vehicle Shed – Front Elevation</p>

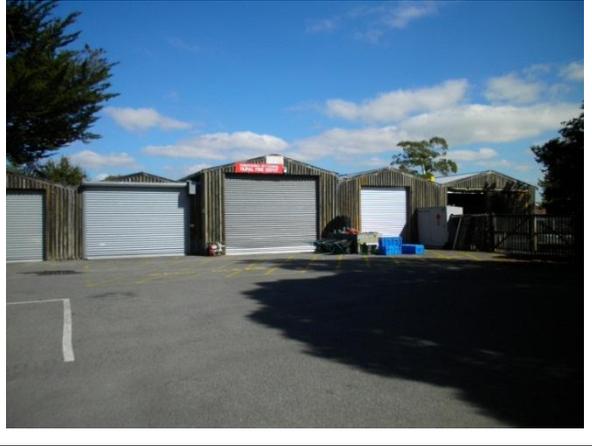
<p>Bottle Lake Park Vehicle Shed – Front Elevation</p>

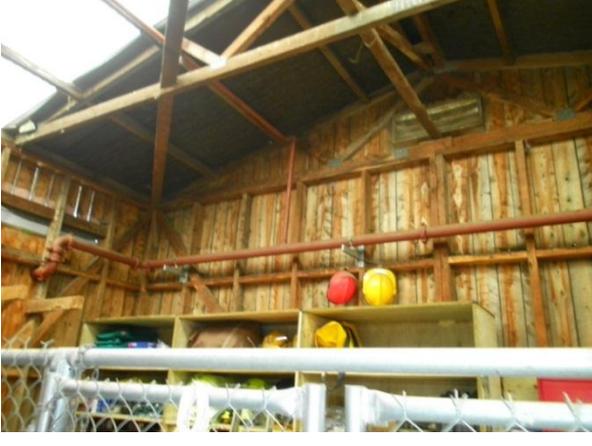
<p>Lateral braces for the timber framed wall and roof trusses</p>

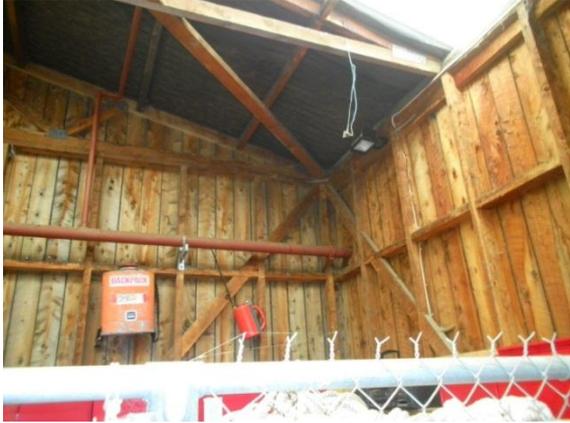
<p>Lateral braces for the timber framed wall and roof trusses</p>

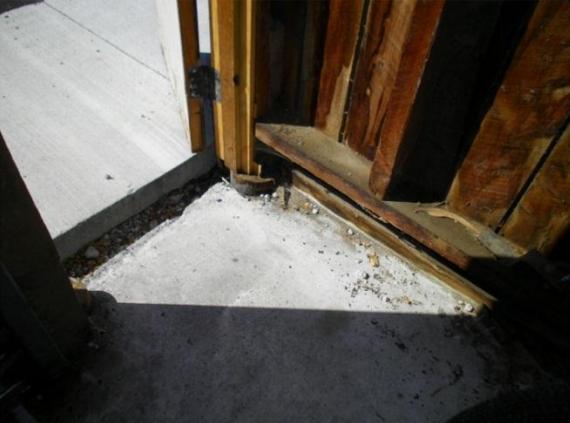
<p>Timber piled foundation and concrete slab which was cast post construction of the timber frame of the vehicle shed</p>

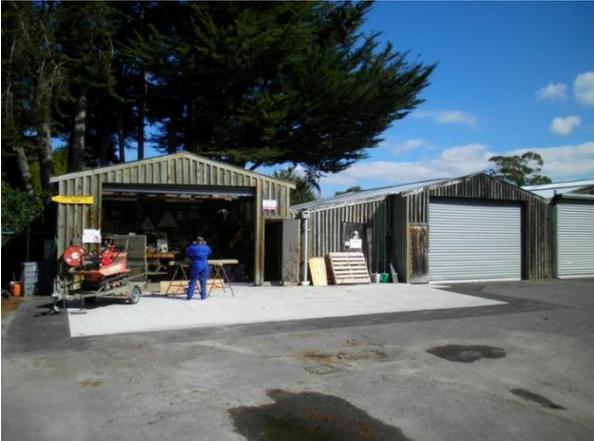
The vehicle shed walls are founded on timber piles and a concrete slab has been cast at ground level post construction internally. It was observed and confirmed on site by the park rangers that post earthquake remedial work has been carried out on the slab on the North Eastern courtyard apron and on the interior. This work was to repair damage done by roots from a tree adjacent to the sheds that toppled due to the earthquakes.

<p>Post-earthquake repairs to the courtyard apron</p>

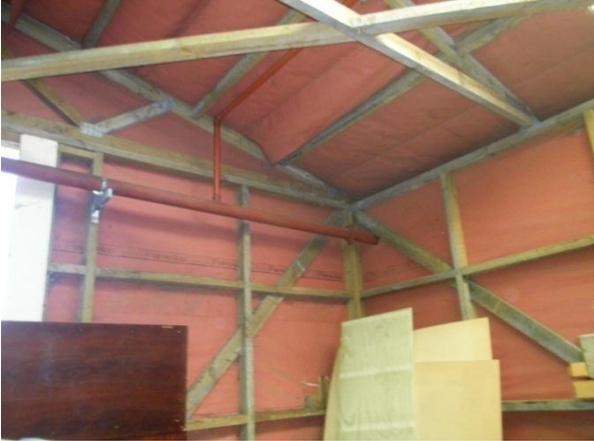
The building has 7 distinct bays, 5 of the bays on the North Eastern end appear to be constructed earlier with the last 2 bays being apparent later additions indicated by the presence of building paper and the lighter colouration of the timber.

<p>New additions evidenced by building paper and lighter colouration on the timber</p>

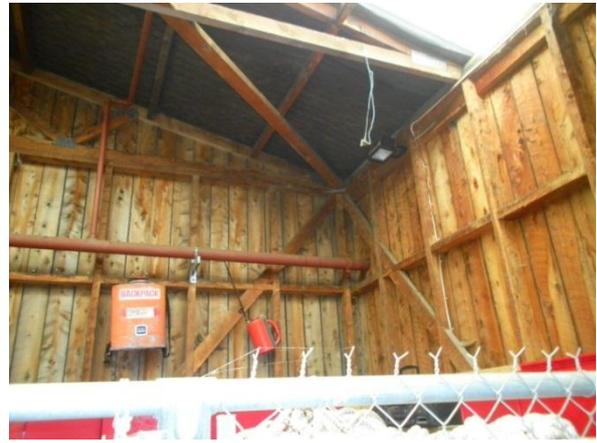
Old section of building (in comparison with above photo)

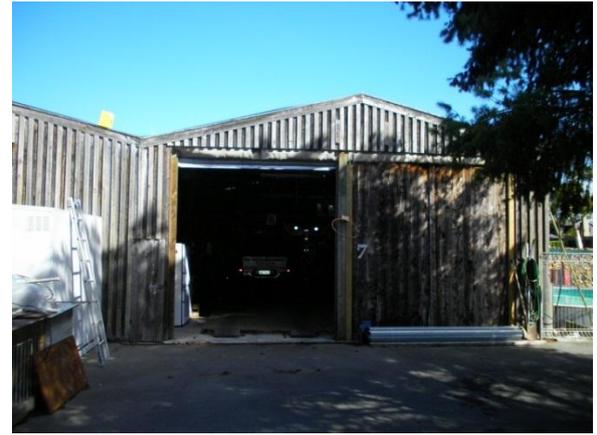
A visual assessment of exterior and interior of the Bottle Lake Forest vehicle shed indicates that apart from increased crack widths in the floor slab, the only other damage noted was the damage to the timber door.

Damage to the existing timber doors
