Bower Park Pavilion/Toilet
PRK 1307 BLDG 001

Detailed Engineering Evaluation
Quantitative Report
Version FINAL

479 New Brighton Road, Christchurch

Christchurch City Council

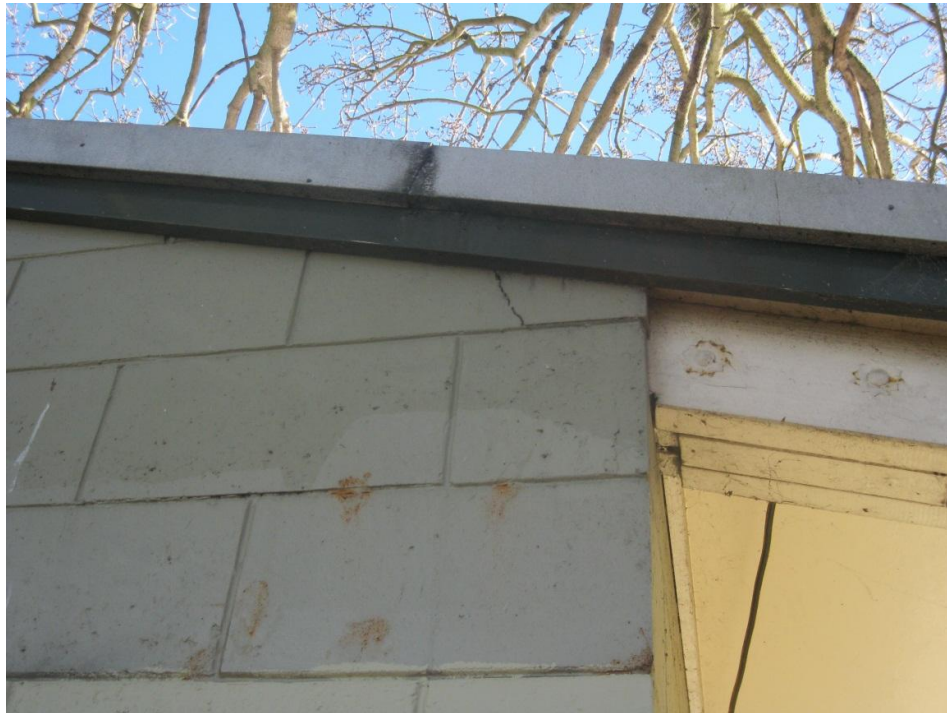
- ▶ Cracking to the top of the eastern rear block wall;
- ▶ Shrinkage cracking to the concrete floor slab across the building;
- ▶ Cracking to concrete floor under the veranda;
- ▶ Evidence of ground movement was observed to the pavement outside the building.

Photograph 5: Cracking to the top of the external blockwork walls on the eastern side

It is recommended that a pourable high flow cementitious grout (e.g. Sika Grout GP or Sika Grout 212 or approved equivalent) be used for repairing for these damages.

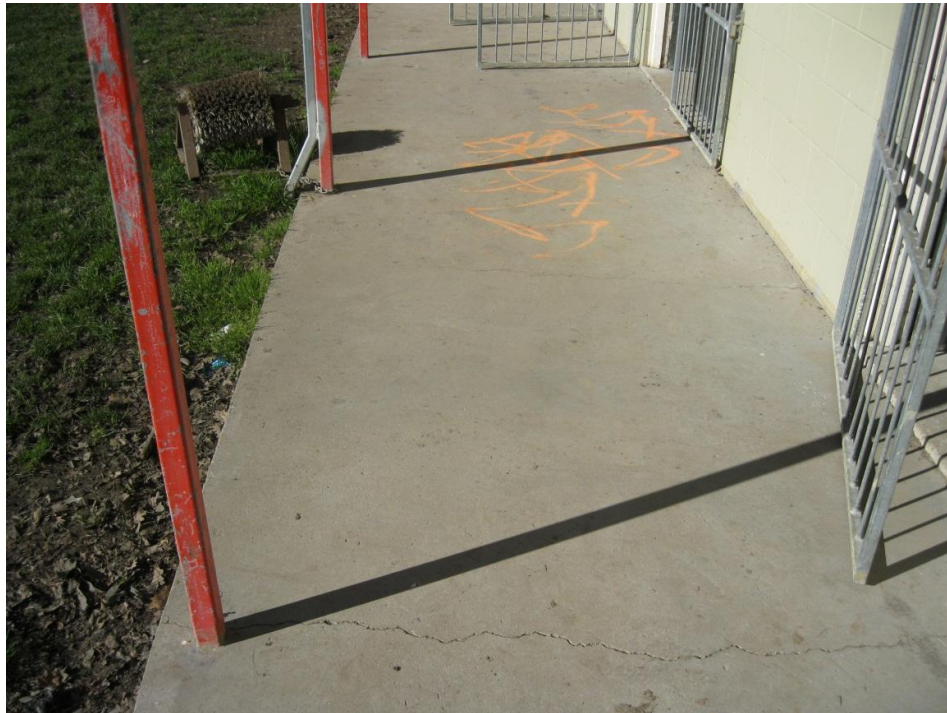
Photograph 7: Cracking to the concrete pavement under veranda canopy

We recommend that an epoxy injection system (e.g. Sika Sikadur Injectokit TH or similar approved) be used for the repair of the slab cracking greater than 0.2mm in width. It should be noted that epoxy injection cannot be carried out where crack widths are less than 0.2mm in width. Repairs should be carried out in accordance with manufacturer's instructions.

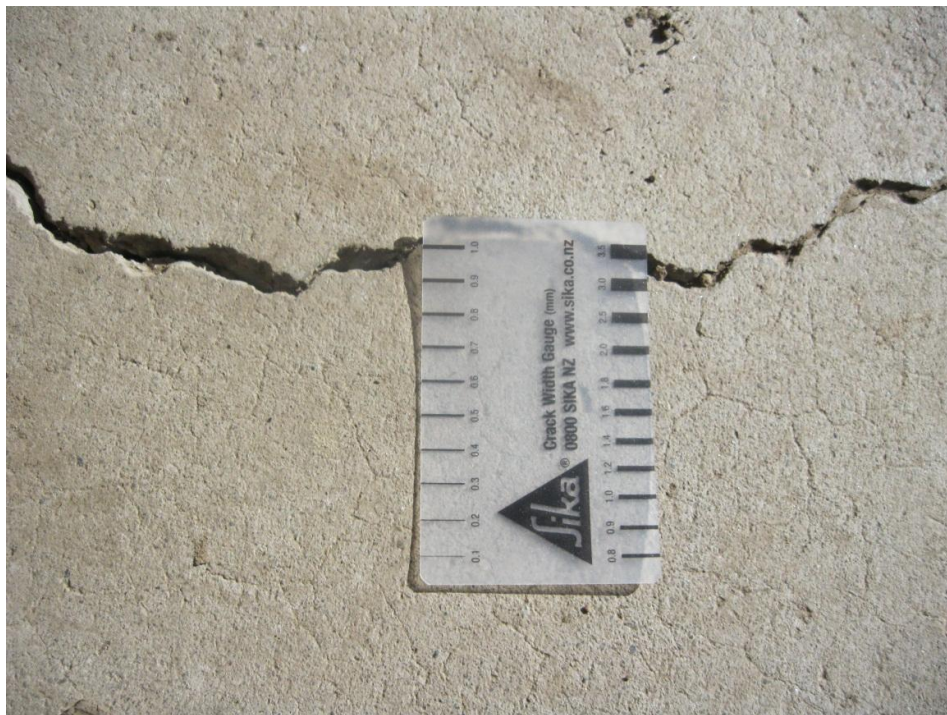
Photograph 8: As above

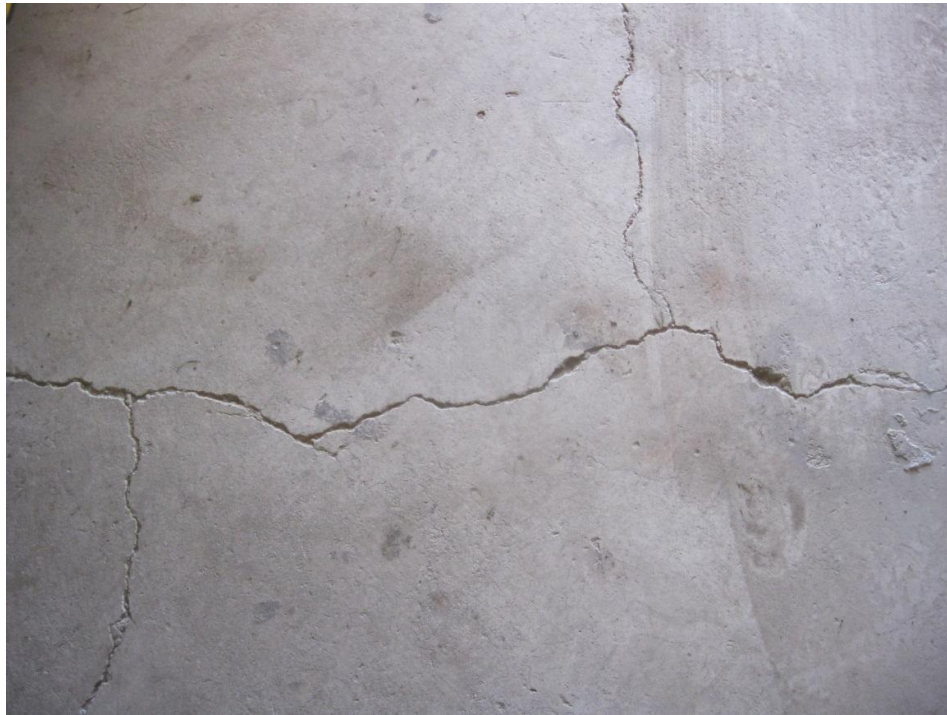
Photograph 9: Typical shrinkage cracks to the concrete floor slab throughout the building

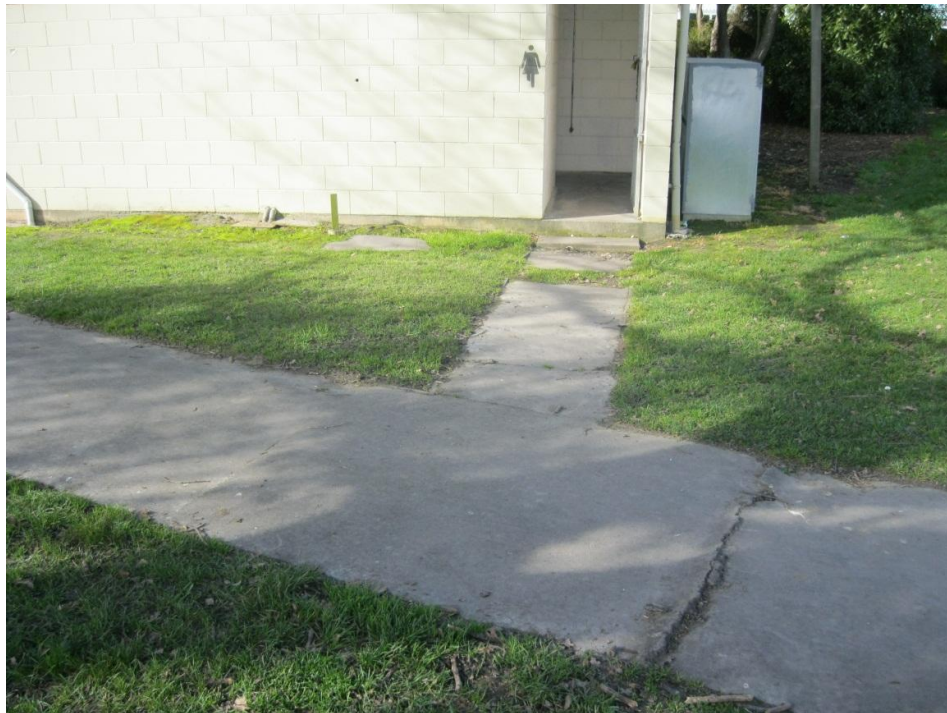
Evidence of ground movement was observed to the pavement outside the building.

Photograph 10: Damage to the pavement outside the building

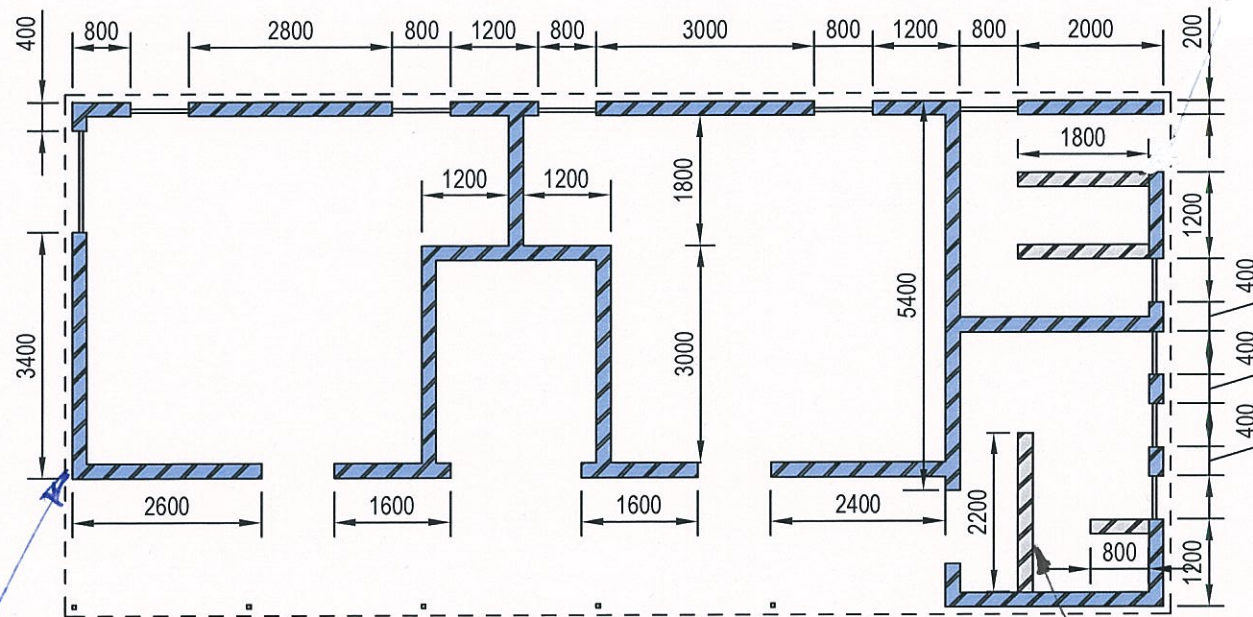
Out-of-Plane Analysis
Bower Park Pavilion
 51-31526-29.

Full height Block Wall
 $H = 2.6\text{m} \sim 3.4\text{m}$ (to apex).
 unreinforced, unfilled.
 Simply supported.
 $\% \text{ NBS} = \underline{60\%}$

Cantilevered Block Wall
 $H = 2.2\text{m}$.
 unreinforced, unfilled.
 $\% \text{ NBS} = \underline{19\%}$
