CHRISTCHURCH CITY COUNCIL
PRK_1133_BLDG_002 EQ2
Bradford Park - Toilets
192 Milton Street, Sydenham

QUALITATIVE ASSESSMENT REPORT
FINAL

- Rev B
- 07 December 2012

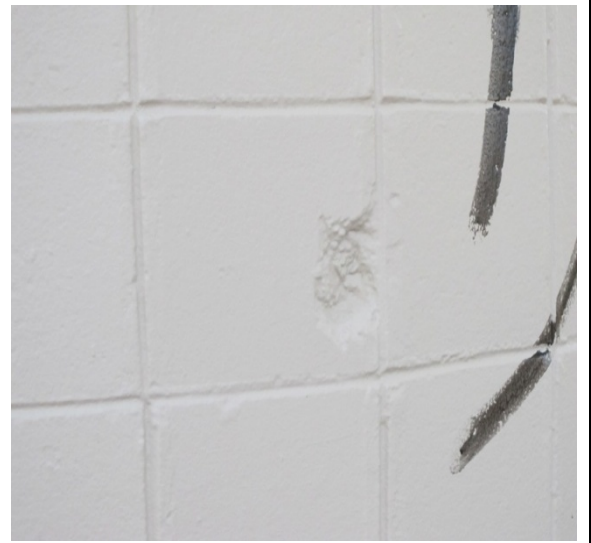
- 1) No earthquake-related damage was observed during our site inspection.
- 2) Impact damage was noted on the outer west wall and the top of the inner west wall. This is not believed to be earthquake-related damage.
- 3) Impact damage was noted on the roof cladding above the west toilet entrance. This is not believed to be earthquake-related damage

Photo 6: Impact damage on west wall.

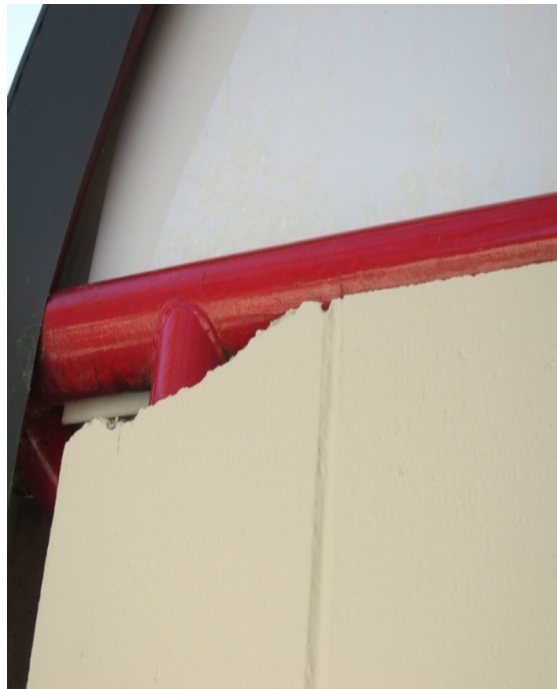
Photo 11: Impact damage to top of masonry wall above west toilet entrance.

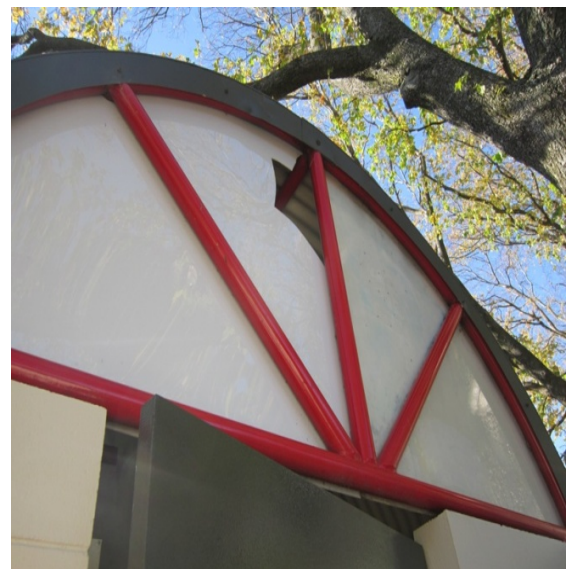
Photo 14: Impact damage on roof cladding above west toilet entrance.

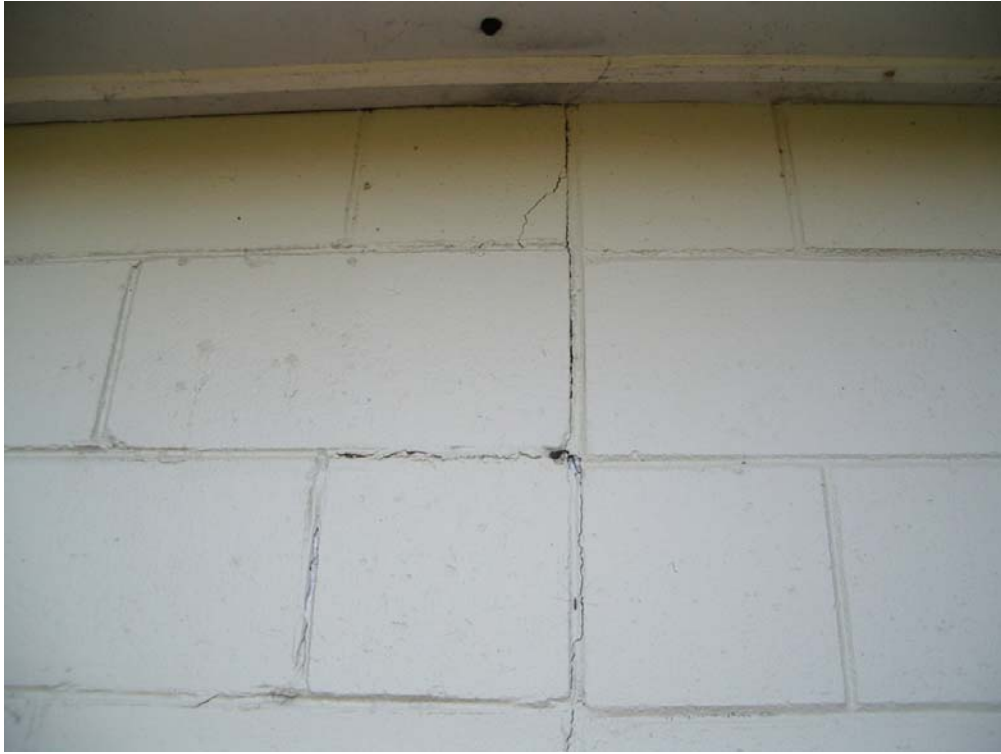
The pavilion and toilets were observed to be a masonry block buildings with sheet metal roof and slab on grade foundations. From the external inspection there was minor step cracking noted in masonry blocks at one location (on the southern side of the pavilion) at the top of the wall.

■ **Figure 9 Minor cracking observed**
