CHRISTCHURCH CITY COUNCIL
PRK_1358_BLDG_001 EQ2
Bridge Reserve Shed
5 Santa Cruz Lane, New Brighton

QUALITATIVE ASSESSMENT REPORT
FINAL

- Rev B
- 25 March 2013

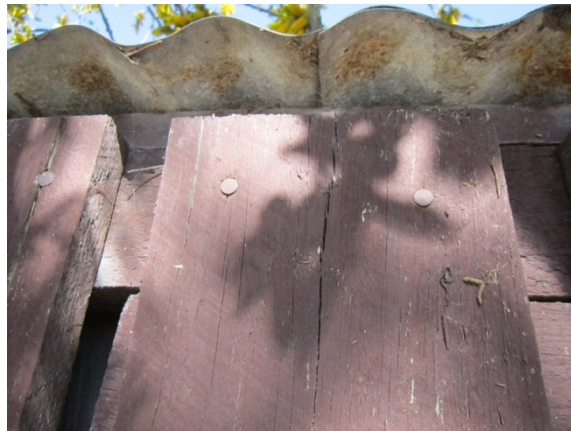
- 1) No earthquake-related damage was observed during our site inspection.
- 2) Splitting along the grain of timber elements was noted, but is believed to be age-related damage rather than earthquake damage.
- 3) Rusting of steel connections was noted.

Photo 5: Splitting of timber elements along the grain (typical)

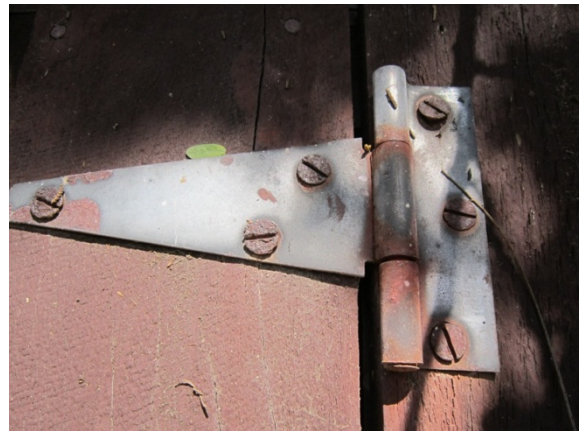
Photo 6: Rusting of steel elements (typical)

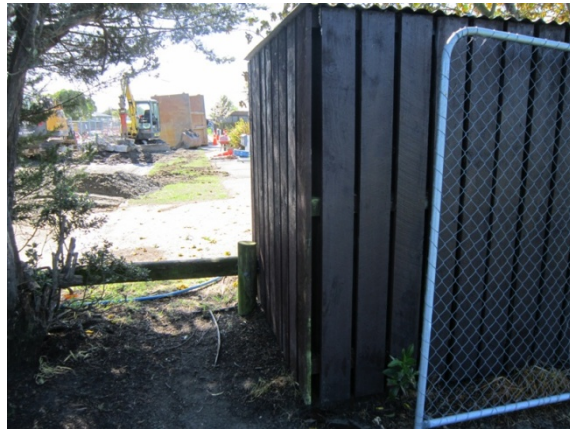
Photo 11: Construction work nearby, indicating ground movement occurred.

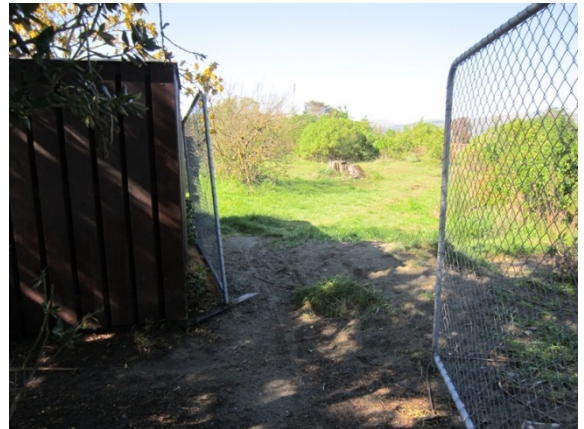
Photo 12: Soil ejecta west of building, near the Avon River.

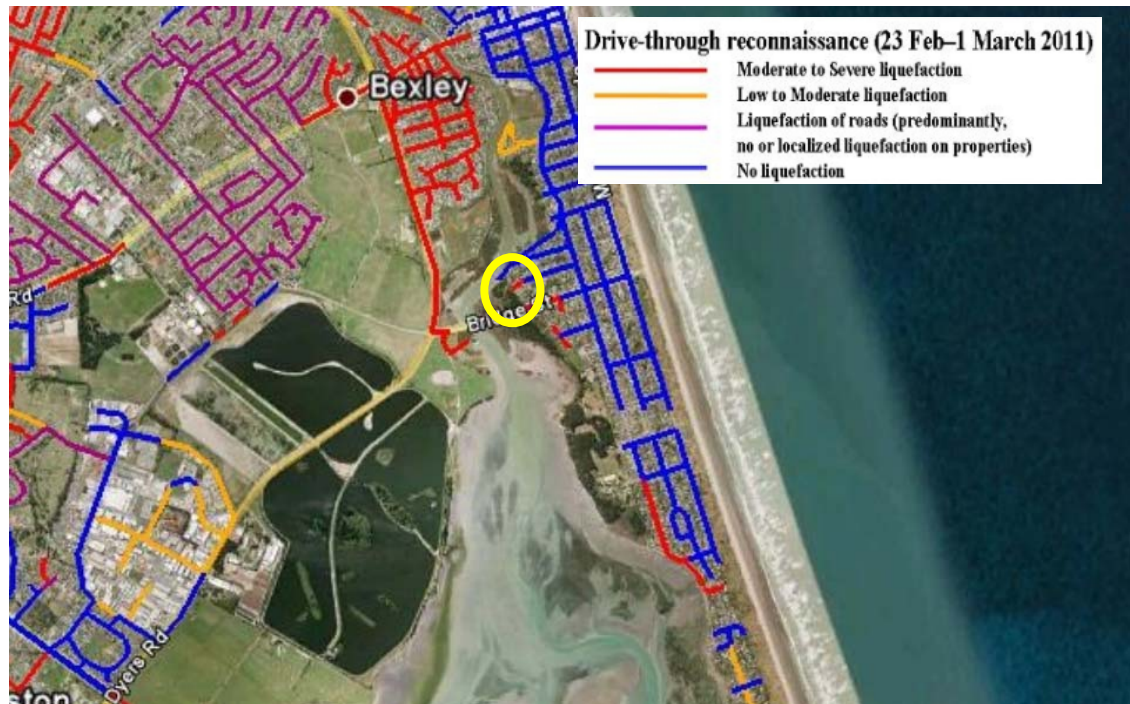
■ **Figure 4 – Liquefaction map (Cubrinovski & Taylor, 2011). Site marked in yellow.**

Following the 22 February 2011 event drive through reconnaissance was undertaken from 23 February until 1 March by M Cubrinovski and M Taylor of Canterbury University. Their findings show moderate to severe liquefaction along the west and central parts of Bridge Street as well as at the west end of Blake Street to the north of Bridge Street.

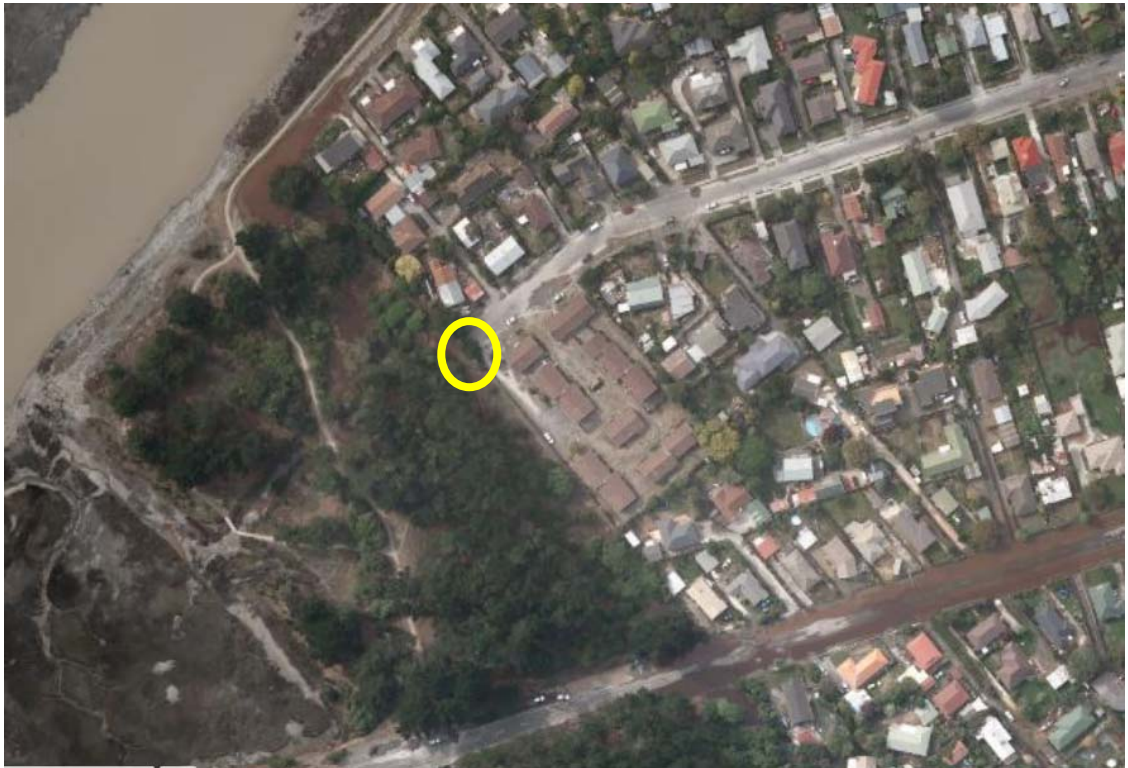
■ **Figure 5 – Aerial photography from 24 Feb 2011 (<http://viewers.geospatial.govt.nz/>)**

Aerial photography shows significant liquefaction after the 22 Feb 2011 event. Sand and silt ejecta can be observed in the estuarine area to the west of the site as well as within the residential area to the east including on Blake and Bridge streets. There is liquefaction induced flooding (brown) on Bridge Street and within Bridge Reserve.

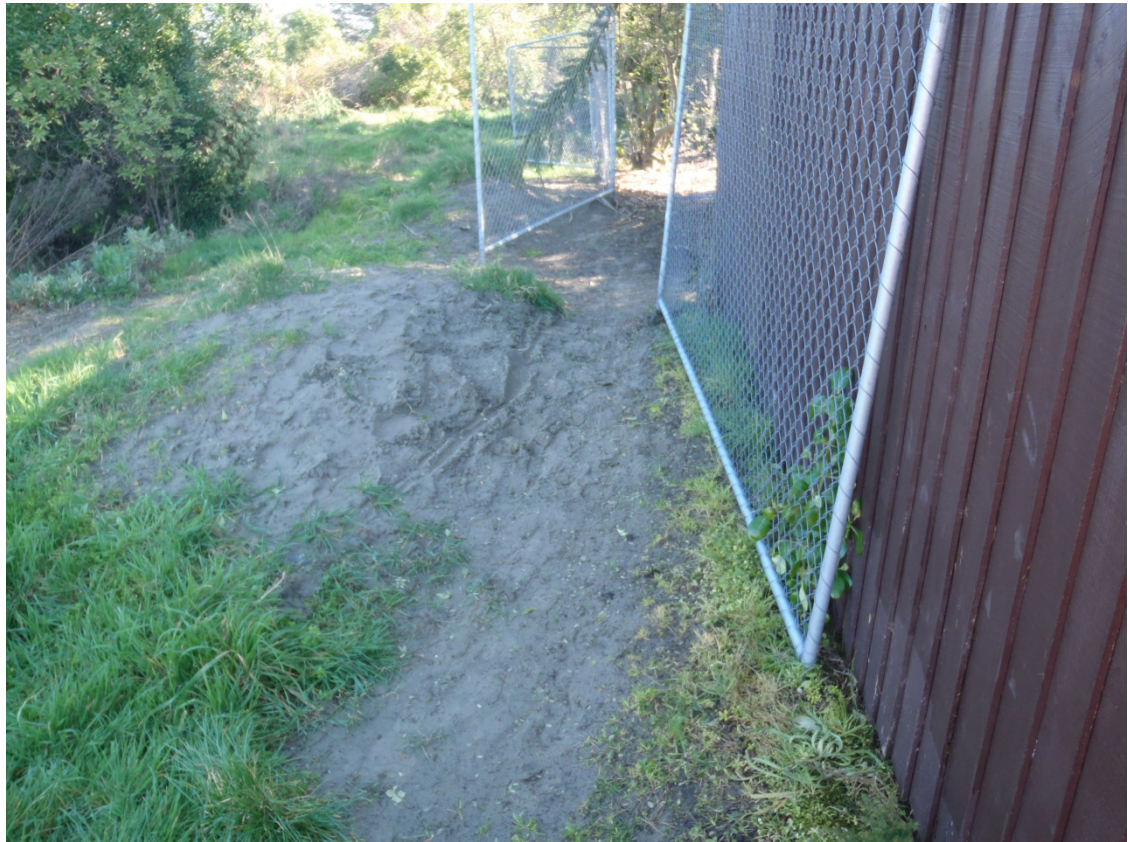
There is evidence of liquefaction to the rear of the shed towards the Avon River. This has also been confirmed on the aerial photography post 22 February 2011 and 4 September 2011 earthquakes.

■ **Figure 8** - Liquefied silt ejecta at the rear of the shed
