Bridgewater Courts Housing Complex PRO 1347

**Detailed Engineering Evaluation
Quantitative Assessment Report**

**14 Bridge Street, South Brighton,
Christchurch 8061**

Date: October 2013
Reference: 6-QC318.00
Status: Final

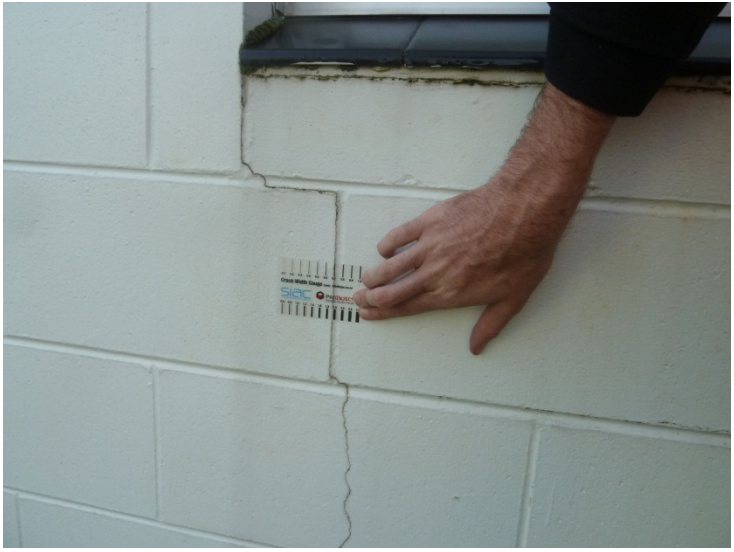
Stepped cracking to external block veneers along mortar joints and through the block itself was observed on most unit facades (photos 5-13). This appears to have occurred primarily around where wall openings are located. Also consistently observed was cracking of the mortar in the vertical veneer blockwork junction between units (within a sub-block).

5	Typical cracking along block veneer mortar joint and actual block

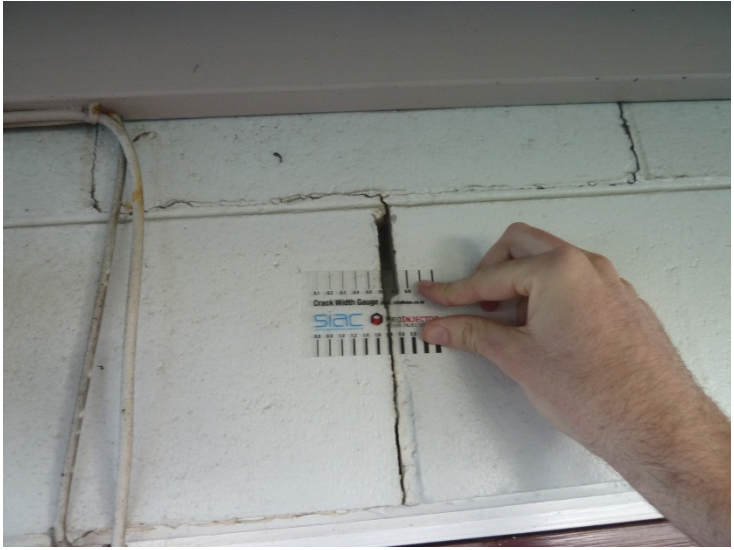
6	Typical cracking located above entry door opening

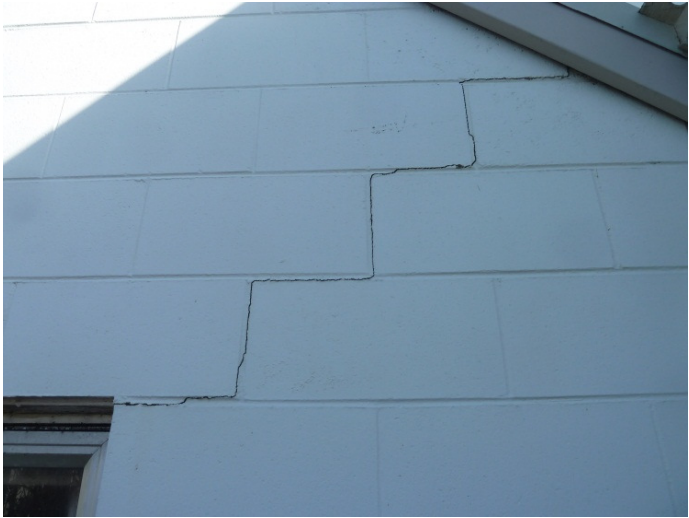
7	Typical stepped cracking along block veneer mortar joint. Located around wall opening

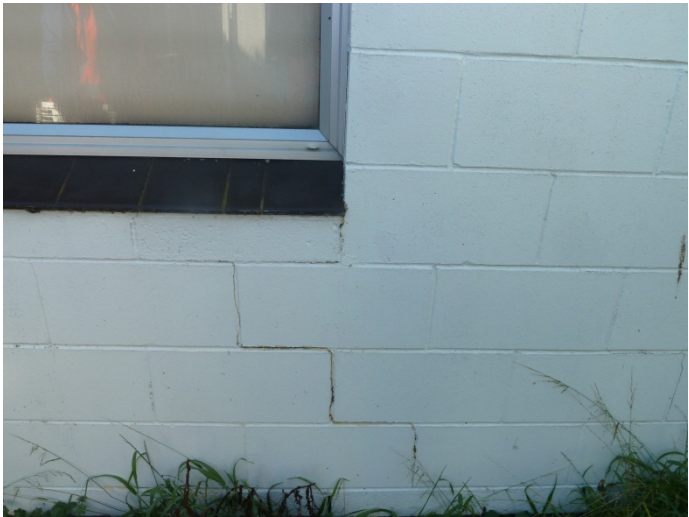
8	Typical stepped cracking to blockwork veneer

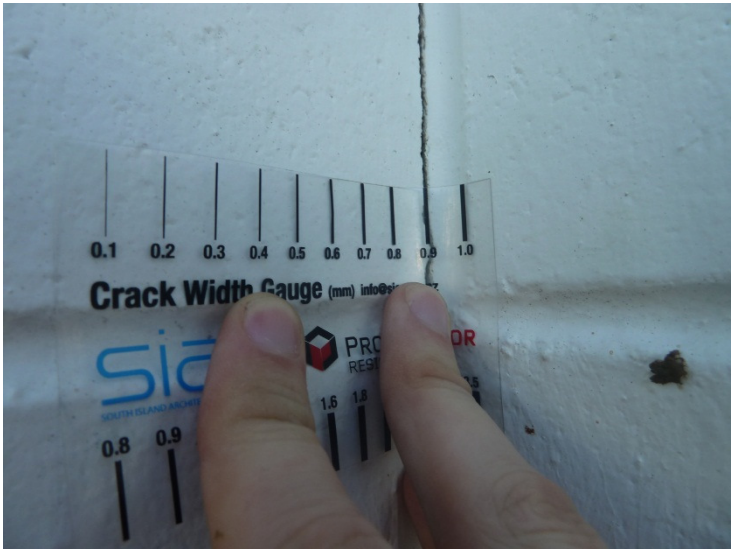
9	Cracking along blockwork veneer mortar joint

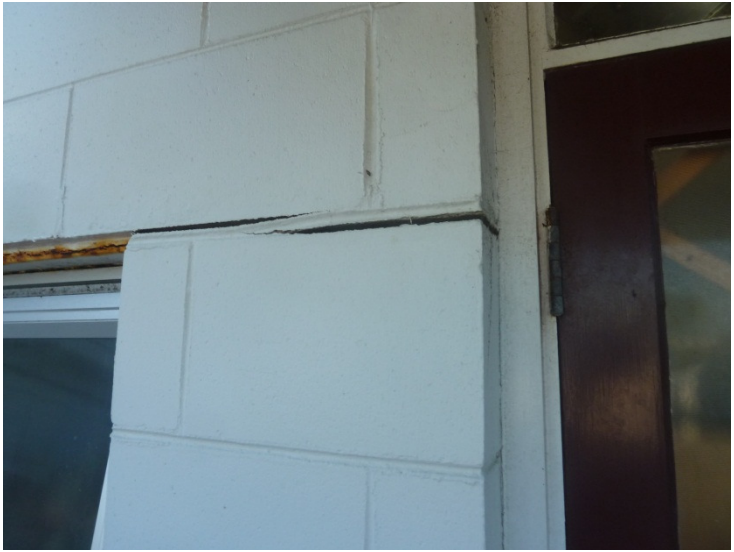
10	Cracking of horizontal mortar joint

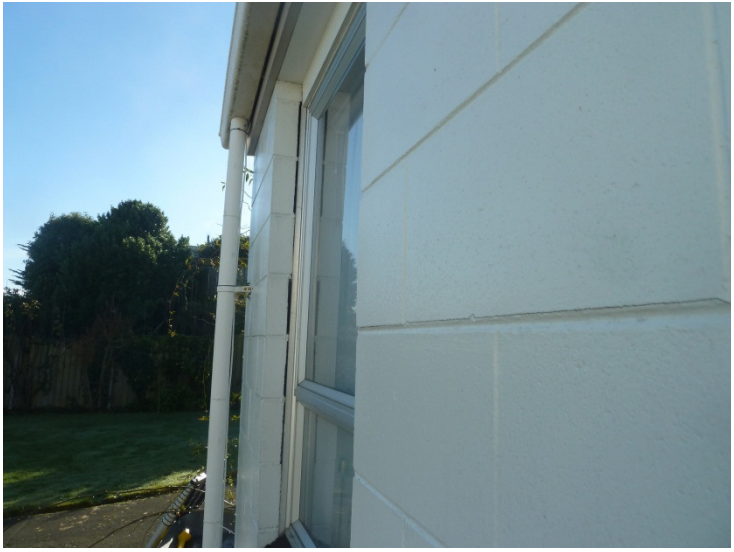
11	Separation occurs between the blockwork veneer and window opening

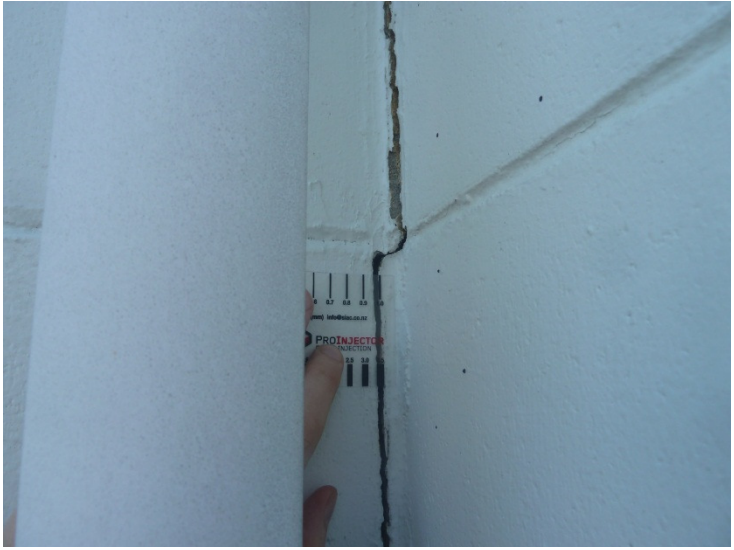
12	Typical cracking observed along vertical mortar junction where units connect to one another

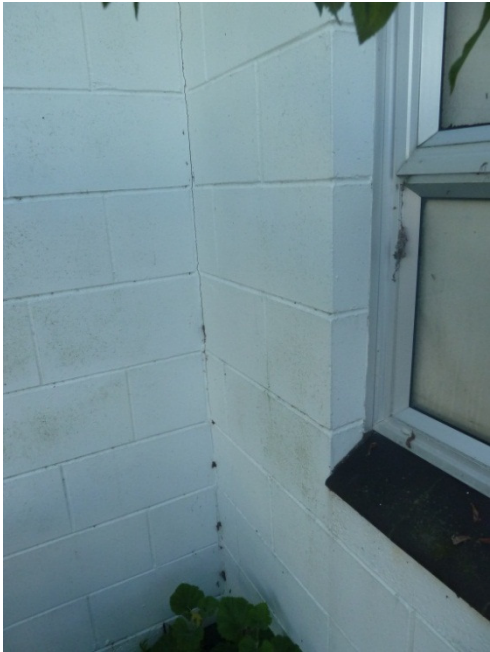
13	Typical cracking observed along vertical mortar junction where units connect to one another

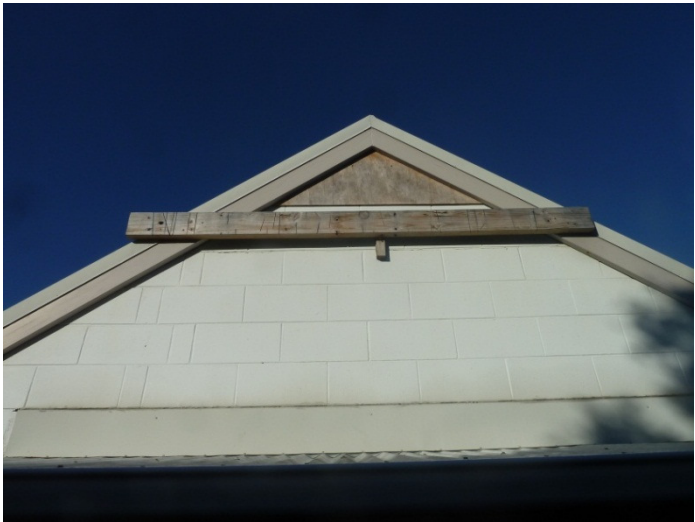
Overall, all residential units appear to have suffered no significant structural damage. It is noted that a majority of the units suffered varying levels of stepped cracking to their exterior blockwork veneer. The veneer blocks at the apex of some end elevations have become dislodged especially in the block containing units 11-15 and 20-23.

14	Dislodged apex blockwork veneer. Units 11-12 and 13-14

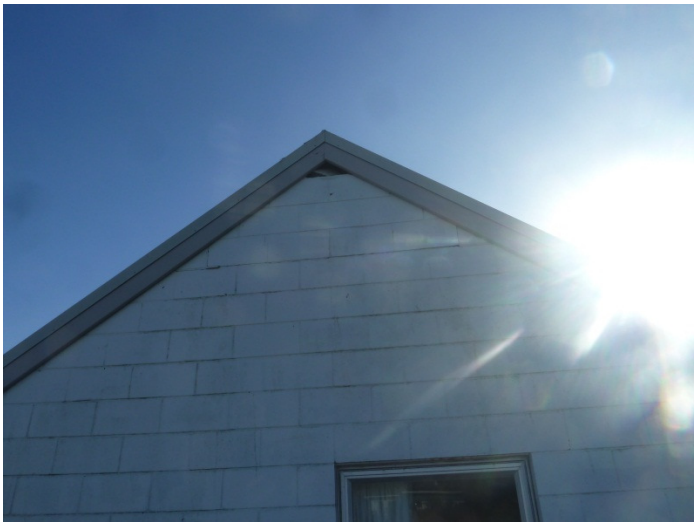
15	Typical dislodged blockwork units 20-23

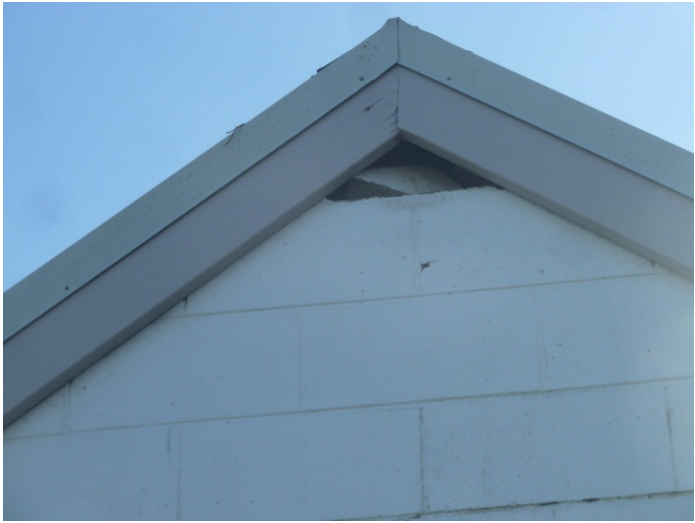
16	Typical dislodged blockwork units 20-23

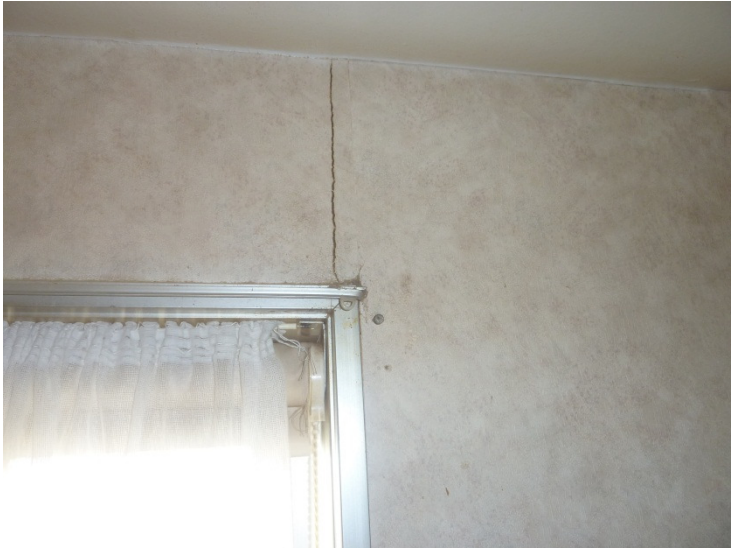
Some cracking of GIB ceiling diaphragms and wall linings was observed in many of the units (photos 17 and 18). This was consistent throughout all the units visited.

18	Typical wall lining cracking located around window opening
