**Britomart Reserve Toilets  
PRK 3649 BLDG 001 EQ2**

**Detailed Engineering Evaluation**

**Quantitative Assessment Report**

**82 Beach Road, Akaroa**

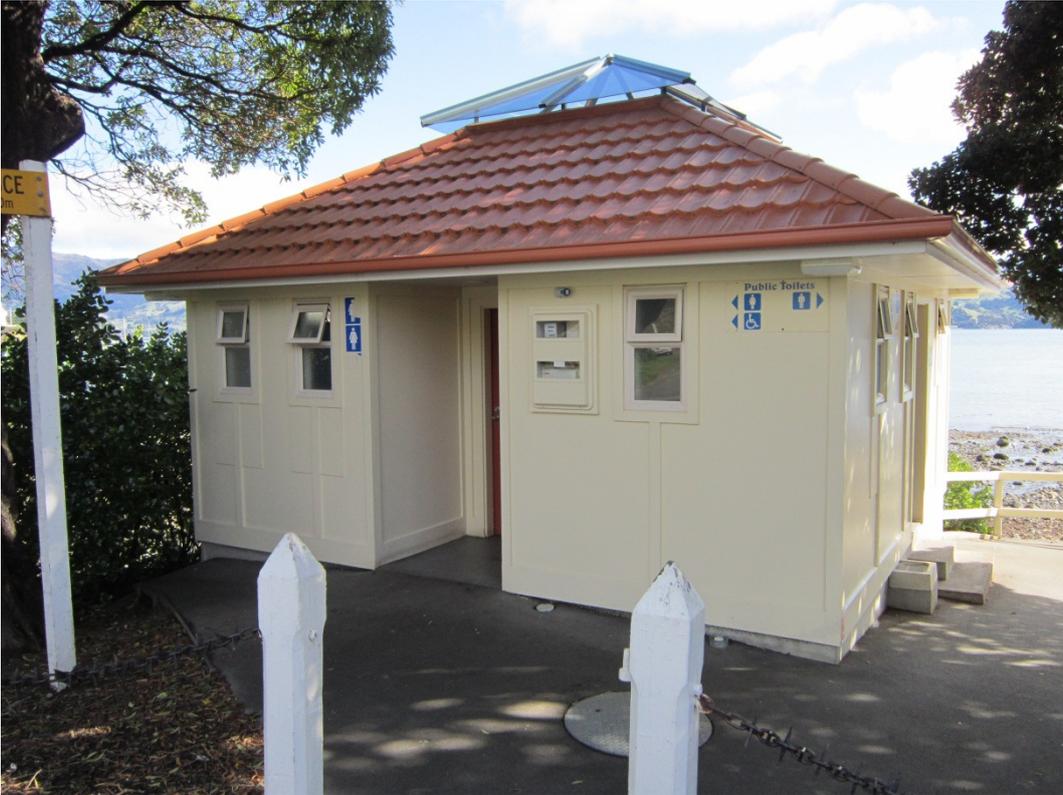
**Photo 1: Building frontage and side wall**

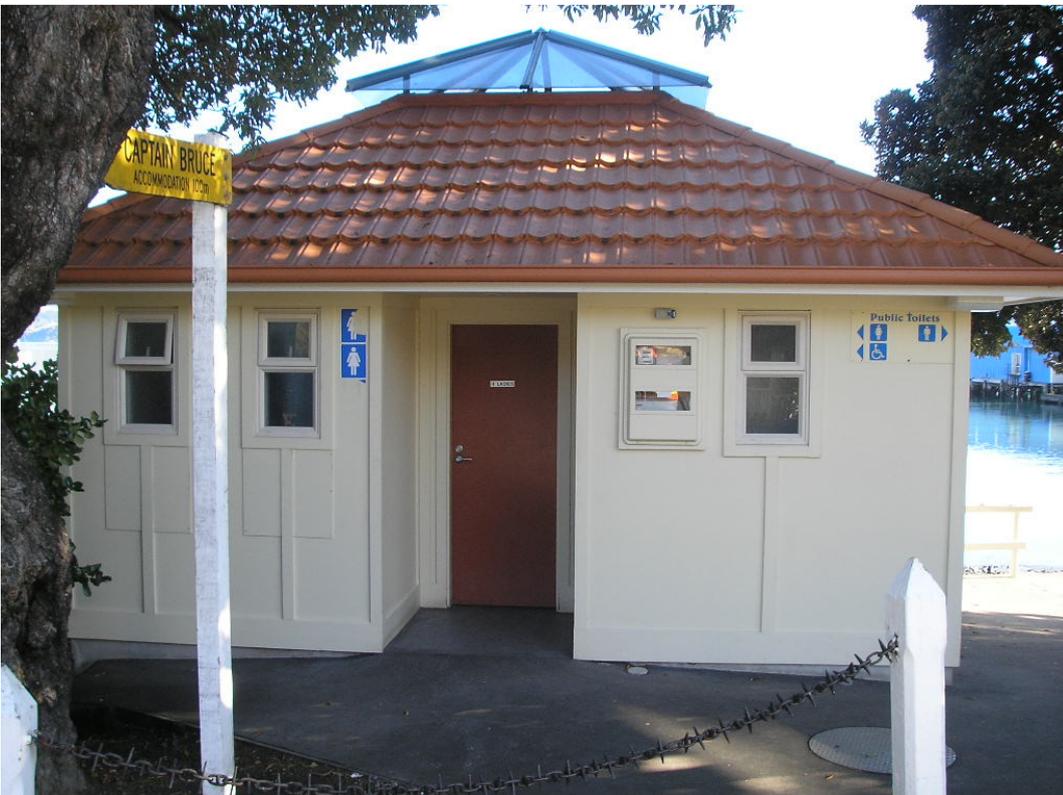
**Photo 2: Building frontage**

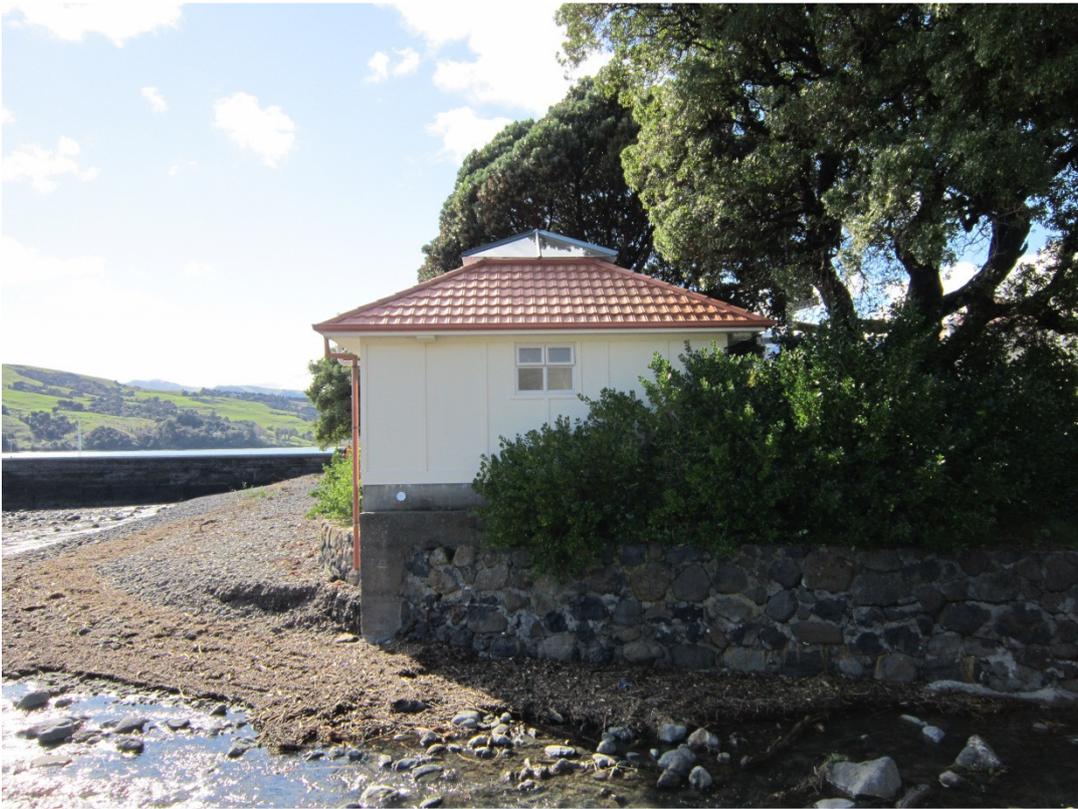
**Photo 3: Building side wall**

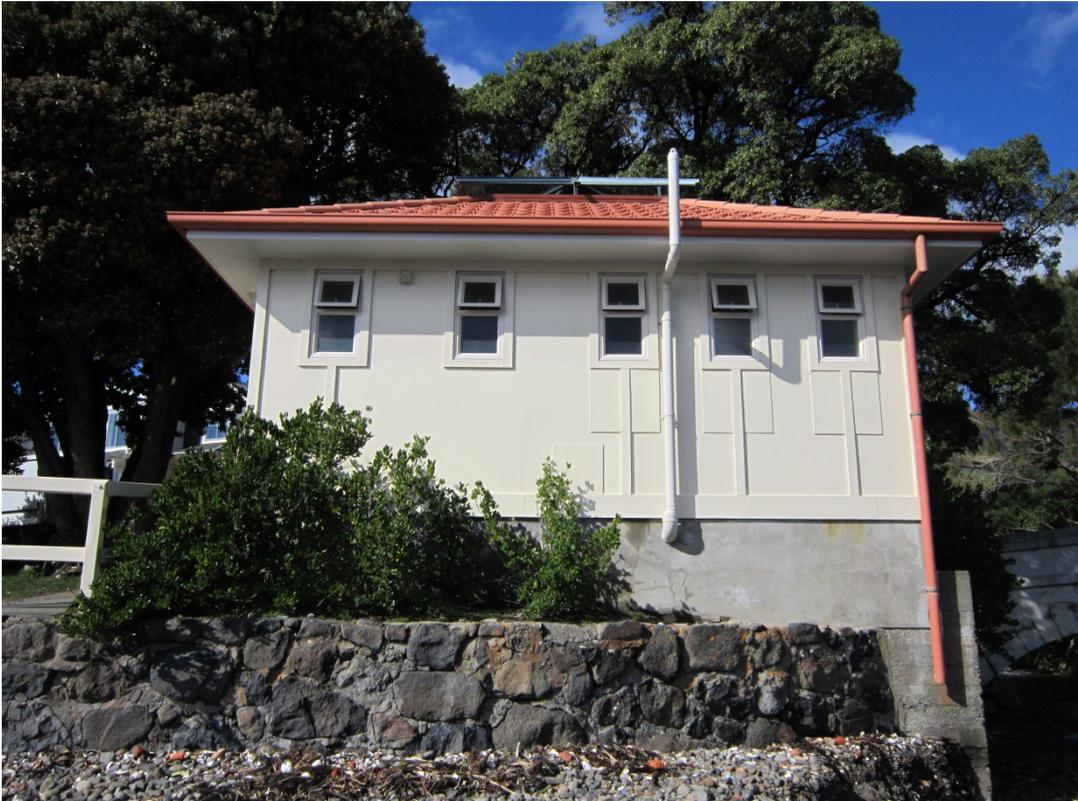
**Photo 4: Building rear**

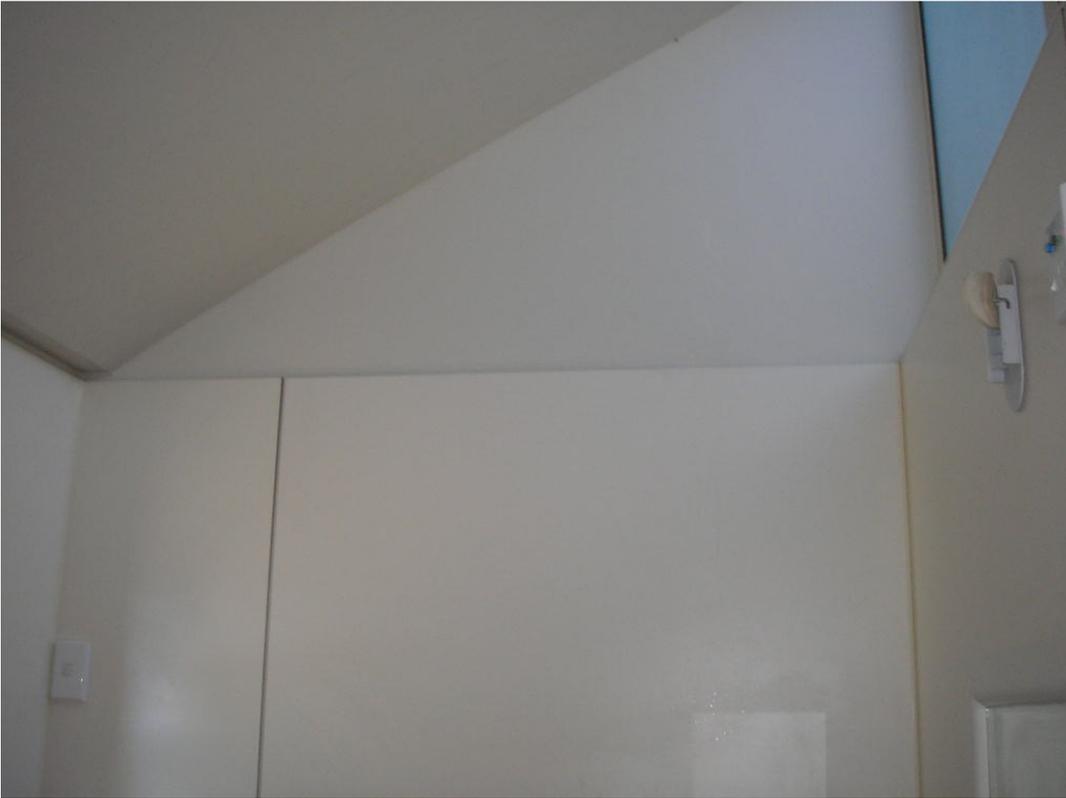
The plasterboards in the ceiling will likely provide some flexible diaphragm action to distribute the roof seismic loading to adjacent walls. However, it is unlikely to be a critical element as the bracings walls are spaced closely together.

**Photo 5: Typical ceiling detail**

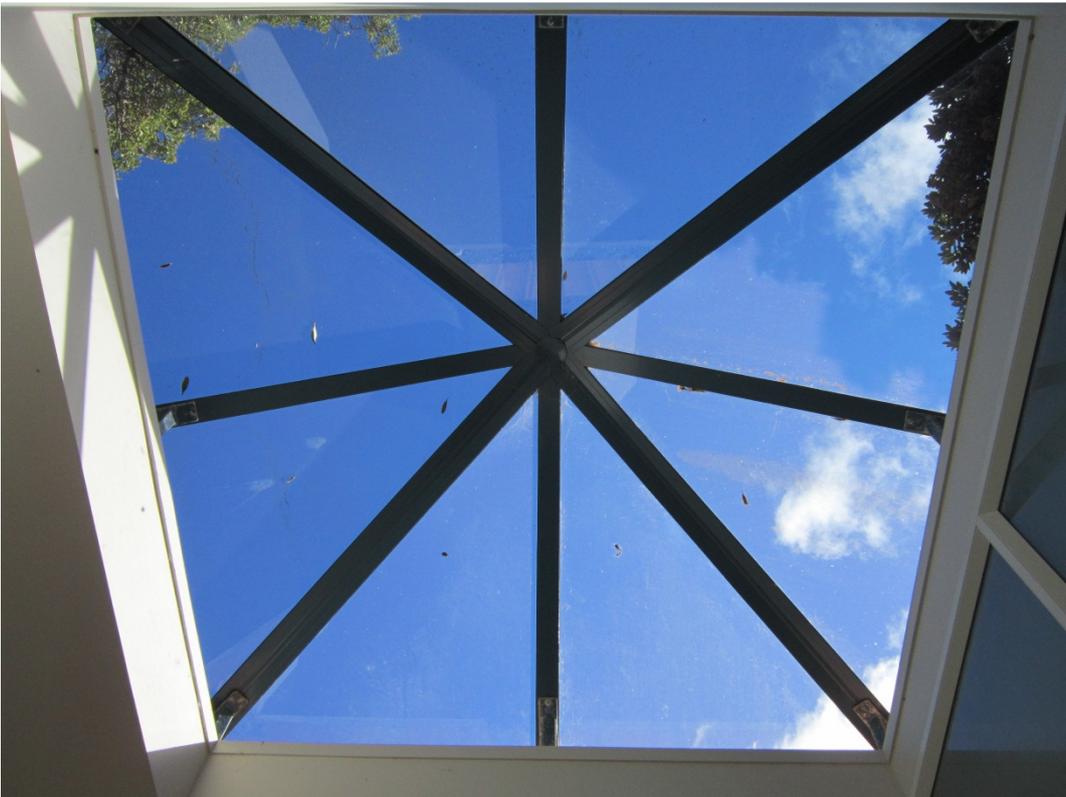
While not structurally significant, it is worth noting that the material and supporting detail of the skylight should be further investigated. This is a potential hazard in a future seismic event.

**Photo 6: Skylight detail**
