Brooklands Domain Toilets
Qualitative Engineering Evaluation

Reference: 229612
Prepared for:
Christchurch City Council

Functional Location ID: PRK 0140 BLDG 001 EQ2

Date: 11 January 2013

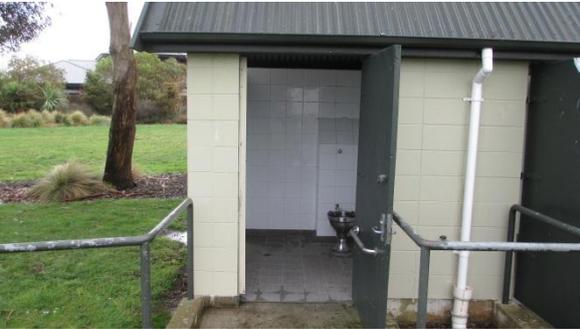
The maximum gradient in the floor was found to be 1.3%. However, the floor levels for the Brooklands Domain Toilets are considered acceptable despite not being within the recommended tolerances. This is because wet areas typically have an in-built fall for drainage and are often outside the DBH’s floor slope recommendations.

<p>Interior view of the tiled floor.</p>
