Brougham Village Standalone Garages

BU 1072-001 EQ2

Detailed Engineering Evaluation

Quantitative Report

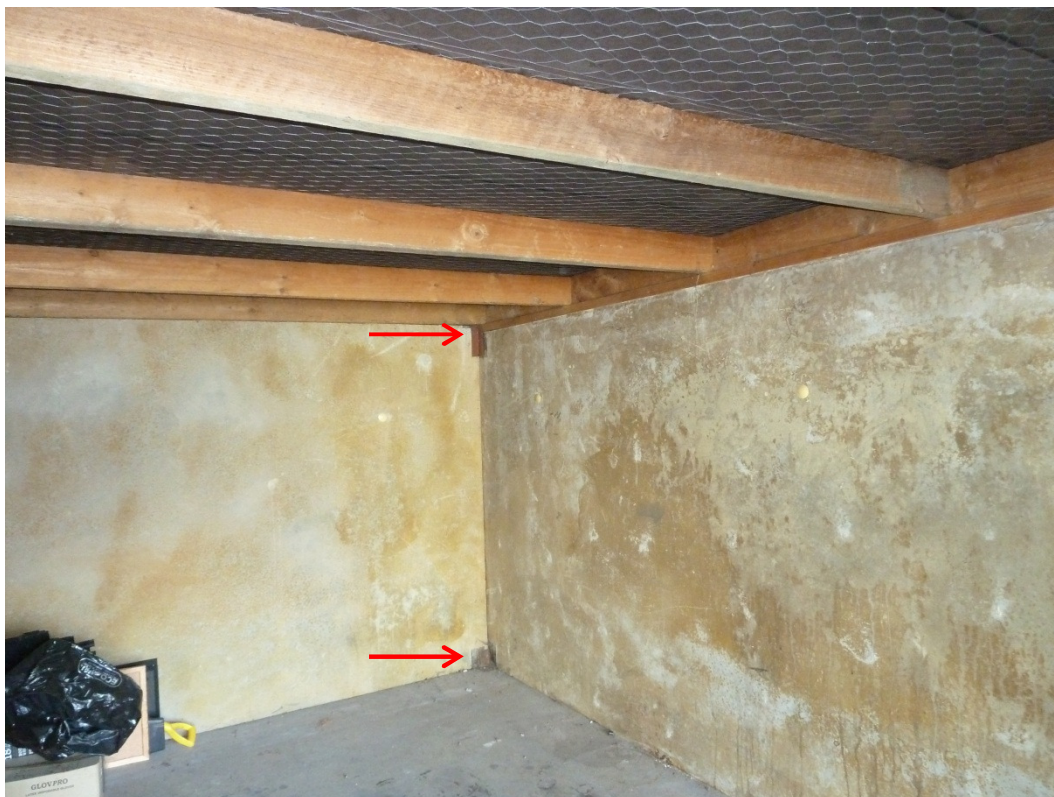
Photo 2: View of the interior of one of the garages. Welded steel plate connections have been indicated

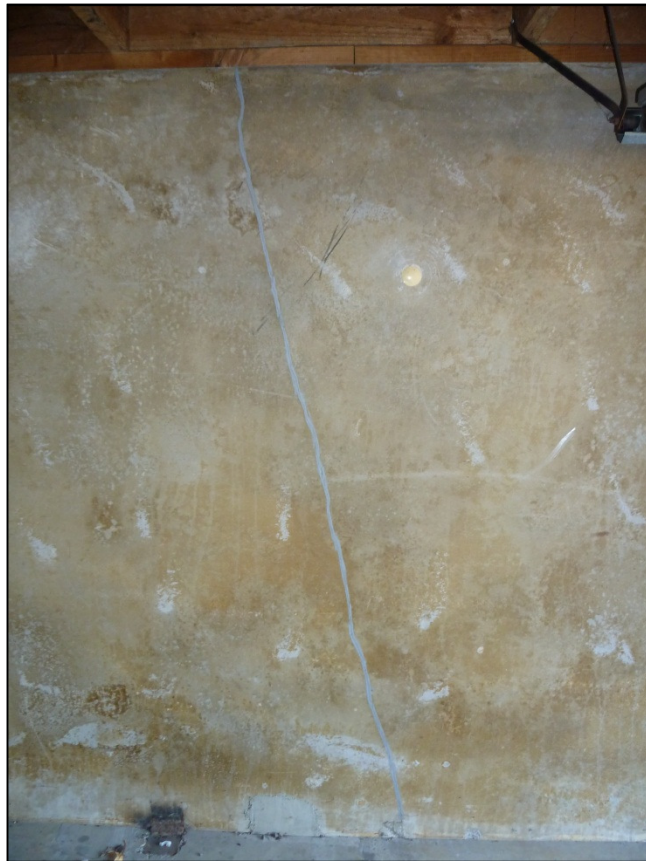
There is evidence of slab damage caused by subsidence on site; however this may be historic damage. One panel showed evidence of a crack up its full height which has been repaired in the past.

Photo 3: 1mm crack up the full height of one panel. The crack has been repaired/sealed

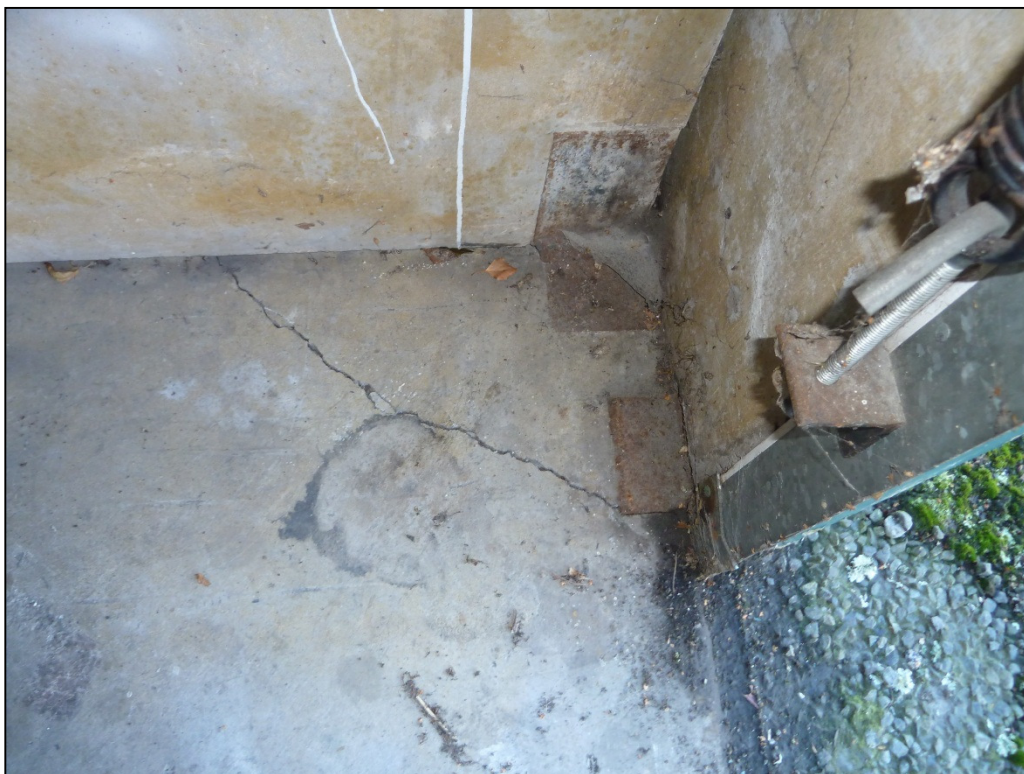
The buildings appear to have suffered little damage as a result of the recent earthquake events with the only notable damage being slab cracking in the corners due to subsidence. One panel showed evidence of a crack up its full height which has been repaired in the past.

Photo 4: Typical cracking in corners of slabs

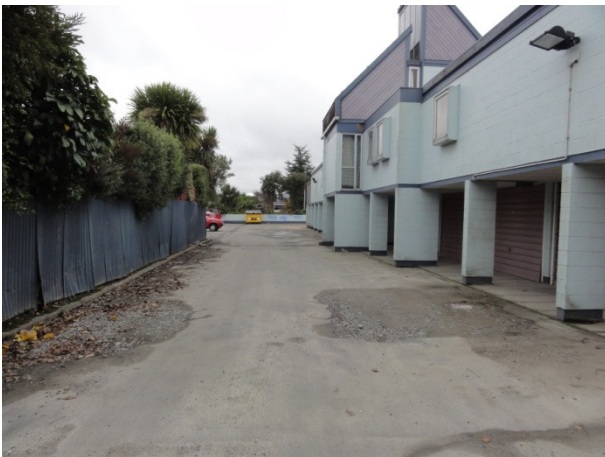
View East, damage to Asphalt

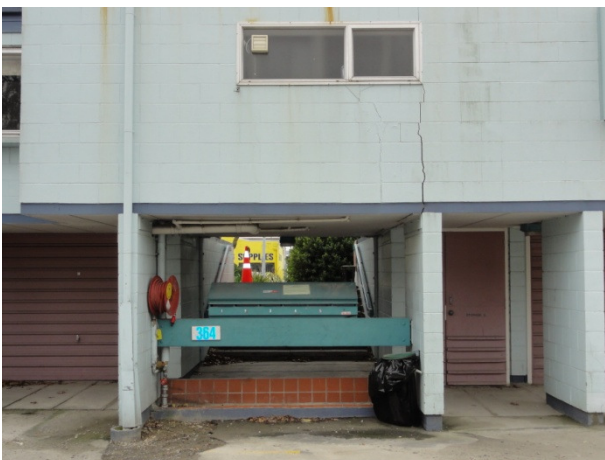
Structural Damage to 2nd and 3rd Storey at Unit 364

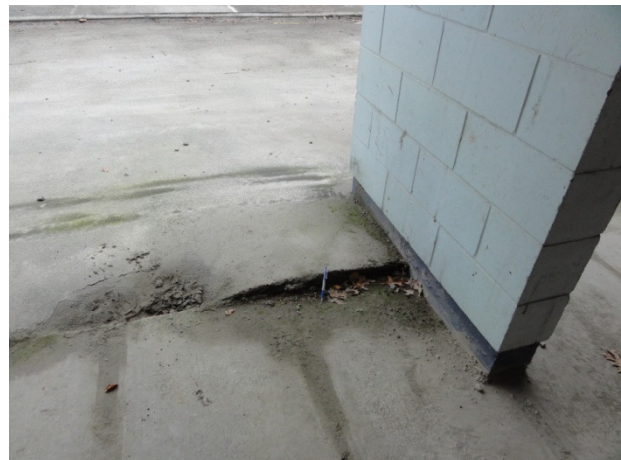
Ground Heave at footing adjacent to Unit 364

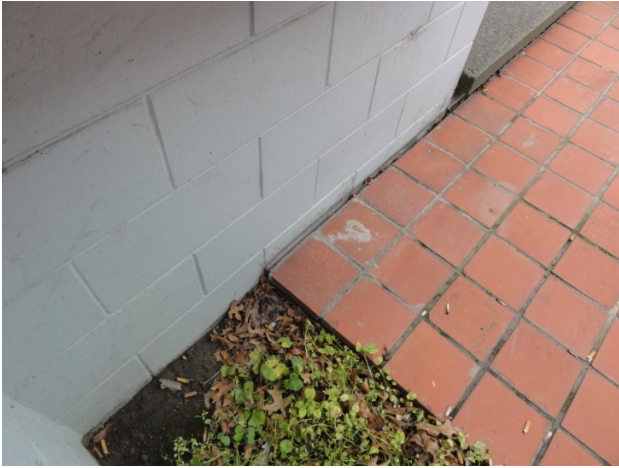
10mm crack, movement towards Brougham Street at Unit 368

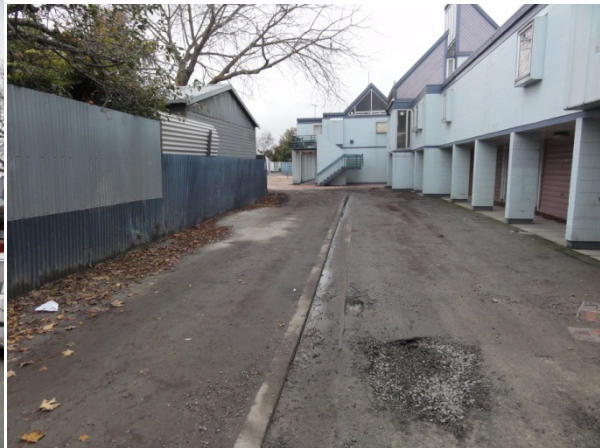
Heave and damage to driveway.

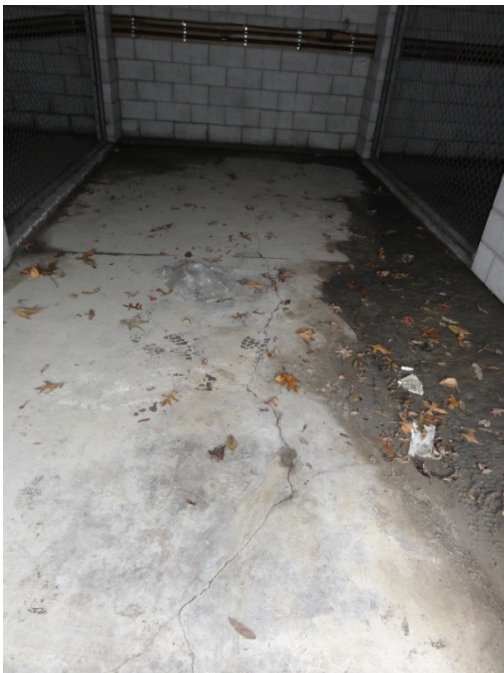
Garage 33 near Unit 388 crack in floor slab and liquefaction

1. Inspect the ground floor slabs within all the Garages for units 356 to 400, to check for subsidence and liquefaction damage.
2. Excavate and inspect foundations in key areas to confirm there has been no damage or ground disruption.
3. Undertake a Level Survey of the buildings.

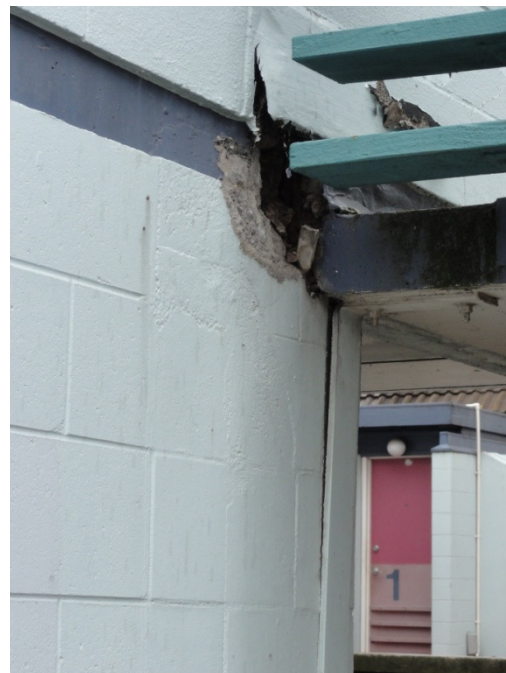
Typical Structural Damage

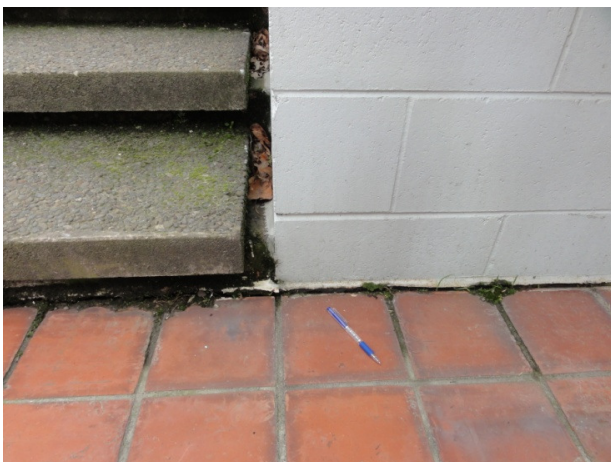
10mm settlement of patio tiles

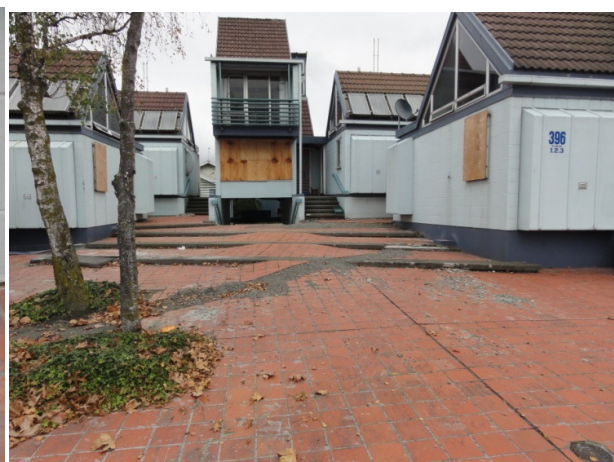
Typical damage to buried services

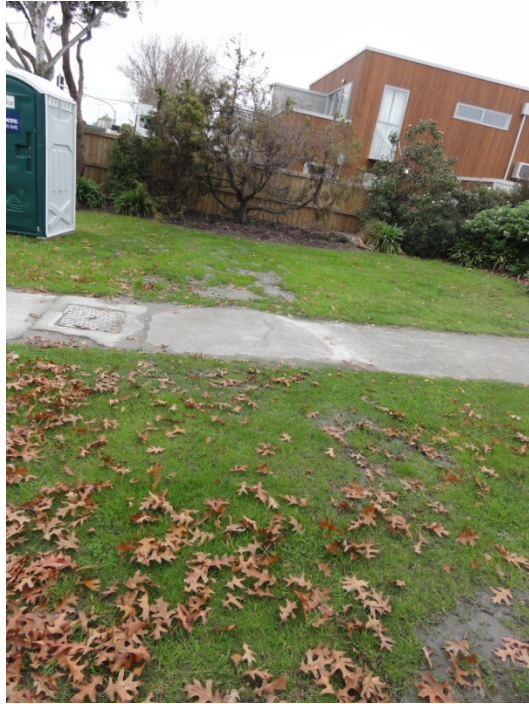
Ground Heave above service trench

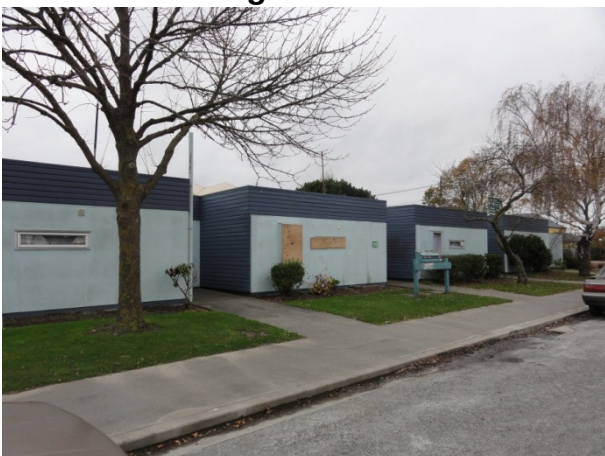
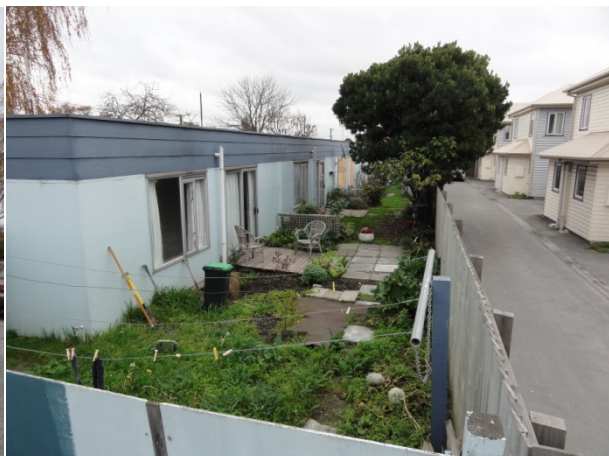
No visible damage, unit 2 yellow stickered due to severe liquefaction

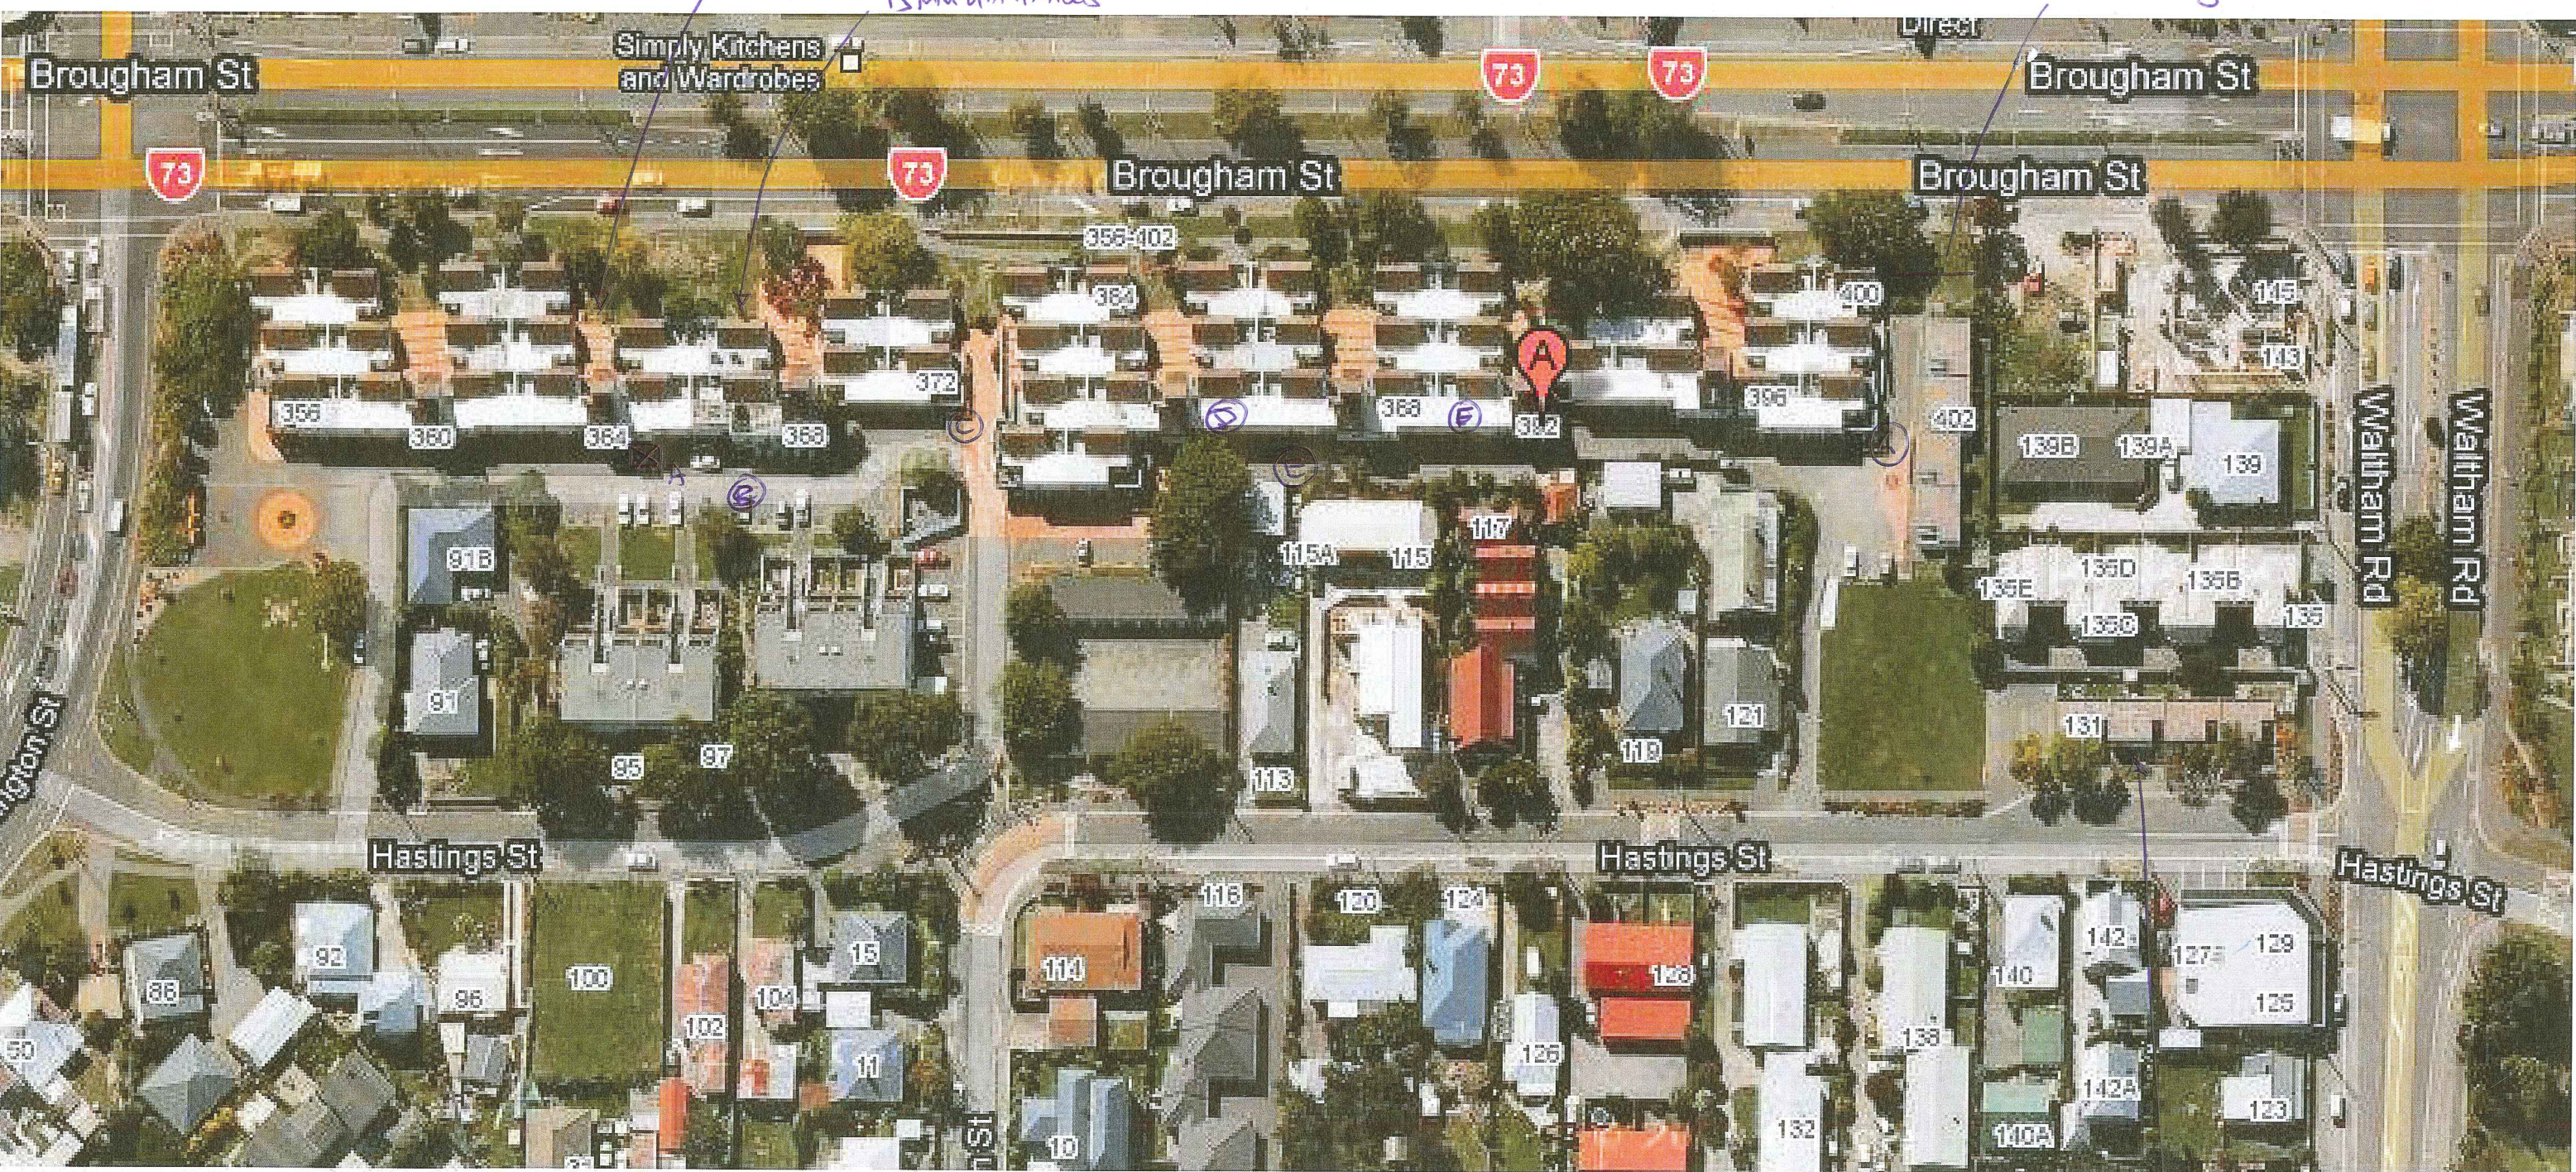
Record of Damage

20mm gap in tiles
15mm gap in tiles

100mm of ground heave.

- (A) Wood heave 80mm
- (B) Damage to carpark area
- (C) Damage to buried services
- (D) Severe cracking in 1st floor slab.
- (E) Heave in driveway 100mm
- (F) Garage 33 Cracking in ground floor slab.
- (G) Damaged services.
