Burwood Park South
Pavilion/Toilets
Qualitative Engineering Evaluation

Reference: 229604
Prepared for:
Christchurch City Council

Functional Location ID: PRK 0724 BLDG 002 EQ2

Date: 24 June 2013

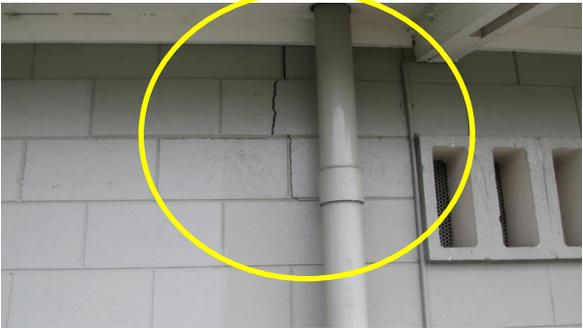
- Step cracking in the mortar joints; and
- Cracking to the face shell of the concrete masonry unit.

Damage from seismic actions will typically be concentrated on the weaker elements of a structure. This explains the damage noted above as wall openings and unfilled spans of concrete masonry walls are inherently the weakest parts of lightly reinforced concrete masonry wall buildings.

<p>Seismic damage – exterior view of cracking in the concrete masonry unit.</p>

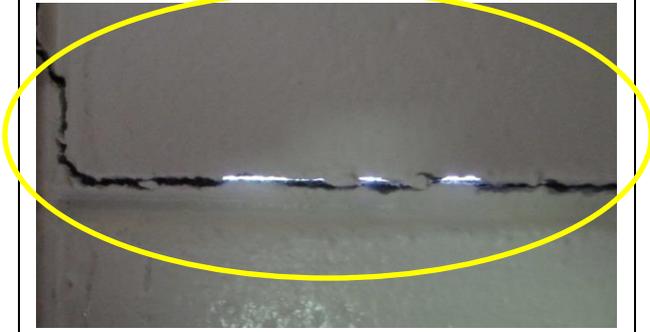
<p>Seismic damage – interior close up on the same crack indicating</p>

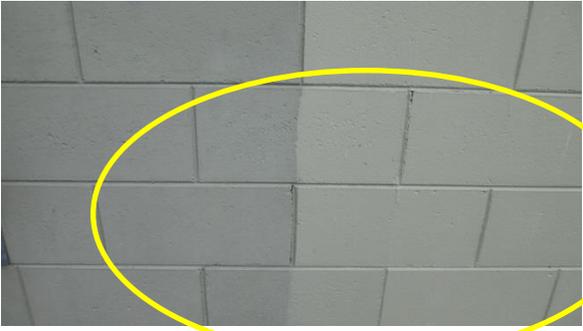
<p>Seismic damage – exterior view of step cracking in the concrete masonry unit.</p>

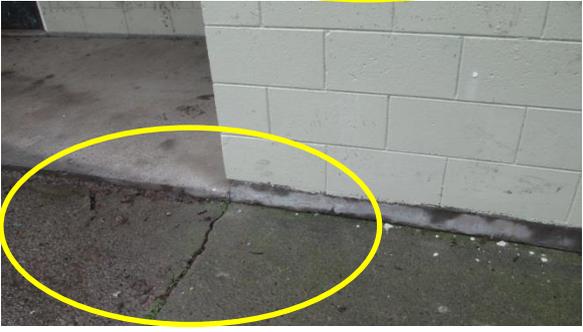
There have also been noted instances of cracking to the apron of the building, which we consider to be non-seismic related.

<p>Age-related damage – cracking in the concrete apron.</p>

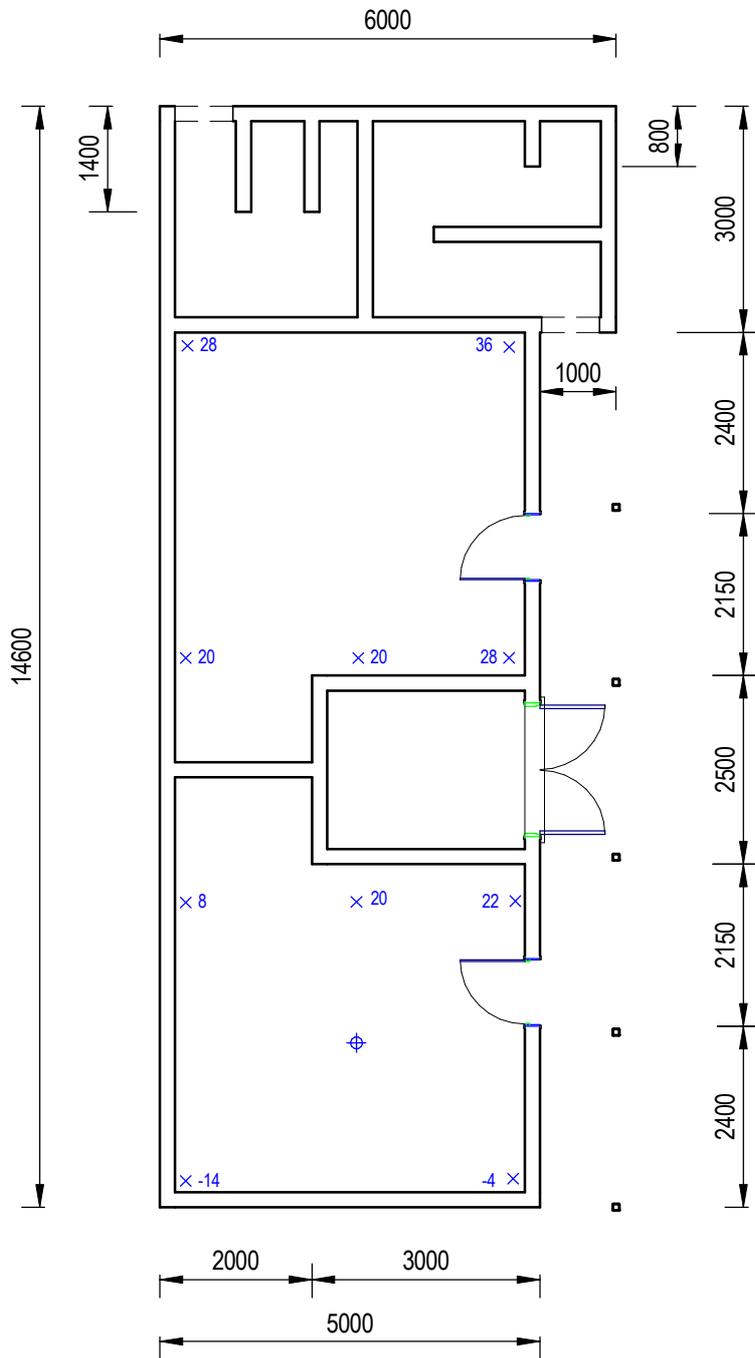
PRELIMINARY NOT FOR CONSTRUCTION	
PROJECT No. 229604	
SCALE 1:100	SIZE A4
DRAWING No. S-01-01	REV

The maximum floor slope for the Burwood Park South Pavilion/Toilets noted was 0.5% or 1:200 which were within the aforementioned thresholds and are considered “acceptable”.
