**Burwood / Pegasus Community  
Boardroom  
BU 2637-001 EQ2**  
Detailed Engineering Evaluation  
Quantitative Report  
Version FINAL

5 Union St (133 Brighton Mall)  
New Brighton

Christchurch City Council

**Date**  
30 October 2012

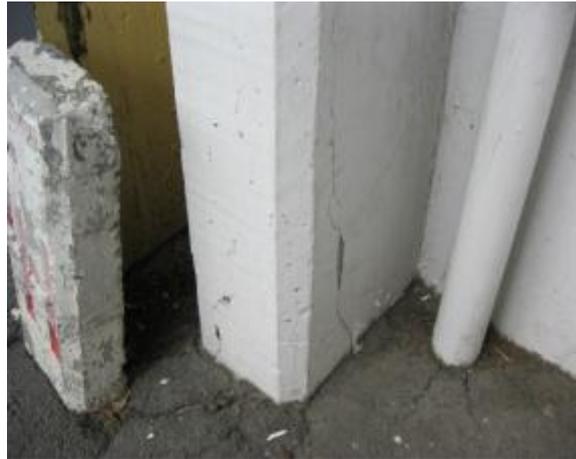
Moderate Crack damage to concrete column

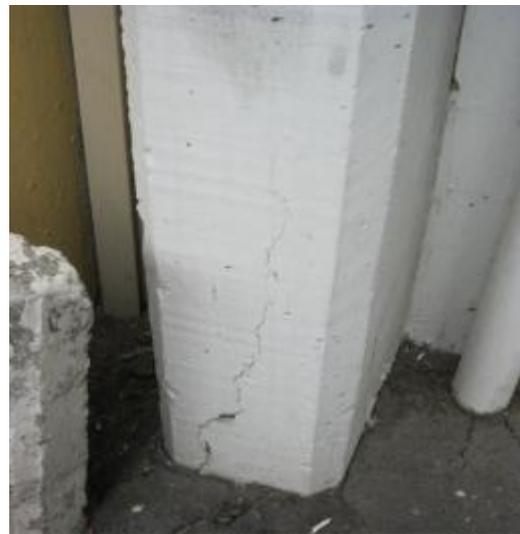
For lateral loading across (west – east direction) the building, loads at roof level are transferred to the steel roof beams and into the eastern cantilever concrete columns which are connected to the concrete foundation beams. The concrete columns are primary elements providing seismic restraint to the building and these columns are the most critical structural elements for seismic actions across the building. This is evident from the quake damage cracking found near the base of these columns.

Moderate Crack Damage to concrete column

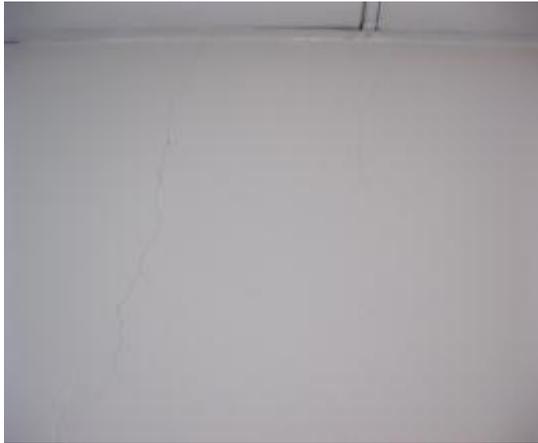
Crack to Concrete wall panel

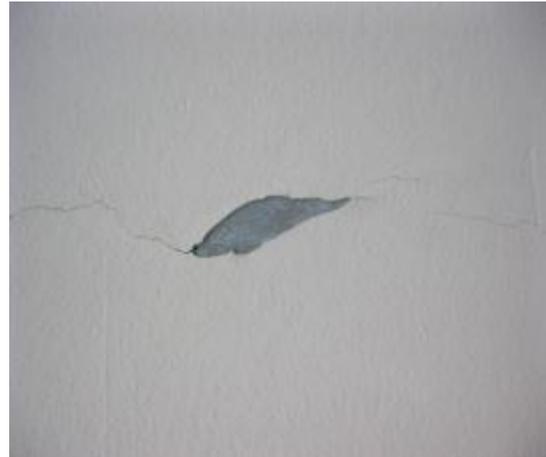
Concrete wall crack

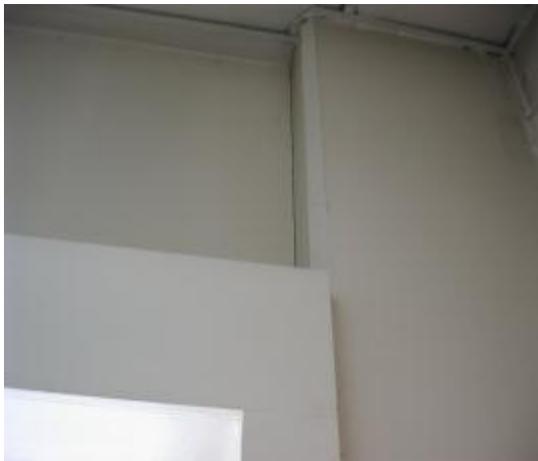
Gap between column and wall

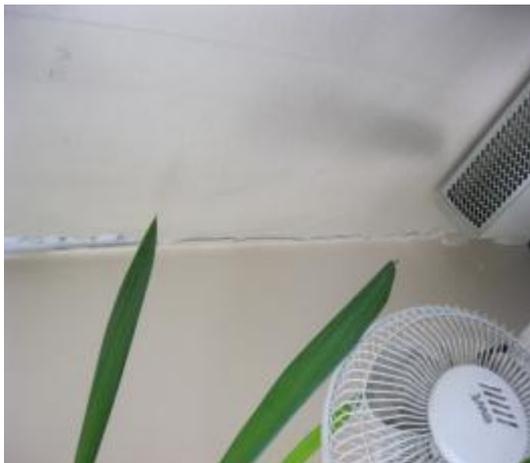
Plaster lining crack at wall - ceiling

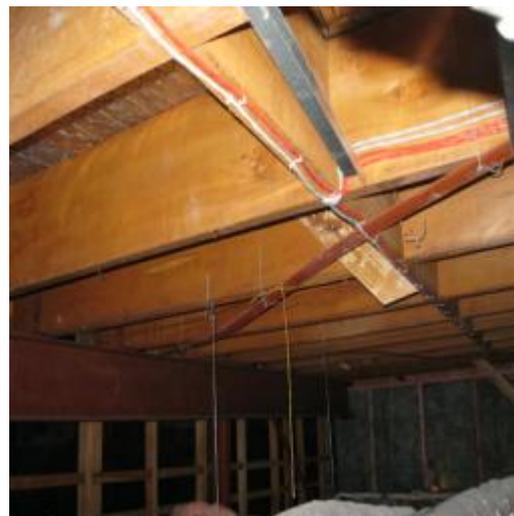
There is evidence of some yielding of the roof braces but no sign of any failure of the steel members or their connections. From the crack damaged columns, broken windows and sagging roof bracing, this indicates that there is possibly insufficient bracing along the western side of the building.

Sagging (stretched) roof bracing

Critical structural elements are the sagging steel roof bracing which appear to have yielded. These should be replaced with new bracing. The structural analysis of the other structural elements has identified critical items which impact on the %NBS to the building.

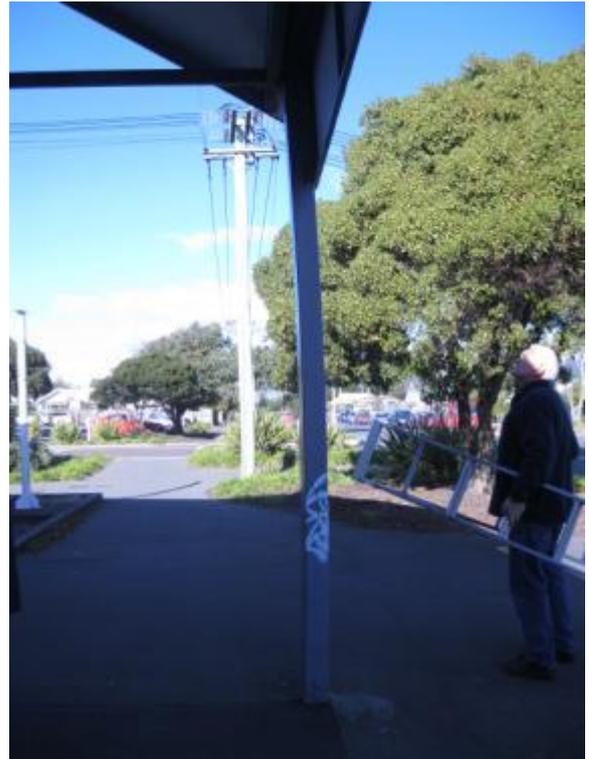
No significant ground damage was observed during the site inspections. There is no evidence of foundation settlement other than one bowed timber post supporting the canopy as a likely consequence of localised ground liquefaction.

Bowing timber post to canopy

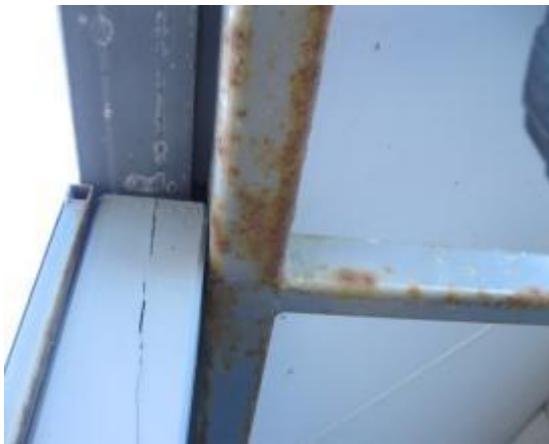
Crack in timber post of canopy
