Burwood Play Centre
Qualitative Engineering Evaluation

Reference: 227679
Prepared for:
Christchurch City Council

Functional Location ID: BU 0719 001 EQ2

Date: 23 January 2013

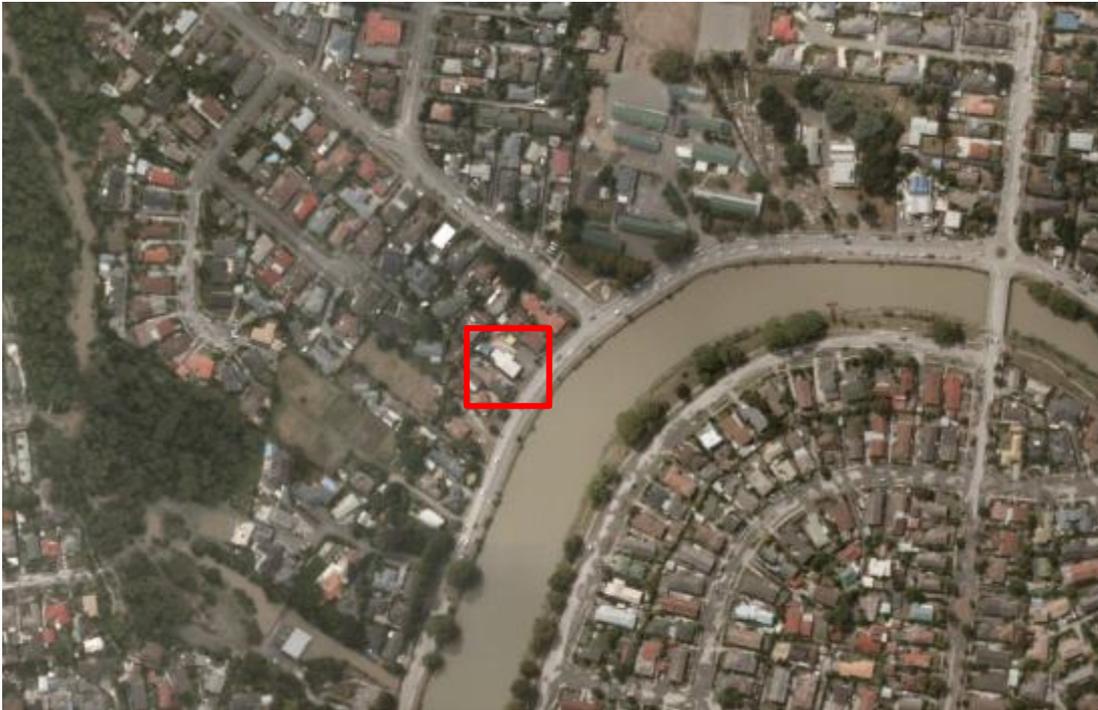
Aerial photo: Liquefaction is visible in the surrounding area.

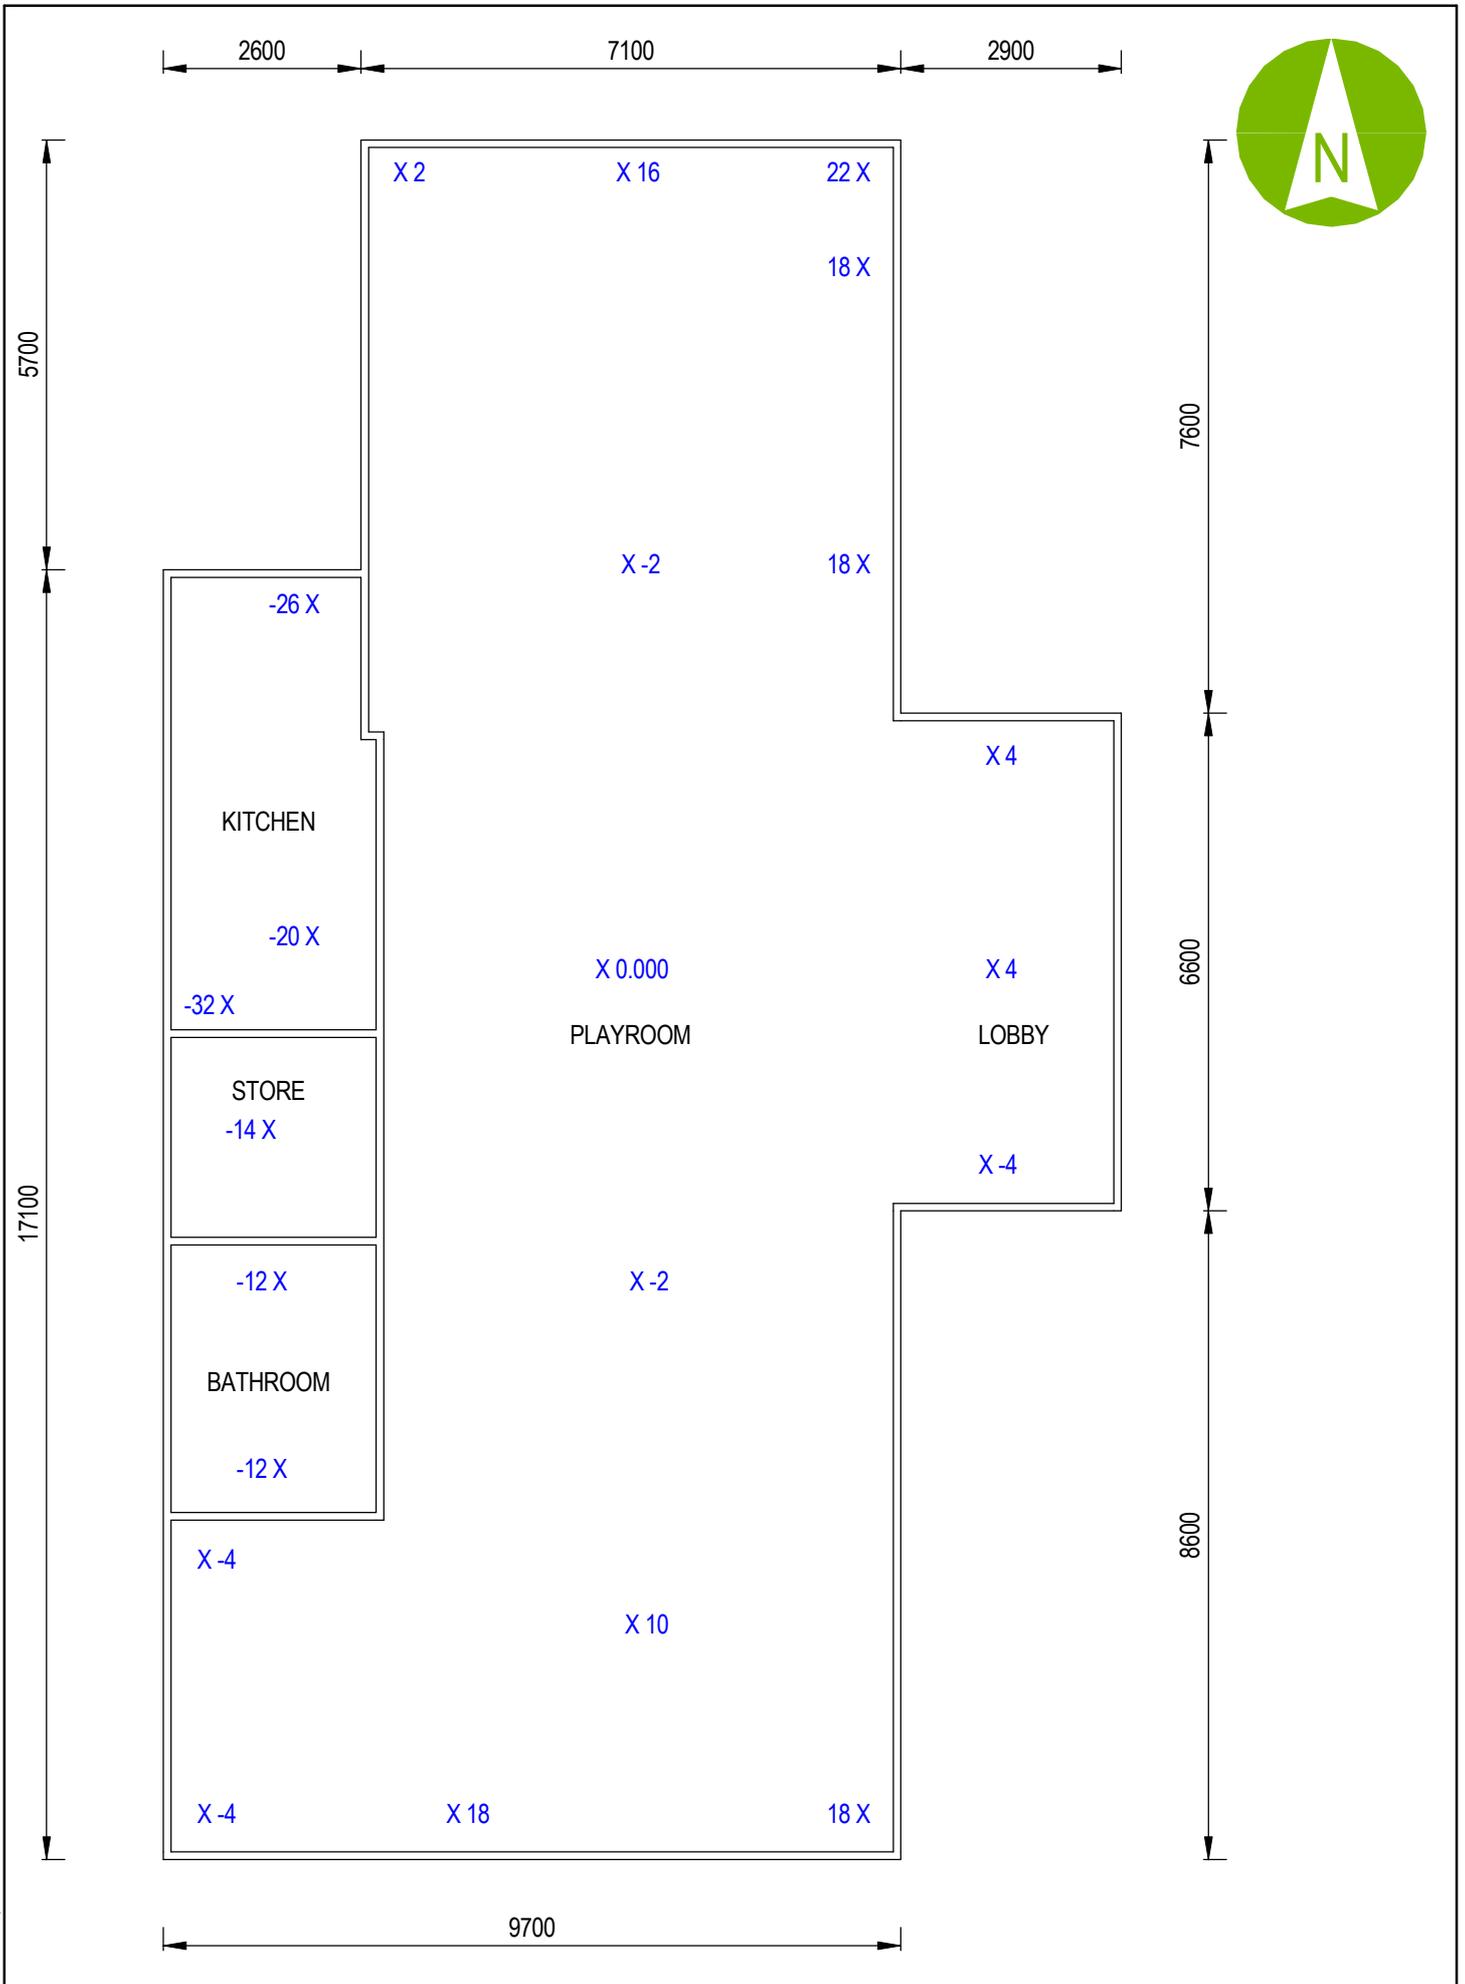
PROJECT	TITLE
BURWOOD PLAYCENTRE	LEVEL SURVEY

The land below the Burwood Play Centre is zoned TC3 and as such has been identified as prone to significant liquefaction and settlement. Additionally there is evidence of settlement and liquefaction in the surrounding land. A level survey was carried out within the Burwood Play Centre to determine the extent of any differential settlement and the settlement was found to be acceptable.
