Camp Bay Foreshore Toilets

PRK 3706 BLDG 001 EQ2

**Detailed Engineering Evaluation
Quantitative Assessment Report**

Date: November 2012

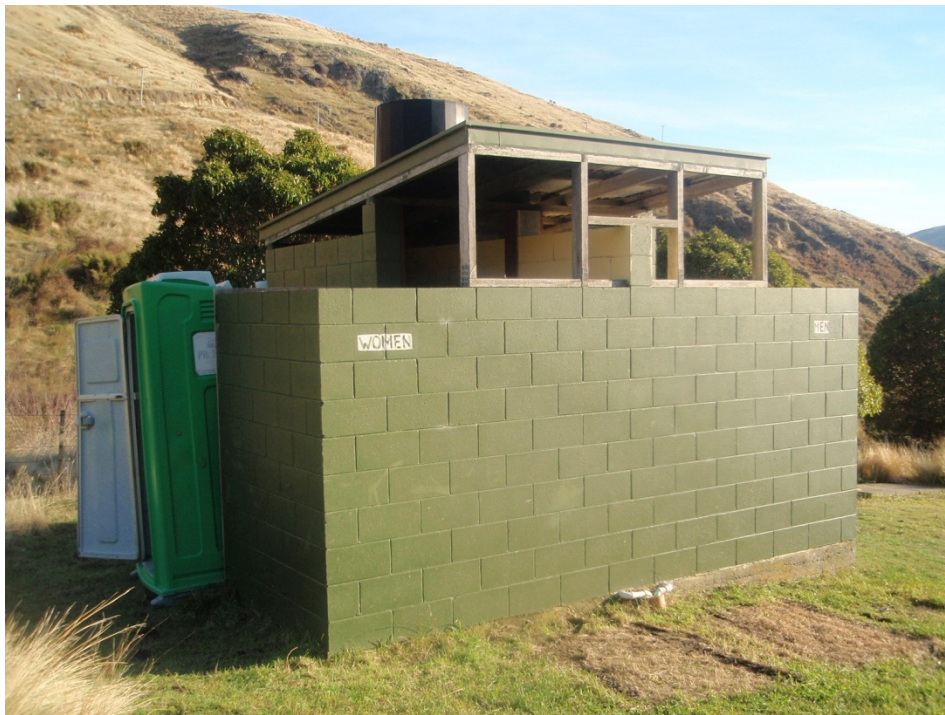
Building frontage

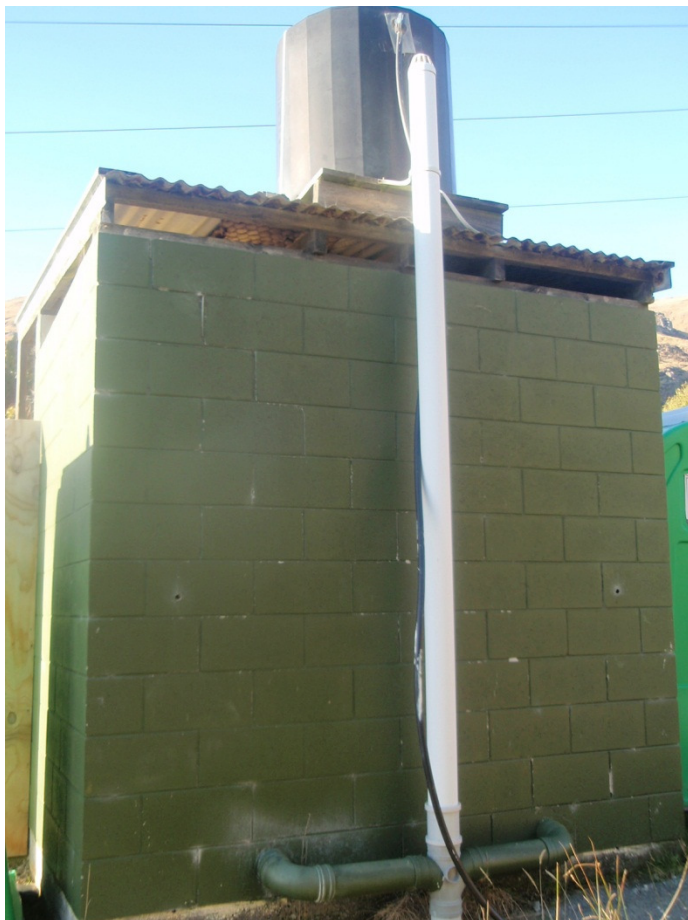
Building rear

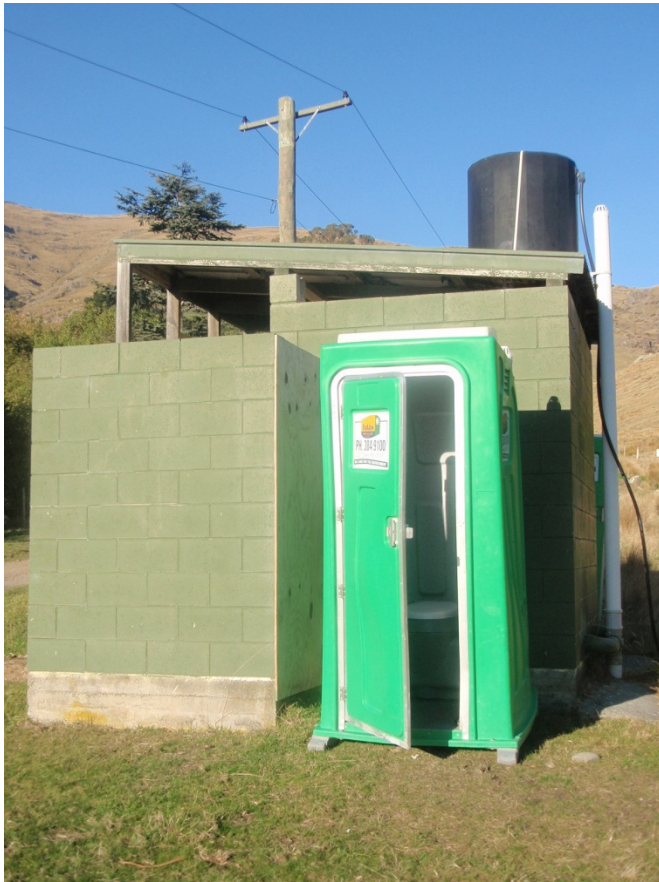
Building side

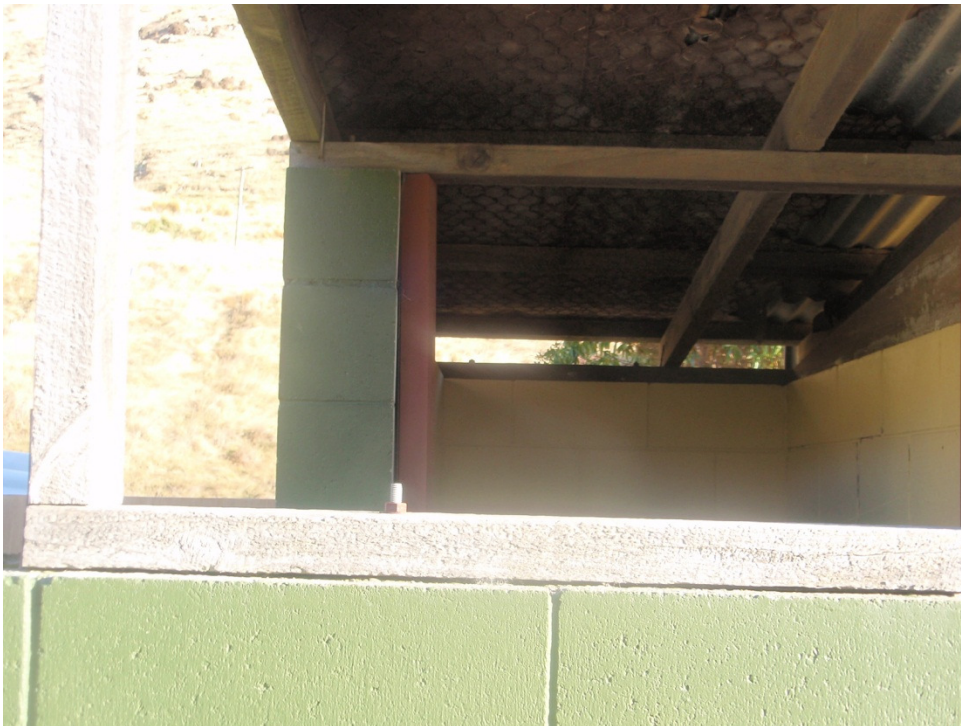
It was also noted that there was corrosion to the roof cladding and the connections between the roof framing and the masonry block walls.

Roof timber framing to masonry walls connection

- a. Strengthening works be carried out to increase the seismic capacity of the building to at least 67% NBS.
- b. Further investigations are carried out to ensure that the water tank on the roof and its fixing can withstand a code design earthquake.
- c. The cracking observed in the mortar joint in the rear exterior wall is repaired.
- d. The maintenance issue of the corroded roof cladding is considered by CCC in the future.
- e. The roof framing is checked to confirm if it is securely connected to the masonry block walls.

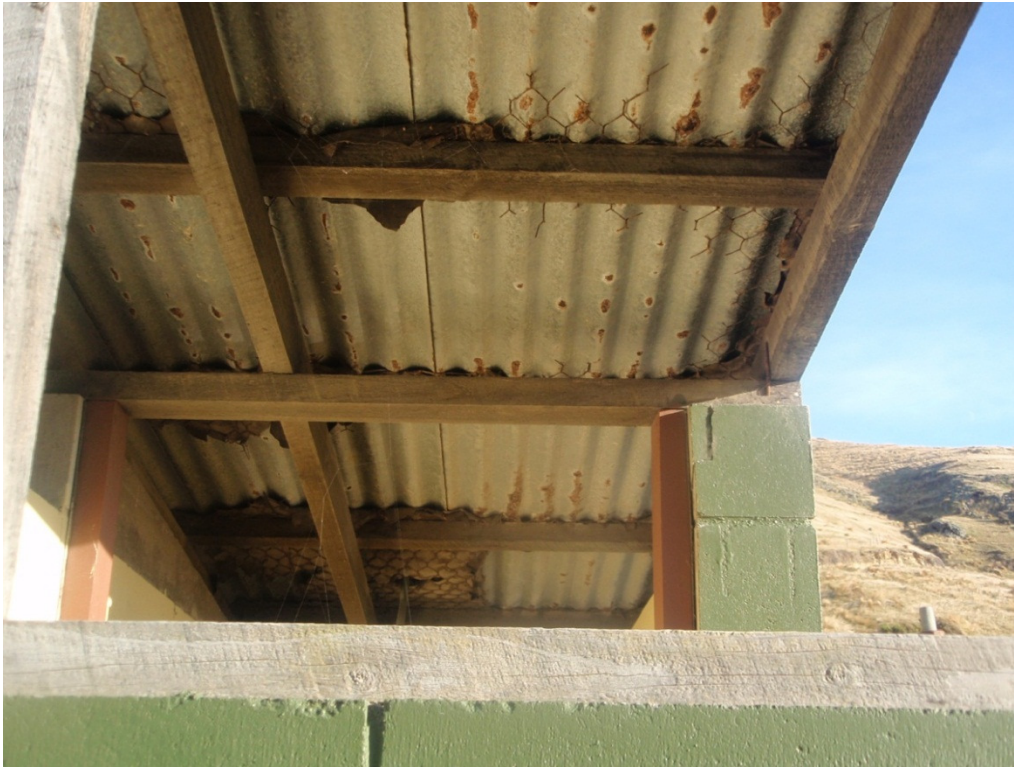
Corroded corrugated iron roofing

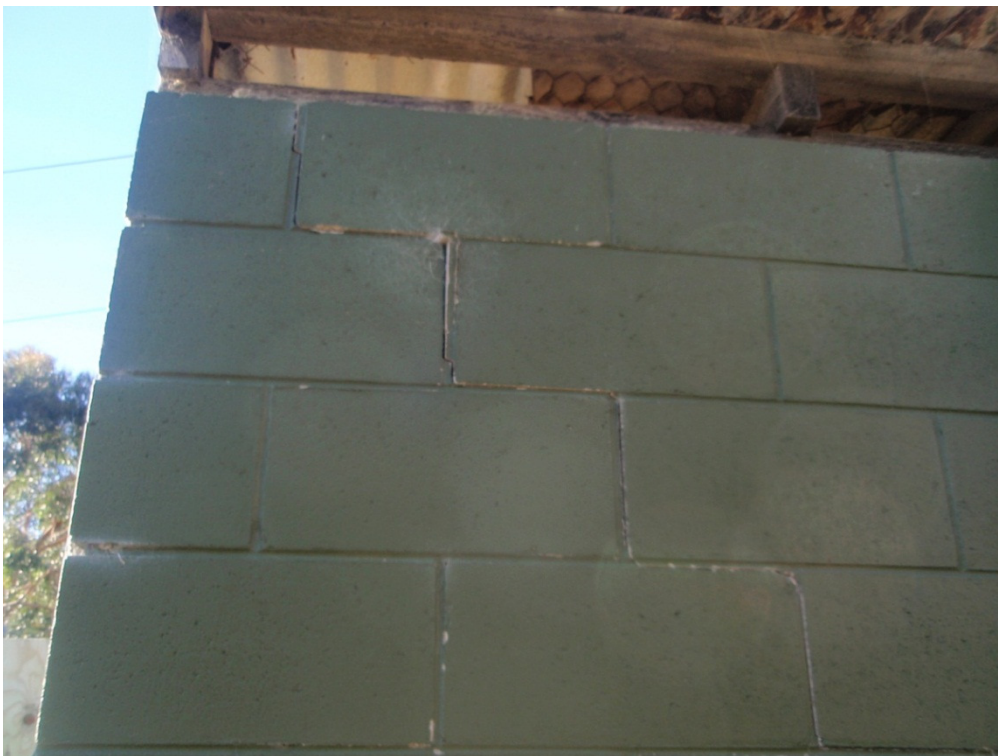
Step cracking to the mortar joint was observed on the exterior wall at the rear of the building. The step cracking does not cross the end cell and this is consistent with the observation that only the end cells are filled and reinforced. The cracking on the structure should have no effect on the gravity and lateral load resisting capacity of the structure.

Cracked exterior wall at the rear of building
