Carey Street Housing Complex PRO 1132

**Detailed Engineering Evaluation
Quantitative Assessment Report**

Quantitative Assessment Report

Date: January 2014
Reference: 6-QC325.00
Status: Final

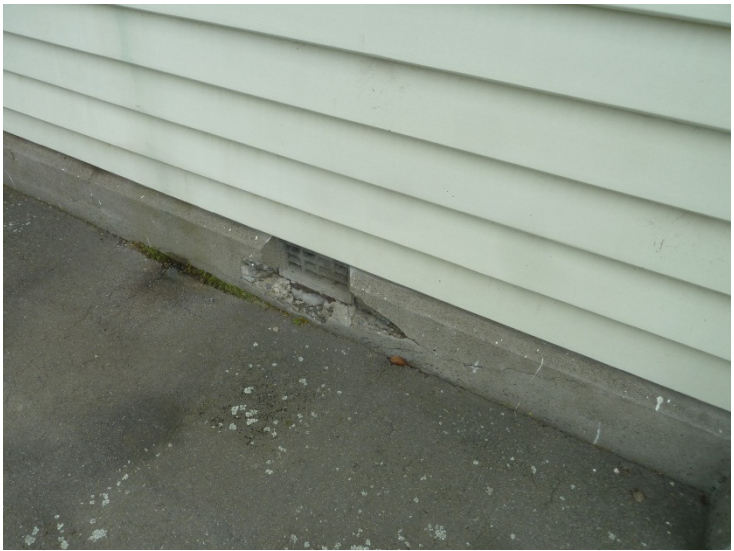
Minor hairline cracking and spalling of the render on the concrete perimeter foundation footing was observed on the building blocks (photo 8).

8.	Spalling of concrete perimeter footing

- The concrete perimeter footings repaired on blocks where cracking occurs.
- Cosmetic repairs be undertaken as required.
- All buildings be strengthened to at least 67% NBS.

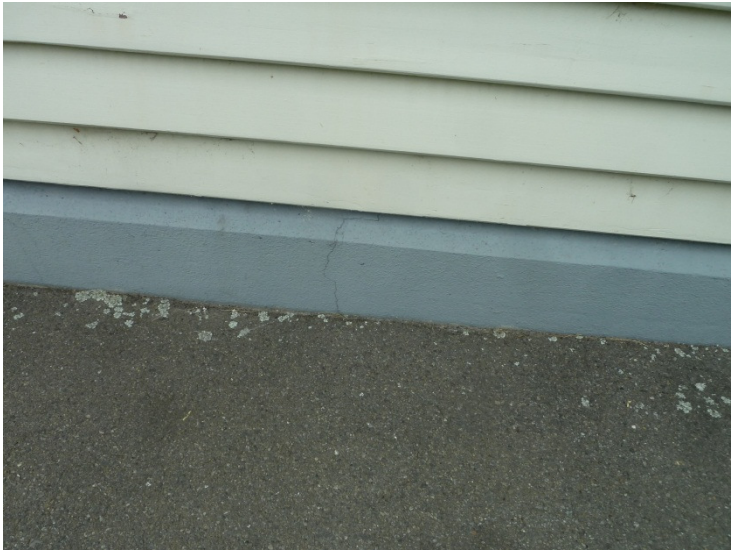
9.	Cracking in render on concrete perimeter footing

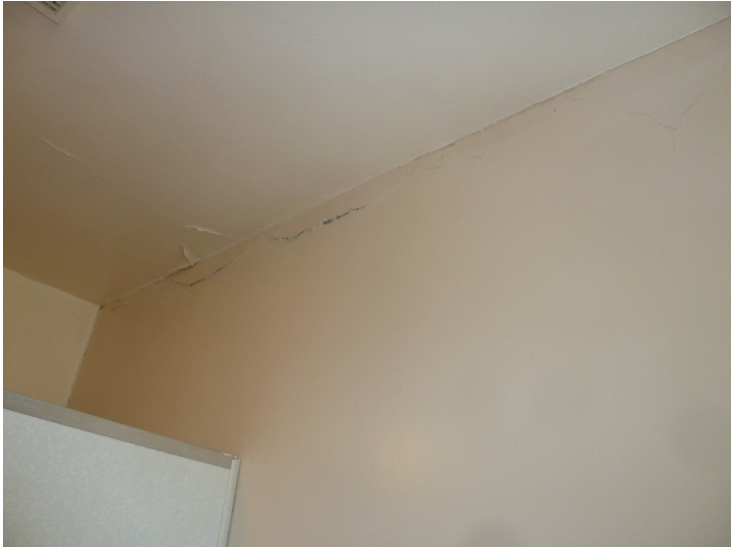
Some cracking of the lining on the double brick fire wall was noted in the bathroom of unit 4 and 18 (photos 11 and 12). This is due to separation of the fire wall from the timber framed walls.

11.	Cracking of lining on the double brick fire wall in Unit 4

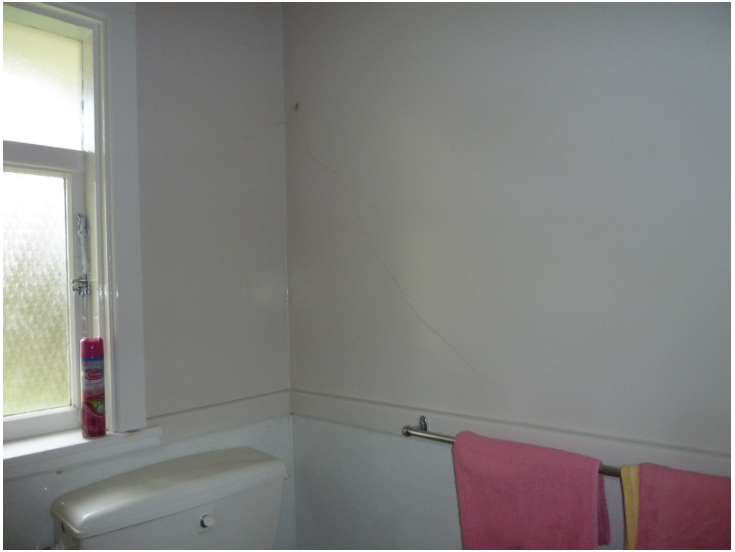
12.	Cracking of the lining on the double brick fire wall in Unit 18

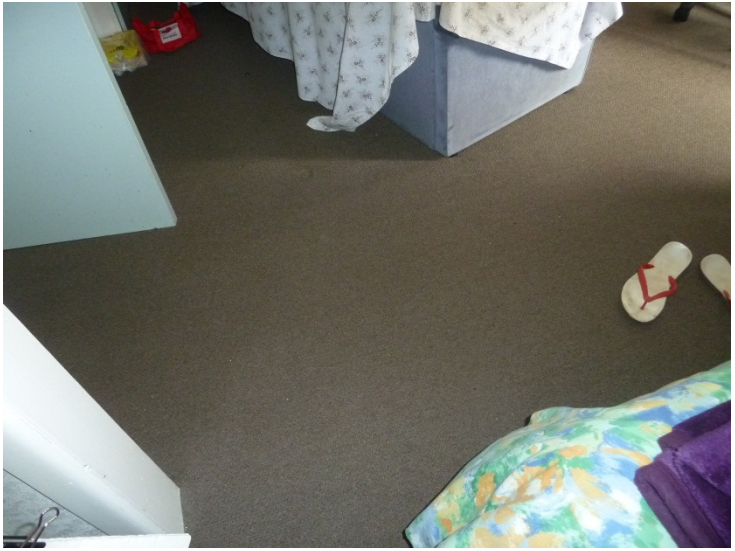
The residential units have suffered minor damage to non-structural elements. Structural damage to the residential units was minor. The piles in Unit 45 have sustained some damage causing a noticeable drop in the living room floor.

The results of the level survey indicate the possibility of ground settlement due to the earthquakes. This is particularly evident in Units 2, 5, 6 and 8 where floor slopes were measured to be beyond the 5mm/m limitation set out in the MBIE guidelines. Unit 5 has suffered the most damage where a pile appears to have sunk in the living area.

13.	Unit 5: Damage to floor piles causing a 'slump' lounge room floor

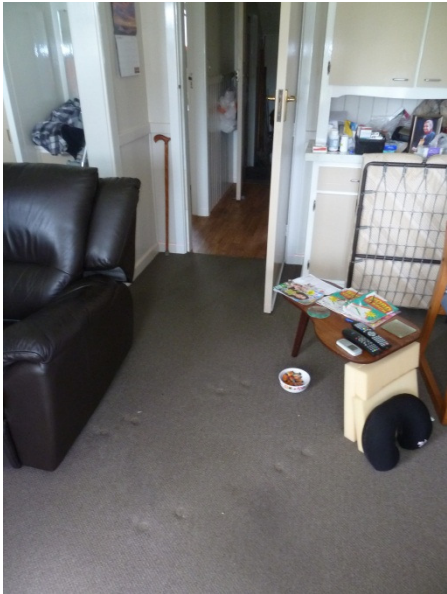
14.	Unit with gradual floor slope from front-to-back

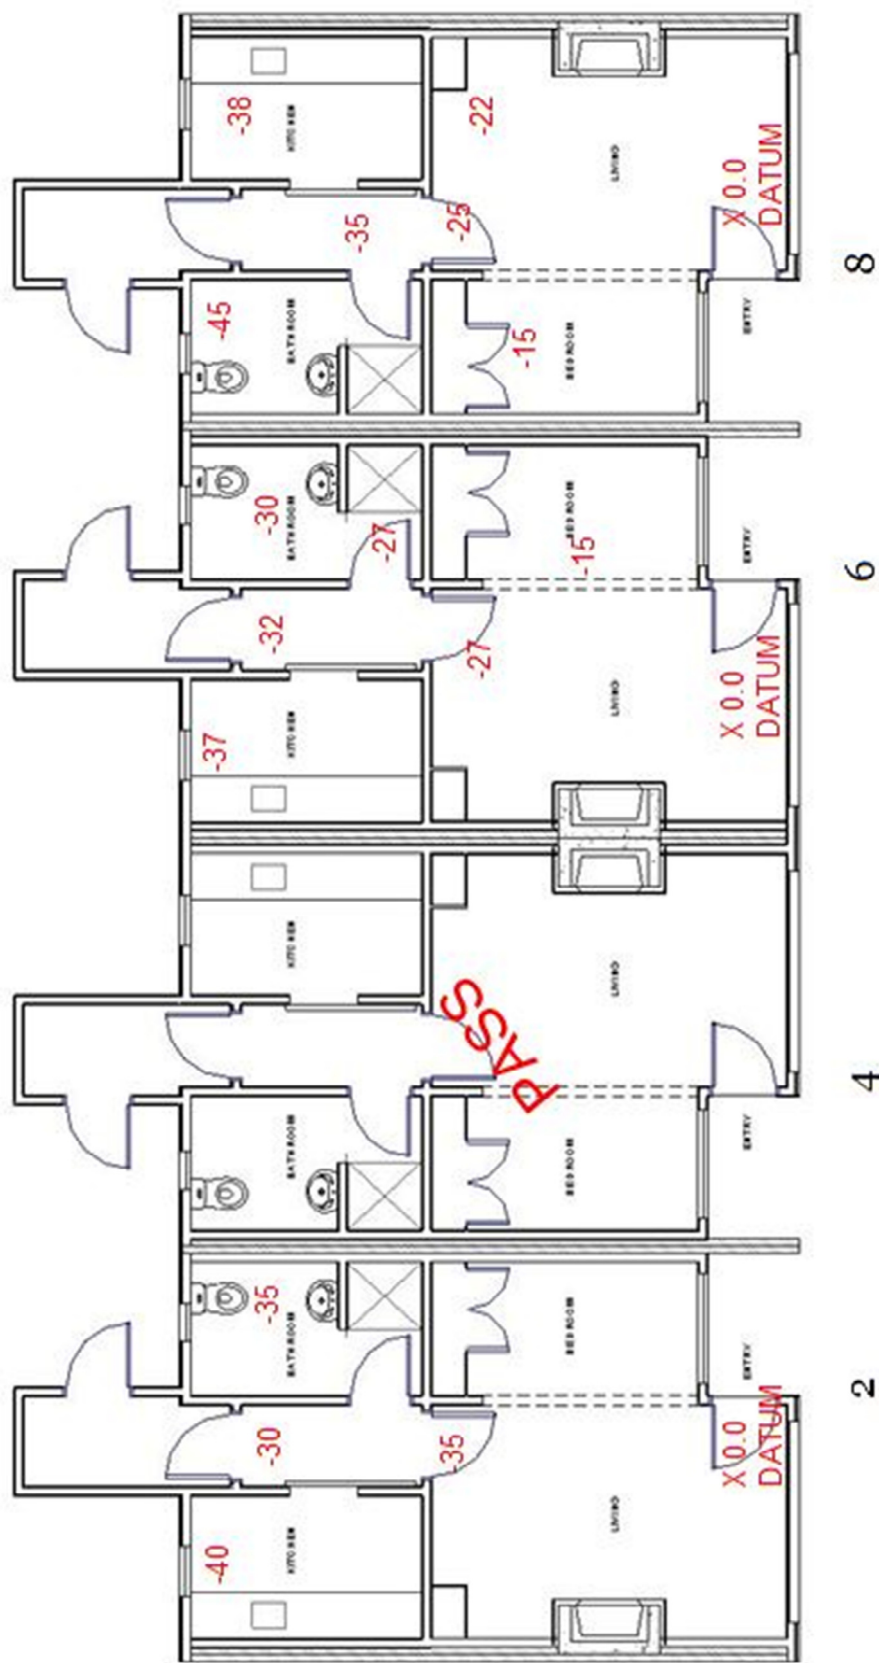
Appendix B – Level Survey

A full level survey was not deemed to be necessary at Carey Street it is located in a TC2 zone. Properties in TC2 zones suffered moderate damage due to liquefaction and/or settlement. In lieu of a full level survey, a laser level was placed in each unit so that differentials in vertical levels could be measured at the extreme ends of the unit. These values could then be used to determine the floor slope of the entire unit. For this site, (the maximum slope in a unit was 8.3mm/m which exceeds the 5mm/m limitation set out in the MBIE guidelines.

Block	Unit No.	Comment	Maximum Fall
A	1	Pass	
	3	Pass	
	5	Fail	Pile dropped in lounge.
	7	Pass	
B	9	Pass	
	11	Pass	
	13	Pass	
	15	Pass	
C	17	Pass	
	19	Pass	
	21	Pass	
	23	Pass	
D	25	Pass	
	27	Pass	
	29	Pass	
	31	Pass	
E	26	Pass	
	28	Pass	
	30	Pass	
	32	Pass	
F	18	Pass	
	20	Pass	
	22	Pass	
	24	Pass	
G	10	Pass	
	12	Pass	
	14	Pass	
	16	Pass	
H	2	Fail	8.3mm/m
	4	Pass	
	6	Fail	6.4mm/m
	8	Fail	5.9mm/m
