Toilet Block - Cashmere Rd / Valley Rd
Reserve
PRK_1795_BLDG_001 EQ2
Detailed Engineering Evaluation
Quantitative Report
Version Final

73 Cashmere Road, Cashmere

Christchurch City Council

Date
05/02/13

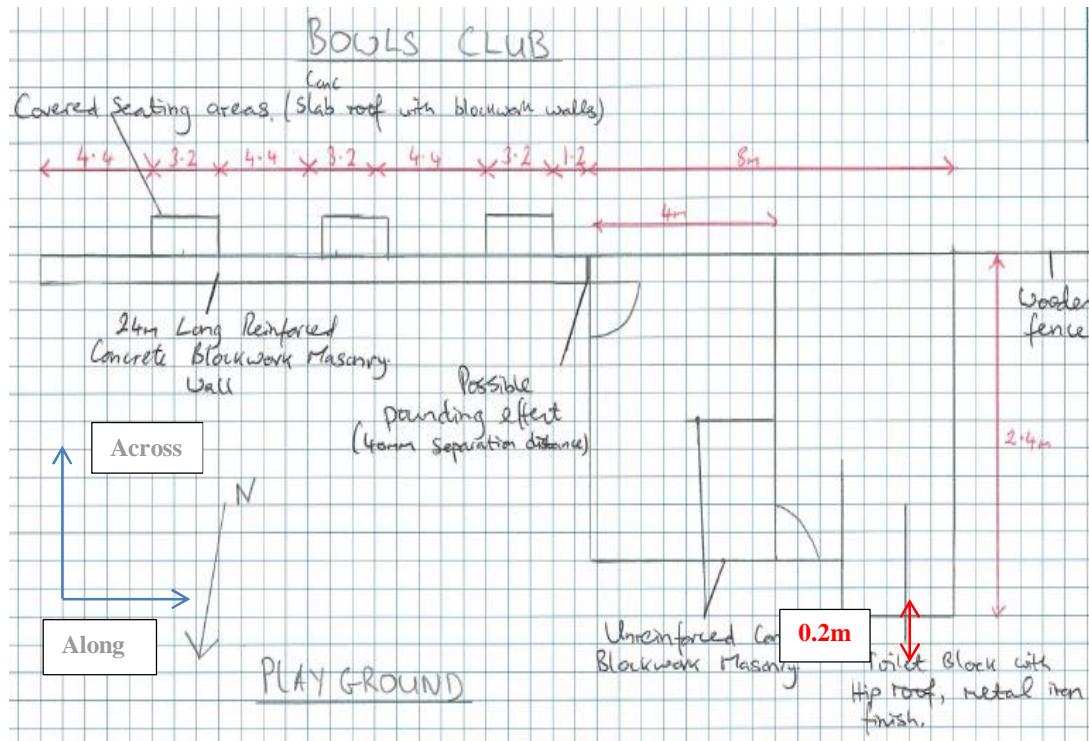
Figure 2 Plan Sketch Showing Key Structural Elements

Adjacent to the toilet block on the eastern side is a 15 series reinforced masonry wall. It is 2.2 m high and 24 m long in total. No reinforcing was evident in the top two courses of masonry blocks via the electromagnetic scan, so the top two courses not structurally tied to the bottom wall that is reinforced.

Note: Significant horizontal and vertical cracking was observed on the reinforced masonry wall during the initial inspection on 15 February 2012. Repairs to cracking were completed on 5 May 2012 by others.

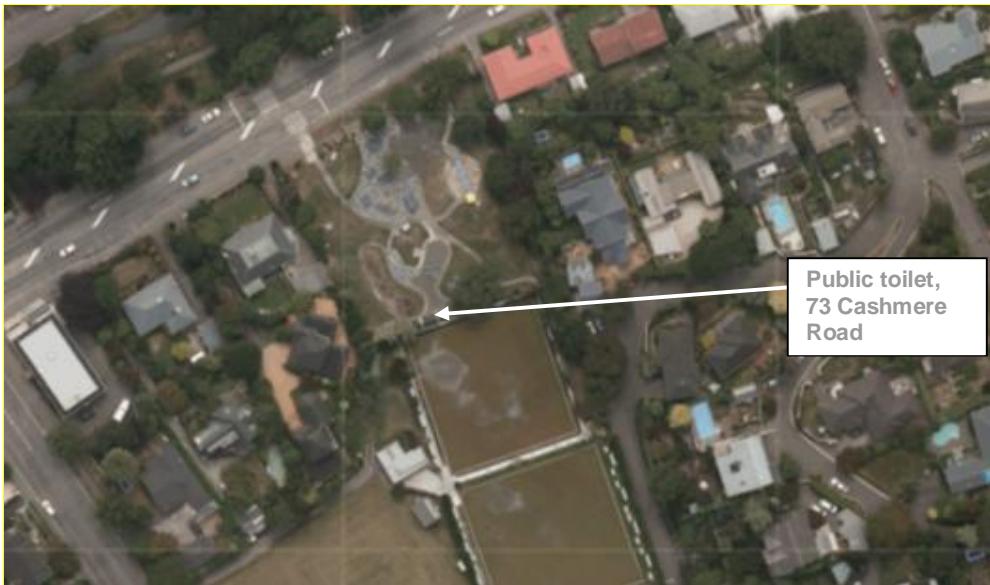
Figure 3 Post February 2011 Earthquake Aerial Photography²

Aerial photography taken following the 22 February 2011 earthquake (Figure 3) shows evidence of liquefaction (in the form of sand boils) outside the building footprint and in the surrounding area.

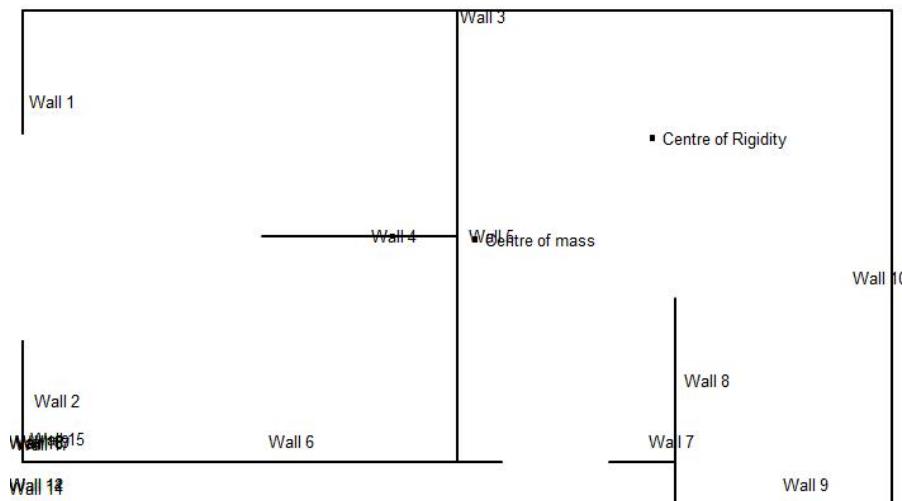
Figure 4 Plan Details and Wall Location

As indicated in Table 4, Wall 3 and Wall 6 could potentially fail in diagonal tension failure. This failure is a force controlled failure mode, as a result of diagonal cracking, a rapid deterioration of strength could lead to ultimate collapse even at small deformation.

On the other hand, rocking failure was found to be critical for the rest of the walls and the in-plane shear capacity ranges from 0.38 kN (for Wall 1 and 2) to 5.52 kN (for Wall 10). As rocking failure is drift controlled failure mode, large deflection but within the drift limit as per Section C8.5 in NZSEE guidelines (02/2011) can be acceptable with gradual degradation of strength.

The percentage of New Building Standard (NBS) is the ratio of the shear demand over the shear capacity and the value of In-plane %NBS of each wall is shown in Table 5. Wall 1 is found to have the lowest value of in-plane %NBS of 5%.

The building capacity has been assessed to be 5% of New Building Standard and in accordance with the aforementioned NZSEE guidelines it is deemed earthquake prone. As the building has been assessed to have a %NBS less than 34%NBS, it is deemed to be Earthquake Prone. It is recommended that strengthening options be explored and implemented to bring the %NBS of the building up to the required 67% in order to comply with Christchurch City Council policy regarding the strengthening of potentially Earthquake Prone buildings.

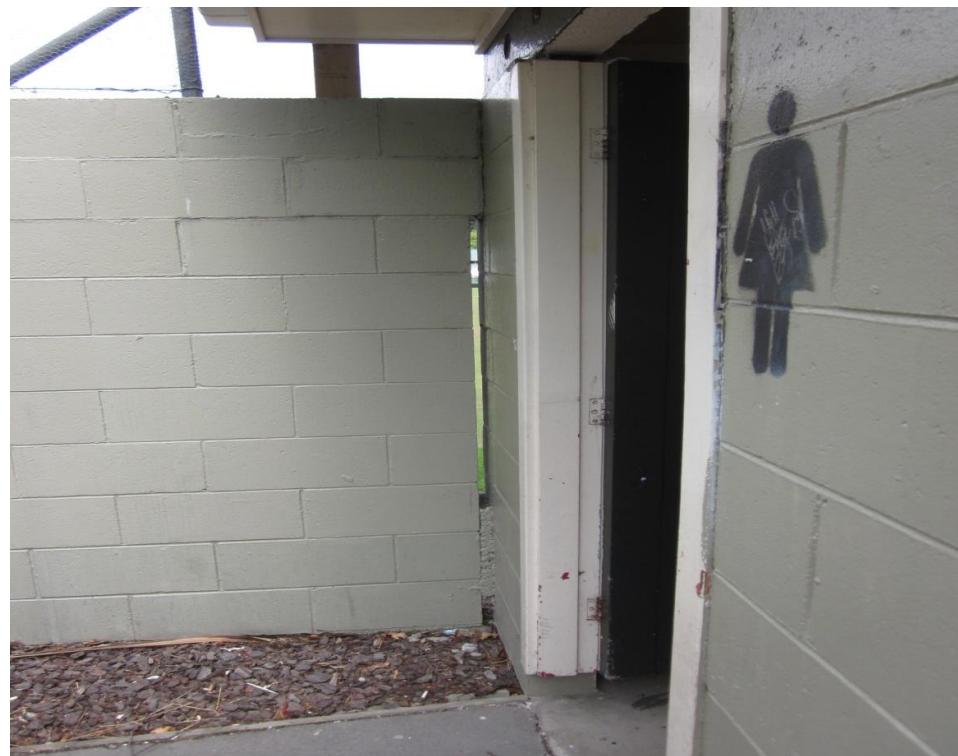
Photograph 6: Potential pounding effect with evident building separation

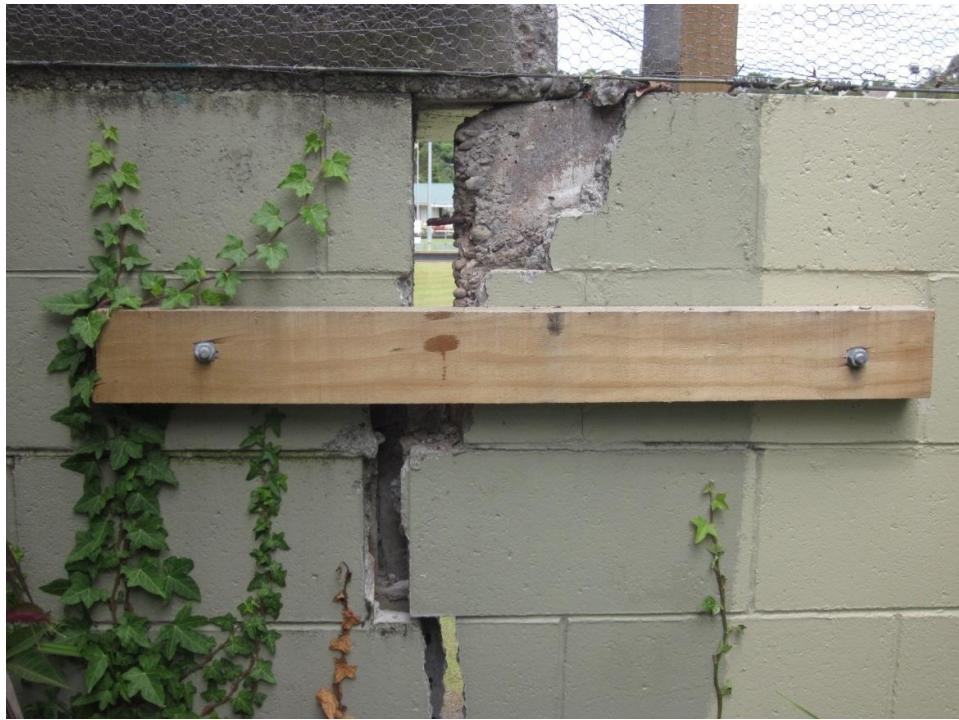
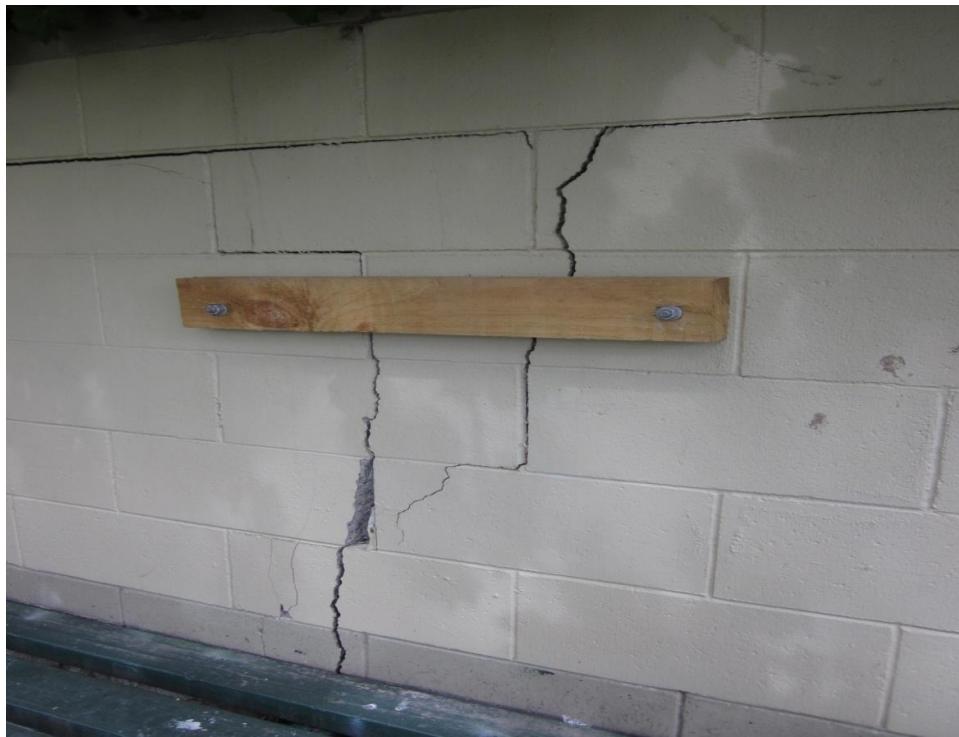
With regards the adjacent reinforced concrete blockwork masonry wall significant damage was observed. A horizontal cracking along the second course of block was evident and significant vertical cracking was observed on the wall with the width up to 60 mm. Refer to Photographs 7 and 8 in Appendix A.

Photograph 7: Cracking to the masonry boundary wall found during the initial inspection on 15 February 2012.

Photograph 8: As above
