Cathedral Square Police Kiosk
BU 1217-001 EQ2
Detailed Engineering Evaluation
Quantitative Assessment Report
Christchurch City Council

Cathedral Square Police Kiosk Detailed Engineering Evaluation Quantitative Assessment Report

Date: October 2012
Reference: 6-QUCCC.43
Status: Final

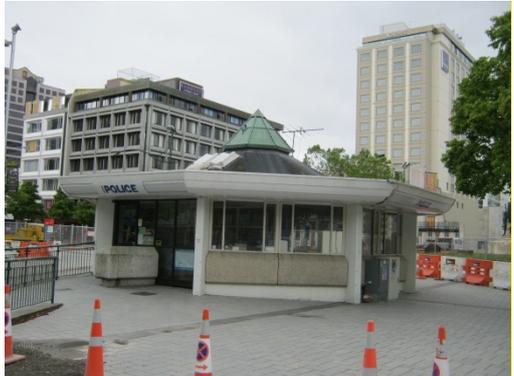
Police Kiosk – Cathedral Square		
No.	Item description	Photo
1.	View of south-west corner of kiosk.

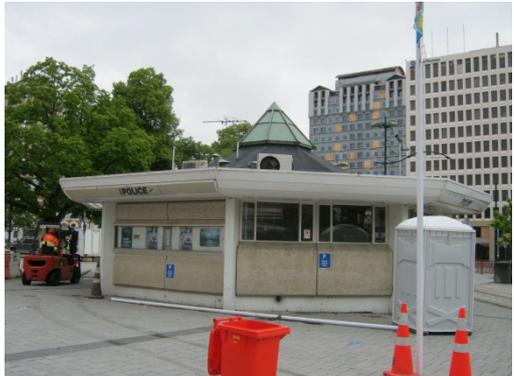
2.	View of north-east corner of kiosk.

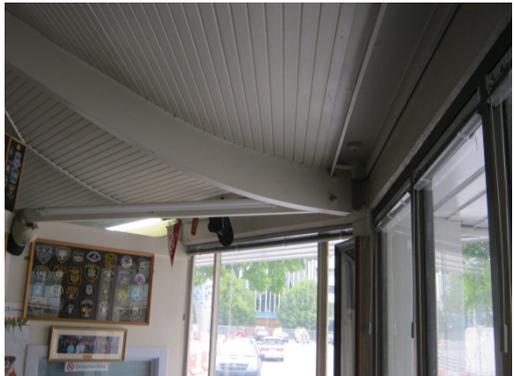
3.	Glulam rafter beam.

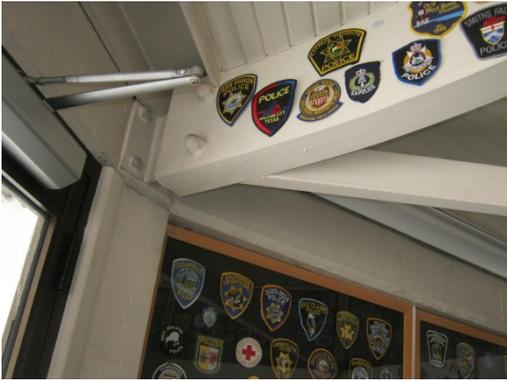
<p>4.</p>	<p>Connection of glulam rafter to precast column.</p>

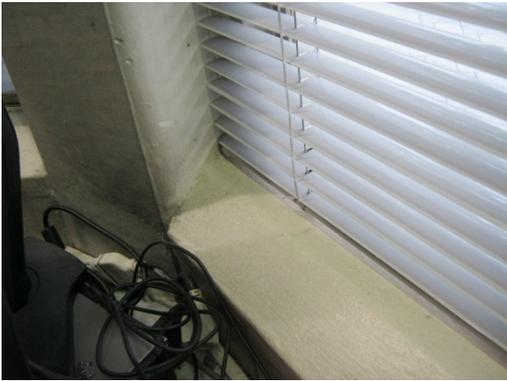
<p>5.</p>	<p>Interface of partial height blockwork walls and precast column.</p>

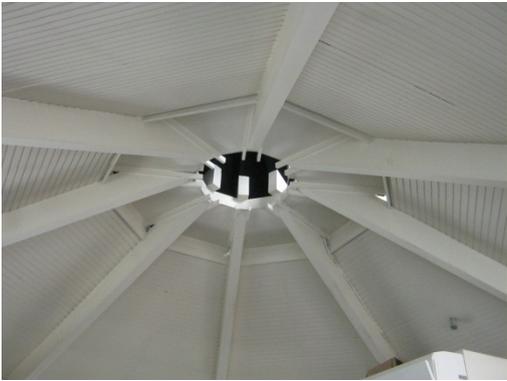
<p>6.</p>	<p>Steel compression ring beam.</p>

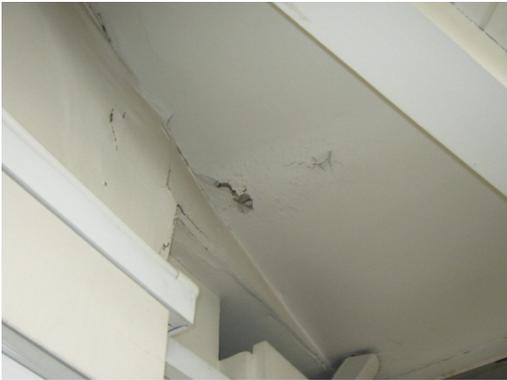
- Cracking at the gib wall intersection with the pitched roof.
- 10-20mm differential settlement in the ground floor slab in the southeast corner.

<p>7.</p>	<p>Cracking at the intersection of the partition wall with the ceiling.</p>
