Cathedral Square Toilets

PRK 1224 BLDG 002 EQ2

Detailed Engineering Evaluation

Quantitative Assessment Report

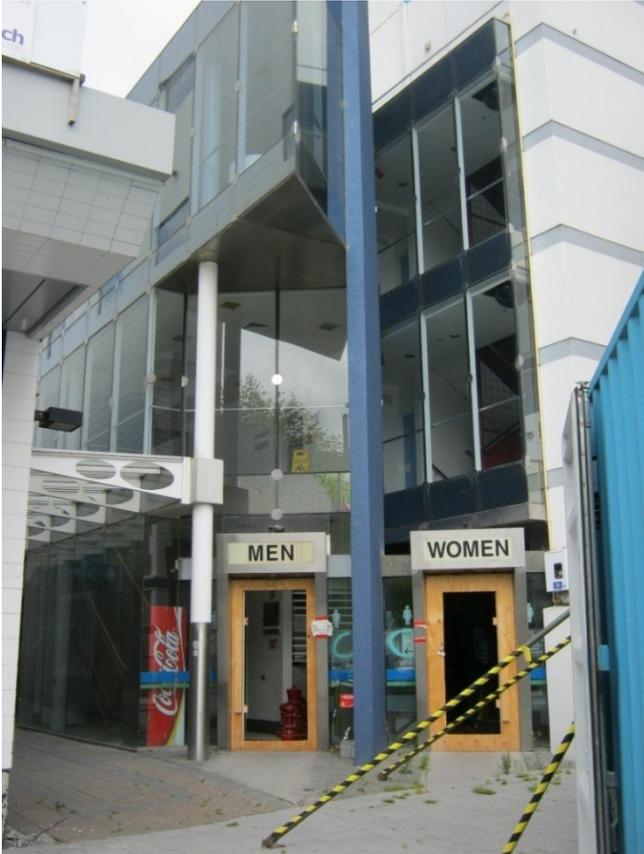
Photograph 1. Looking southeast at the Toilet building from Cathedral Square.

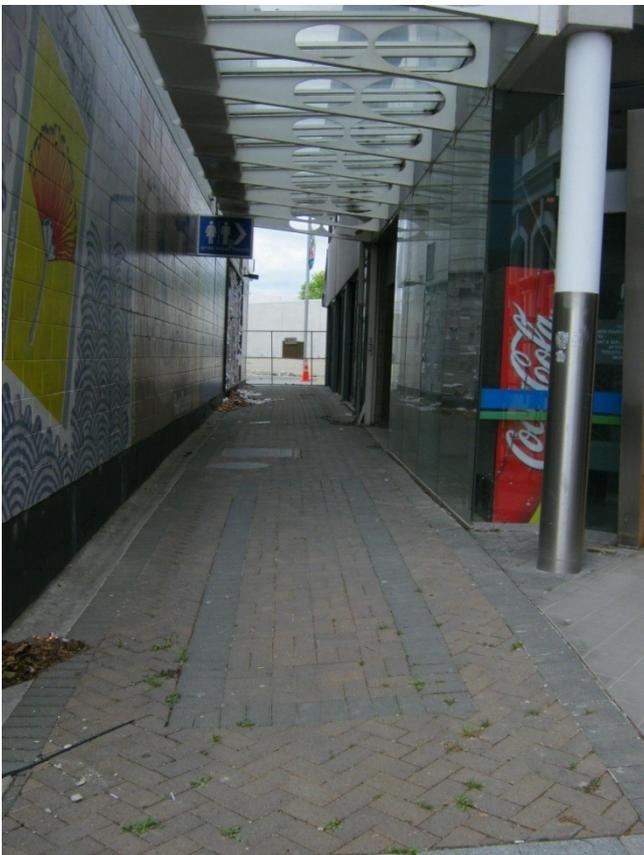
Photograph 2. Looking south at Strand Lane between the IBM and Toilet buildings.

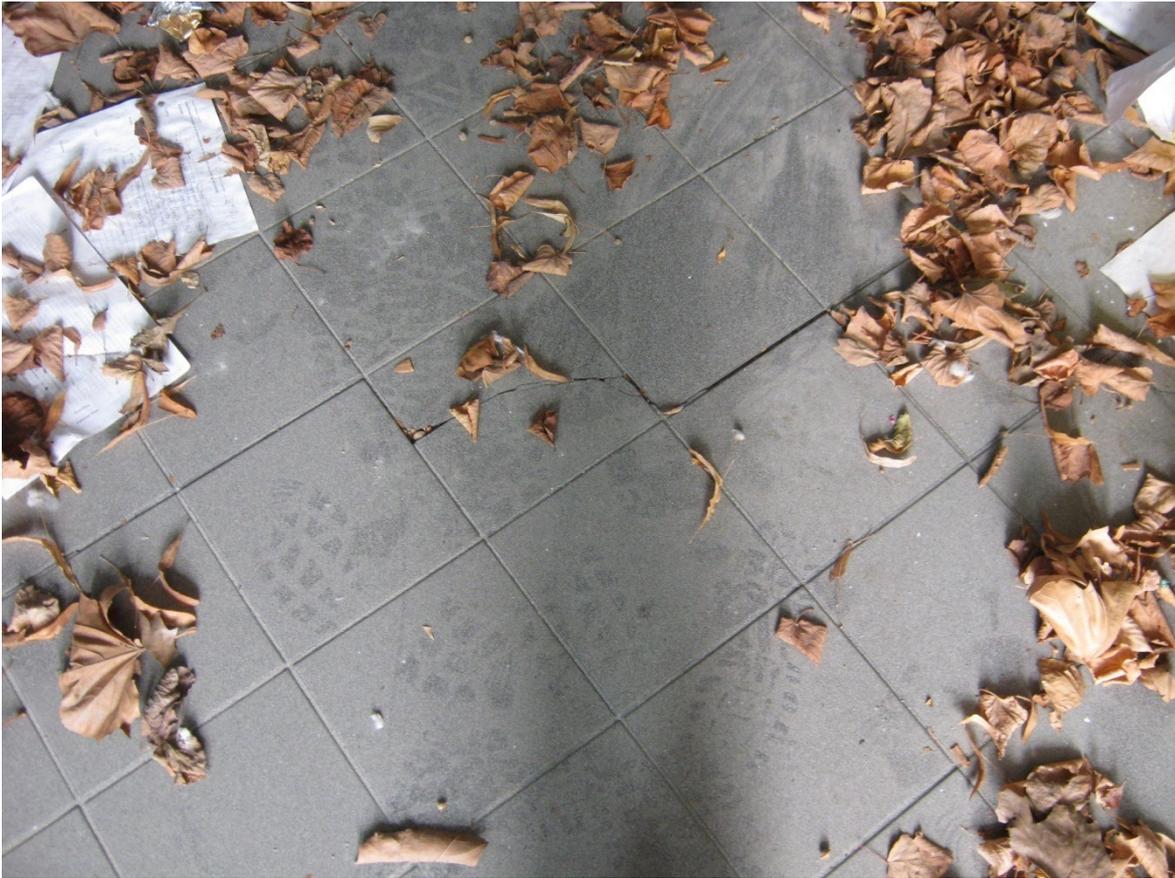
The ground floor of the women's facilities has a minor crack from the start of the precast stairs to the curved feature wall. Slight vertical movement was also observed with doors sticking at ground floor.

Photograph 3. Small crack in floor tile inside Women's Toilets (Ground Level).

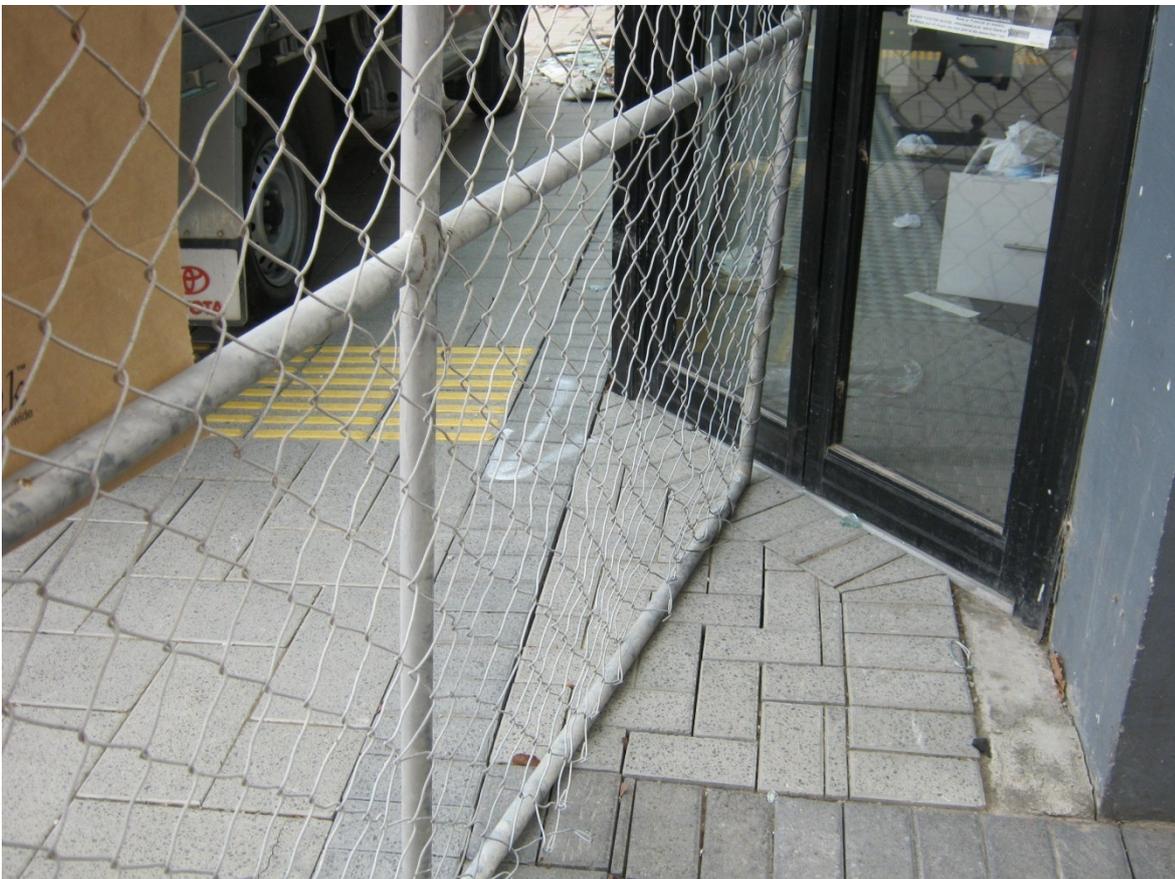
- Inspection of the toilet building's perimeter and ground level revealed no surface evidence of liquefaction or differential settlement. Some differential settlement may have occurred in the paving stones in the footpath between the toilet and IBM building, likely as a result of surficial movement on top of poorly compacted fill; refer to Photograph 4.
- There appears to have been no damage to the building that is the result of ground settlement or liquefaction. A minor crack approximately 5mm wide was observed in a floor tile in the women's toilets; refer to Photograph 3; however this may have been present before the earthquake as no other cracking was observed.
- Lateral spreading is not considered to be a risk due to the relatively large distance from the Avon River.

Photograph 4. Some movement in the pavers outside the toilet building entrance.

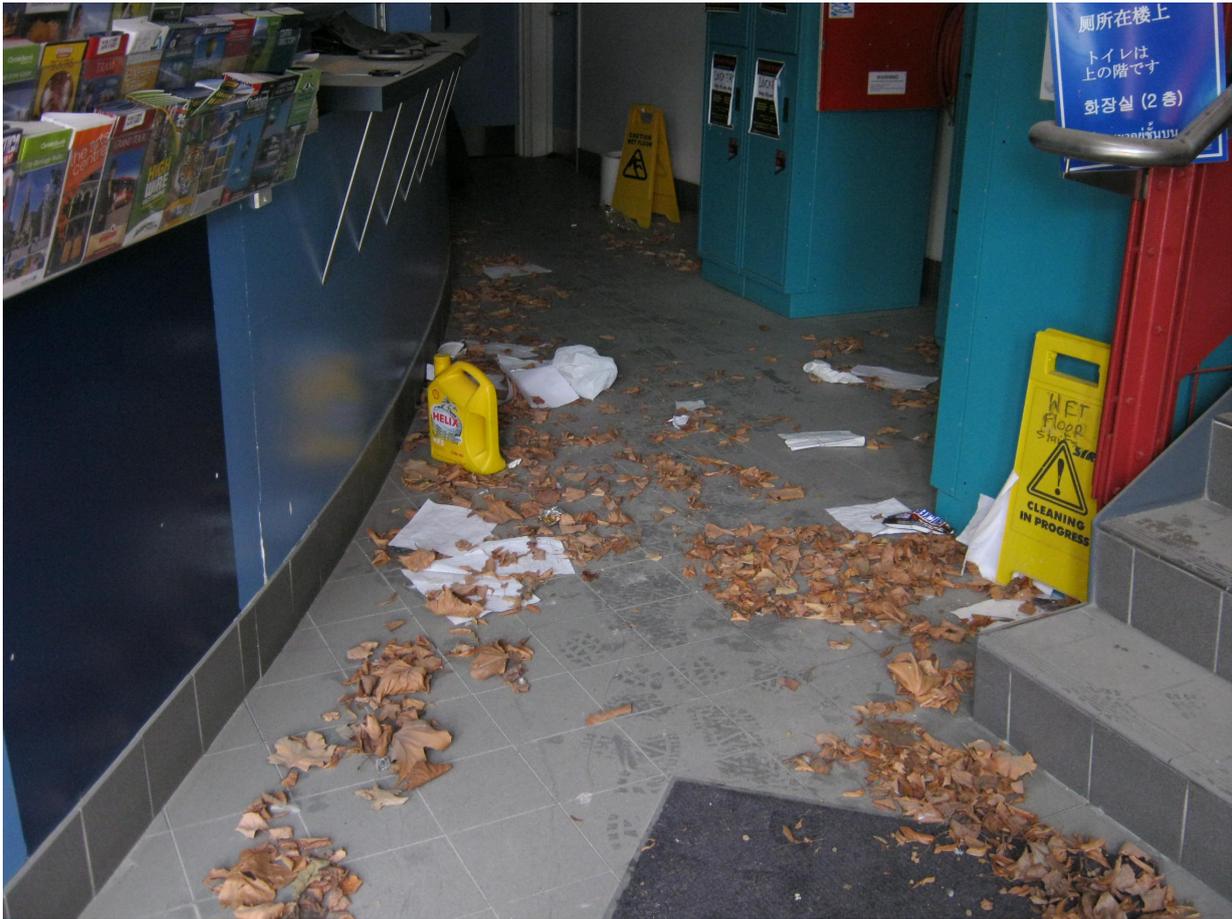
Photograph 5. View of the inside of the ground level of the Women's Toilets.
