**Cedar Park
Housing Complex
PRO 2631**

**Detailed Engineering Evaluation
Quantitative Assessment Report**

Quantitative Assessment Report

90 Bristol Street, St Albans

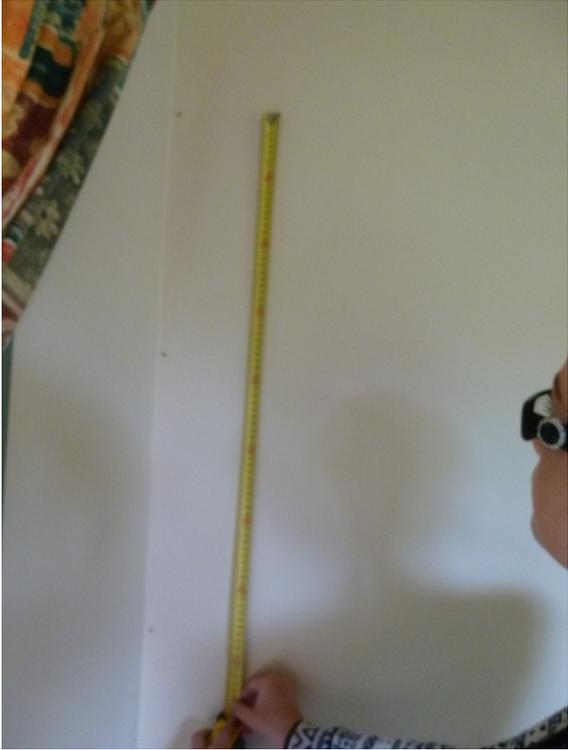
The internal lining nail spacings were measured on site to vary between 350-400mm.

<p>17.</p>	<p>Plasterboard nail spacings (300mm average)</p>

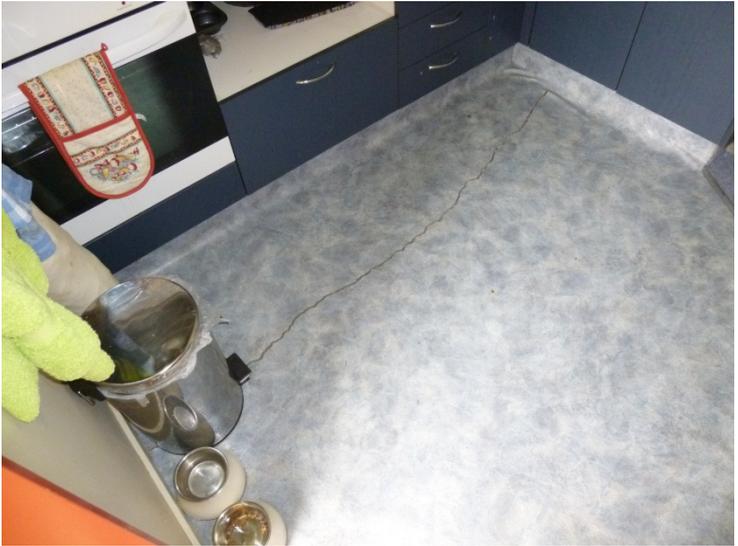
Foundation damage was observed in Units 12, 13, 17, 19. Cracks were observed running through garage areas where no floor coverings were present.

Unit 13 has a severe (5mm) crack in the kitchen area.

<p>18.</p>	<p>Unit 13 - Crack in kitchen floor slab</p>

- Veneer at height (gable ends) have the veneer ties checked.
- Repairs be undertaken to affected areas of exterior paving to remove trip hazards.
- A site specific geotechnical site investigation be carried out to determine the cause of cracking in the floor slabs.
- Cosmetic repairs be undertaken as required.

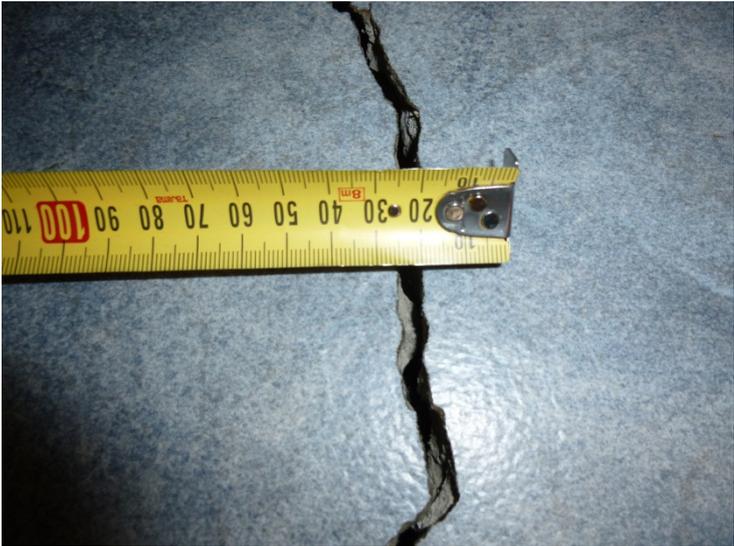
19.	Unit 13 - Crack in kitchen floor slab

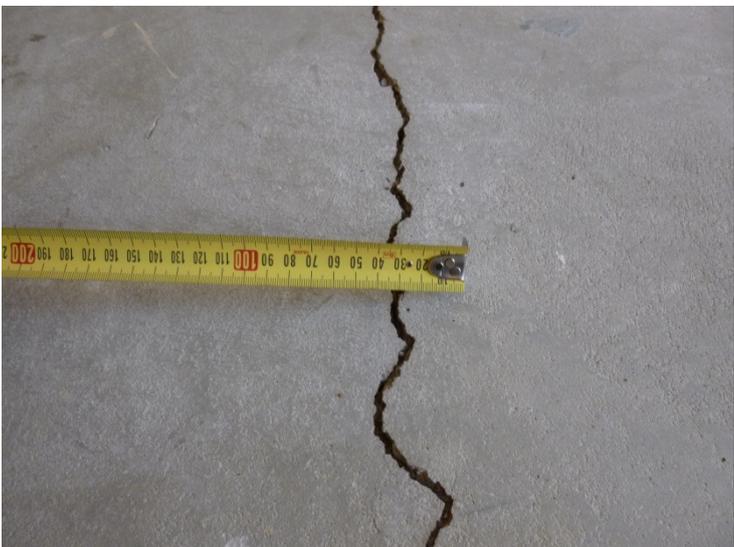
20.	Unit 12 - Crack in garage floor slab

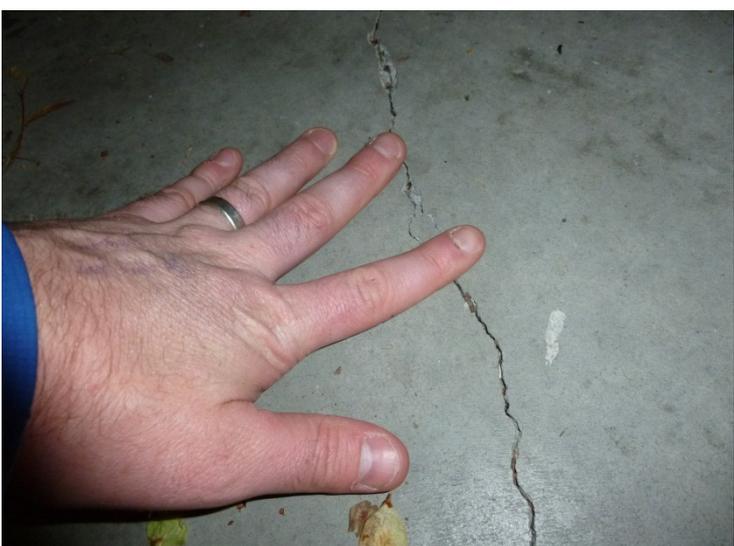
21.	Unit 17 - Crack in garage floor slab

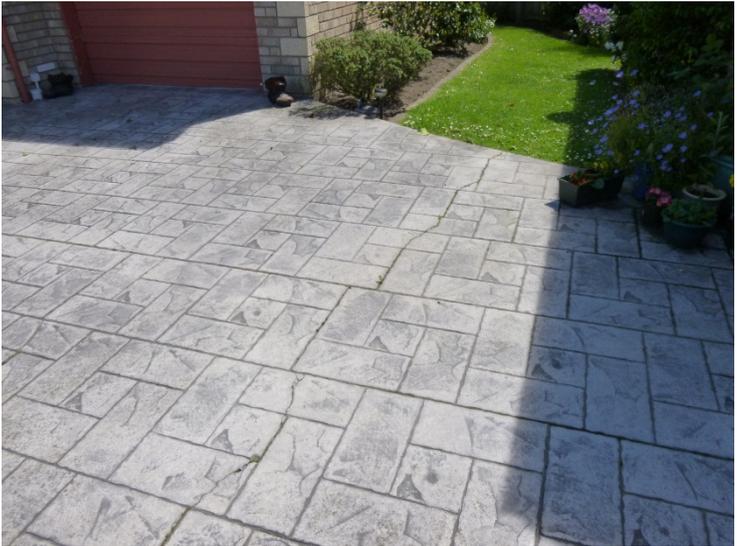
<p>22.</p>	<p>Crack in driveway paving</p>

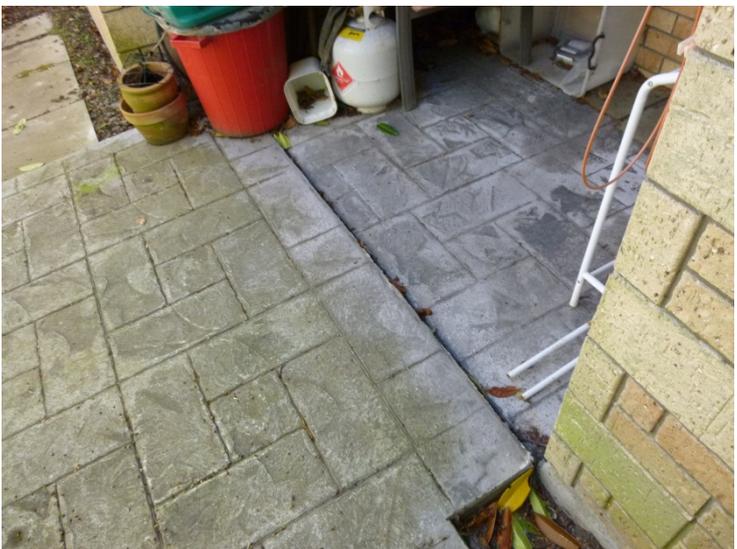
Ground settlement has caused steps between external paving to develop which present potential trip hazards to elderly residents.

<p>23.</p>	<p>Unit 1,6 – Step in paving</p>

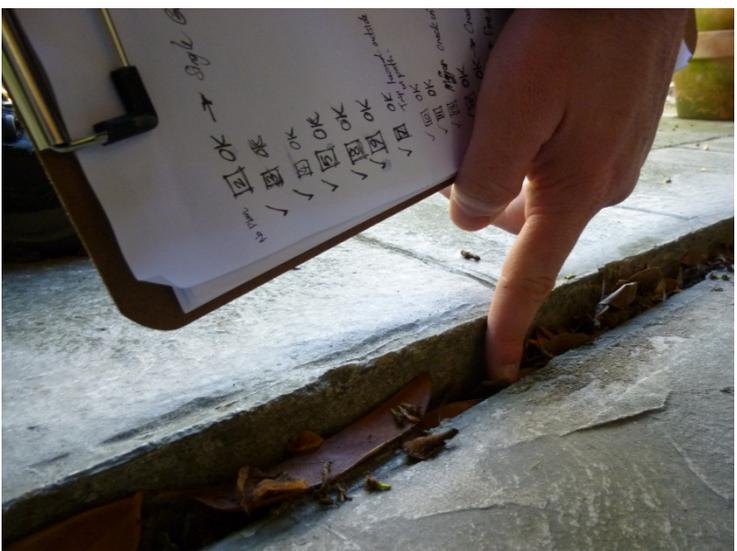
<p>24.</p>	<p>Unit 1,6 – Step in paving</p>

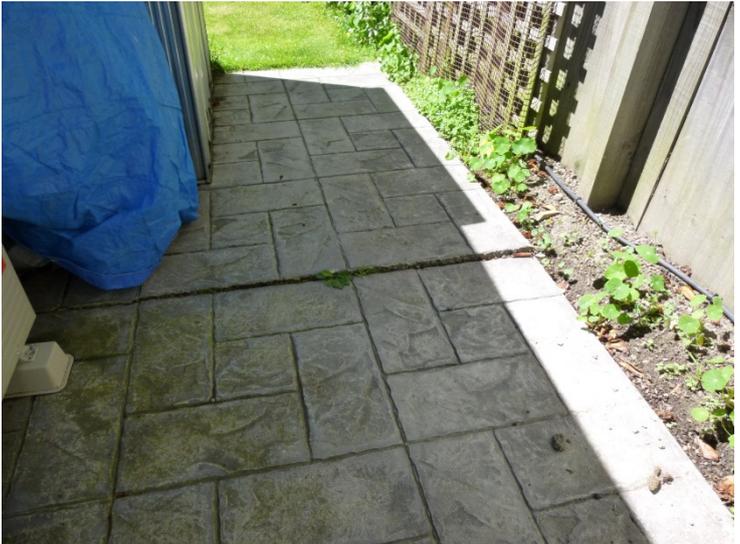
25.	Typical step in external paving
