Centennial Hall, Spreydon

BU 1098-001 EQ2

Detailed Engineering Evaluation

Quantitative Report

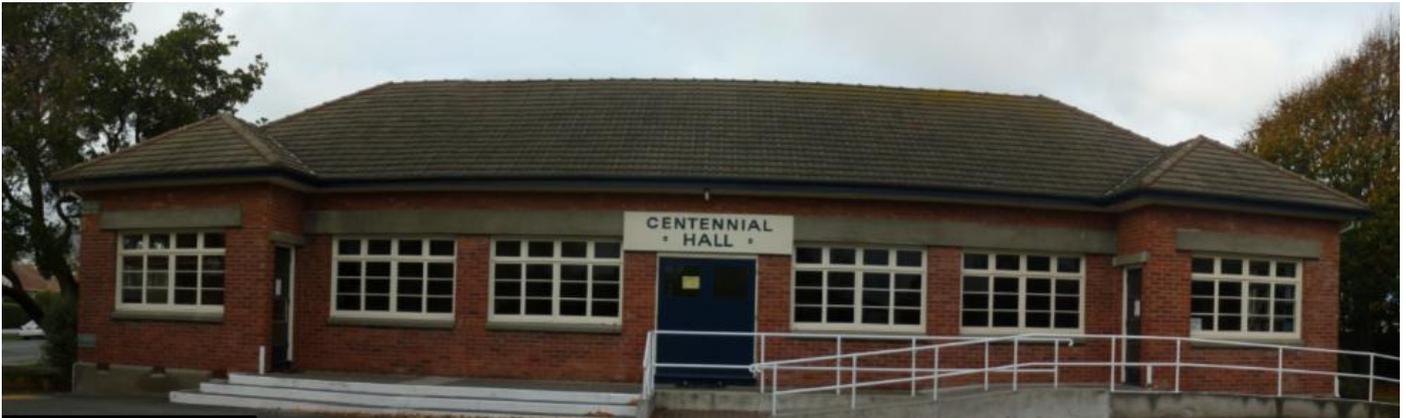
Photo 1: Northern perimeter wall

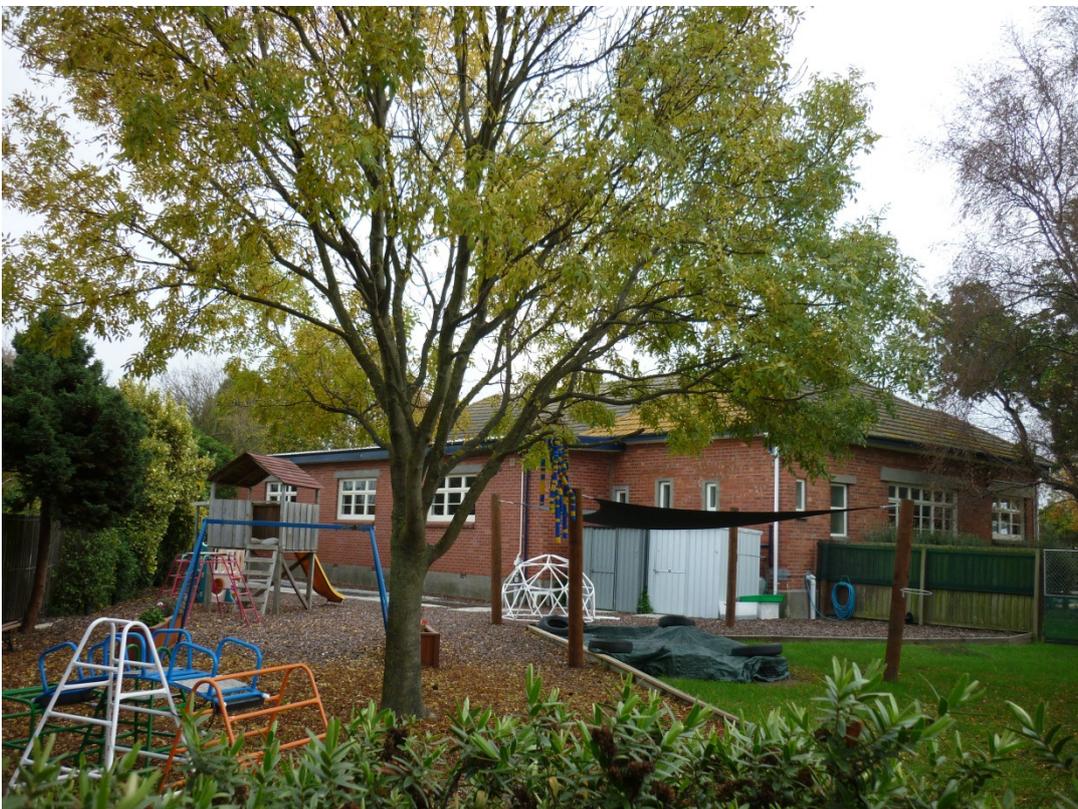
Photo 2: View of the south eastern perimeter wall

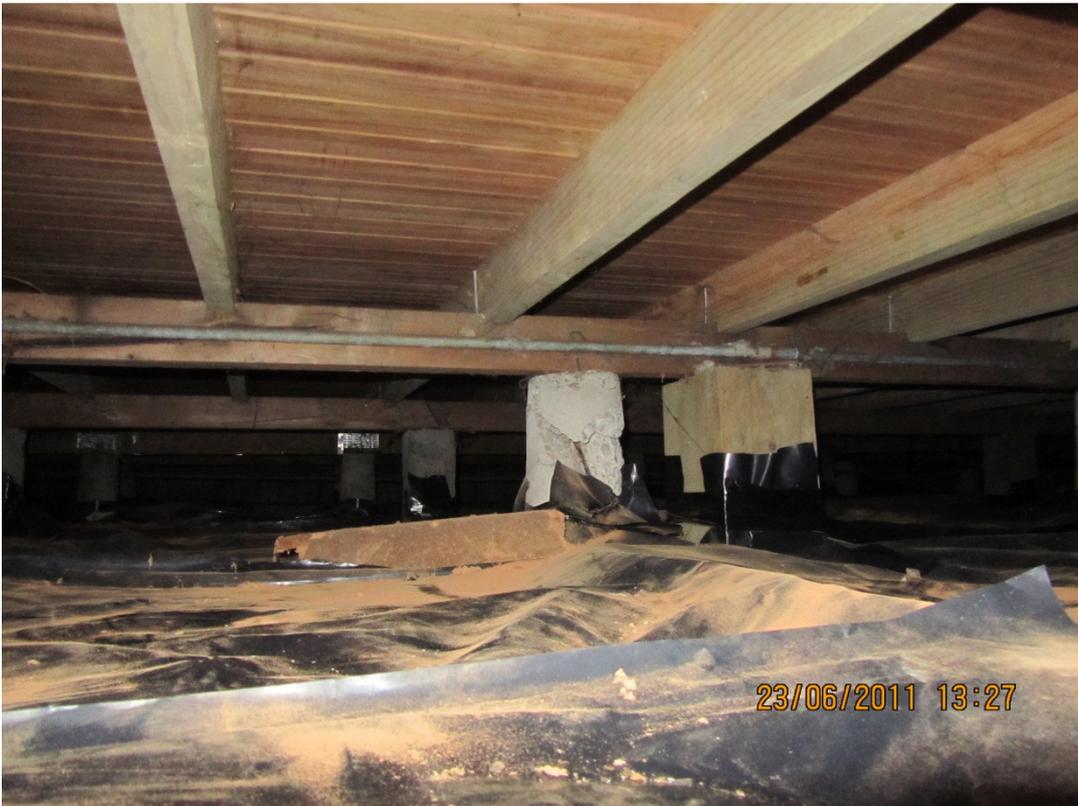
At least one pile has failed and the floor is being temporarily supported by timber blocks. Other piles have visible cracks.

Photo 3: View of the sub floor and the failed pile

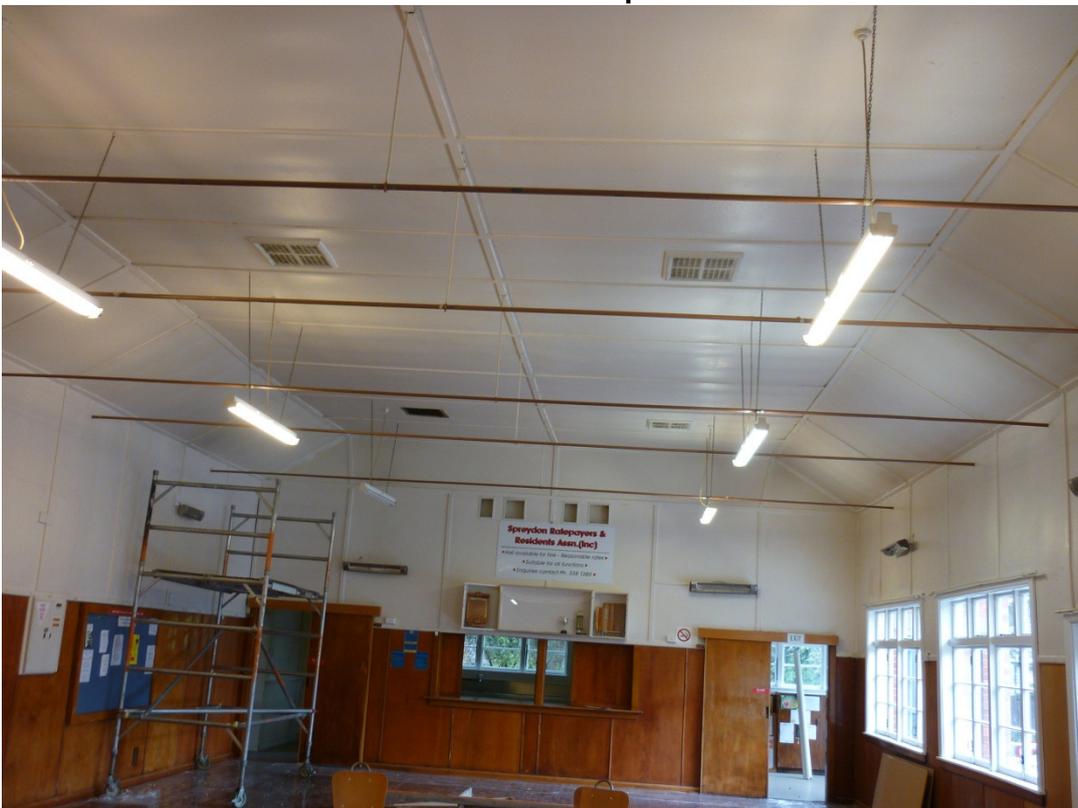
Photo 4: View of interior towards the west wall

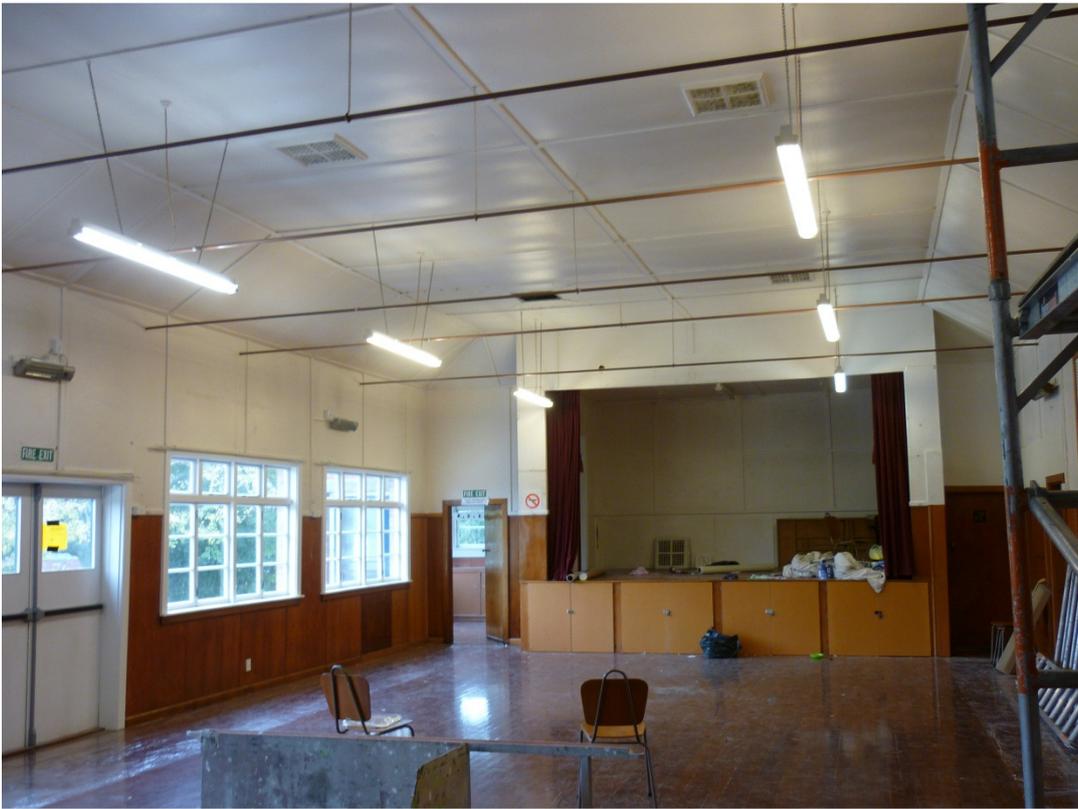
Photo 5: View of interior towards the north and east walls

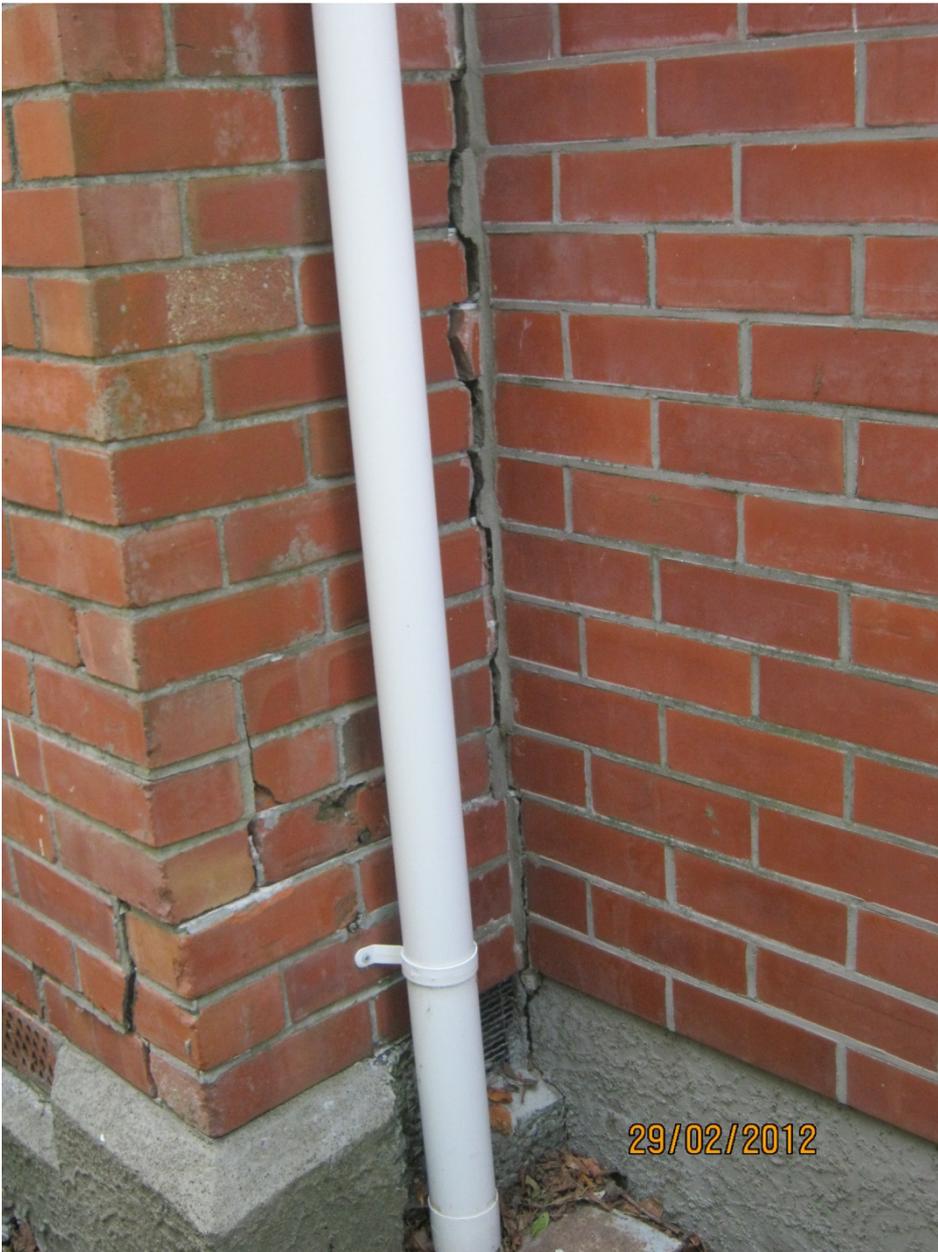
Photo 6: View of the large crack in the western wall

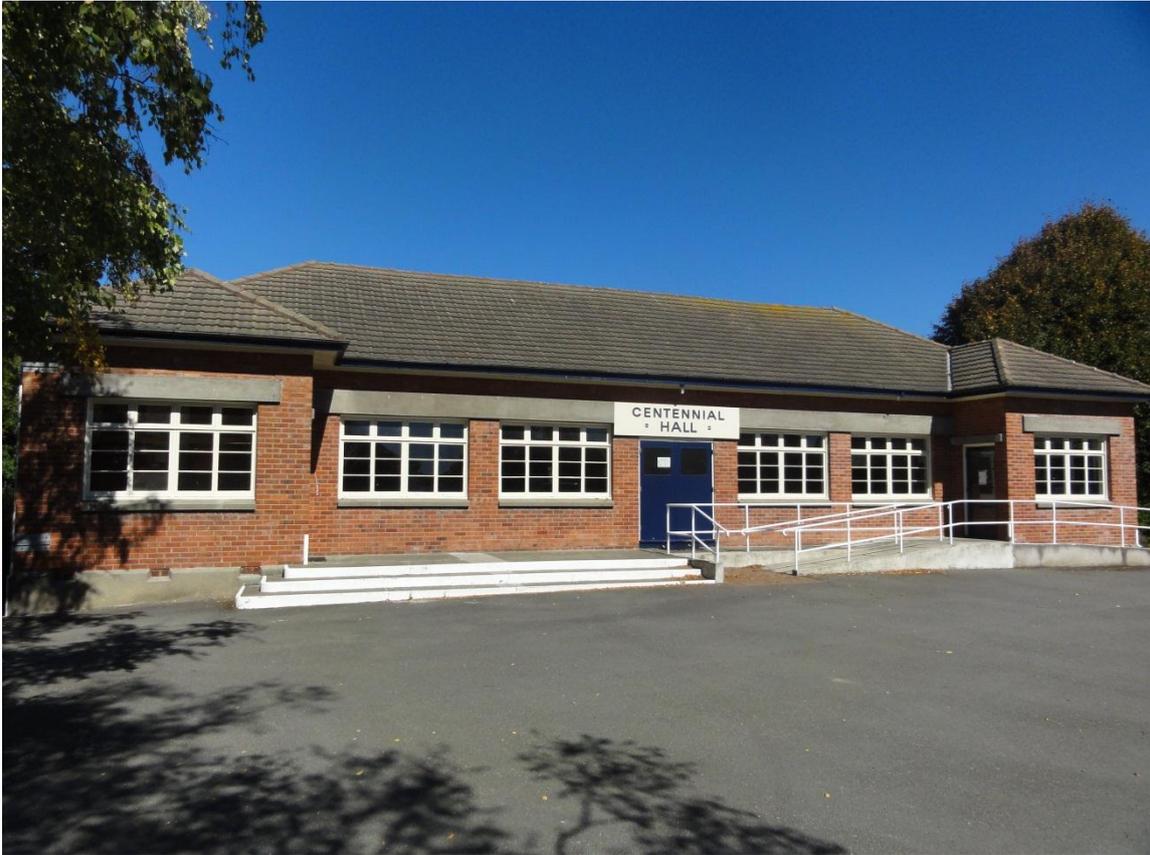
Photo 1: North elevation of the Centennial Hall building.

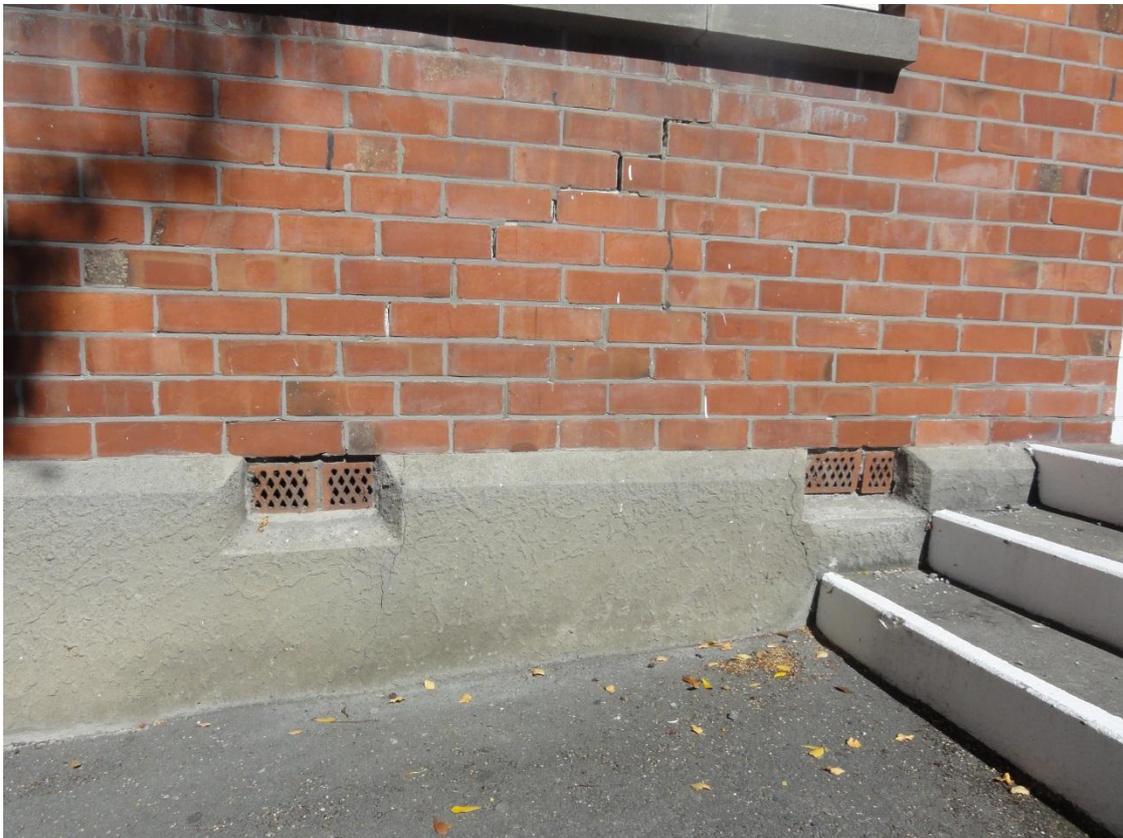
- An area of pavement, approximately 4m², has been affected by up to 50mm of heave in the carpark north of the building.
- Multiple cracks up to 3mm wide were observed at several locations around the concrete perimeter strip footing (Photos 2, 5 and 6).

Photo 2: 2mm cracks on the north elevation perimeter strip footing.

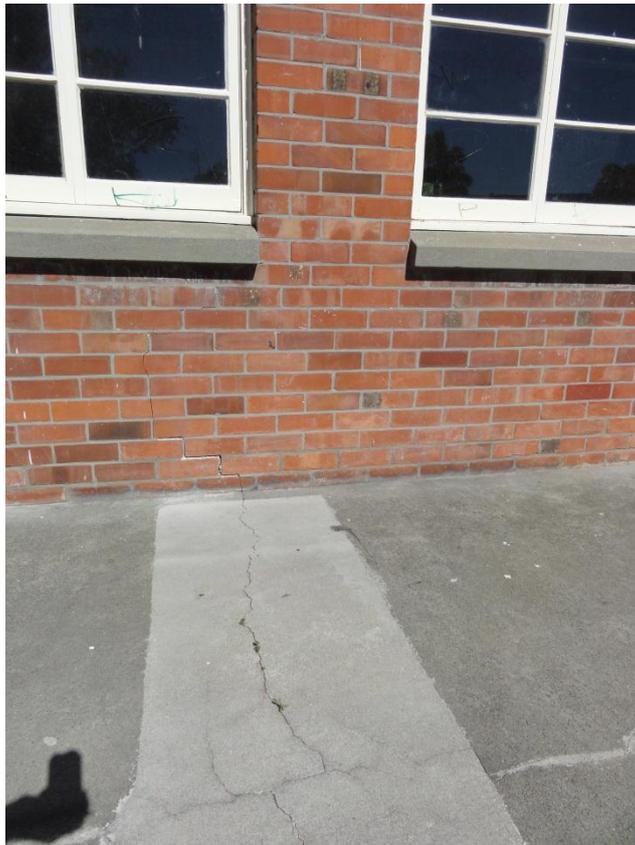
- Cracking (approximately 5mm wide) at the patio and down the steps on the north elevation of the building. One crack extends into the masonry wall (Photo 3).

Photo 3: 3mm wide crack in patio, which continues as step cracking in the masonry blockwork.

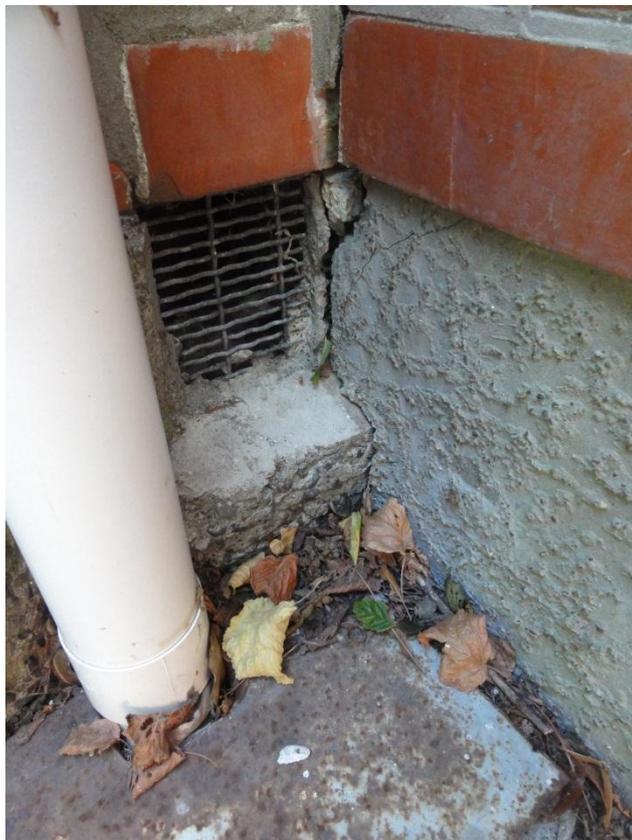
- It appears there has been an extension of the original buildings footprint on the southern elevation. There is a 5mm wide crack at the join between the old and new perimeter strip footings (Photo 4).

The seismic oscillations appear to have also caused the buildings southern extension foundations to separate from the original building foundations by 5mm. The cracking becomes wider as it goes up the wall, which suggests that settlement has occurred in the south west corner of the building. We recommend a detailed level survey is undertaken to more accurately assess the foundation performance.

Photo 4: Upto 5mm wide crack at the joint of adjacent footings.

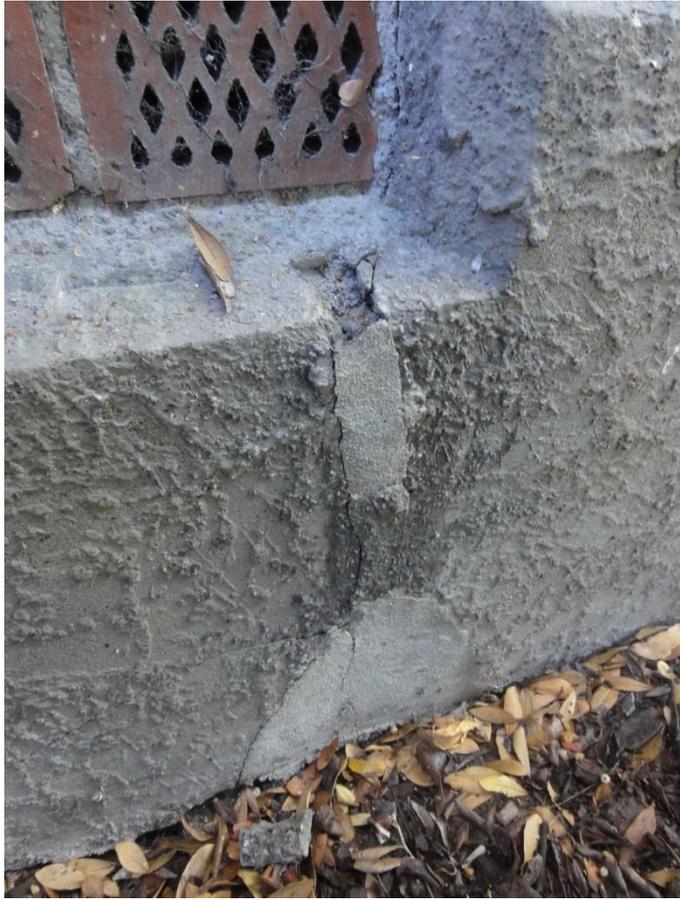
Photo 5: Minor crack on the east elevation footing. Plaster is breaking off.

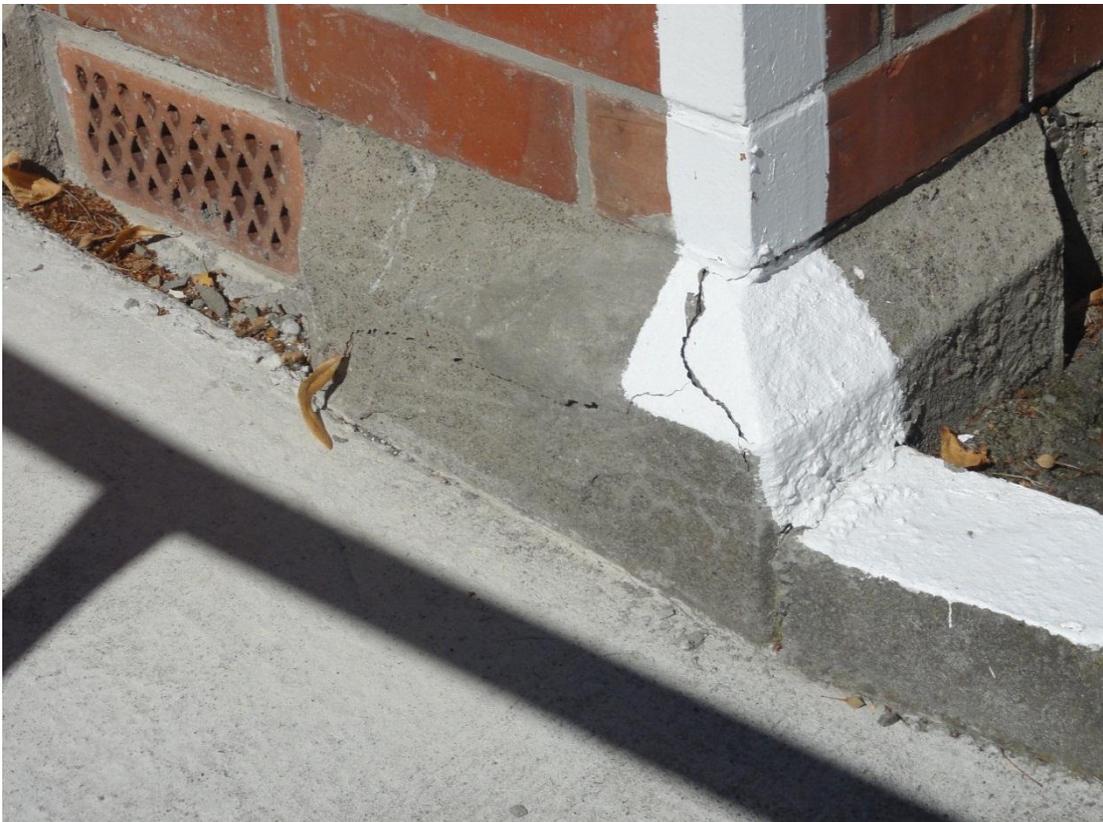
Photo 6: 3mm wide cracking on the north west corner foundations.

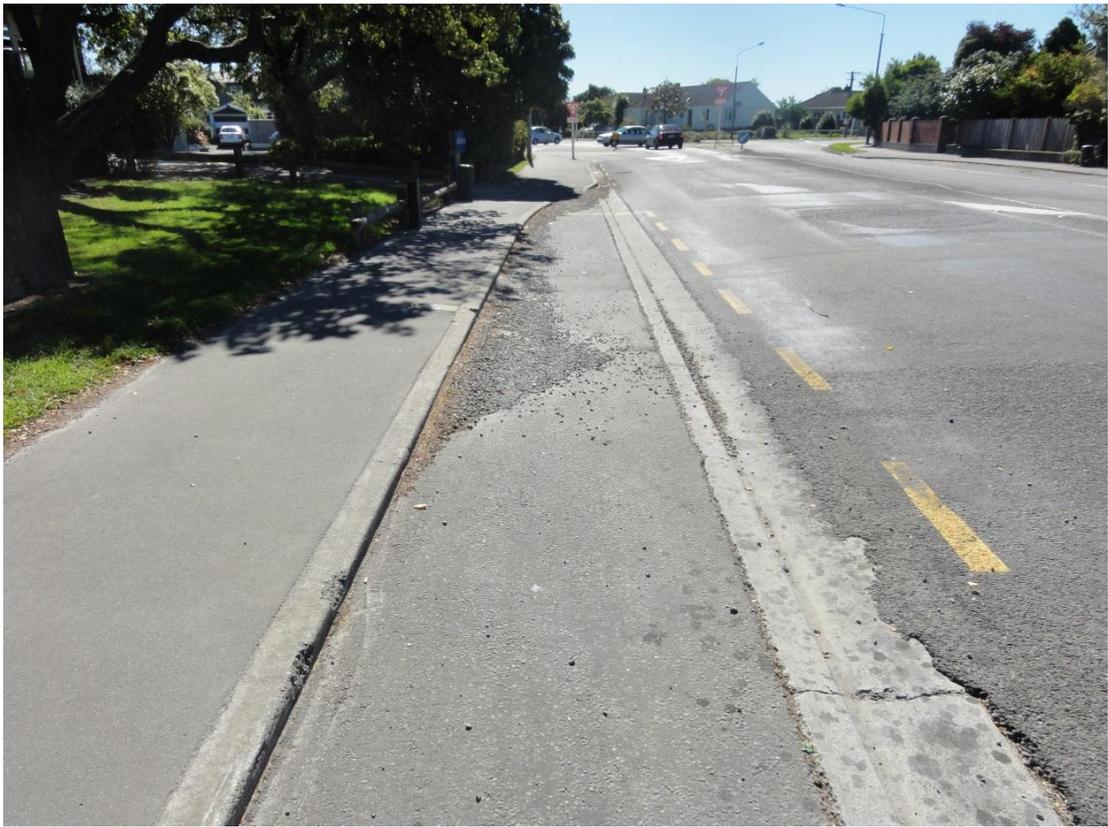
- Minor surface rupture of liquefaction has occurred in the children's area directly south of the building (Photo 9).
- Approximately 10mm of settlement appears to have occurred at the bus lay by area, 10m east of the Centennial Hall building (Photo 7).

Photo 7: Bus lay by area appears to have settled by approximately 10mm.

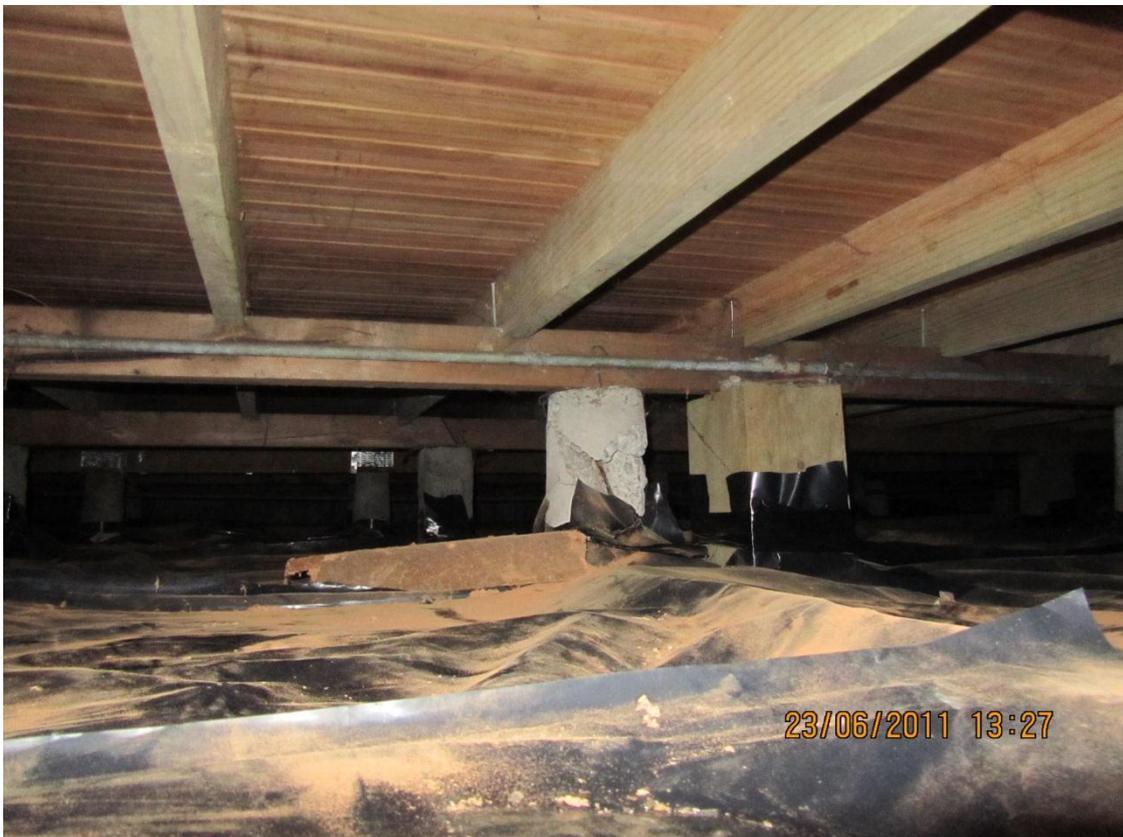
Photo 8: Replaced pile.

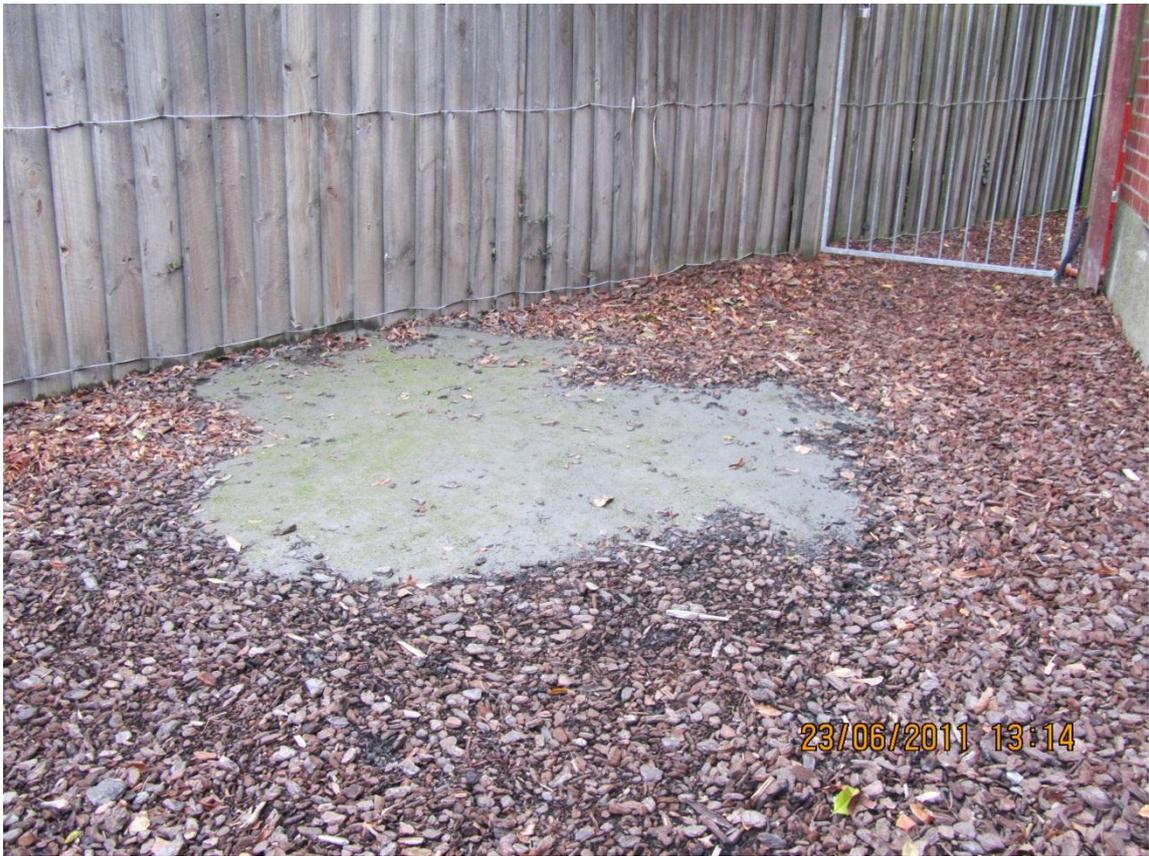
Photo 9: Liquefaction on the south side of the building.
