**Pavilion/Toilet – Lyttelton Street /
Centennial Park
PRK_1095_BLDG_002 EQ2
Detailed Engineering Evaluation
Qualitative Report
Version Final**

Detailed Engineering Evaluation
Qualitative Report
Version Final

Christchurch City Council

Date
1 October 2012

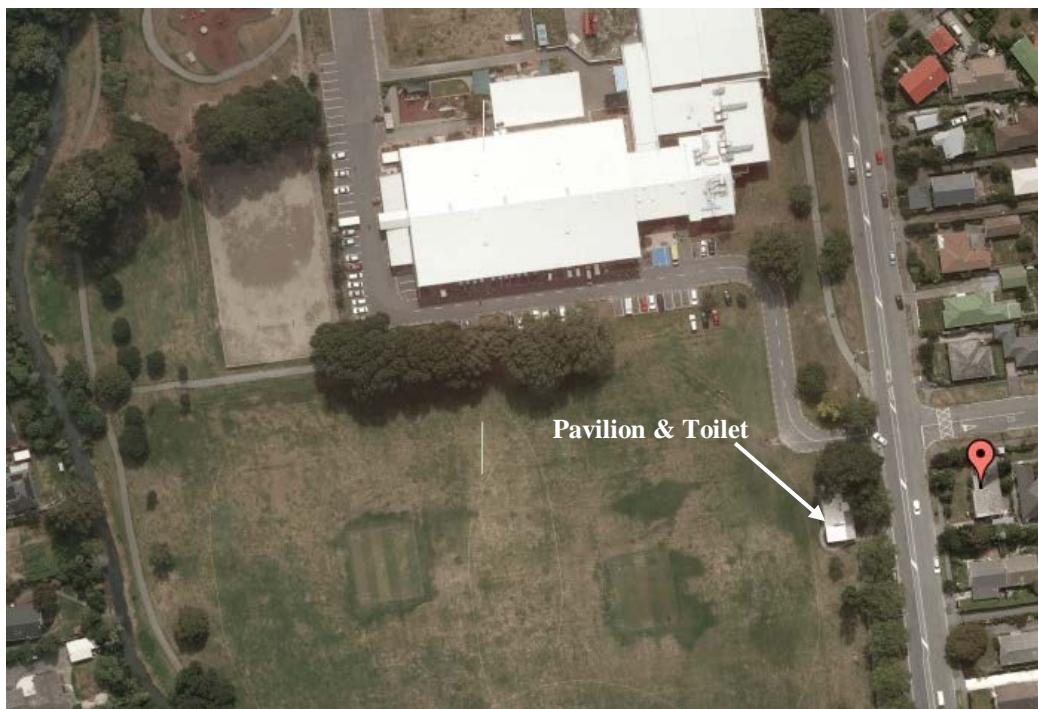
Figure 2 Post February 2011 Earthquake Aerial Photography²

Aerial photography taken following the 22 February 2011 earthquake shows minor to moderate signs of liquefaction close to the site, as shown in Figure 2.

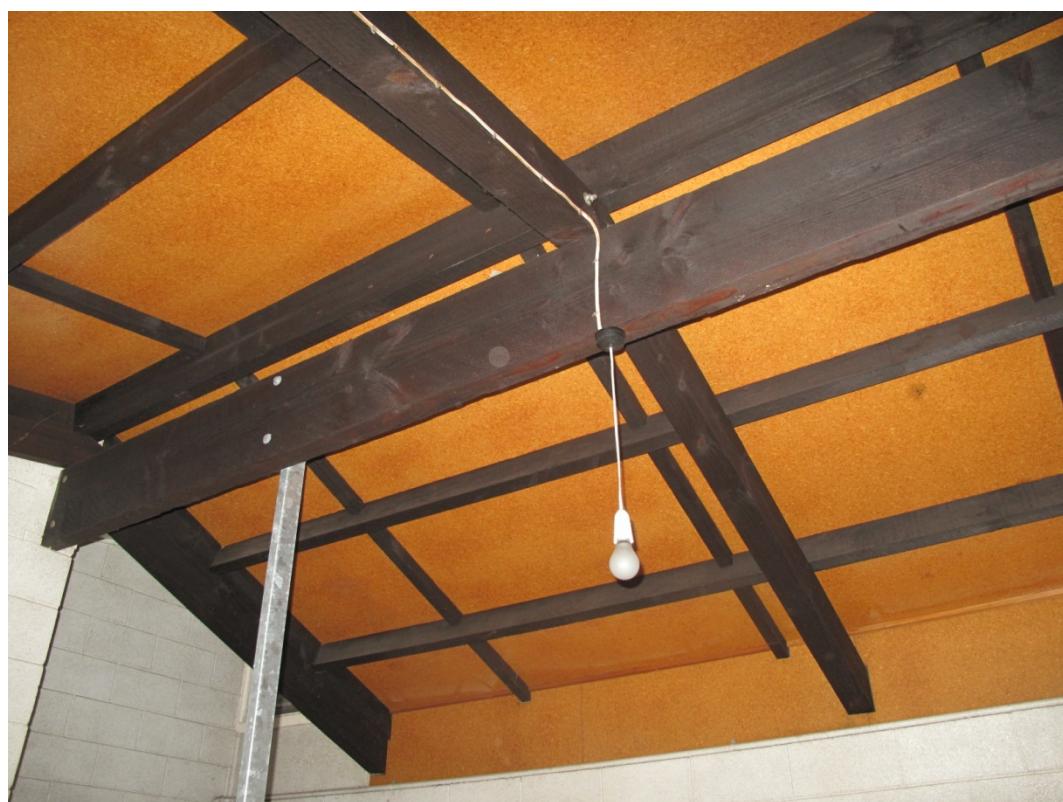
No roof bracing was visible. Roof elements such as the purlins and roof material were clearly visible and are expected to provide sufficient bracing to the roof structure. See photographs 4 and 5 in Appendix A. The edges of the canopy are securely bolted to steel support posts. See photographs 6 and 7.

Photograph 4 Purlins, rafters and beams supporting the roof.

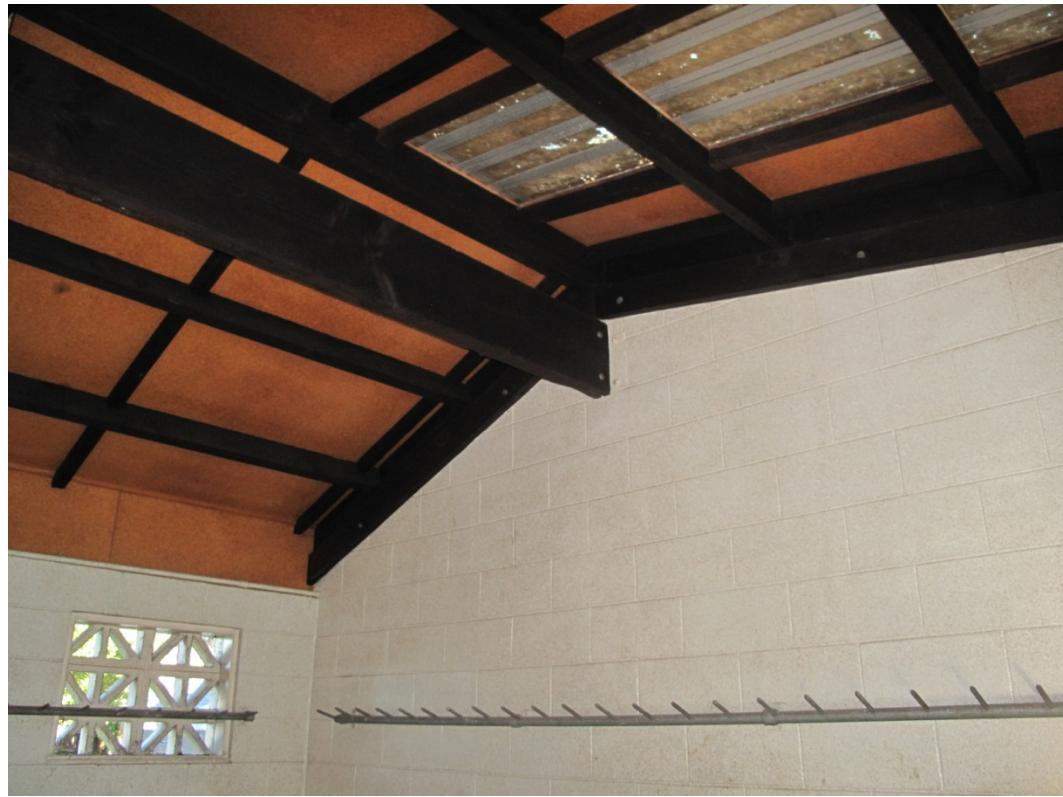
Photograph 5 Eaves beam and central beam bolted to the southern end of the block.

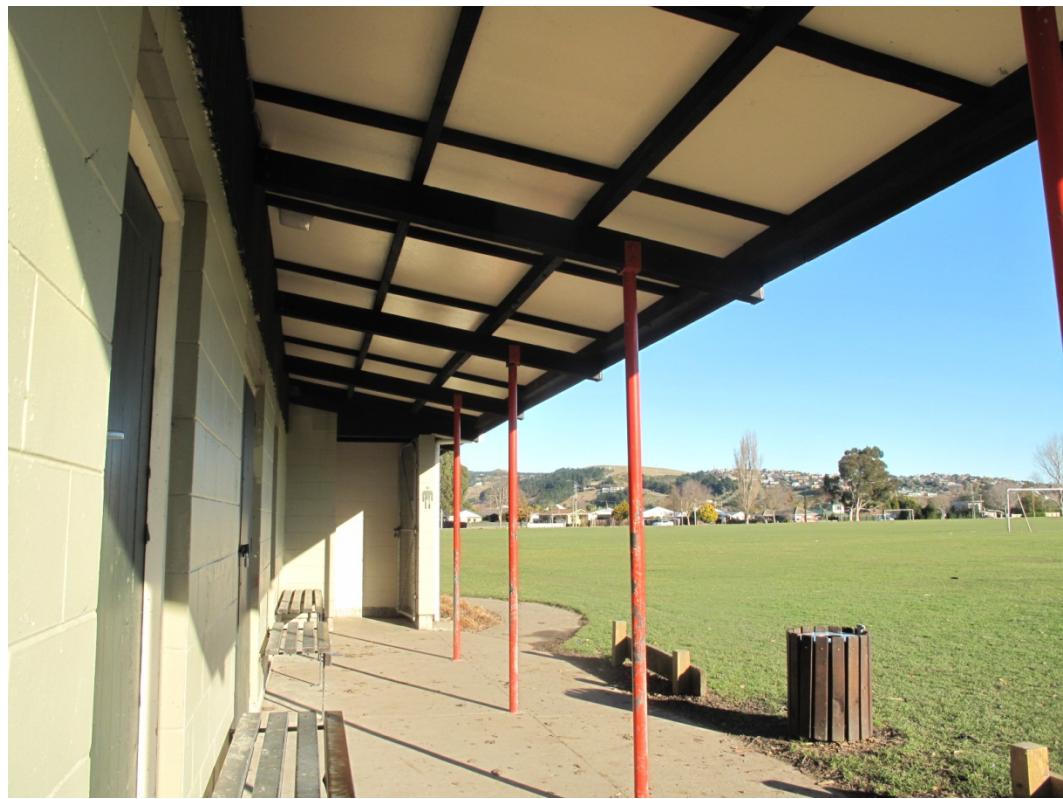
Photograph 6 Steel support posts holding up the canopy rafters.

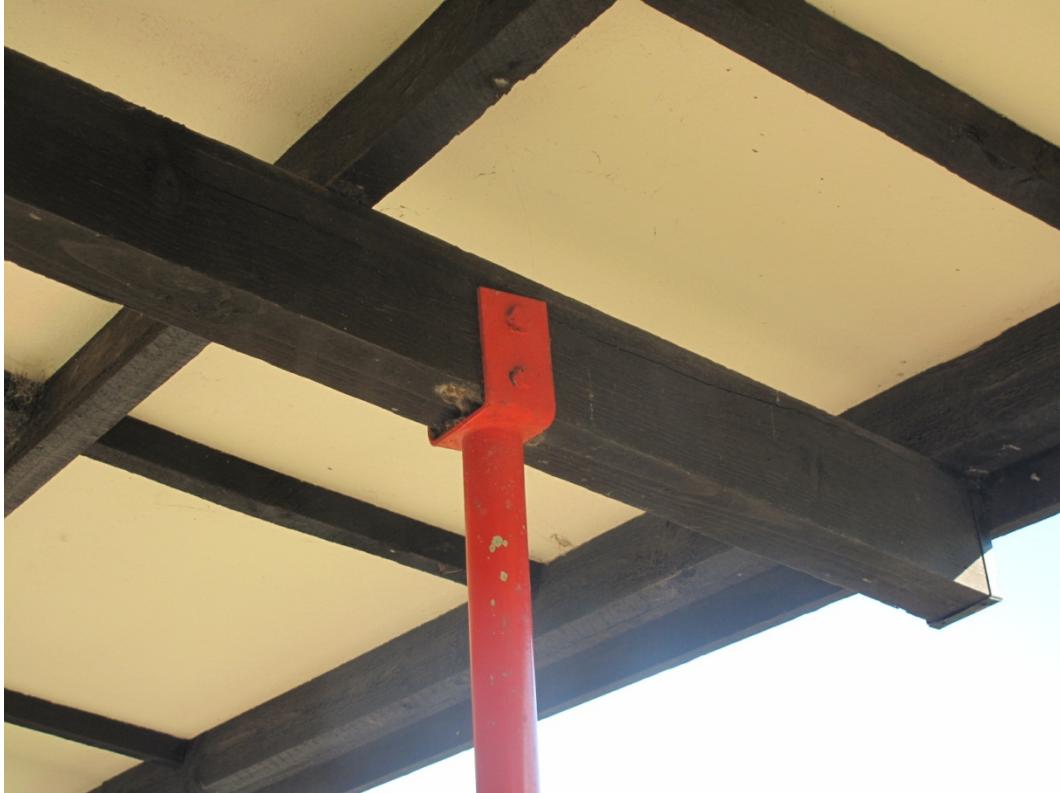
Photograph 7 Connection between the steel support posts and canopy rafter.

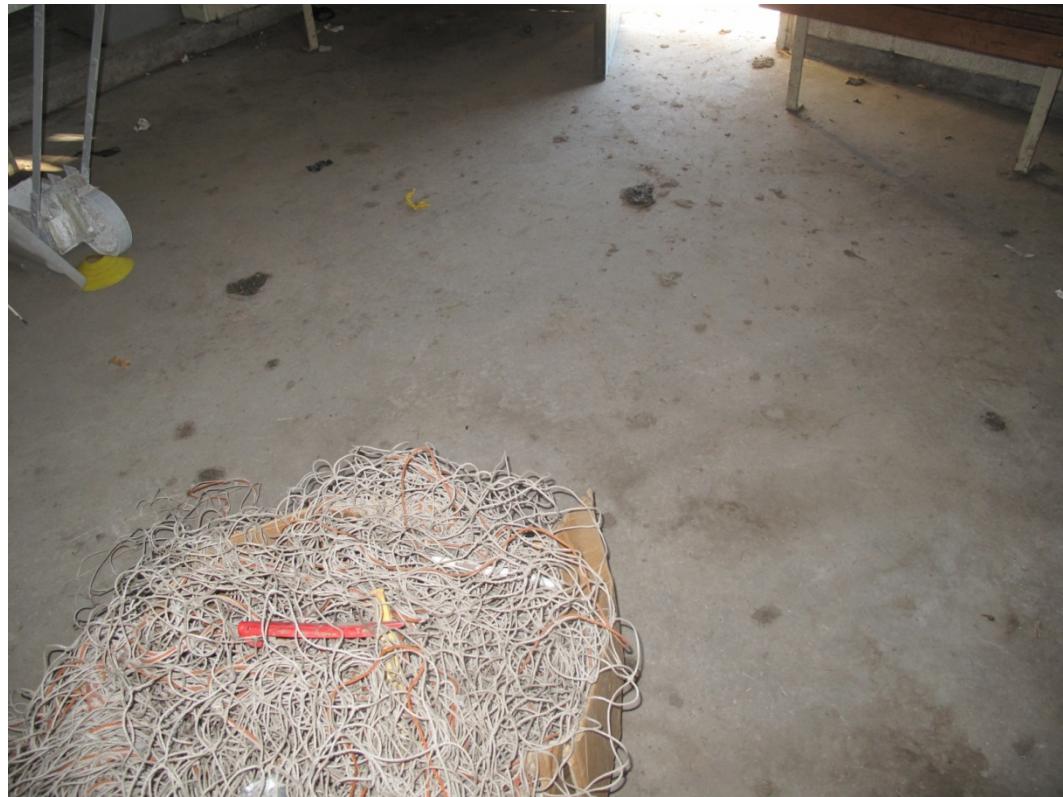
Photograph 9 No visible damage to the slab on grade flooring.
