**Cleland Street
Housing Complex
PRO 0378**

**Detailed Engineering Evaluation
Quantitative Assessment Report**

8 Cleland Street, Belfast, Christchurch

Date: December 2013

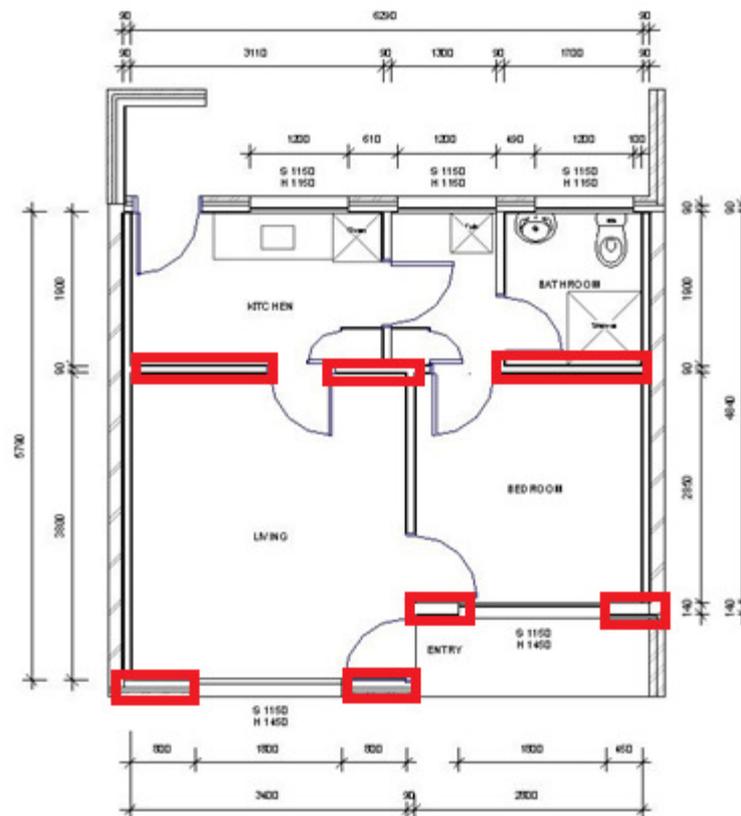
Figure 6: Walls used for bracing in the longitudinal direction.

The residential units have a capacity of 54% NBS as limited by the in-plane shear capacity of the timber-framed shear walls in the longitudinal direction.

- Veneer at height (gable ends) have the veneer ties checked.
- Cosmetic repairs be undertaken as required.
- Strengthening schemes be developed to increase the seismic capacity of the residential units to at least 67%NBS.
- Nails (or screws) are to be placed at 150mm centres to the perimeter of the timber walls indicated in figures 6 and 7.

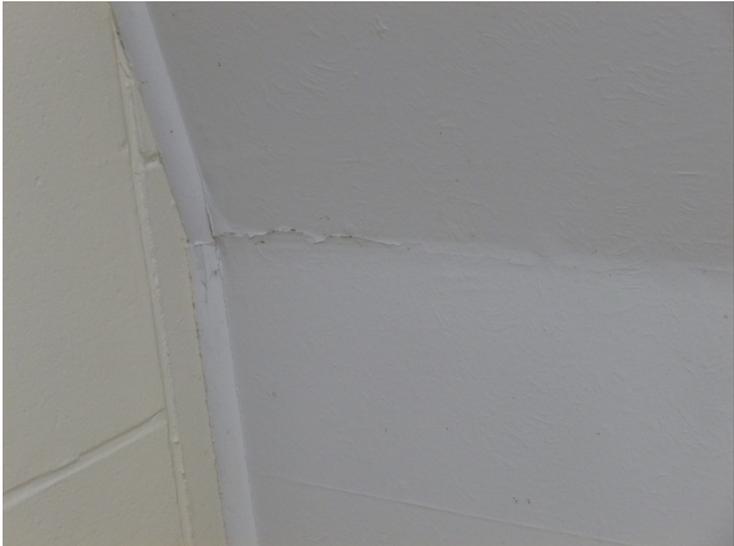
Minor damage was observed to non-structural elements. This included small amounts of cracking to paths around the complex. Minor cracking was also observed in the interior linings of all the units, especially where the plasterboard joined at the corners of windows and where wall and ceiling linings meet (photos 14-16).

14.	Cracking in interior linings along change in ceiling gradient (all units)

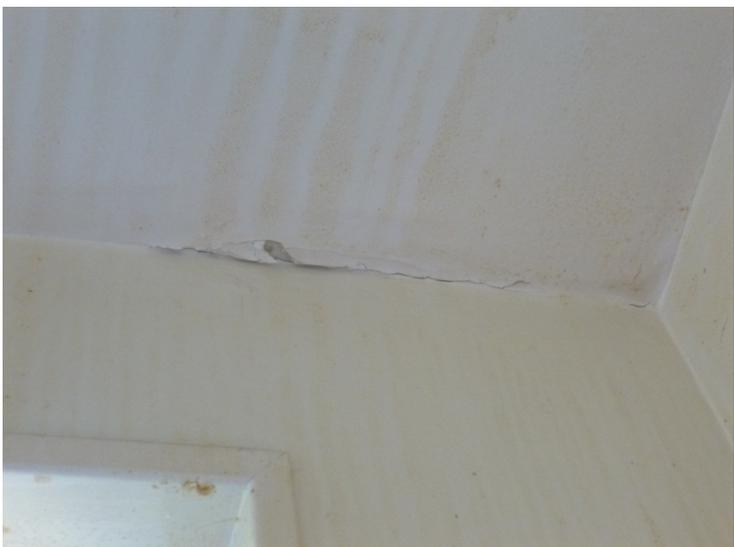
A photograph showing a crack in the white interior lining where the ceiling meets a wall. The crack runs horizontally across the wall, following a change in the ceiling's gradient.
15.	Cracking where ceiling and wall linings meet (varying degrees of severity in all units)

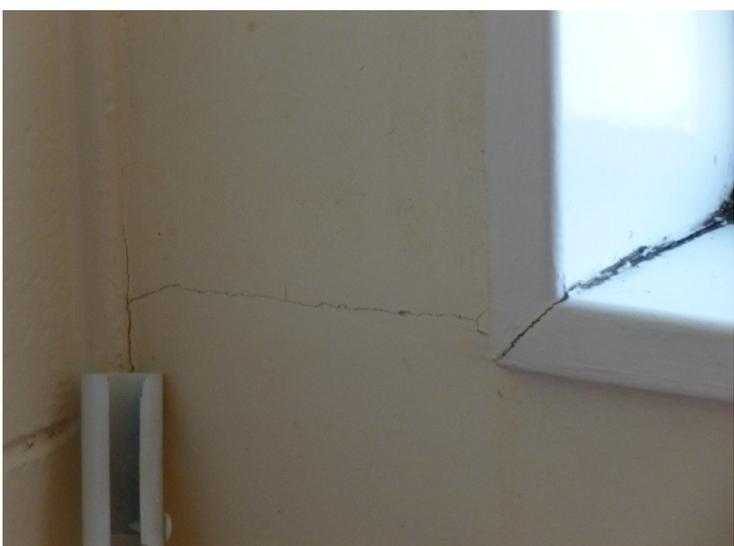
A photograph showing a crack at the junction of a white ceiling and a white wall. The crack is irregular and follows the corner where the two surfaces meet.
16.	Cracking in plasterboard joining from corners of windows (most units)

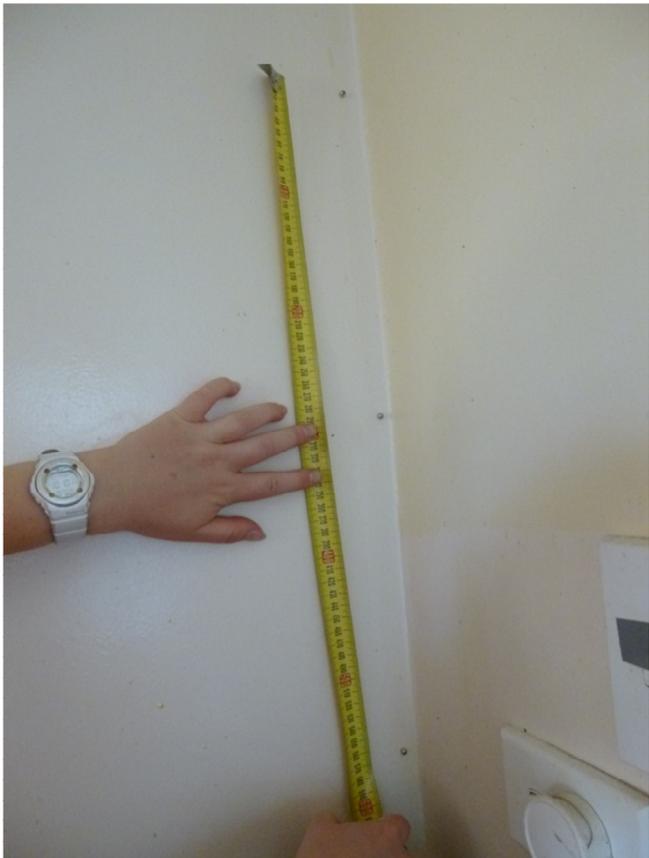
The internal lining nail spacings were measured on site to vary between 300 – 500 mm.

<p>17.</p>	<p>Plasterboard nail spacings (300 mm)</p>

Increasing the number of nails in the plasterboard will improve the performance of the structure but will not change the %NBS.

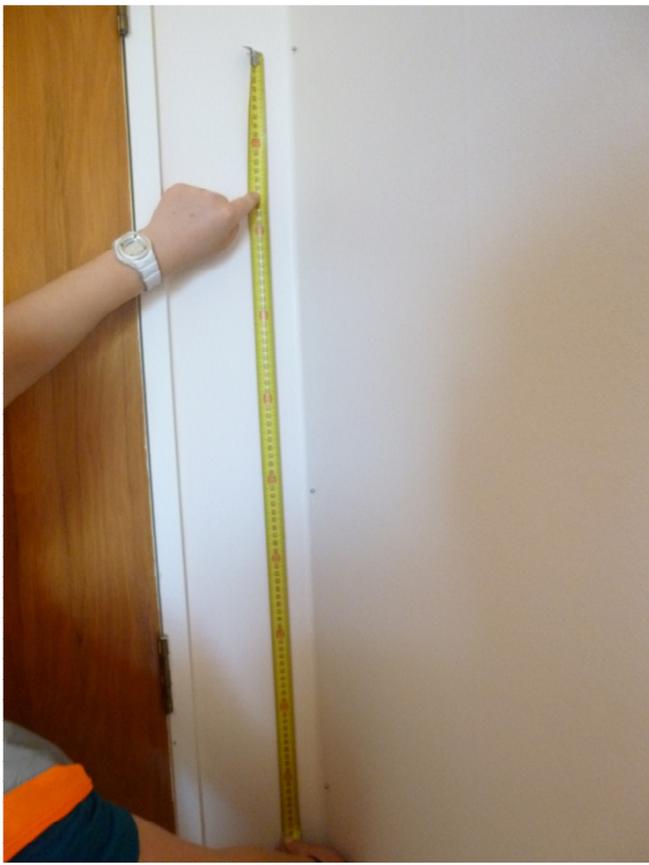
<p>18.</p>	<p>Plasterboard nail spacings (450 – 500 mm)</p>
