**Concord Place
Housing Complex
BE 1063**

**Detailed Engineering Evaluation
Quantitative Assessment Report**

Date: 24/01/2013
Reference: 6-QUCC1.95
Status: Final

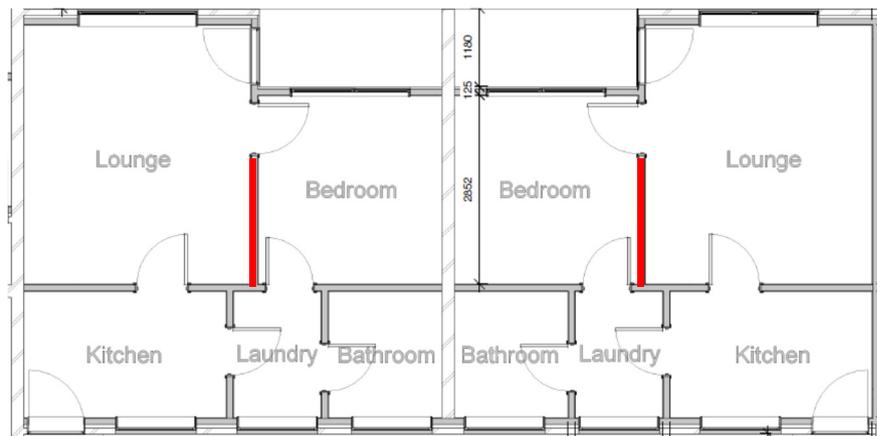
Figure 7: Critical wall for lateral capacity (shown in red) - Units 1 & 2.

Structural Element/System	Failure Mode, or description of limiting criteria based on displacement capacity of critical element.	% NBS based on calculated capacity.
Storage Garages	Bracing capacity of front shear walls in longitudinal direction.	61%
Residents Lounge	Bracing capacity of shear walls in E-W direction.	97%
Units 1-2	Bracing capacity of internal shear wall between the bedroom and the lounge.	65%
Units 3-6	Bracing capacity of shear walls in the front of the bedroom and the lounge.	49%
Units 7-10	Bracing capacity of shear walls in the front of the bedroom and the lounge.	54%

It is recommended that all buildings with an assessed capacity less than 67% NBS be strengthened to at least 67% NBS.

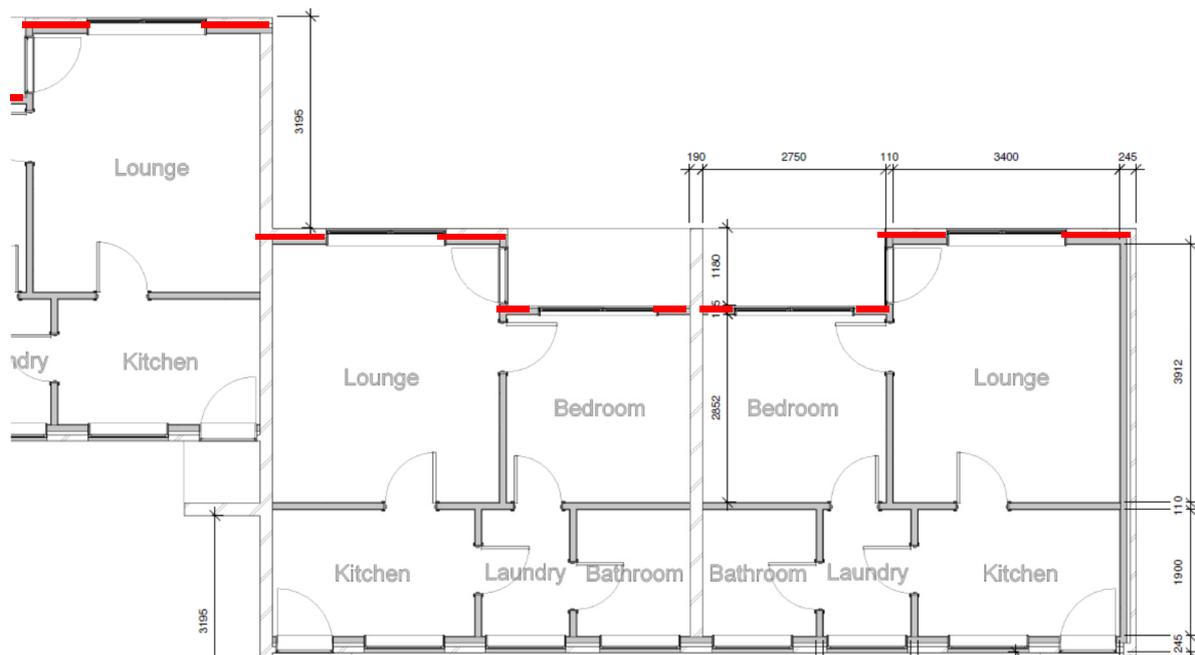
Figure 8: Critical wall for lateral capacity (shown in red) - Units 3 to 53.

Units 11-12 & 14-15	Bracing capacity of shear walls in the front of the bedroom and the lounge.	49%
Units 16-19	Bracing capacity of shear walls in the front of the bedroom and the lounge.	54%
Units 20-23	Bracing capacity of shear walls in the front of the bedroom and the lounge.	49%
Units 24-27	Bracing capacity of shear walls in the front of the bedroom and the lounge.	54%
Units 28-33	Bracing capacity of shear walls in the front of the bedroom and the lounge.	54%
Units 34-39	Bracing capacity of shear walls in the front of the bedroom and the lounge.	49%
Units 40-45	Bracing capacity of shear walls in the front of the bedroom and the lounge.	54%
Units 46-49	Bracing capacity of shear walls in the front of the bedroom and the lounge.	54%
Units 50-53	Bracing capacity of shear walls in the front of the bedroom and the lounge.	54%

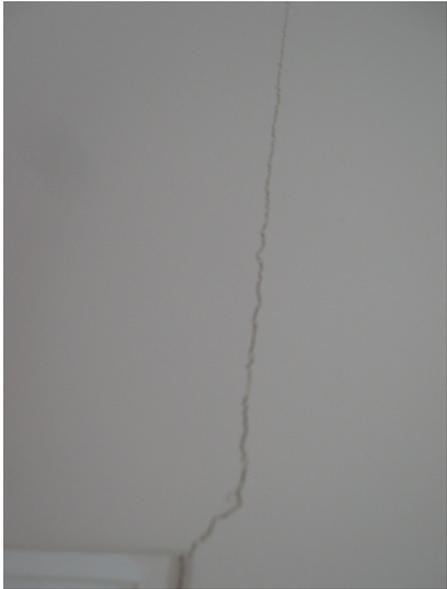
Some cracking of ceiling diaphragms was observed in Units 12 and 14. Cracking of GIB-lined walls was observed in Units 7, 8, 10, 12 and 32.

9	Unit 7; damage to wall lining around door frame.

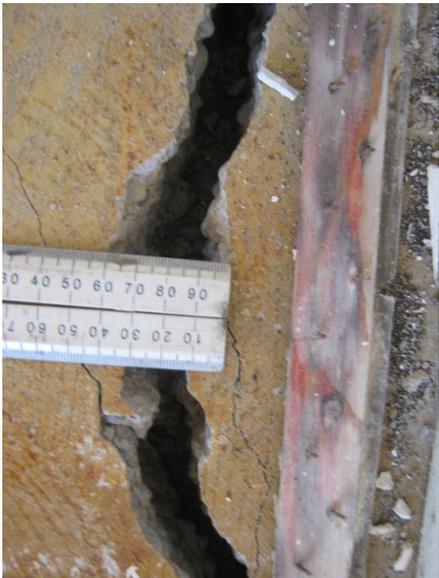
The floor slab of Unit 14 has an approximately 20mm wide crack. A 1-5mm wide crack is present in the slab between units 40 and 41. Foundation damage was not observed in the other buildings.

Evidence of cracking in the floor slabs was observed inside Unit 12 on a visit on 20/8/12. No evidence of cracking of the externally exposed floor slabs was observed on the site visit of 13/9/12. No internal inspection of floor slabs was undertaken on the site visit of 13/9/12.

11	Unit 12; damage to floor slab.

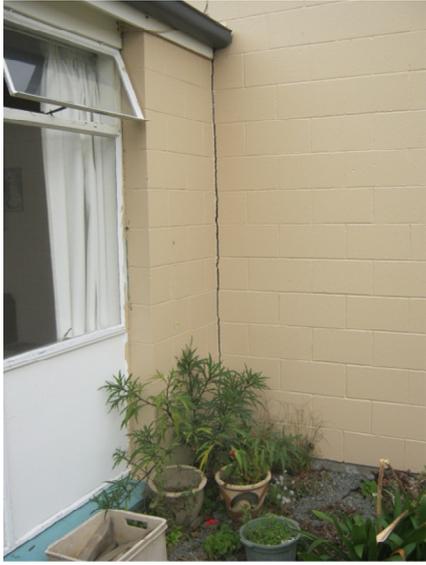
The external wall joint between Units 12 and 14 appears to have separated about 10mm. This separation was also noticed on the interior of the units where the ceiling has come away from the masonry block firewalls. It is anticipated that there was no fixing across this joint prior to the earthquakes. Similar cracking was observed between Units 43 and 44.

<p>12</p>	<p>Units 12 and 14; separation.</p>

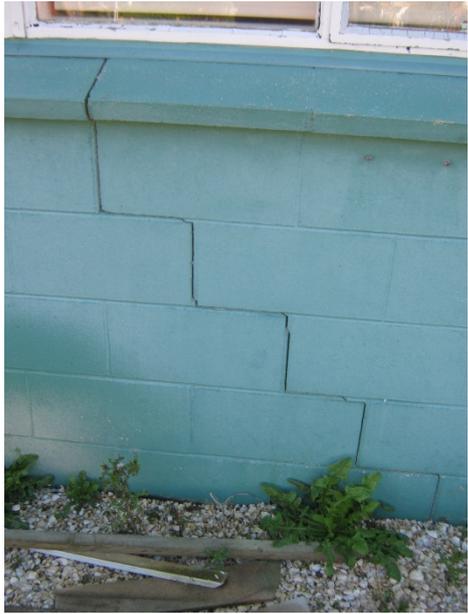
Cracking of the mortar in the brick/block cladding of Units 13, 15, 34, 37, 38, 40, 41, 42 and 43 was observed.

<p>18</p>	<p>Unit 38; damage to block veneer.</p>

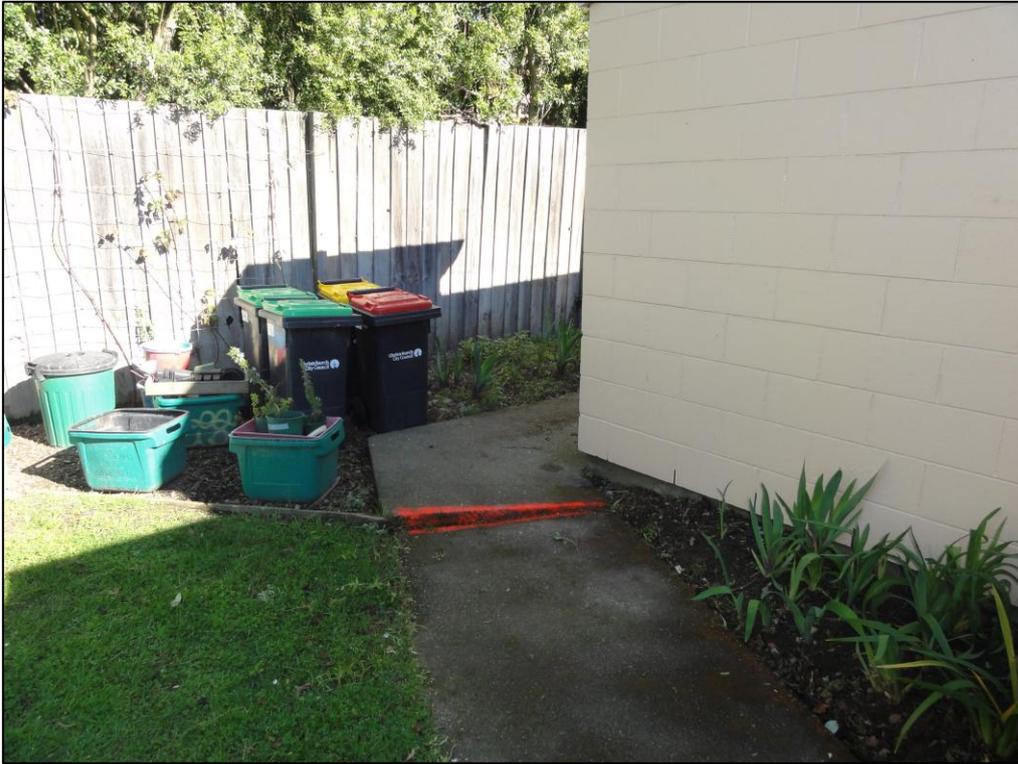
A 40mm deformation in the footpath at a corner of Unit 5 and Unit 11 was observed. The pavement at Unit 39 has displaced from the floor slab by around 20mm.

Photo 1 – Footpath displacement at SE corner of Unit No. 5

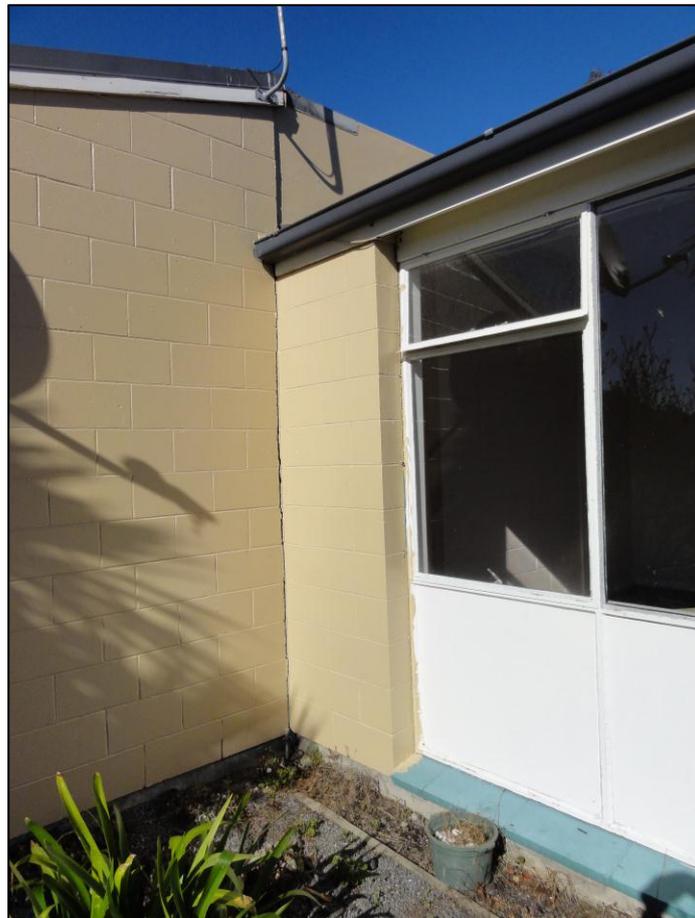
- **Unit 11 to 15:** At Unit 12 an internal wall was displaced by up to an estimated 40 mm (viewed through the window only). The external wall join between Units 12 and 14 had a vertical crack of approximately 10 mm. (photo 2). The floor slab in Unit No. 12 had cracked, with a crack width of approximately 20 mm (photo 3 - from a visit on 29/8/12). The rear wall of Units 14 and 15 had a crack running through mortar down to the floor slab which itself appeared to have no cracking (photo 4). The footpath pavement was displaced by 40 mm adjacent to Unit 11 (photo 5).

Photo 2 Vertical crack between No. 12 on left and No. 14 on right

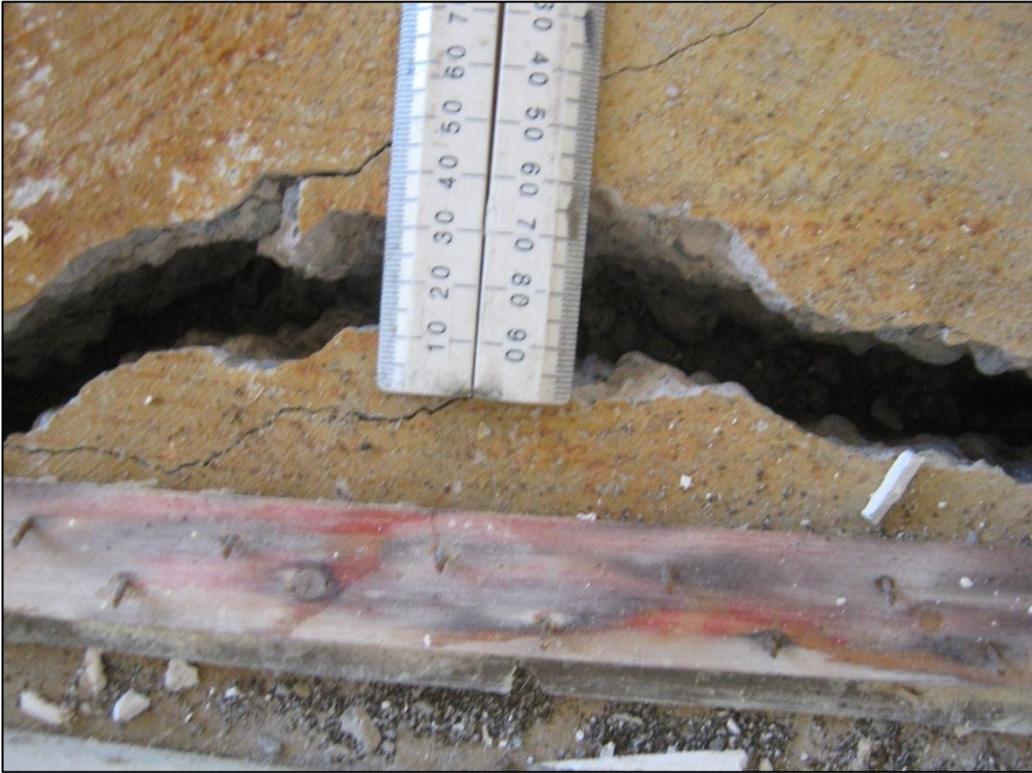
Photo 3 Cracked floor slab inside Unit No. 12 (20 mm wide)

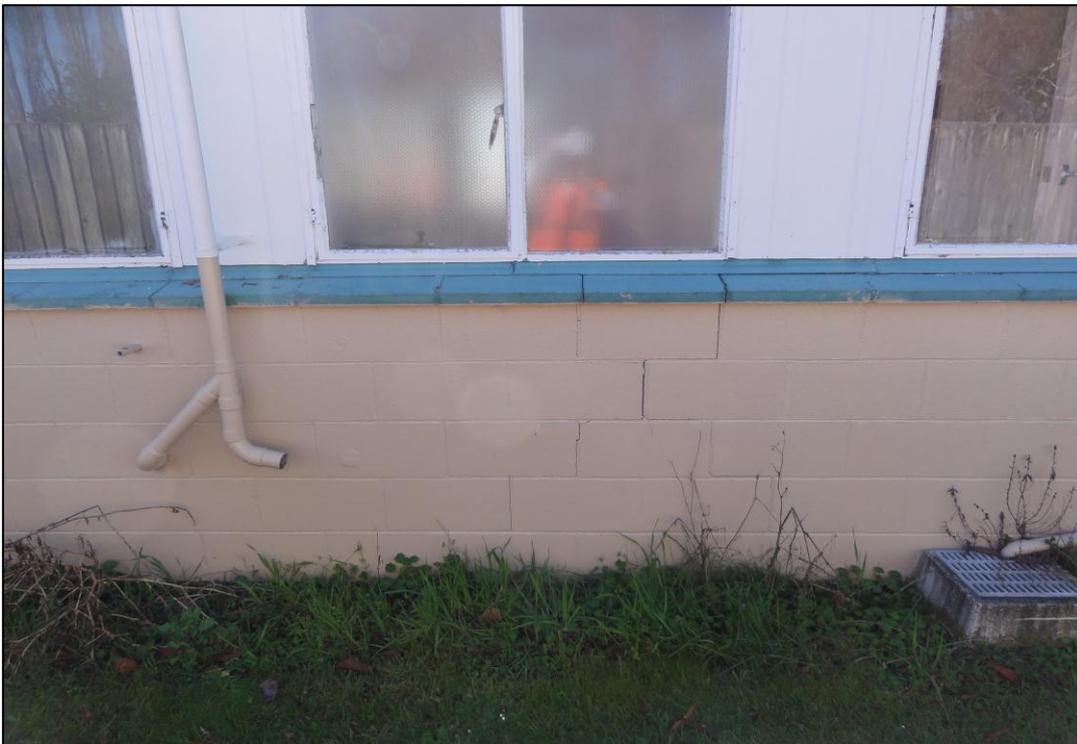
Photo 4 Step crack in the mortar of concrete masonry wall between Unit No. 15 (left) and Unit No. 14 (right)

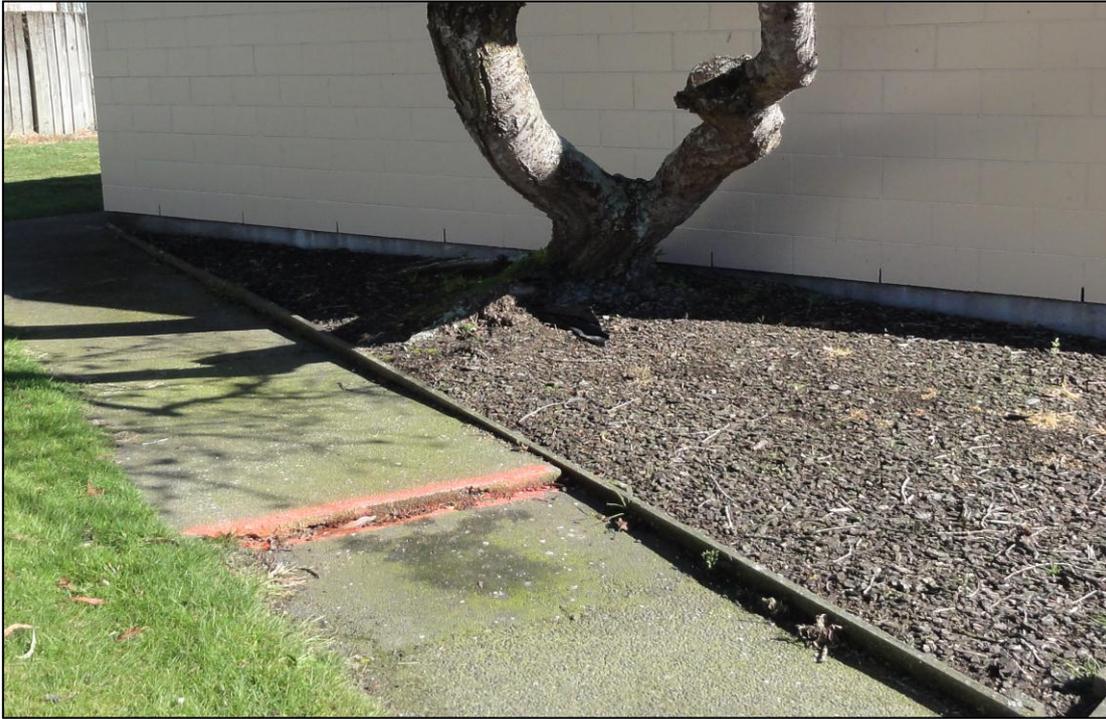
Photo 5 Footpath displacement of approx. 40 mm to the south of No. 11

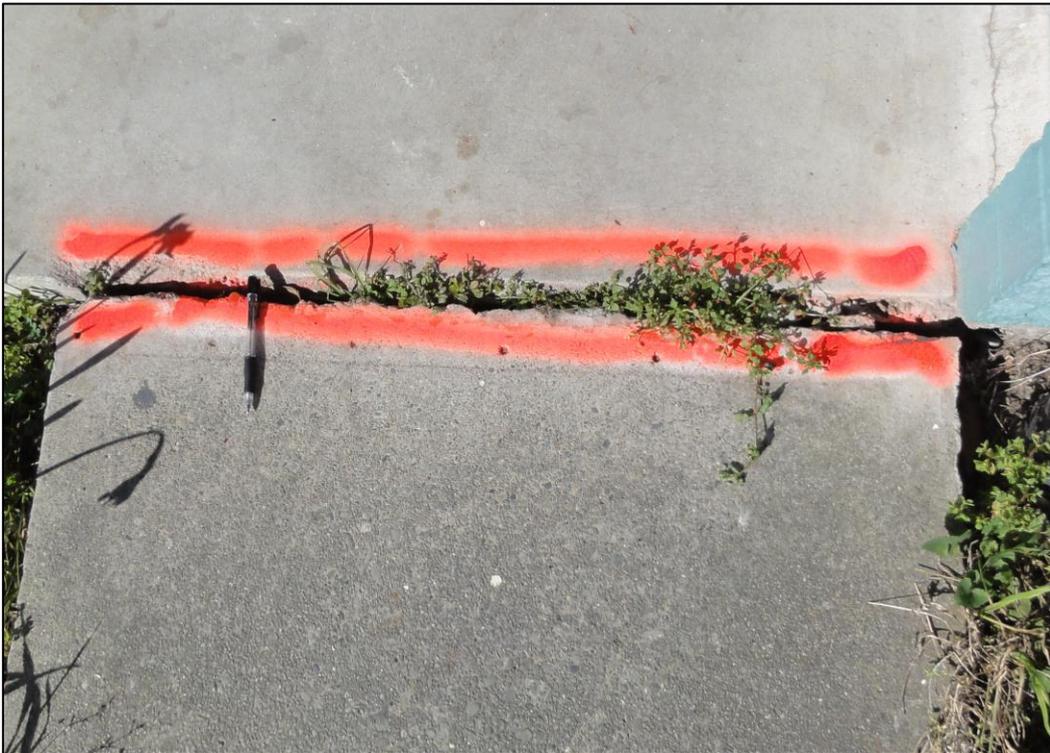
- **Units 16 to 33** had no notable signs of deformation on the external walls or floor slabs. Horizontal displacement of a concrete footpath away from the floor slab at Unit 28. Was noted (photo 6).

Photo 6 Footpath pulling away from Unit floor slab at No. 28 of 20 mm

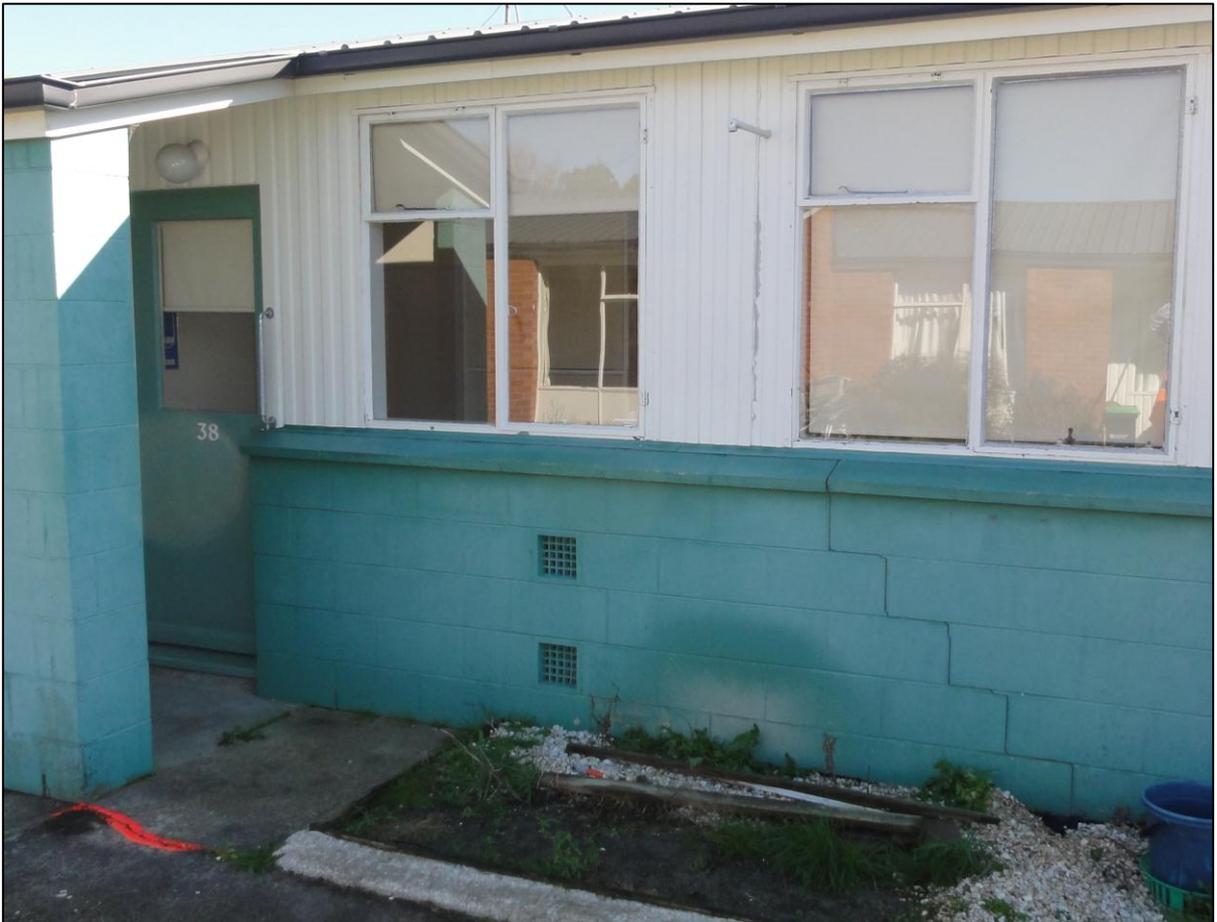
Photo 7 Step crack in mortar, south side of No. 38

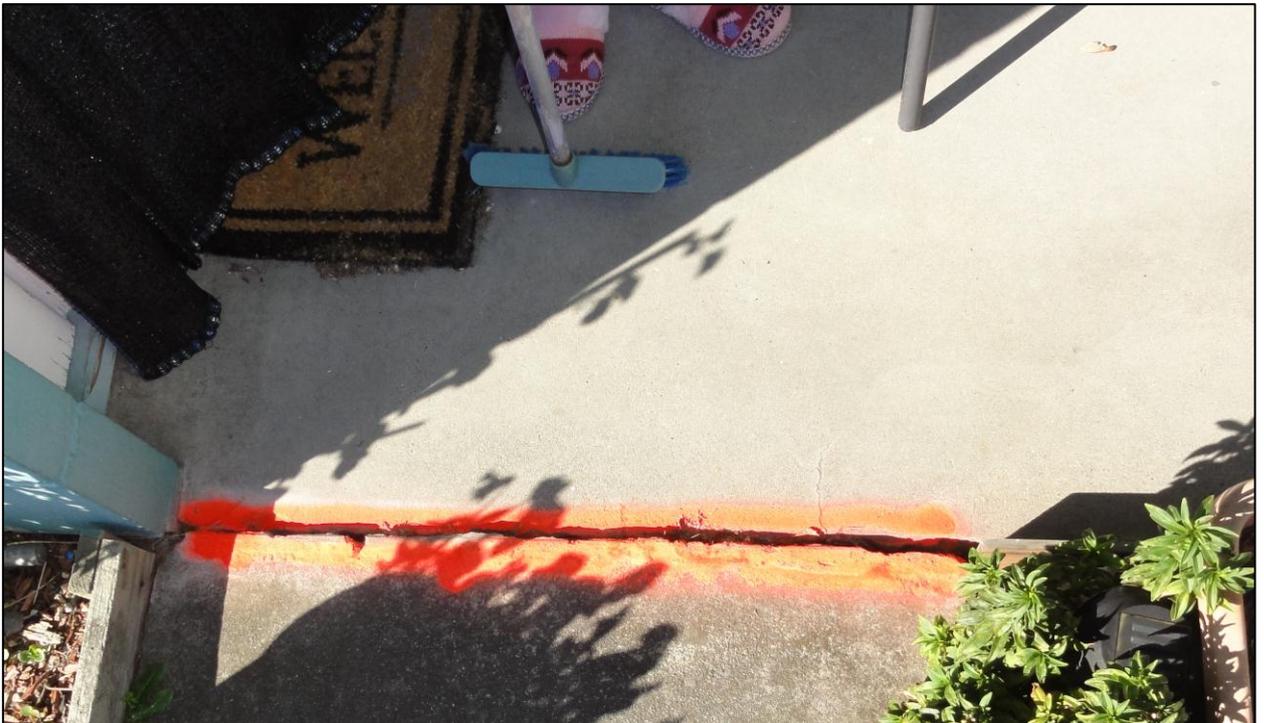
Photo 8 Footpath pulling away from Unit 39 floor slab. About 20 mm displacement horizontal and vertical (footpath up).

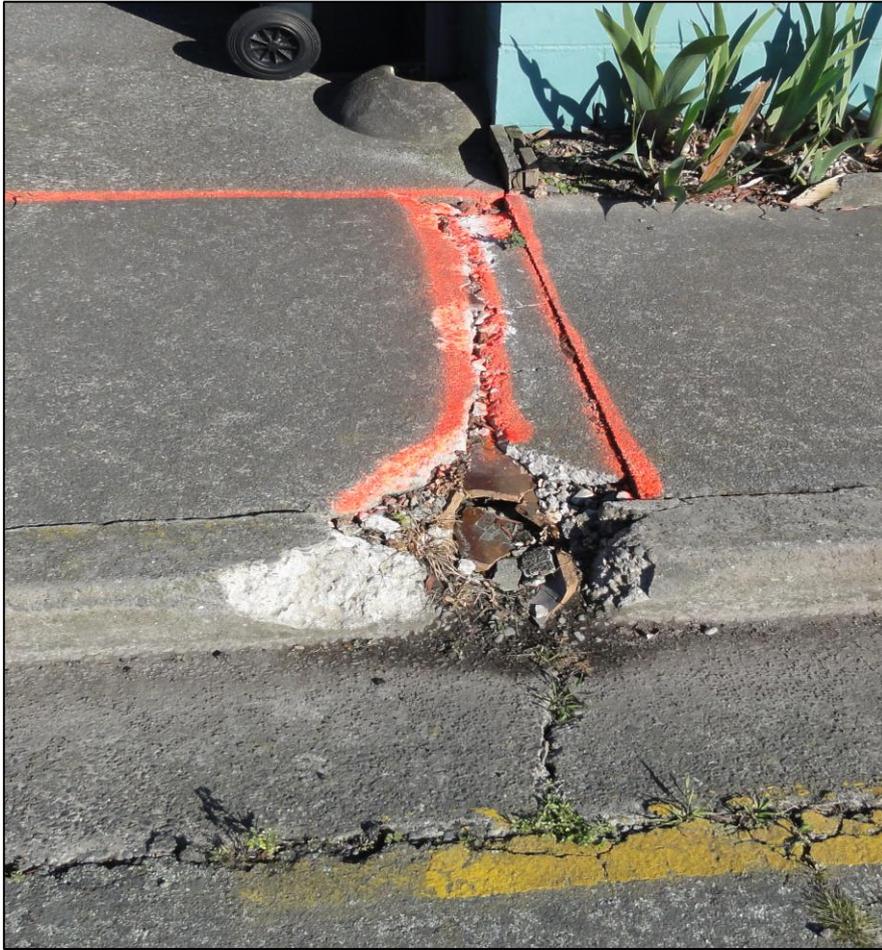
A broken clay stormwater drain was observed outside of Unit 39.

Photo 9 Broken 100 mm diameter clay drainage pipe east of Unit No. 39

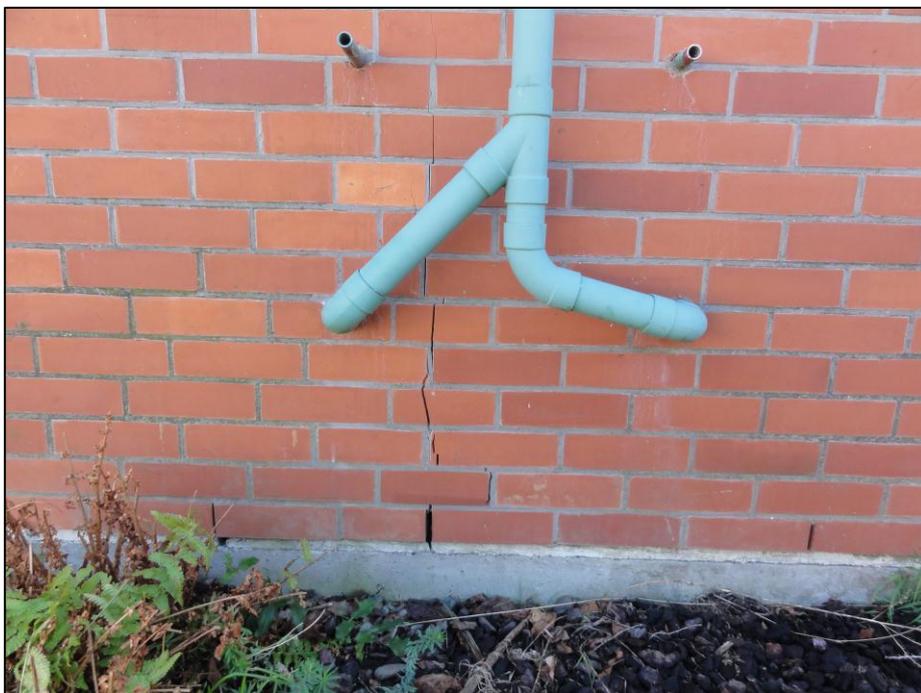
- **Units 40 to 45:** Between Units 40 and 41 a 1 to 5mm wide crack runs from the floor slab (which appears not to be cracked) through bricks and mortar for 1 m. (photo 10). A crack was noted in the wall join between Units 44 and 43. Between Units 42 and 43 a crack runs from floor slab (which does not appear to be cracked) through bricks and mortar up to a window (photo 11). At Unit 41 severe cracks (up to 20 mm wide) are present in mortar at porch (photo 12 and 12a).

Photo 10 Crack through mortar and bricks. Note intact floor slab. Unit No. 40 Left, Unit No. 41 Right.

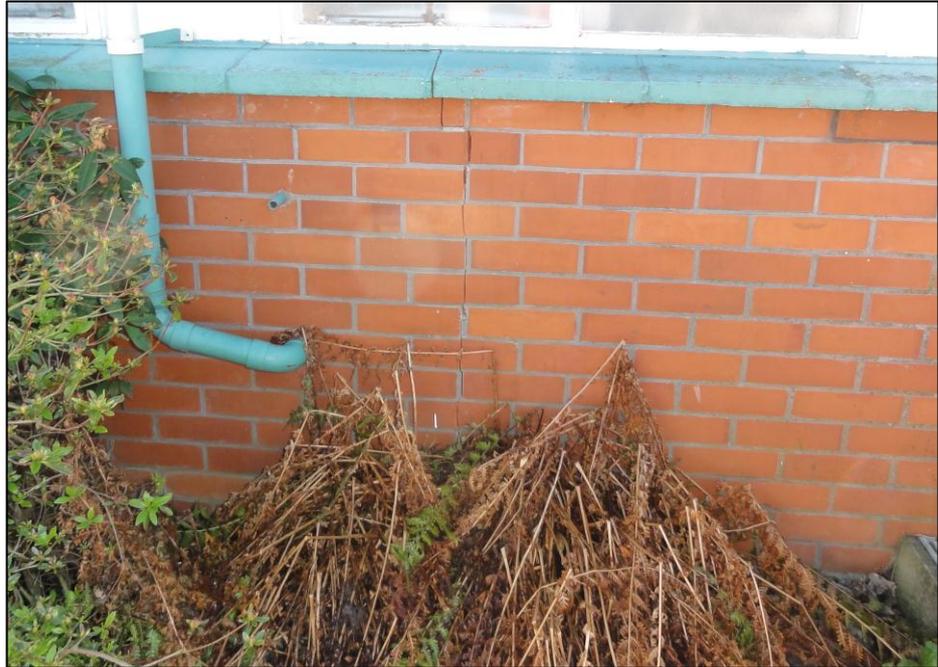
Photo 11 Crack through mortar and bricks from floor slab to window. No cracking observed in floor slab. (South wall of No. 42).

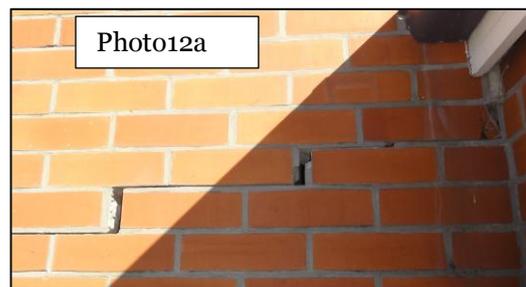
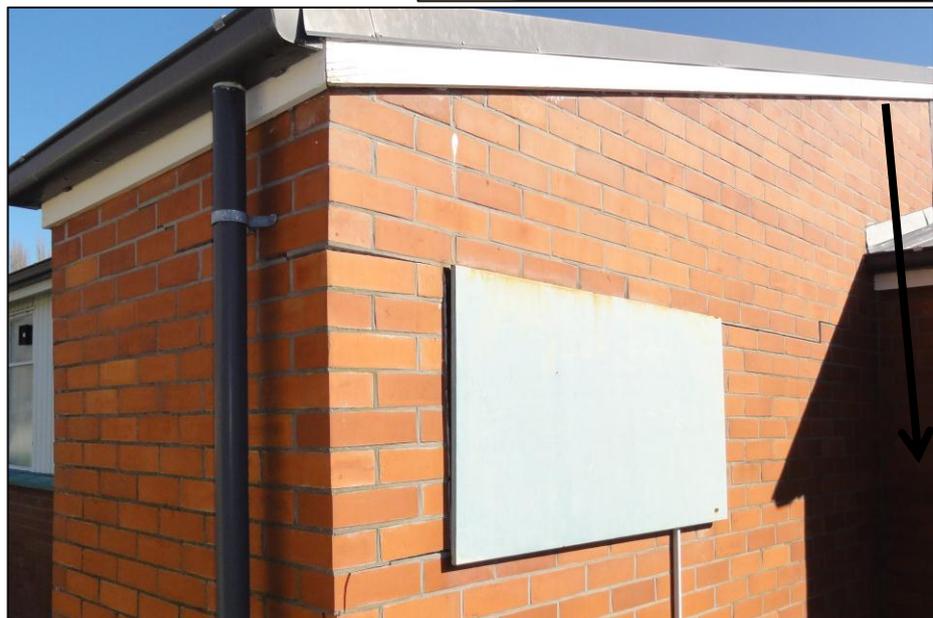
Photo 12 and 12a Cracking in mortar from downpipe to doorway on the right. Unit No. 41 porch (Unit No 42 door on right).

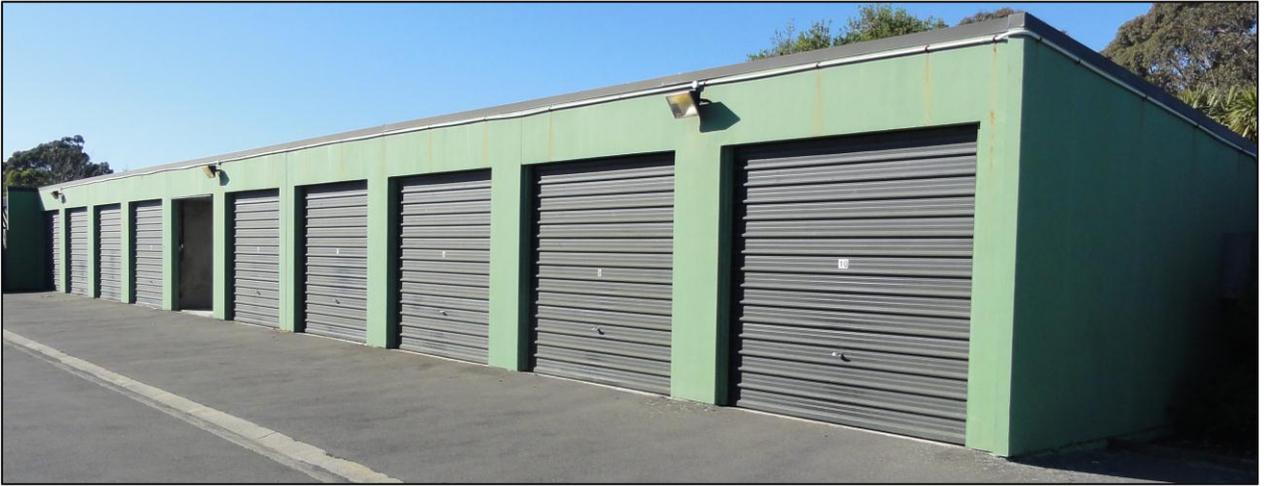
Photo 13 Garage Block No obvious visible indication of movement

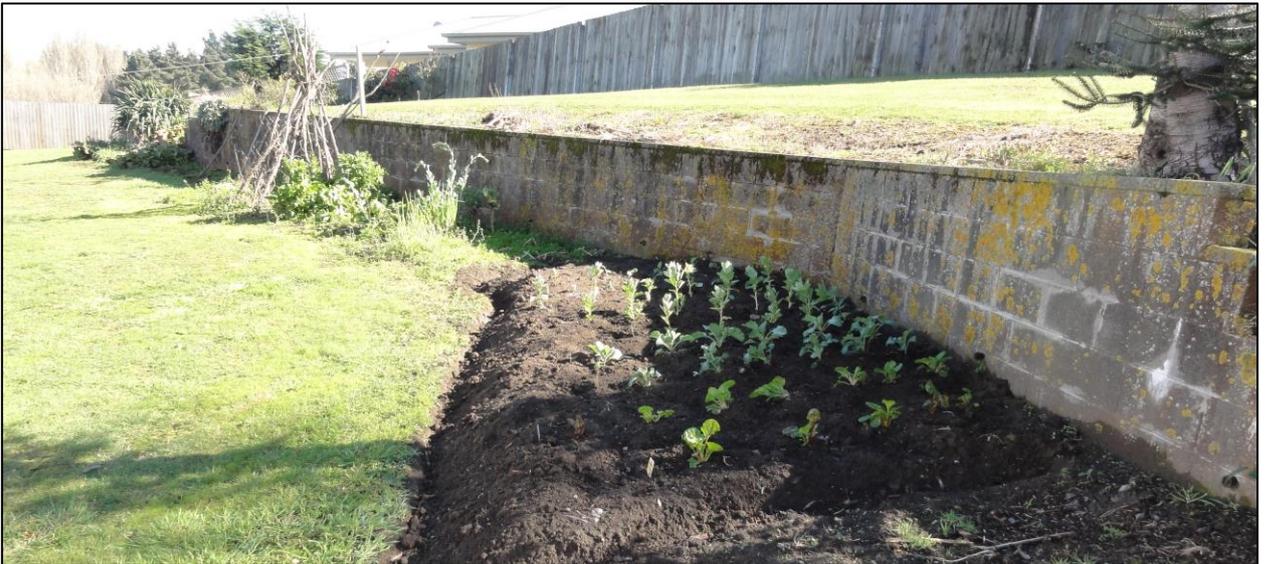
- **Garage Block** was only subject to a cursory examination where no visible defects were recorded (photo 13).
- **Retaining wall:** A concrete block retaining wall approximately 1 m high at the north end of the site, supporting higher ground to the north was examined for any movement. The wall appeared sound with no apparent cracks or displacement (photo 14).

Photo 14 Retaining wall at north of site. No obvious visual indication of movement
