# **Coronation Hall**

## **PRK 1099 BLDG 001 EQ2**

**Detailed Engineering Evaluation**

**Quantitative Assessment Report**

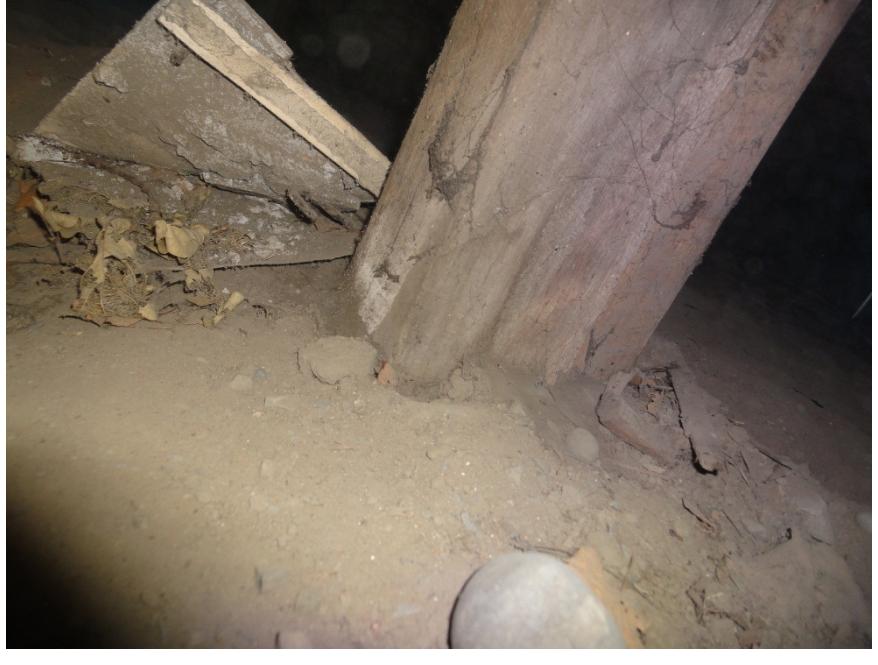
15.	Base of timber pile buried in soil (depth unknown)

1. Confirm the positive attachment of the wall bottom plate to the foundation under the original structure.
2. Inspect at least one pile location under the addition to determine the embedment depth.
3. Improve the foundation under the addition if the timber pile embedment is found to be inadequate.
4. Improve fastening of the floor framing to the foundation under the original structure and the addition (as deemed necessary by further site investigation).
5. Develop a strengthening works scheme to increase gravity capacity of the roof trusses.
6. Develop a strengthening works scheme to increase the seismic capacity of the building to at least 67% NBS.

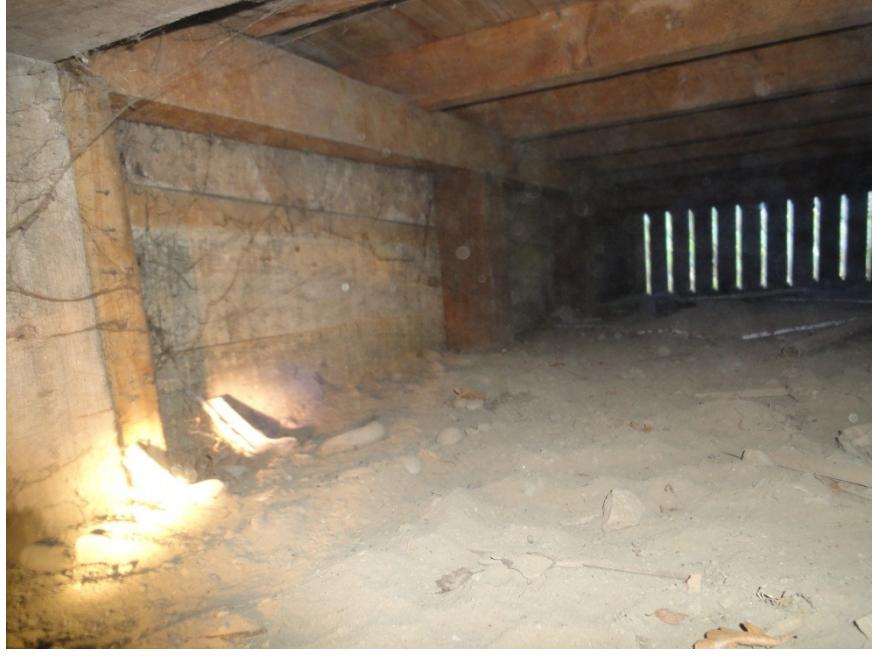
17.	<p>View of concrete foundation under the original structure from the crawl space under the addition. Timber posts are shown outboard of original concrete foundation</p>

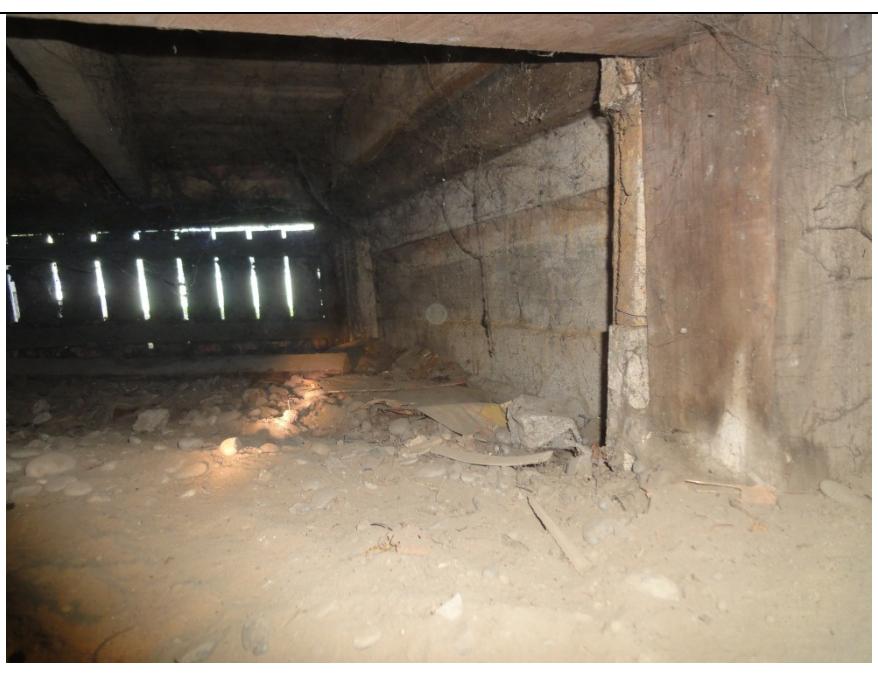
18.	<p>View of concrete foundation under the original structure from the crawl space under the addition. Timber posts are shown outboard of original concrete foundation</p>

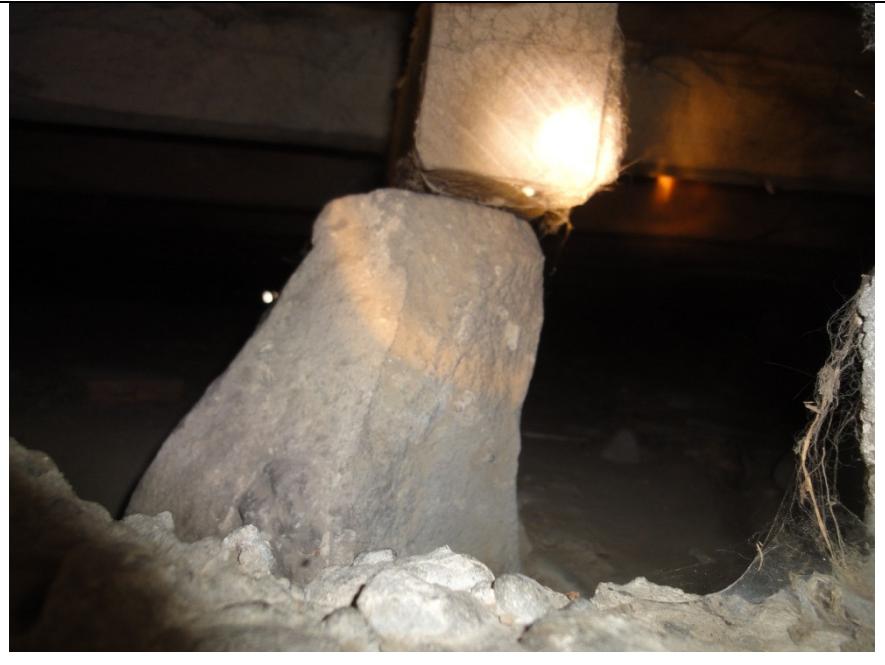
22.	Pad appears to be a piece of stone with floor framing off-centre

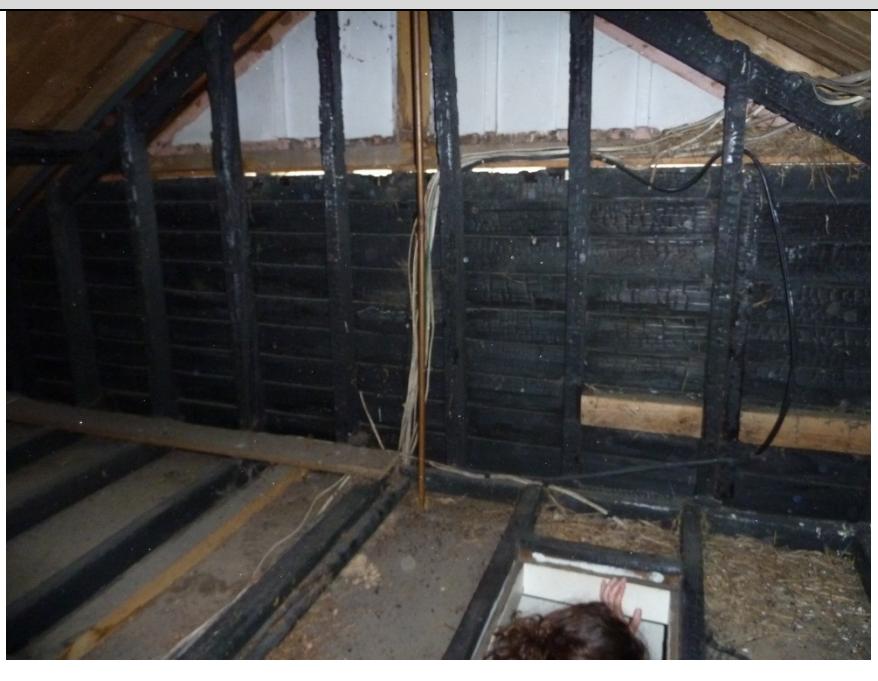
Additionally, the gable end wall and nearby roof framing at the east end of the building exhibited significantly greater damage than the timber framing at the west end. This shows that the second fire may have been concentrated toward the east end of the structure. The roof sarking has been replaced in the three eastern-most bays following the second fire while the sarking in the final two bays remains discoloured by the second fire. This provides further evidence that the second fire was greatest in the eastern-most bays of the hall.

<b>Fire Investigation</b>		
28.	Fire damage to east gable end wall

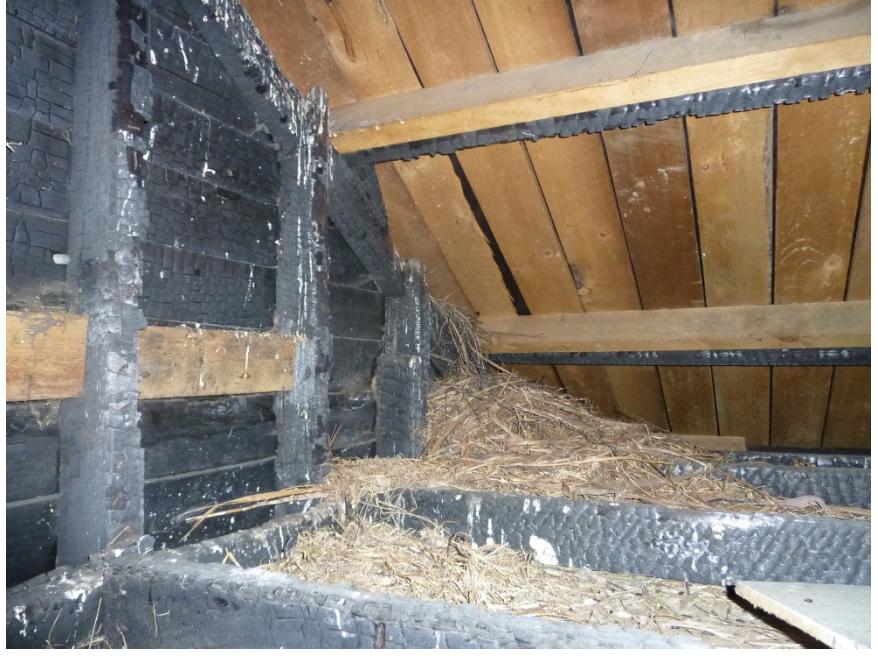
29.	East gable end wall looking toward the south-east corner. Note new straight sheathing and sistered roof purlins in adjacent bay

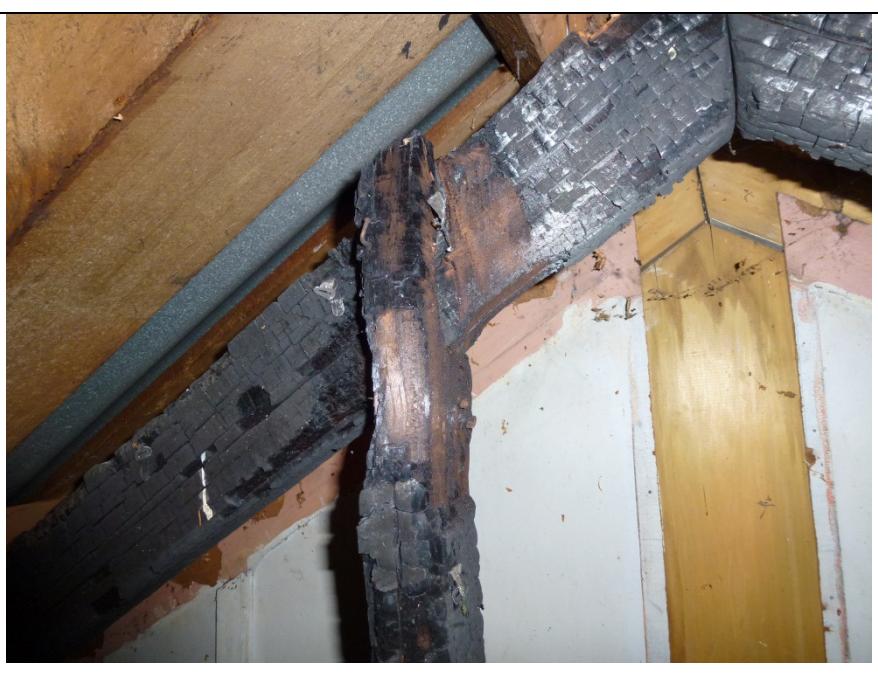
The roof trusses do not provide significant resistance for lateral loading of the structure. Therefore, the damage to these elements has not compromised the lateral force resisting system significantly. However, the gable framed walls at Gridlines A and D play a significant role in the lateral force resisting system because they must resist the loads from the roof diaphragm when the structure is loaded in the transverse direction. The primary concern is that the fire has reduced the effective cross section of the gable end wall vertical members to an extent that they could not reliably hold the wall board nails.

None of the members in the gable end walls appeared to be sistered or replaced following the second fire. Thus, the available cross-sectional area had to be field measured to determine their remaining capacity. The outer char on these members was scraped to reveal the hardwood beneath and outer dimensions recorded. These measurements were further reduced by 9.5mm on each side with char to account for the thermal degradation with an additional factor of safety. The degradation is generally considered to be contained within the first 1/4inch (6.4mm) beneath the char. Based on this effective area analysis, it was determined that sufficient cross sectional area remained beneath the heat affected zone to develop the shear strength of the nailing connections. Therefore, we do not believe the fire damage has reduced the lateral capacity of the building.

30.	Fire damage to timber stud and top chord of east gable end wall

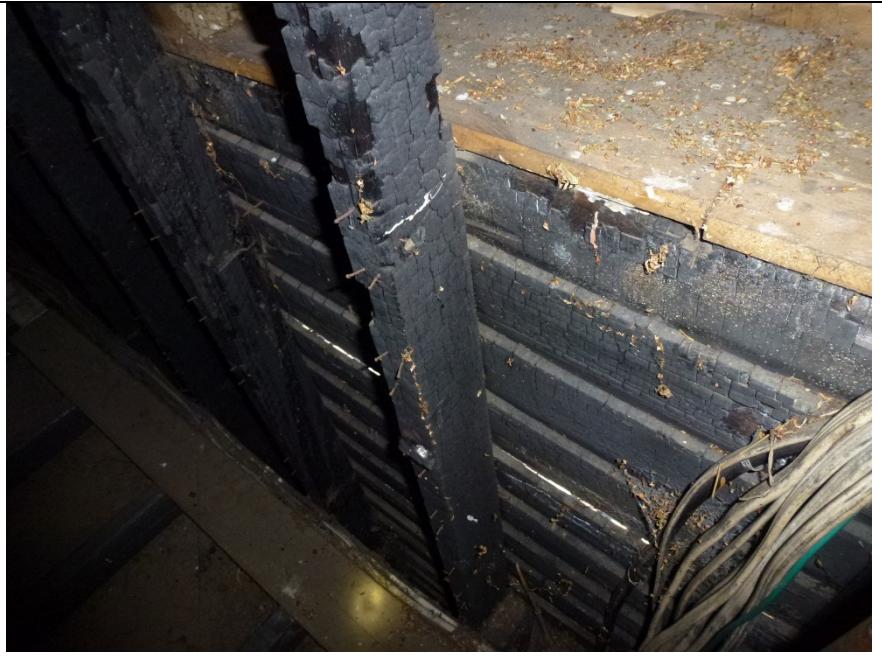
32.	Fire damage to stud of east gable end wall

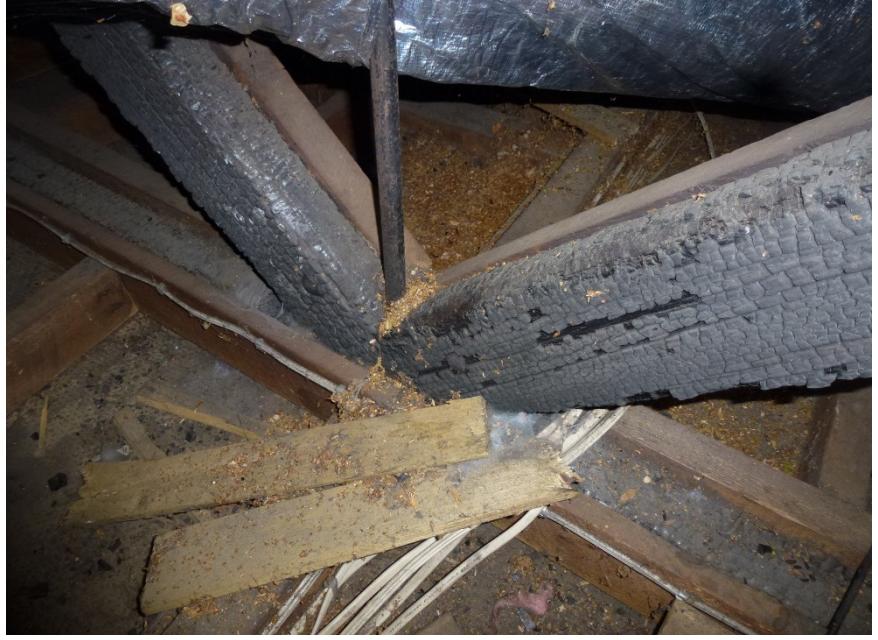
35.	<p>Connection of bottom chord, centre web members and tension rod. Note the sistered secondary truss on the far side of the original truss for all members. The bottom chord has a second sistered member to attach ceiling framing</p>

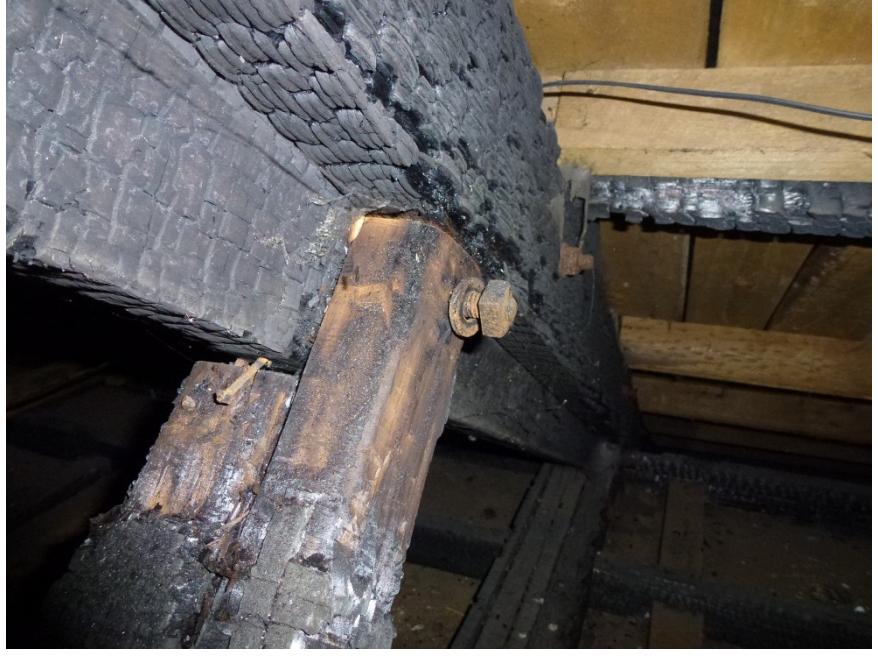
the original trusses. The secondary trusses with additional fire damage do not provide sufficient additional cross sections properties to make up for the losses to the original truss. Based on these facts, the combined properties do not provide sufficient capacity to meet the code requirements for gravity loading. Further compounding this issue is the fact that the second fire has compromised the bolting connections used to sister the two trusses, which calls into question their ability to act compositely. This can be seen in Photographs 39-41 of Appendix 1.

39.	<p>Connection of original outer web member, secondary truss web member, and secondary truss top chord to the original top chord member. Note that char has been removed from the end of the web members and the bolted connection between sistered truss has deteriorated</p>

Based on the gravity loading, it is pertinent that a strengthening plan is developed to improve the behaviour of the roof trusses if the structure is to see extended continued use. However, these trusses have behaved well for an estimated 70+ years since the second fire. Thus, it is believed that these elements do not pose an imminent collapse hazard and the structure does not need to be vacated.

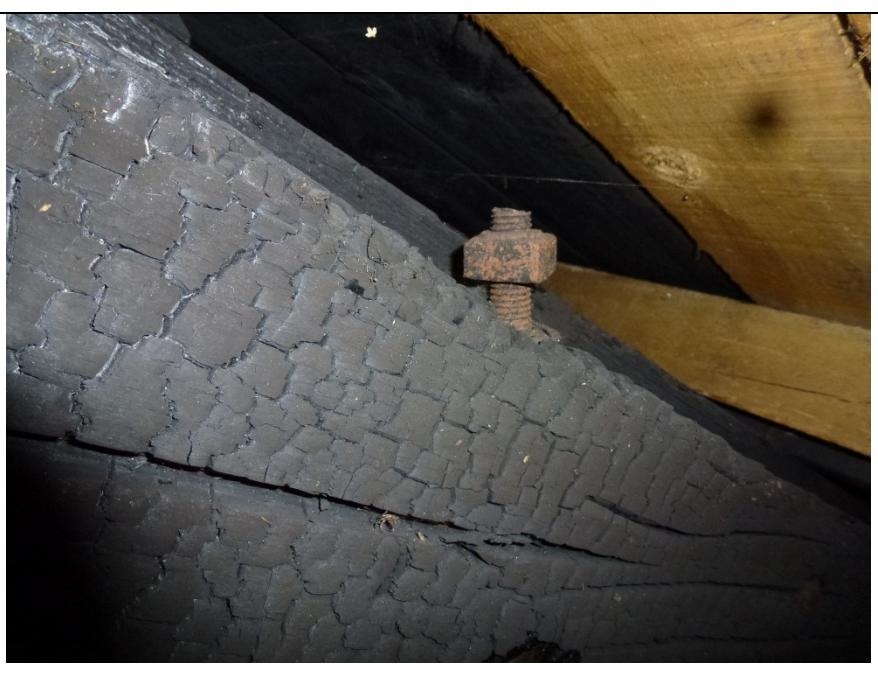
40.	<p>Deterioration of tension rod connection at the top chord</p>

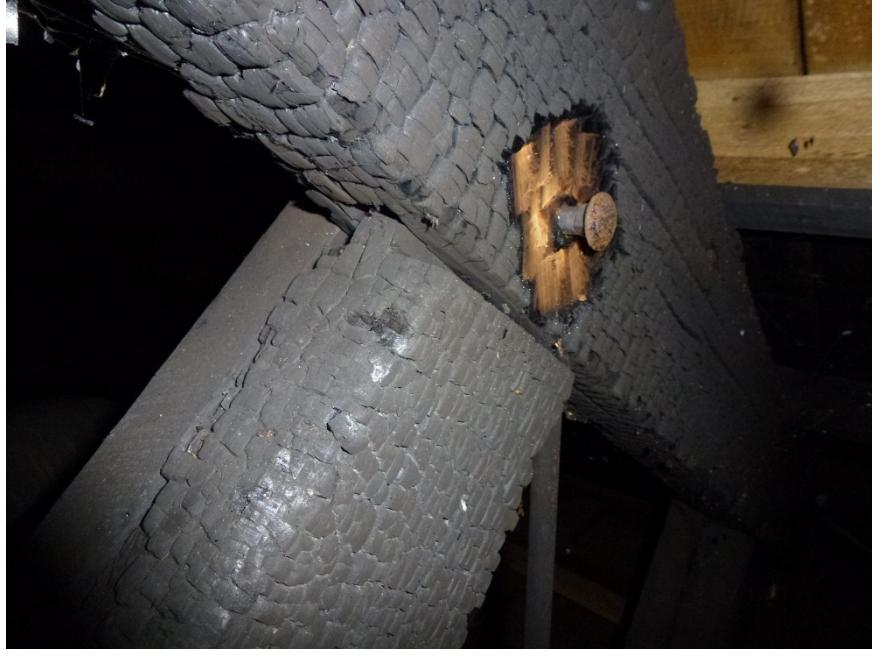
41.	Deterioration of bolted connection of secondary truss to the original truss

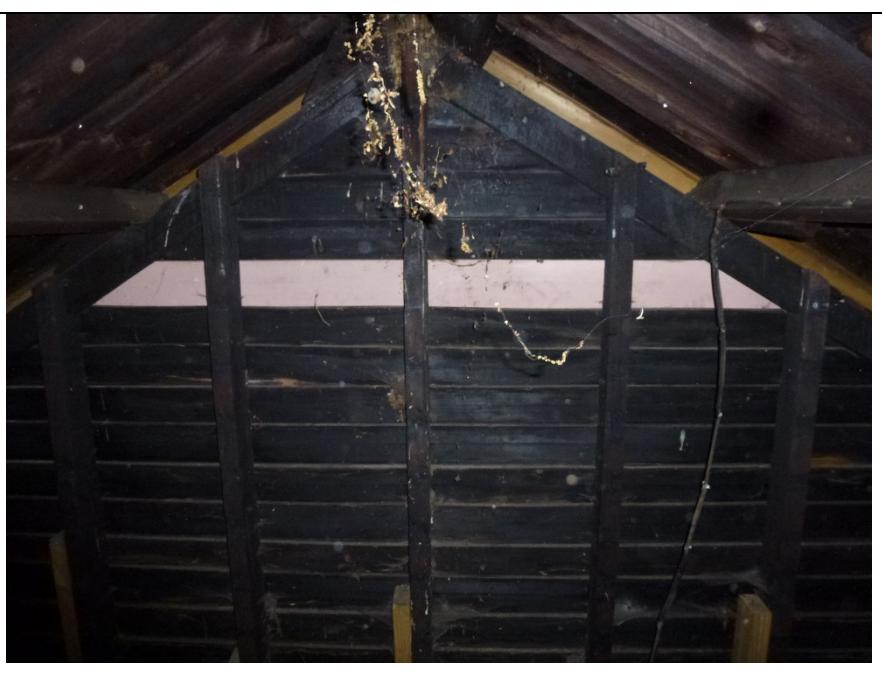
42.	West gable end wall with visible discoloration but no charring

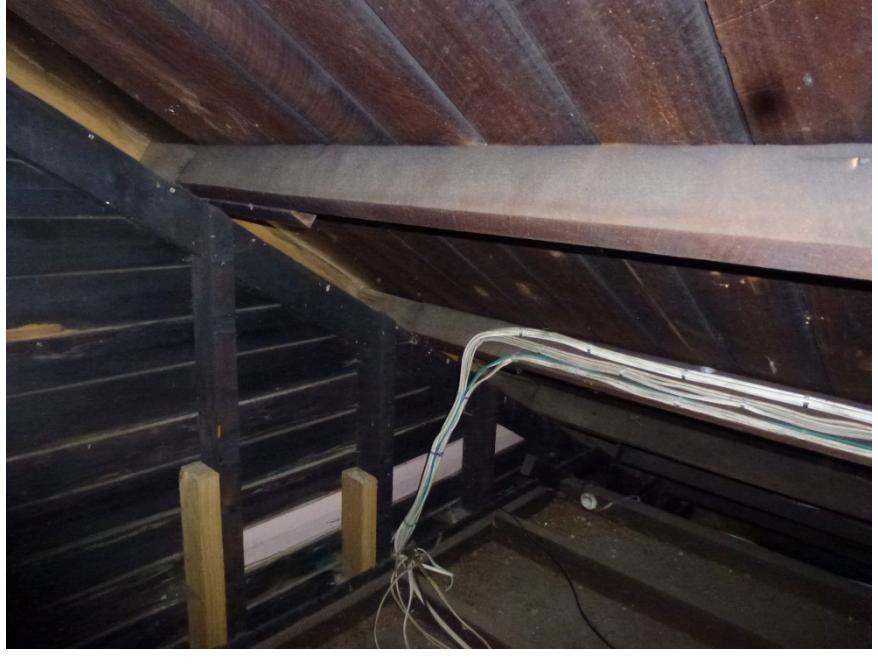
43.	<p>View looking northwest of west gable end wall. Note the straight board sheathing and roof purlins have not been replaced in this bay</p>

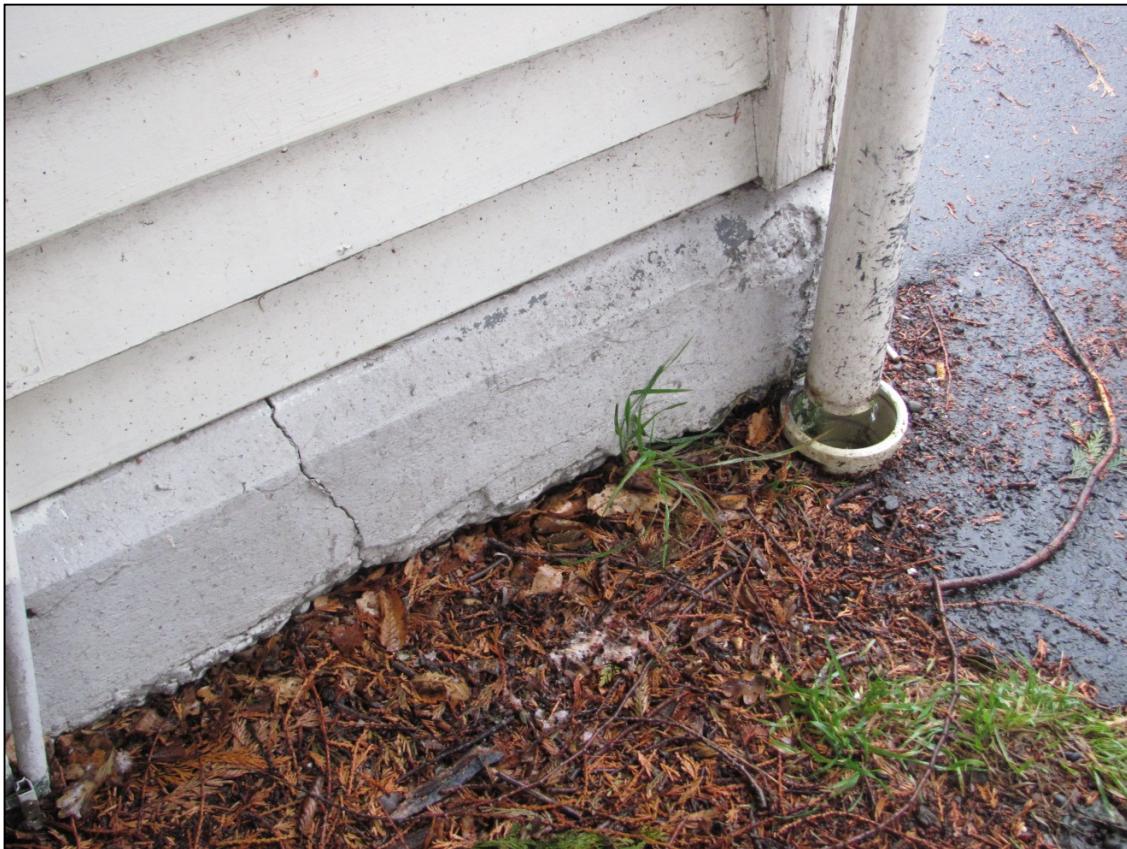
Photograph 5: View of the 3mm wide crack in the concrete footings on the eastern corner of the hall.

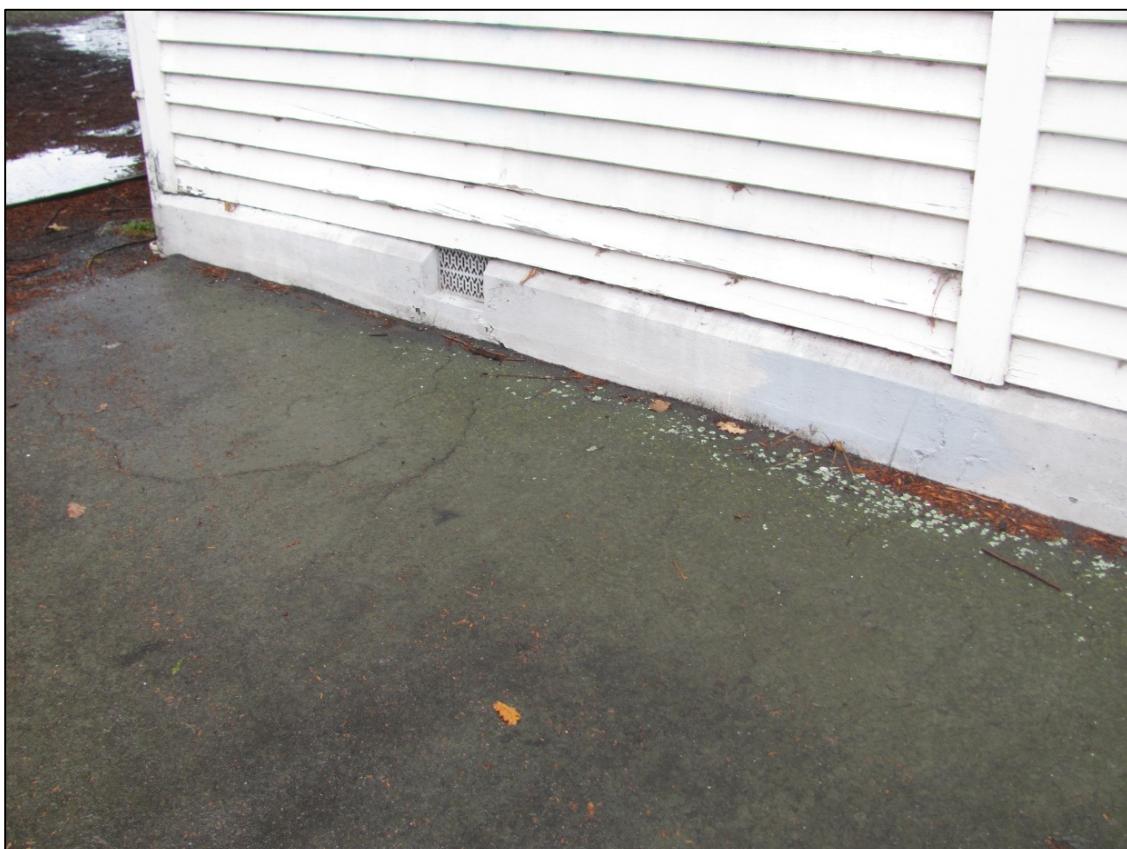
Photograph 6: View of the hairline cracks on the concrete footings on the northeast facing side of the hall.

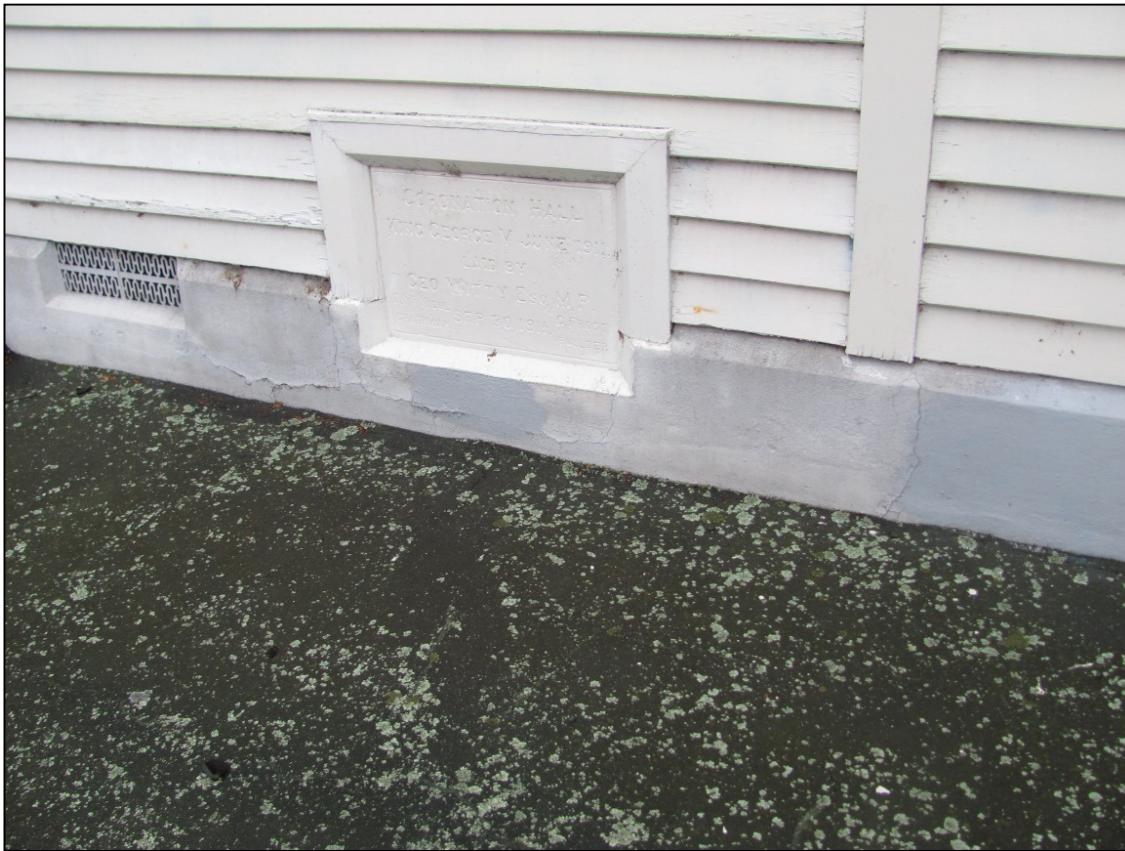
Photograph 7: View of the hairline cracks in the concrete footings on the northeast corner of the hall.

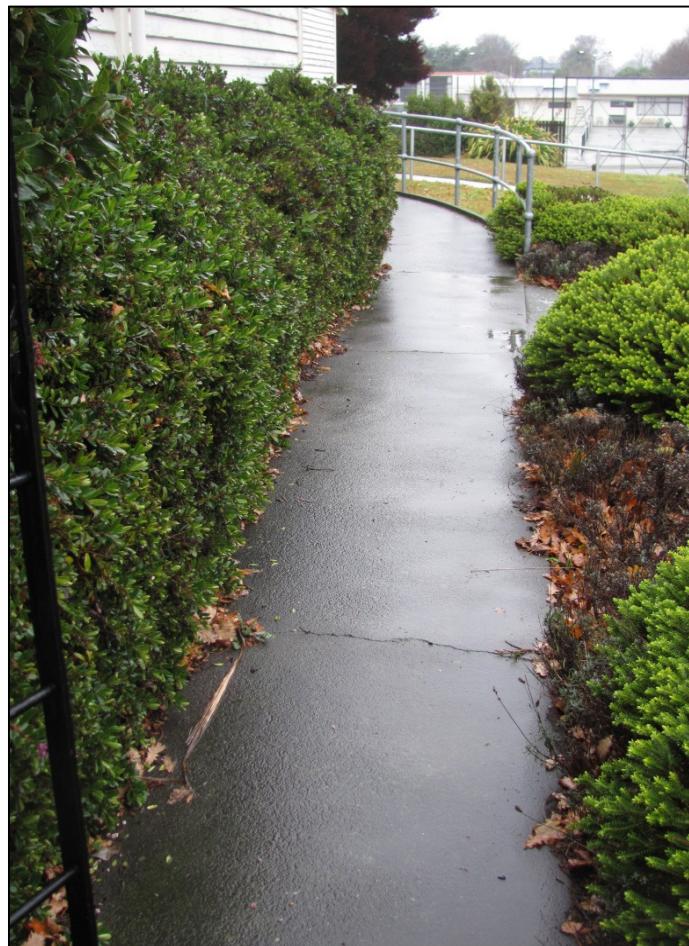
Photograph 8: View of the two 5mm wide cracks in the asphalt pavement located by the northwest side of the hall.

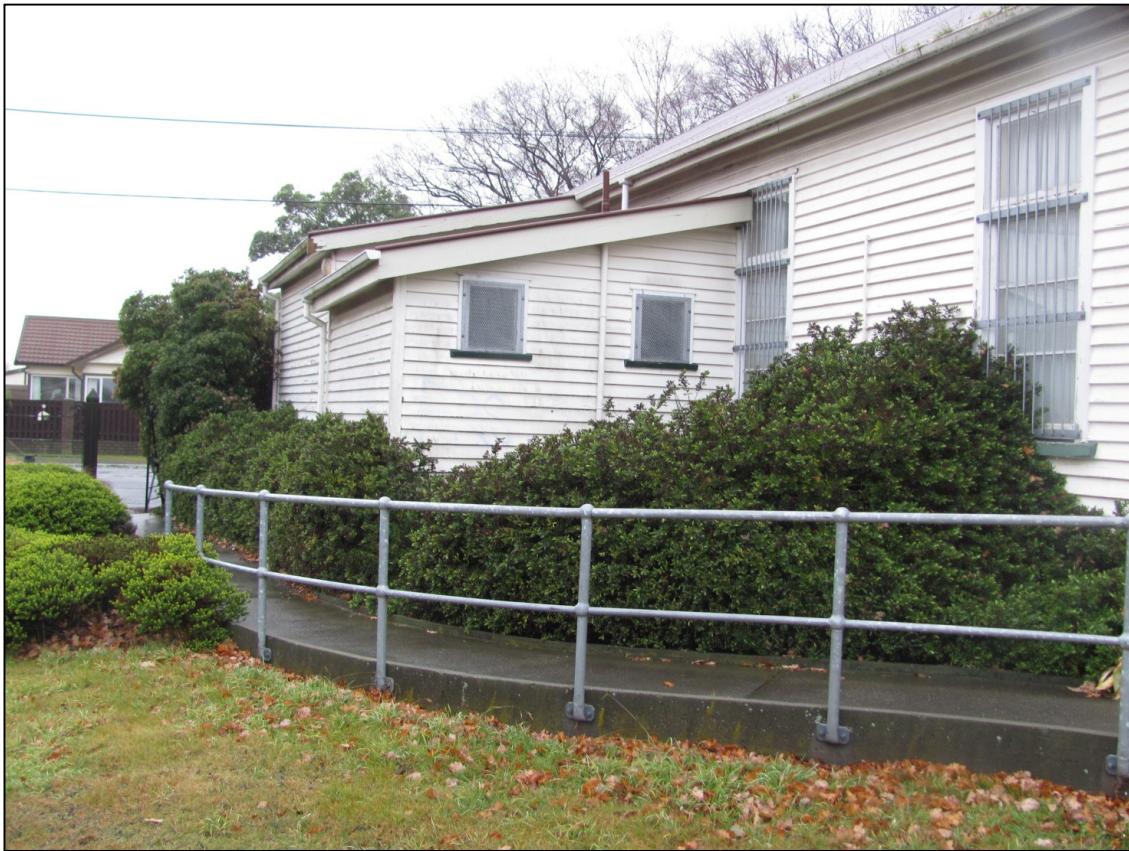
Photograph 9: View of the dense growth of shrubbery along west facing side of the hall obscures the concrete strip footings.
