CHRISTCHURCH CITY COUNCIL
PRK_1823_BLDG_006 EQ2
Coronation Hill Reserve - Storage Shed
Cnr Dyers Pass & Summit Road, Governors Bay

QUALITATIVE ASSESSMENT REPORT

FINAL

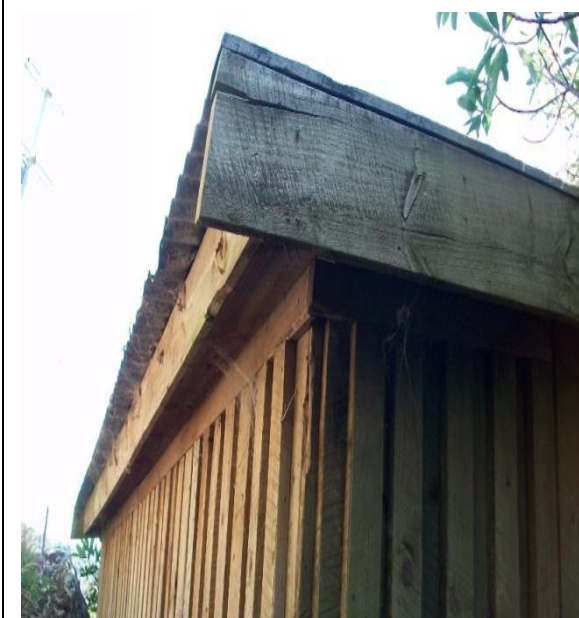
Photo 3: Crack in timber roof beam on the southeast corner

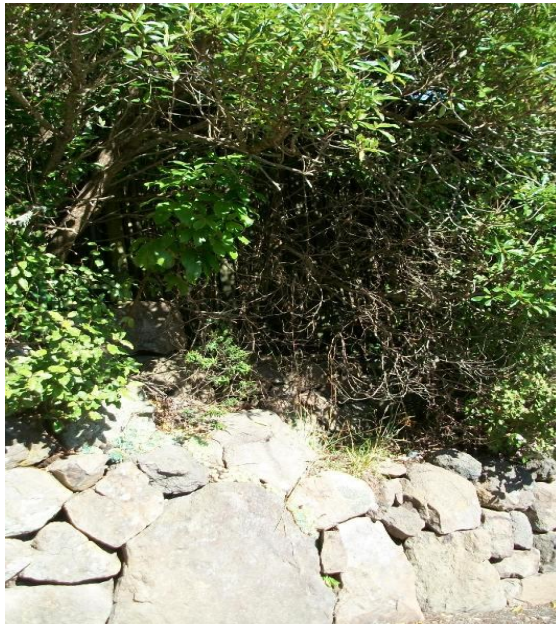
Photo 5: Steep ground slope to the west of the structure.

- Investigation of rock fall hazard on site and the stability of the slopes near the structure.

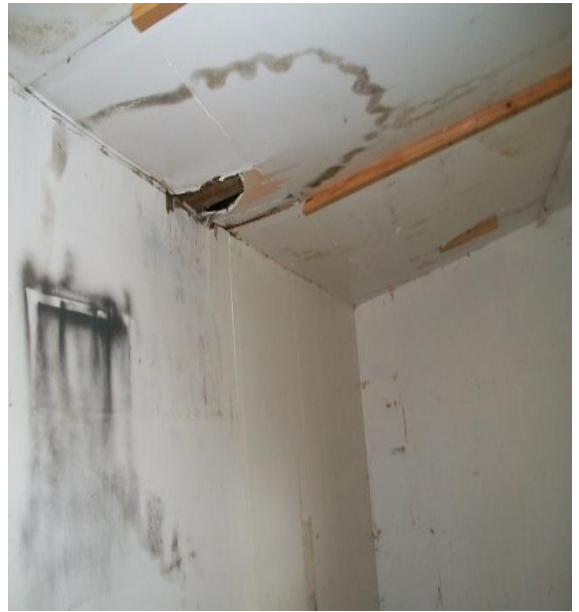
- 1) No earthquake-related damage was observed during our site inspection.
- 2) Cracking along the grain of vertical timber planks in all walls at nail locations. This is not believed to be earthquake-related damage due to the age of the structure.
- 3) Gaps opening up between walls and external timber cladding members. This is not believed to be earthquake-related damage due to the age of the structure.
- 4) Evidence of water damage was noted by sagging ceiling cladding. This is not believed to be earthquake-related damage.

Photo 6: Water damage on the southern area of the ceiling noted due to sagging ceiling cladding panels.

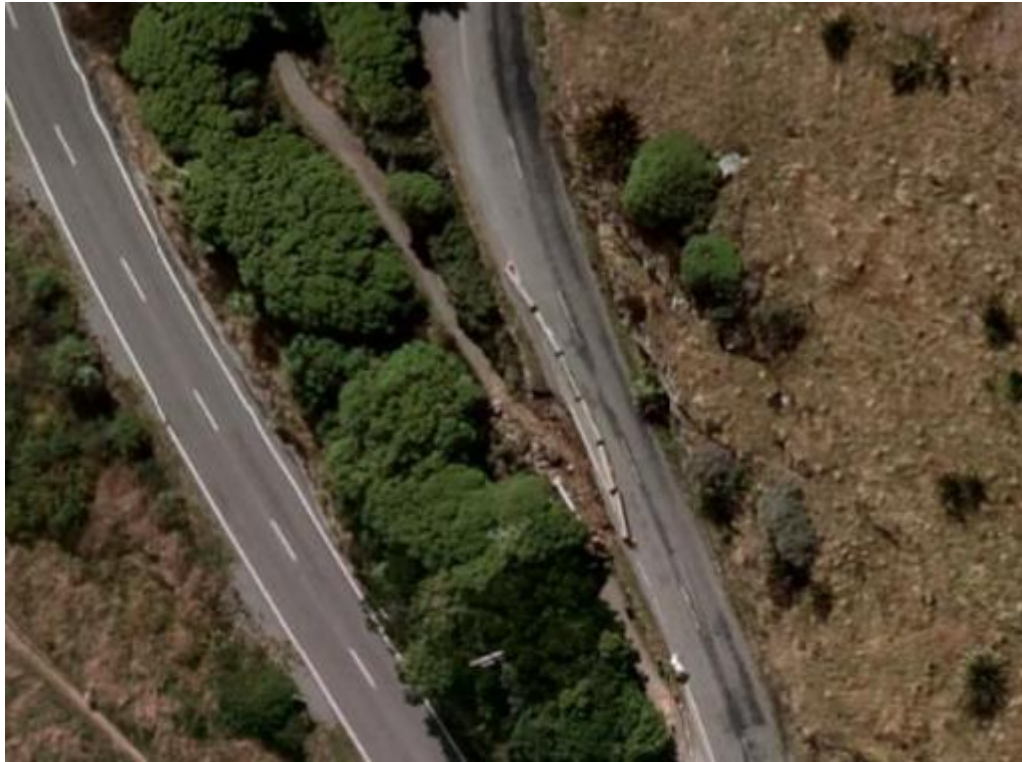
■ **Figure 4 Aerial photograph showing failure of slope near shoulder of Summit Road**

Failure of the slope near the shoulders of Summit Road could be seen from Figure 4, it is believed this failure occurred after the earthquake on 4 September 2010. The Summit Road to the west was closed following the February 22nd 2011 earthquake due to high risk of rock fall, it is expected that this site is likely to have a low to moderate boulder roll risk.
